PRE-RENO
DESIGNATED SUBSTANCE SURVEY

HVAC Systems Revisions &
Hot Tank Replacement

Disco Yard, Building A
150 Disco Road, Toronto, ON

Project No. FE 24-14192

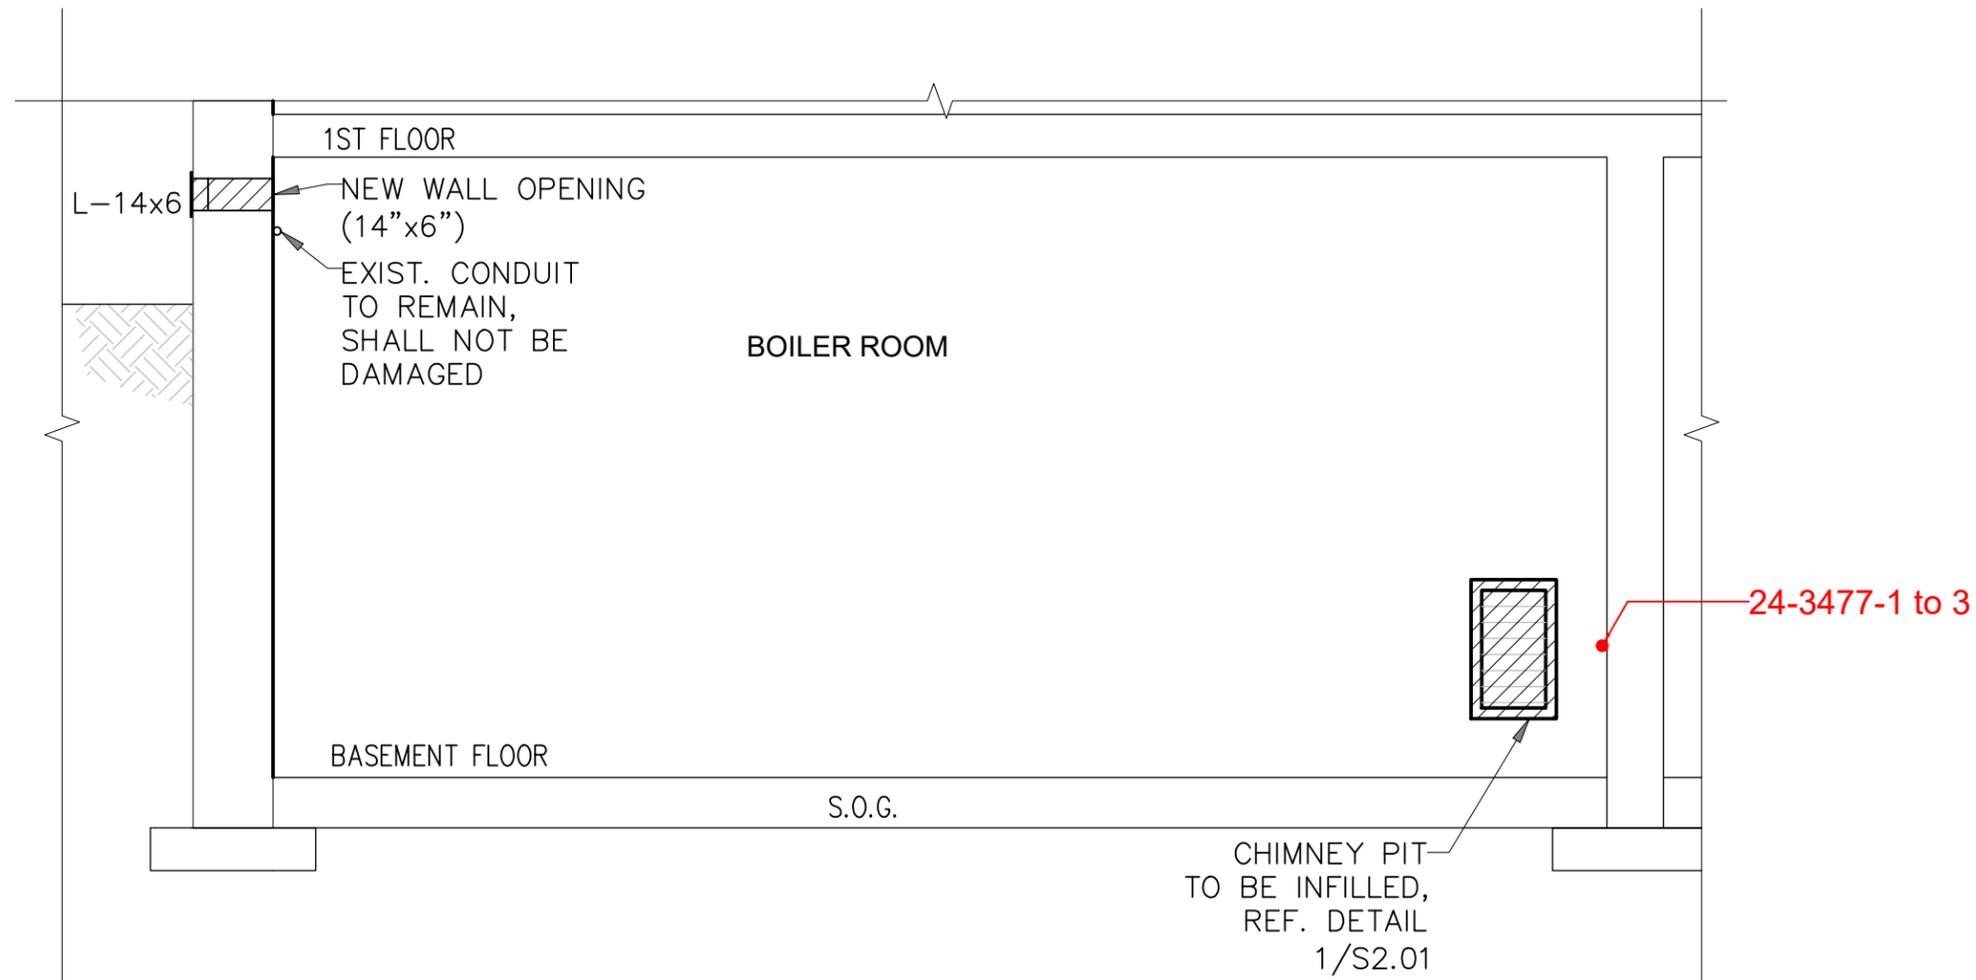
Figure 1

Asbestos Sample Locations -
Building A - Basement

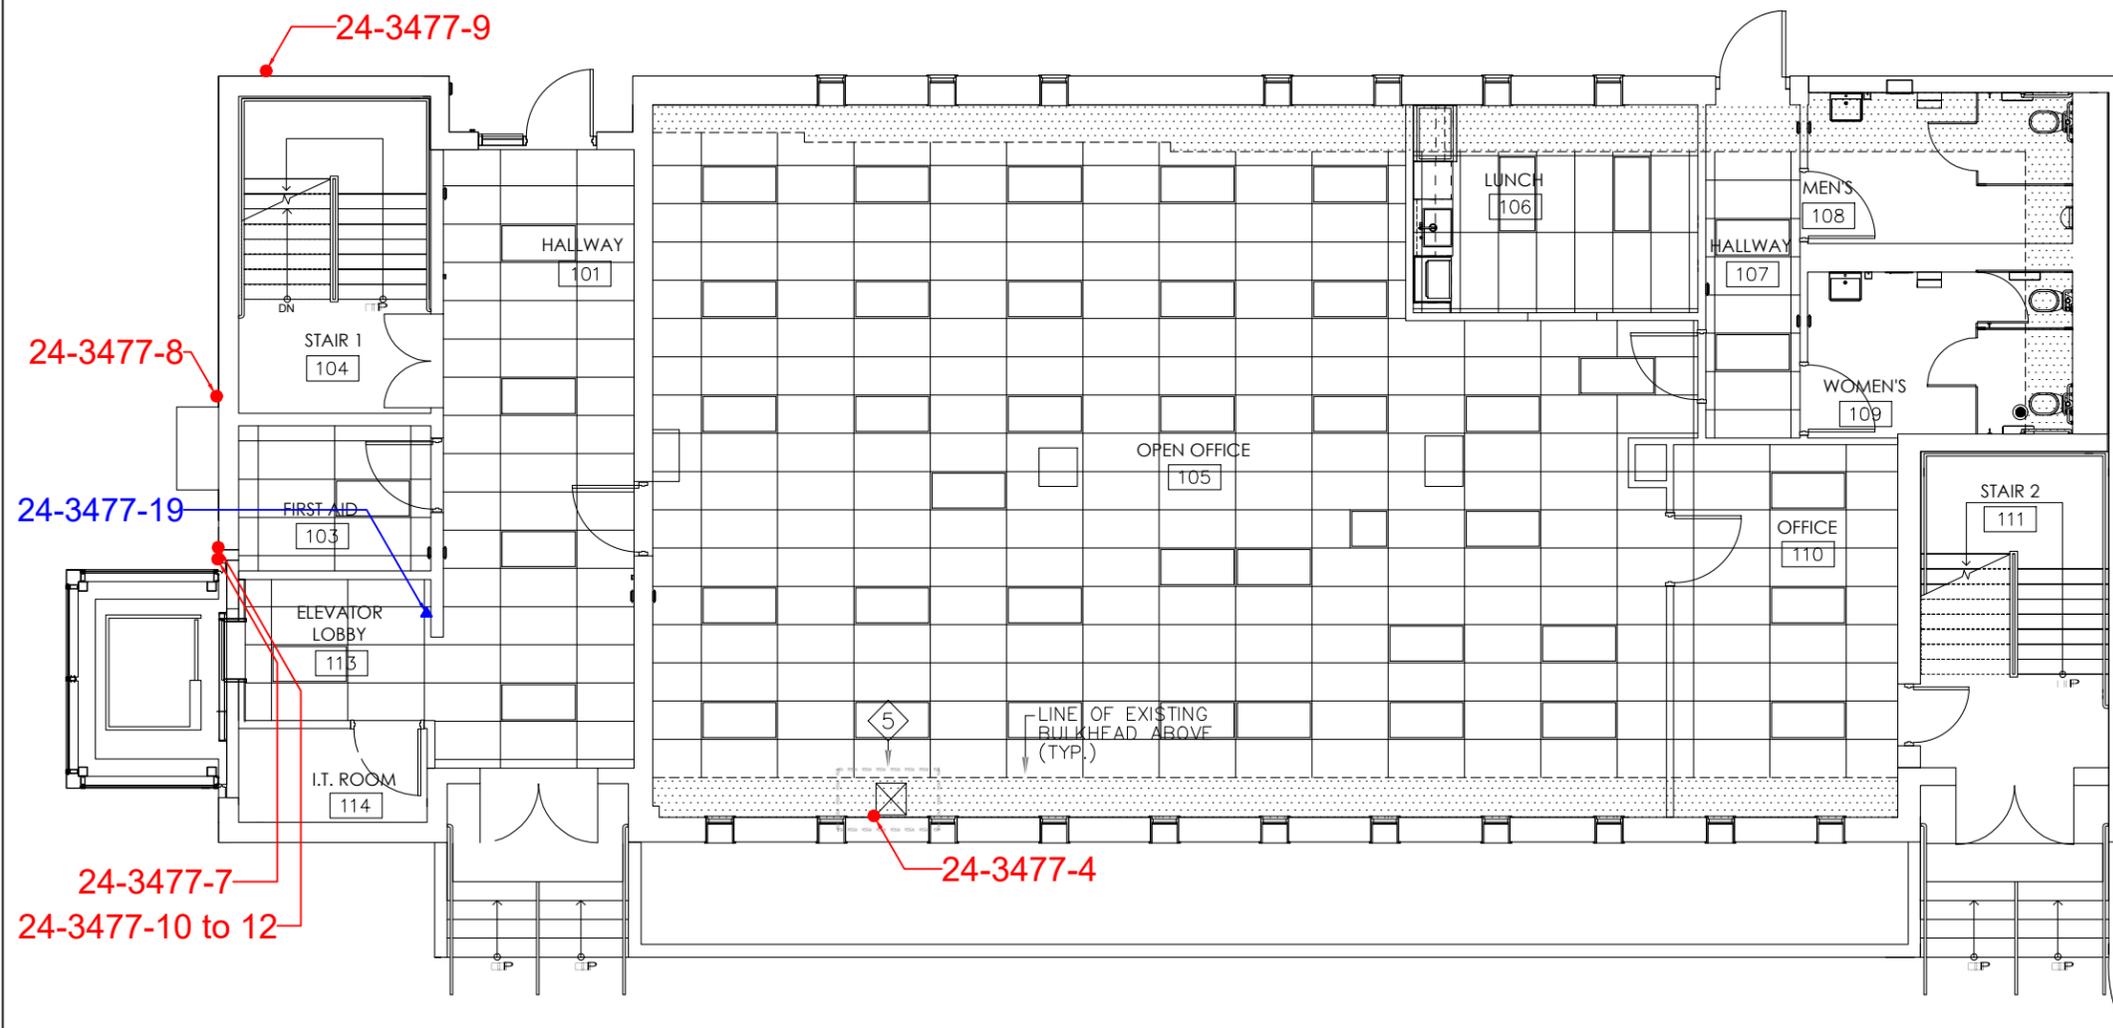
Figure 2

Asbestos and Lead Sample Locations -
Building A - Ground Floor Plan

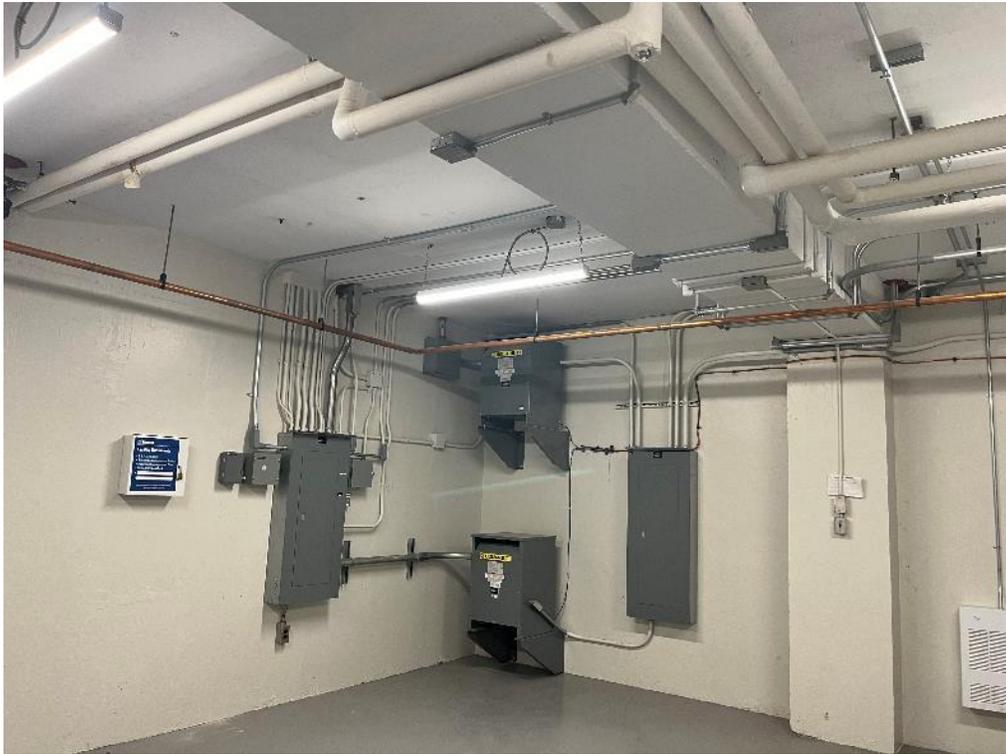
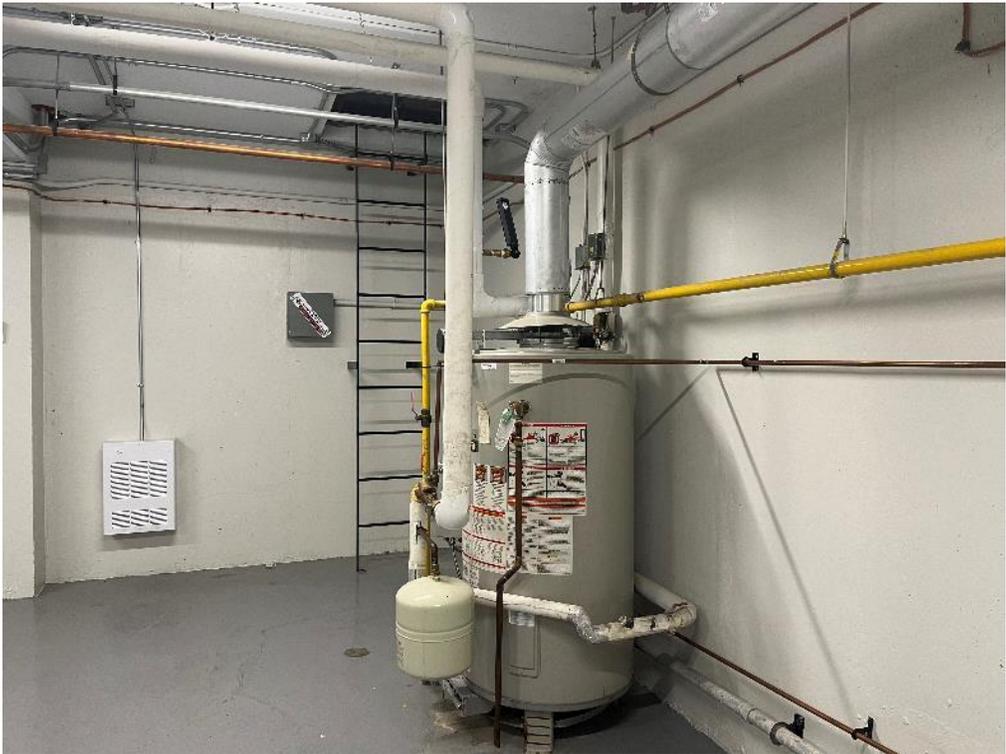
- Fibreglass insulation was observed on the pipes in the Boiler Room; this material is non-asbestos-containing.
- PVC pipe fittings covers were observed in the Boiler Room; this material does not contain asbestos.
- Ductworks in the ceiling space throughout the building were observed without any insulation.

Photos 1, 2 – General view of the Boiler Room.

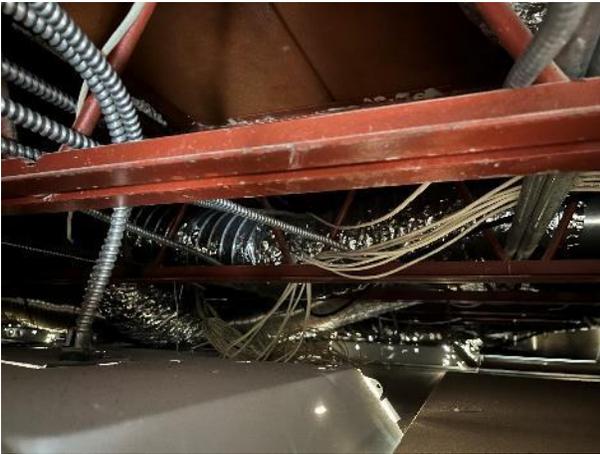
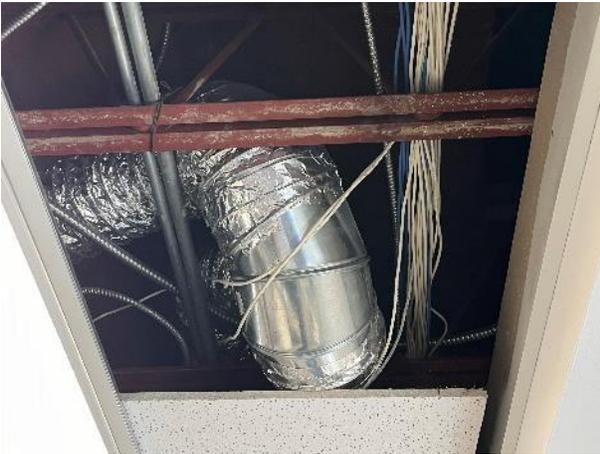
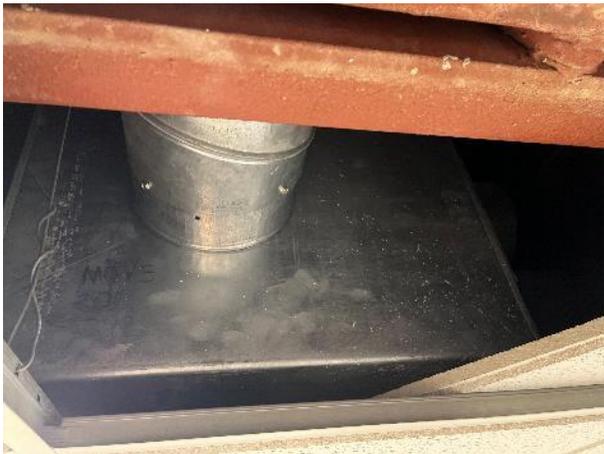
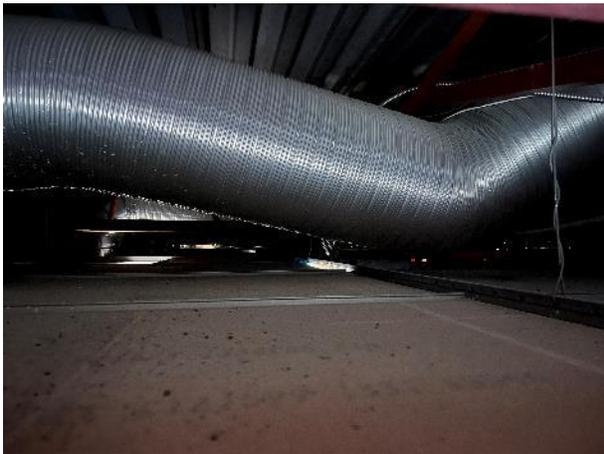
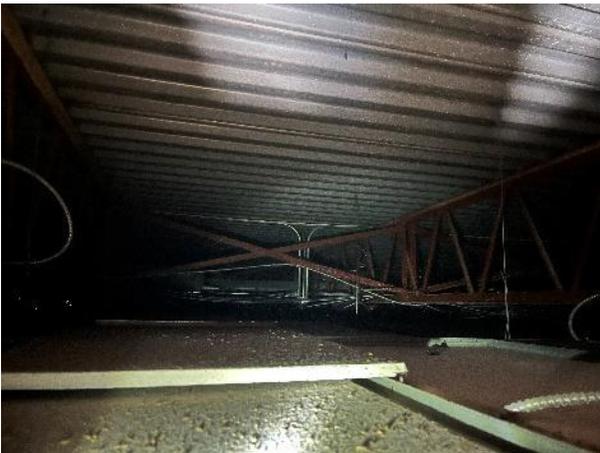
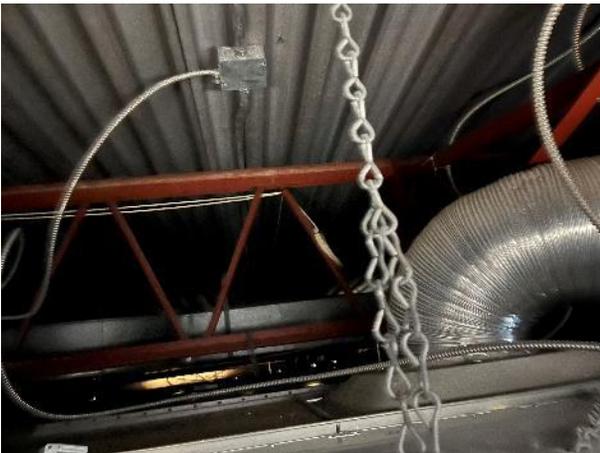
Photos 3 to 8 – View of ductworks in the ceiling space.
