## **Hazardous Building Materials Assessment (Pre-construction)**

Burlington City Hall  
5<sup>th</sup> and 6<sup>th</sup> Floor Washrooms  
426 Brant Street, Burlington,  
Ontario

November 16, 2023

Pinchin File: 320578.008

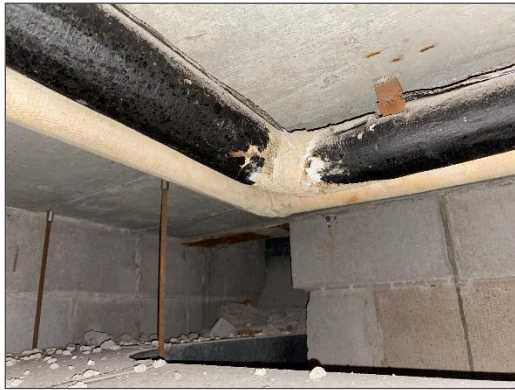
Photo 1

Parging cement, containing asbestos, is present on pipe fittings (elbows) on water system pipes in the assessed area (samples S0036A-C, photos 1 and 2).

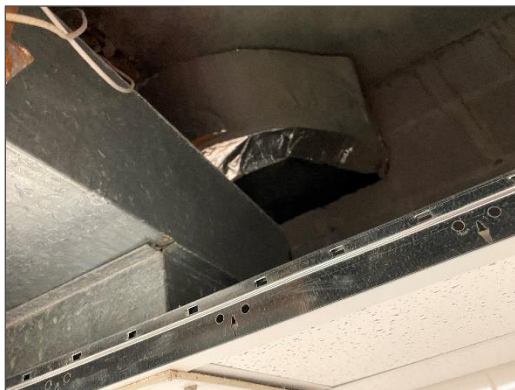
Photo 1

Ducts are uninsulated (photo 1).

Dust within ducts and fan units was previously sampled in the building and determined to be non-asbestos. However, as per O.Reg. 278/05 (Section 12 (4) 3), cleaning and or removal of air handling equipment and ducts in a building with asbestos-containing spray-applied fireproofing is considered an asbestos operation and proper asbestos procedures are required.

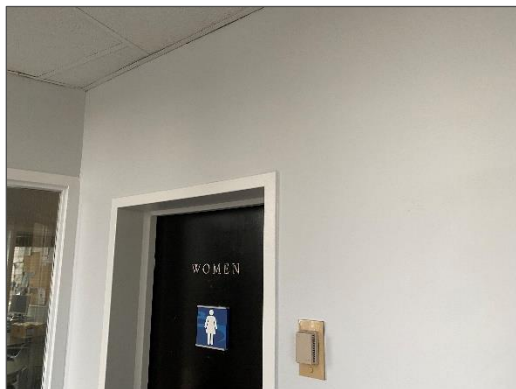
Photo 1

Plaster, containing asbestos in the base layer, is present on walls and ceilings (samples S0001A-C, lab ID 10016431, S0037A-C, lab ID 10036482 photos 1 and 2).
