## **Hazardous Building Materials Assessment (Pre-construction)**

3185 Mavis Road,  
Mississauga, Ontario

Pinchin File: 345030.000

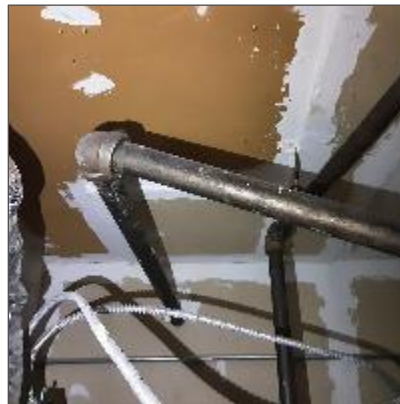
Non-insulated piping, Open Office Area (Loc. 27).

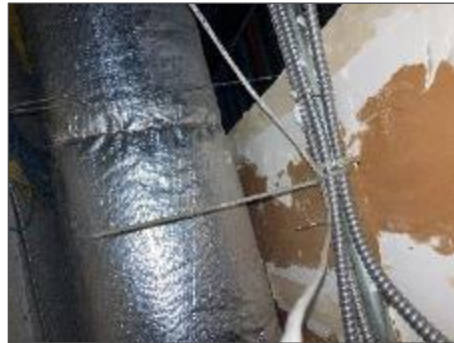
Non-asbestos fibreglass insulated duct, Open Office Area (Loc. 27).

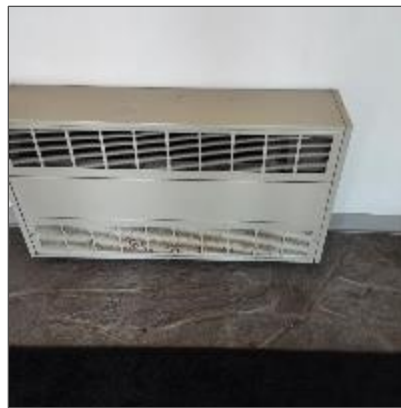
Uninsulated unit heater, Entrance Vestibule (Loc. 48).

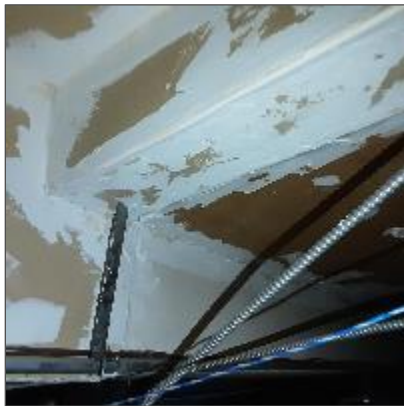
Non-asbestos drywall joint compound on the ceiling above acoustic ceiling tiles, Open Office Area (Loc. 27).

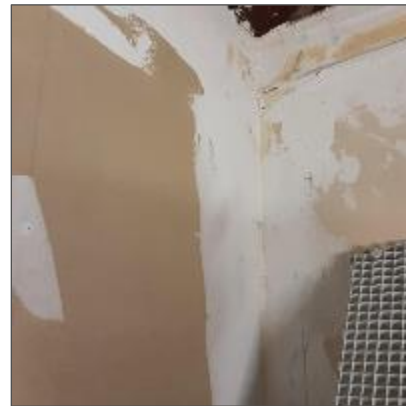
Non-asbestos drywall joint compound on wall finishes, Elevator Pit (Loc. 50).

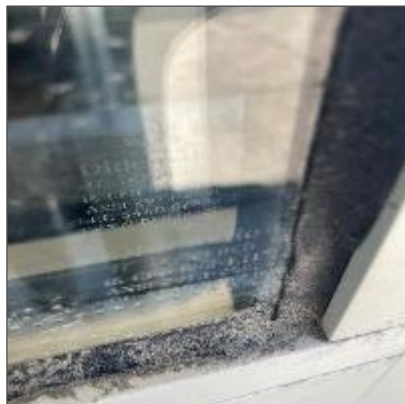
Black butyl sealant at the door frame in the Entrance Vestibule (Loc. 48) does not contain asbestos based on the age of installation of the door (2015).

Date stamp on the door (dated 2015), Entrance Vestibule (Loc. 48).

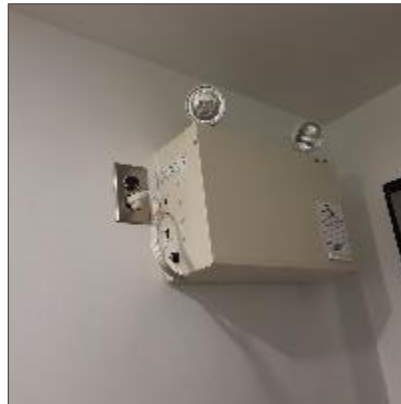
Lead-containing batteries are present in emergency lighting.

Lead-containing batteries in emergency lighting, Men's Washroom (Loc. 31).

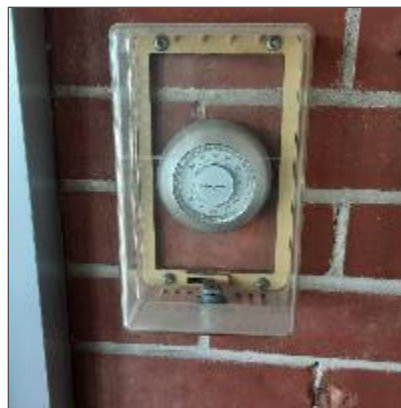
Mercury is present as a liquid in thermostats ampules.

Thermostat with mercury-containing ampule, Entrance Vestibule (Loc. 48)

Do not break lamps or separate liquid mercury from components. Recycle and reclaim mercury from fluorescent lamps and thermostats when taken out of service. Mercury is classified as a hazardous waste and must be disposed of in accordance with applicable regulations.

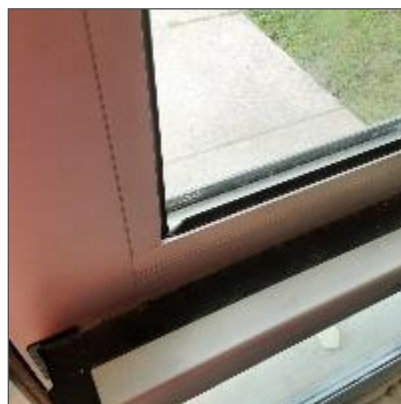
PCBs were banned in 1980; however, are found to be present in caulking and sealants until 1985. Black butyl sealant in the assessed area was installed in 2015 (based on the date stamp present on the door) and is not suspected to contain PCBs.

Non-PCB black butyl sealant, Entrance Vestibule (Loc. 48).

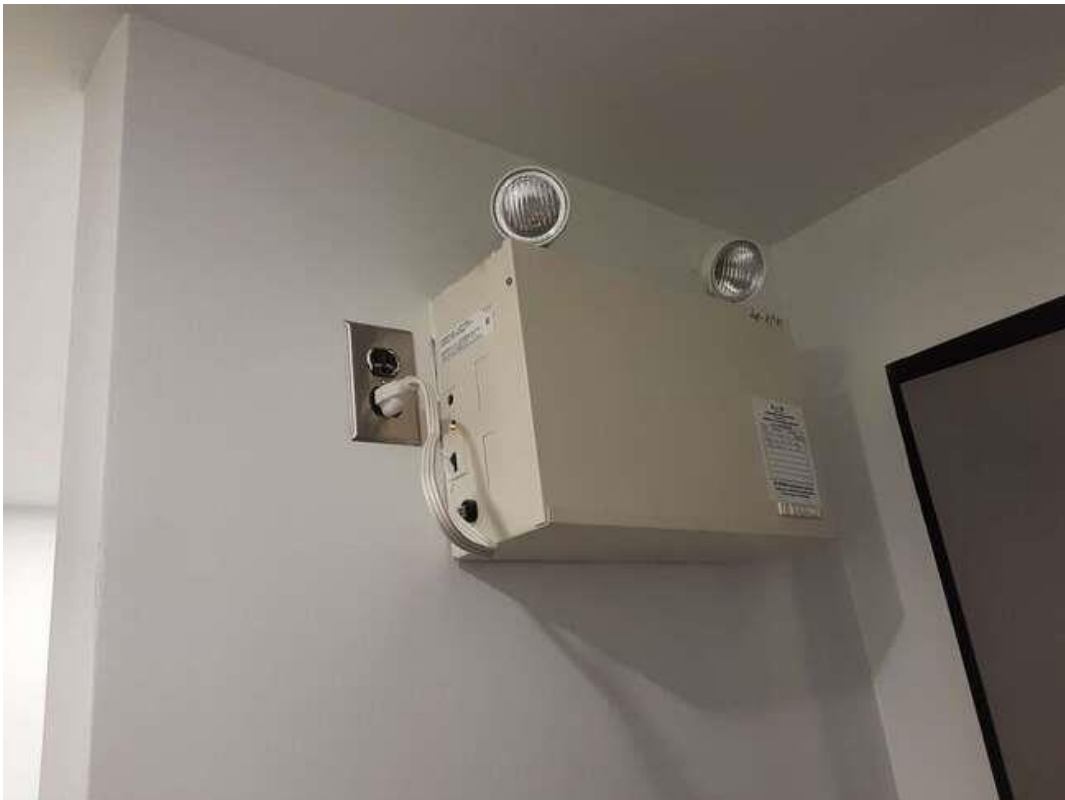
Pb Products, V9000(Yes), BATTERIES IN EMER. LIGHTS, Men's Washroom (Location #: 31).

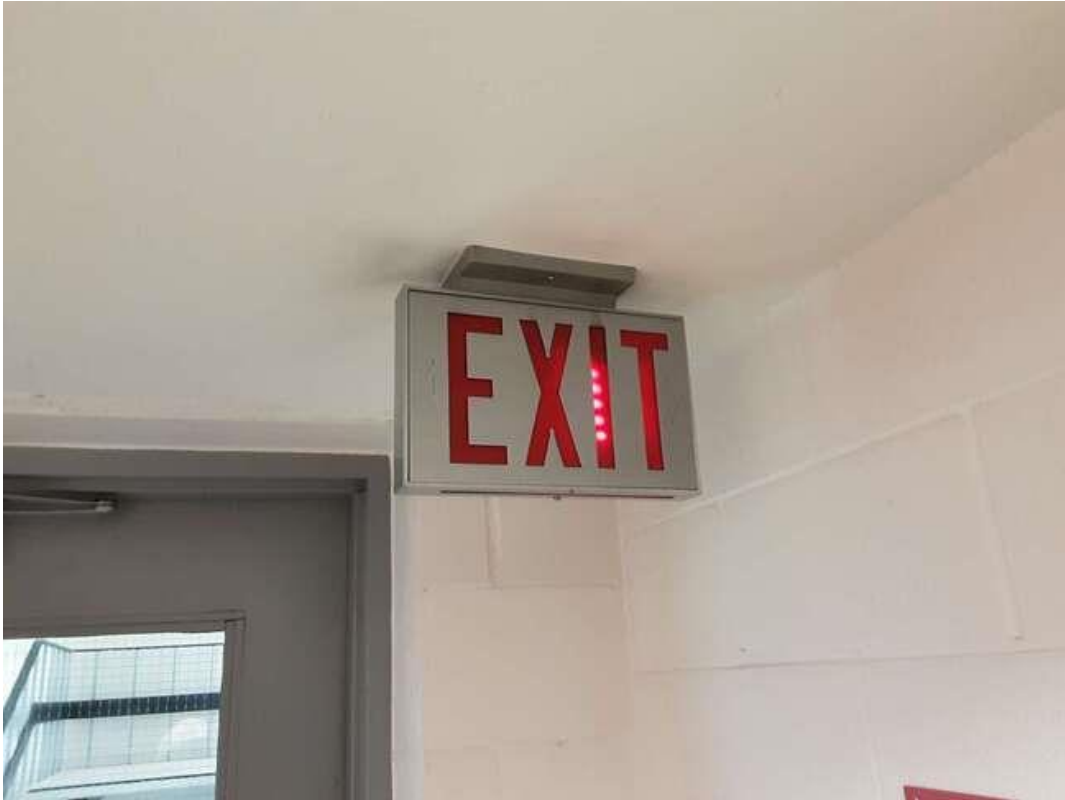
Pb Products, V9500(Presumed), BATTERIES IN EMER. LIGHTS, Corridor Men's (Location #: 47).

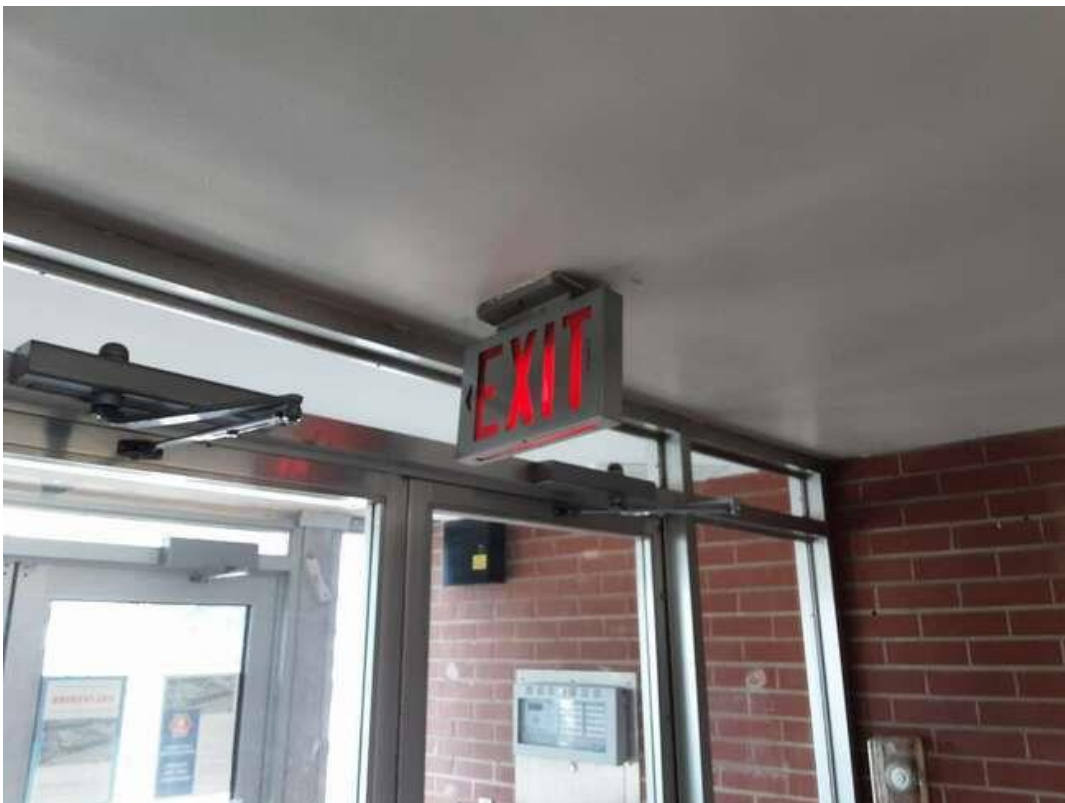
Pb Products, V9500(Presumed), BATTERIES IN EMER. LIGHTS, Entrance Vestibule (Location #: 48).

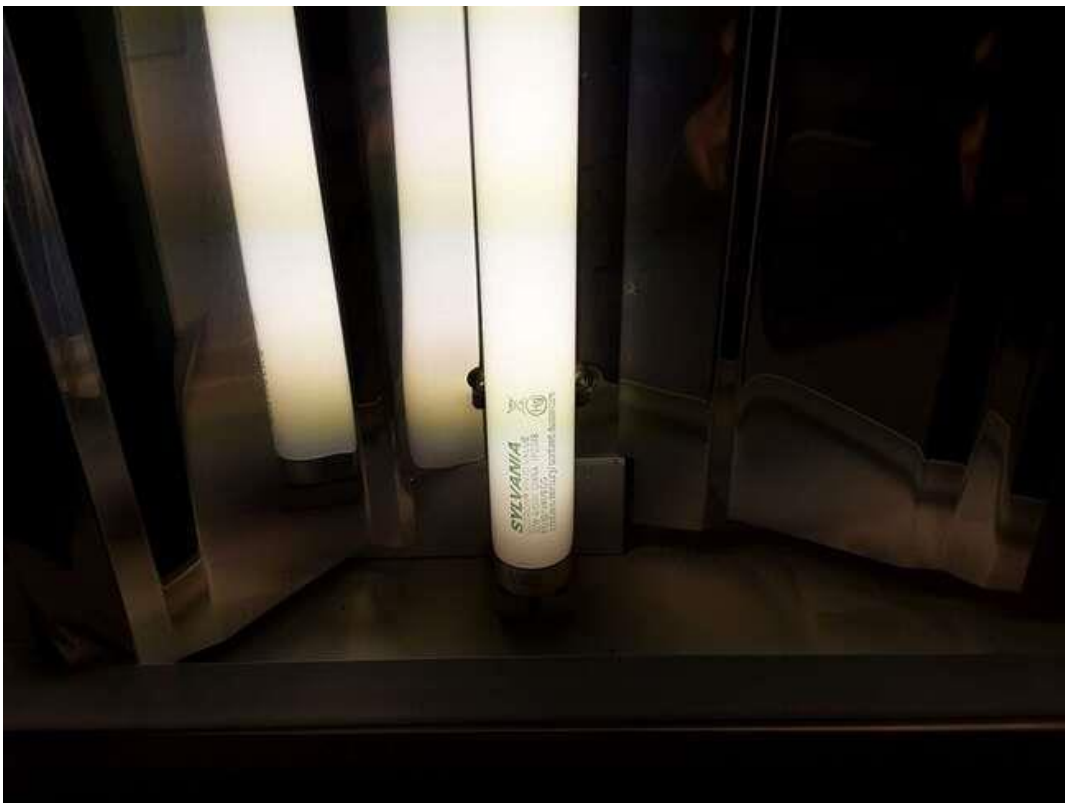
Mercury, V9000(Yes), LIGHT FIXTURE, T8, Corridor Men's (Location #: 47).

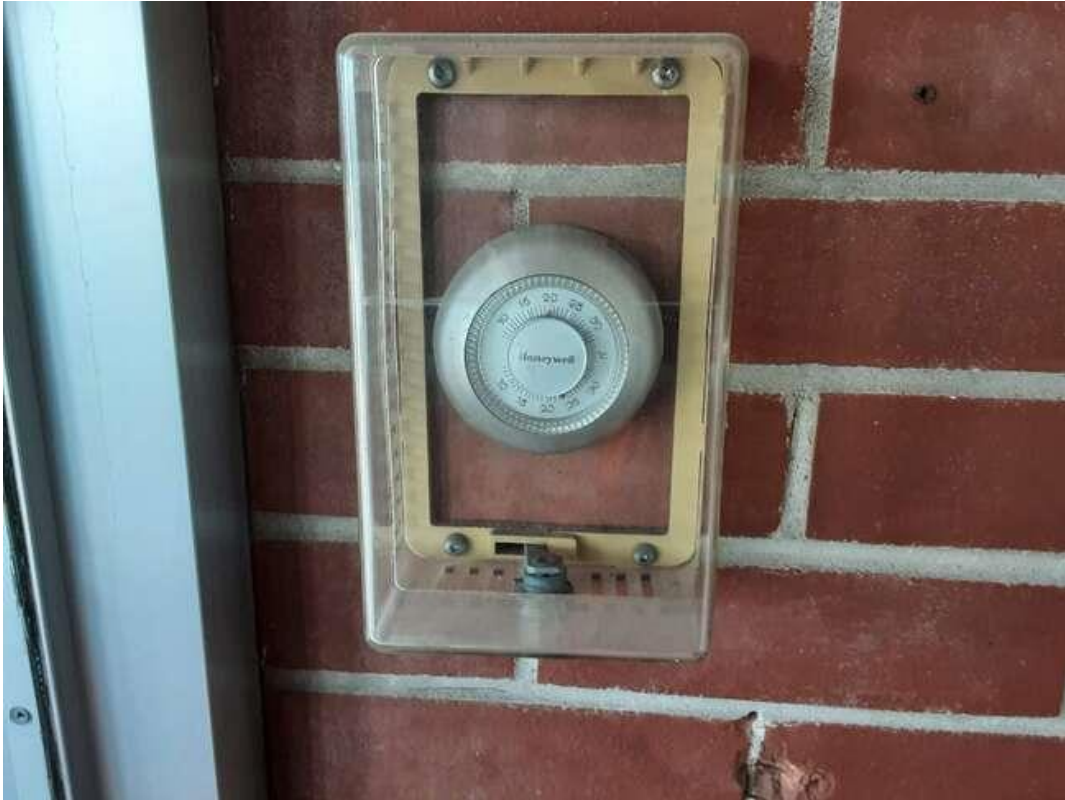
Mercury, V9000(Yes), THERMOSTAT, Entrance Vestibule (Location #: 48).

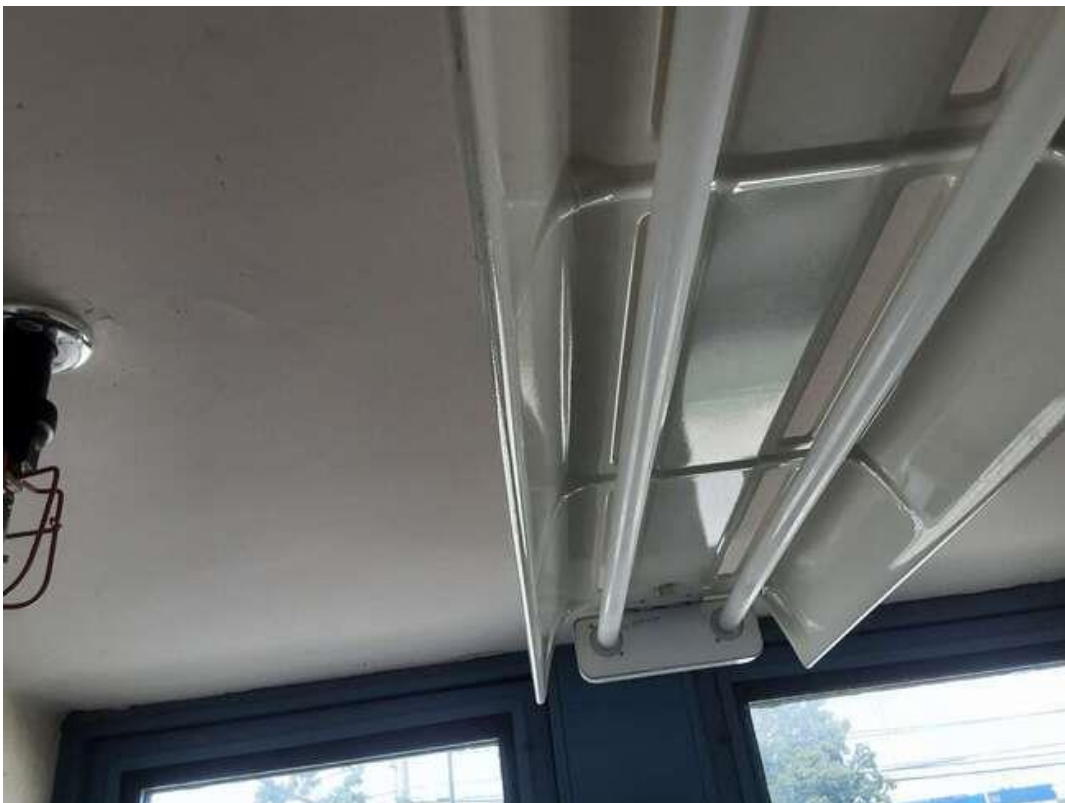
Mercury, V9000(Yes), LIGHT FIXTURE, T8, Sprinkler Room (Location #: 49).
