## **Hazardous Building Materials Assessment (Management)**

Mavis Works Yard South –  
Office – MW1  
3185 Mavis Road,  
Mississauga, Ontario

August 2, 2023

Pinchin File: 325772.000

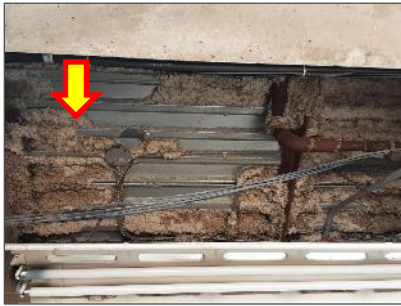
Non-asbestos fireproofing on structure in the Service Bay (Location 32).

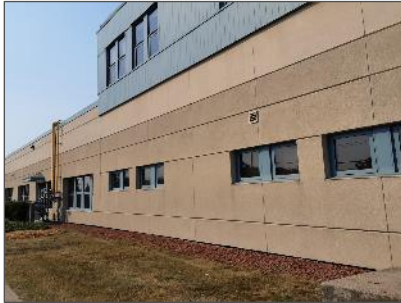
Non-asbestos stucco exterior cladding (Location 41).

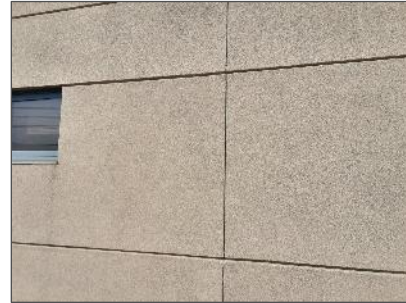
Non-asbestos stucco exterior cladding (Location 41).

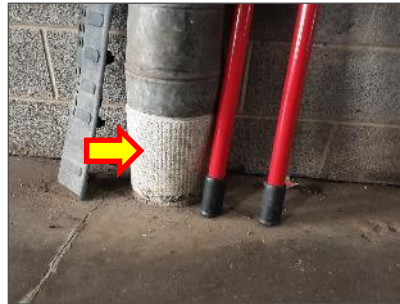
Cement pipe (Transite), presumed to contain asbestos based on visual observation, is present on ducts/pipes in the Service Bay (Location 32). Concealed Transite pipe is presumed present under the concrete floor slabs throughout the building.

Transite pipe in the Service Bay (Location 32).

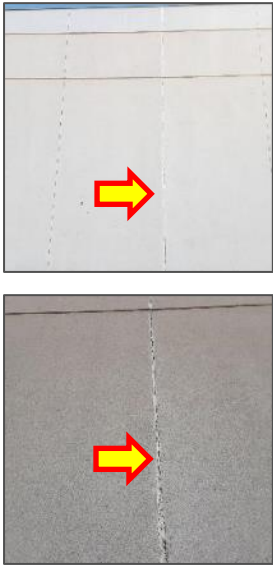
Material, Description and Application	Sample Location (Location #)	Sample Number	Asbestos	Photo
Caulking, white, at wall expansion joint	Exterior (Location 41)	S0026A-C	No

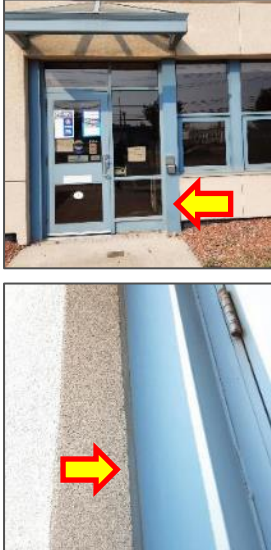
Material, Description and Application	Sample Location (Location #)	Sample Number	Asbestos	Photo
Caulking, blue, between window frame and wall	Exterior (Location 41)	S0027A-C	No

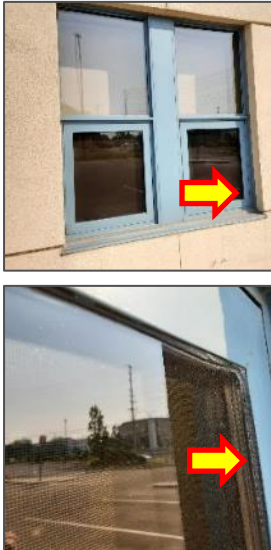
Butyl sealant, black, between window frame and glass pane	Exterior (Location 41)	S0028A-C	Yes

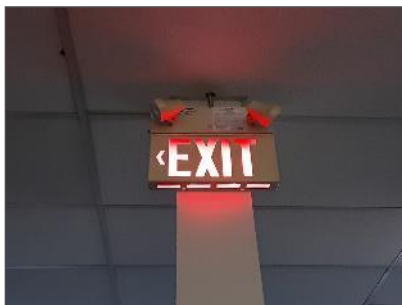
Emergency light with lead-containing battery in the Men's Change Room (Location 8).

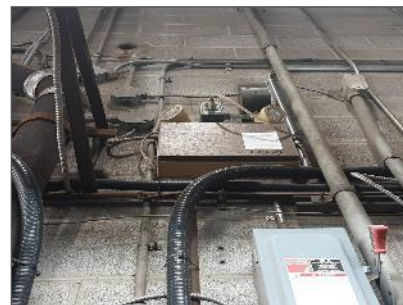
Emergency light with lead-containing battery in the Service Bay (Location 32).

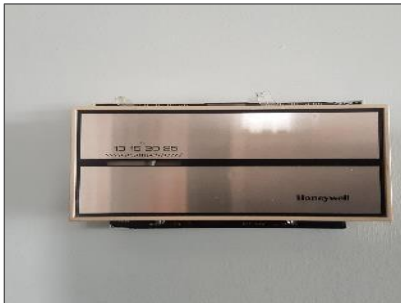
Mercury-containing thermostat in the Office (Location 5).

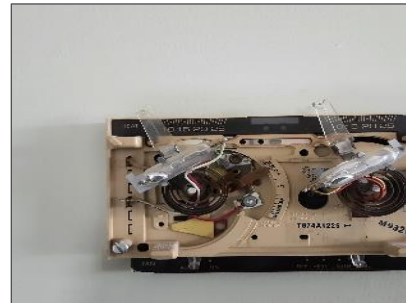
Mercury-containing thermostat in the Office (Location 5).

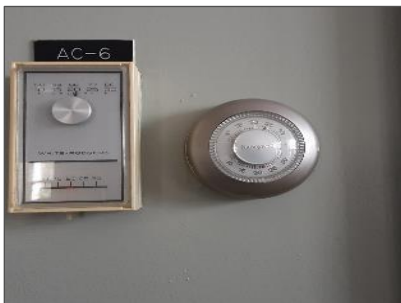
Mercury-containing thermostat in the Office (Location 5).

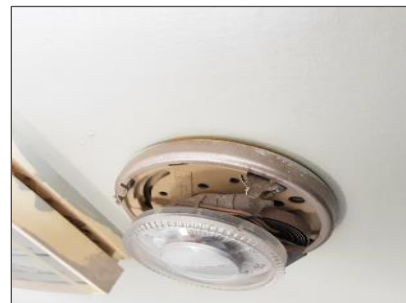
Mercury-containing thermostat in the Office (Location 5).

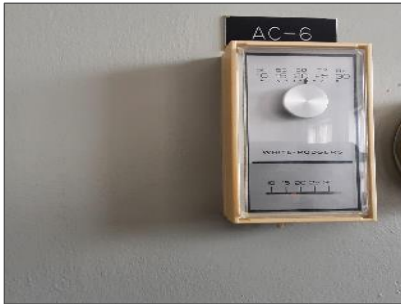
Mercury-containing thermostat in the Office (Location 5).

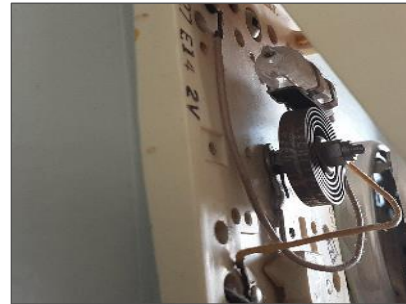
Mercury-containing thermostat in the Office (Location 5).

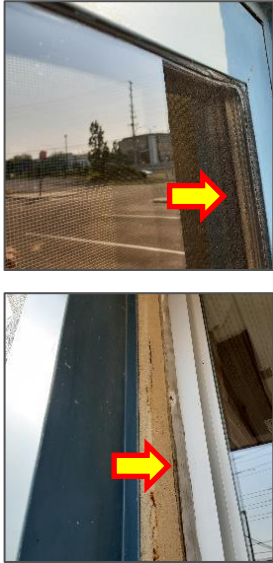
Material, Colour, Application	Sample Location (Location #)	Sample Number	PCB (mg/kg)	Photo
Exterior caulking composite sample; white caulking at wall expansion joint; blue caulking between window frame and wall; black butyl sealant between window frame and glass pane; light grey caulking between door and window frames and the wall	Exterior (Location 41)	P0001	<0.2

Caulking in the table above is considered a non-PCB solid based on the threshold (50 mg/kg).

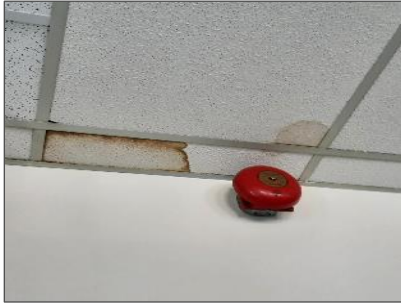
Water-stained acoustic ceiling tiles in the Office (Location 5).

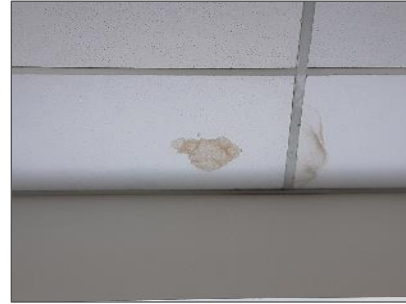
Water-stained acoustic ceiling tiles in the Men's Change Room (Location 8).

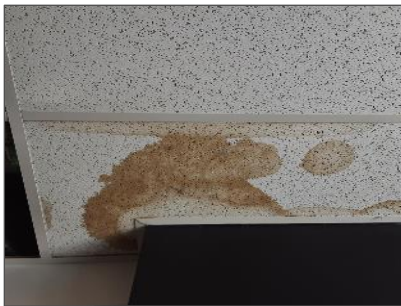
Water-stained acoustic ceiling tiles in the Corridor (Location 19).

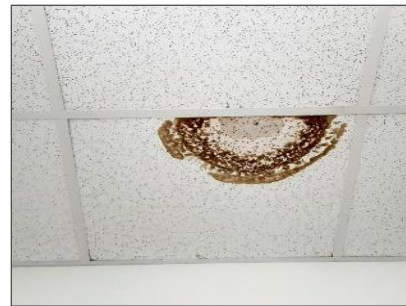
Water-stained acoustic ceiling tiles in the Corridor (Location 19).

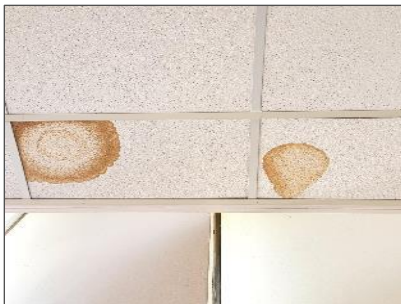
Water-stained acoustic ceiling tiles in the Staircase (Location 39).

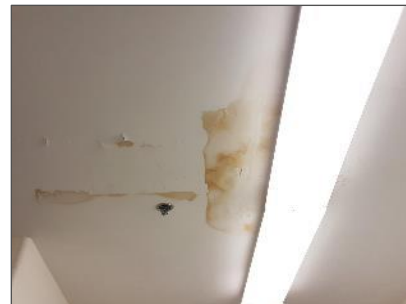
Water-stained drywall ceiling in the Men's Change Room (Location 8).

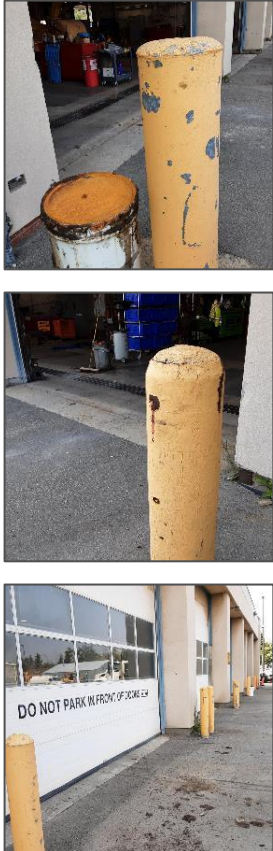
- Lead is present in paints and coatings.
- Batteries of emergency lights contain solid lead.
  - One-hundred square feet of bright yellow lead-based paint on metal and concrete safety bollards is in poor condition, peeling and flaking, at the building Exterior (Location 41).

Material, Quantity & Condition	Location	Recommended Procedure	Photo
Bright yellow lead-based paint on metal and concrete safety bollards, 100 square feet, poor condition, peeling and flaking	Exterior (Location 41)	Remove following Class 2 procedures per EACC guideline.
