Hazardous Building Materials Assessment (Pre-construction)

Roof Replacement Project
3185 Mavis Road,
Mississauga, Ontario

June 4, 2024

Pinchin File: 342395.000

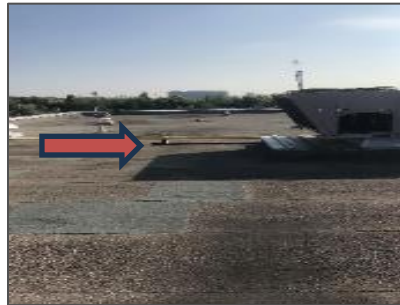
Pipes in the assessed area are either uninsulated or insulated with non-asbestos fiberglass or other non-asbestos insulation such as mineral fibre or elastomeric foam insulation.

Pipe uninsulated, South roof section.

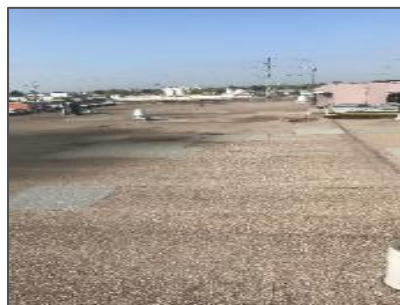
Mechanical equipment (Rooftop AC) is either uninsulated or insulated with non-asbestos fiberglass.

Roof top AC uninsulated, South roof section.

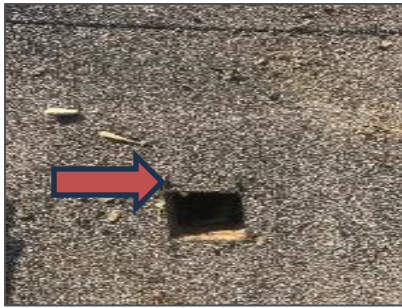
The materials associated with the built-up roof do not contain asbestos (samples S0001A-C).

Built-up roof materials, south roof section.

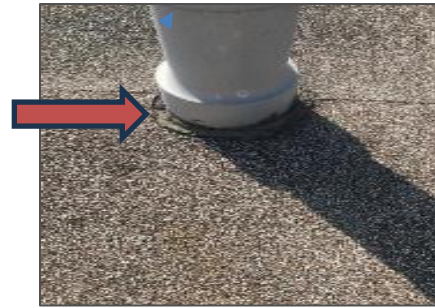
Tar and caulking are present on flashings and vent shafts on the roof does not contain asbestos (samples S0002A-C and S0003A-C).

Caulking, south roof section.

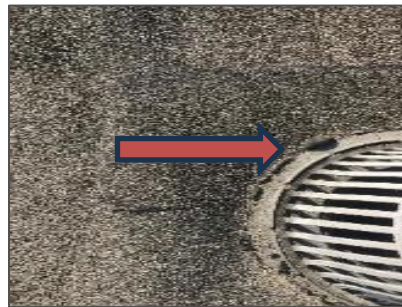
Tar, south roof section.

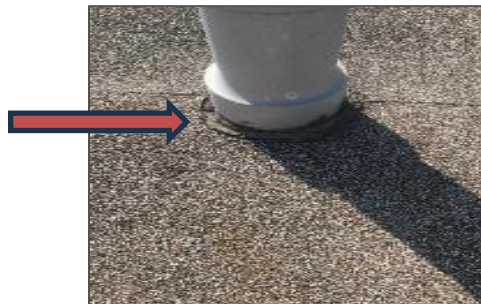
Caulking is present at base of the roof vent (samples P0001) and contains <0.1 mg/kg PCBs. The material is a non-PCB solid based on the threshold (50 mg/kg).

Caulking, South roof section.
