SURVEY FOR DESIGNATED SUBSTANCES AND HAZARDOUS MATERIALS

**Memorial Arena
69 Elliot Street
Brampton, Ontario**

**Building Code: P-097-01
ECO Project No.: 14963**

October 2 , 2015

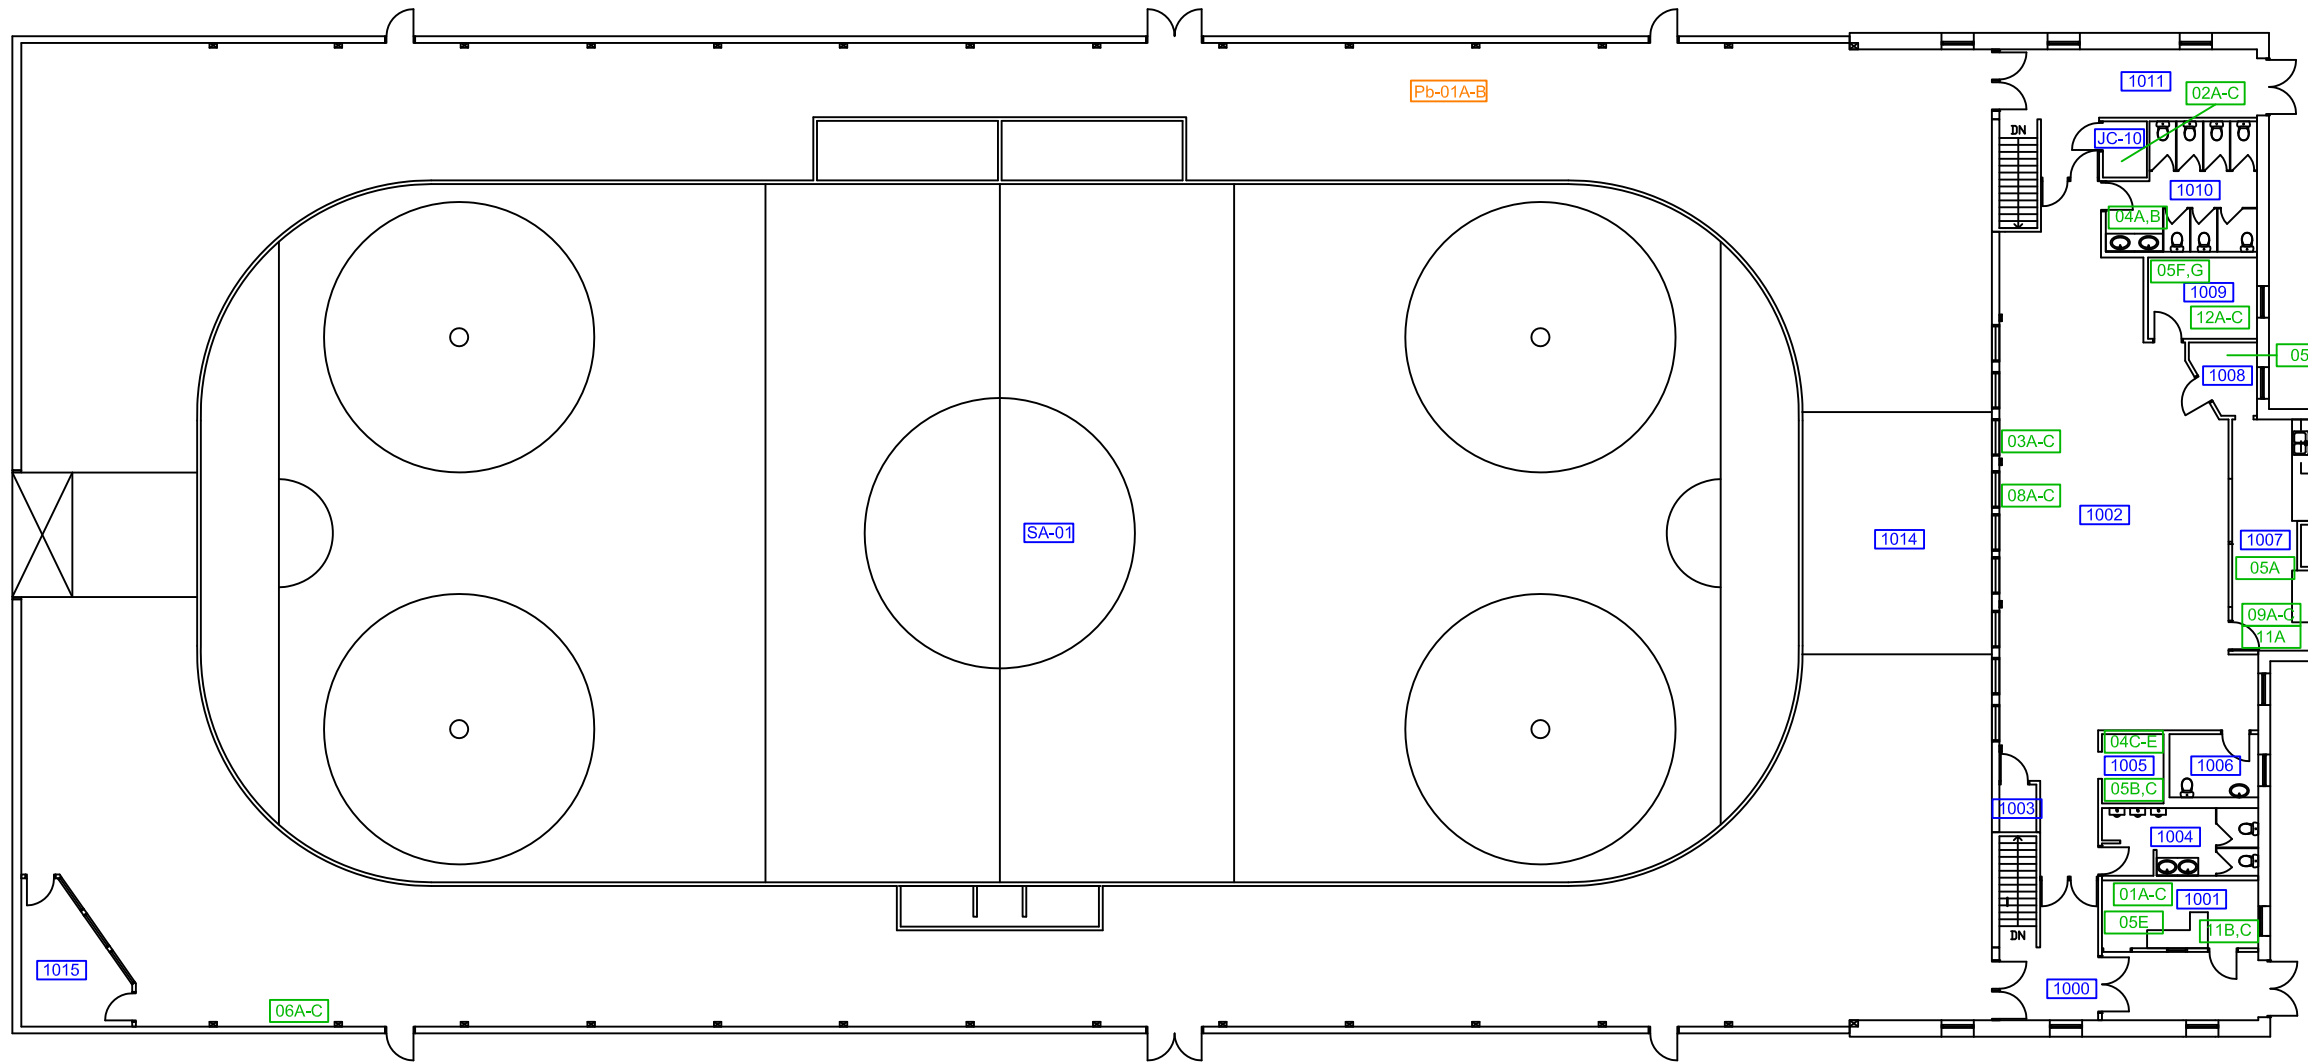
Figure 1

Ground Floor Plan
Locations of Designated Substances and
Hazardous Materials

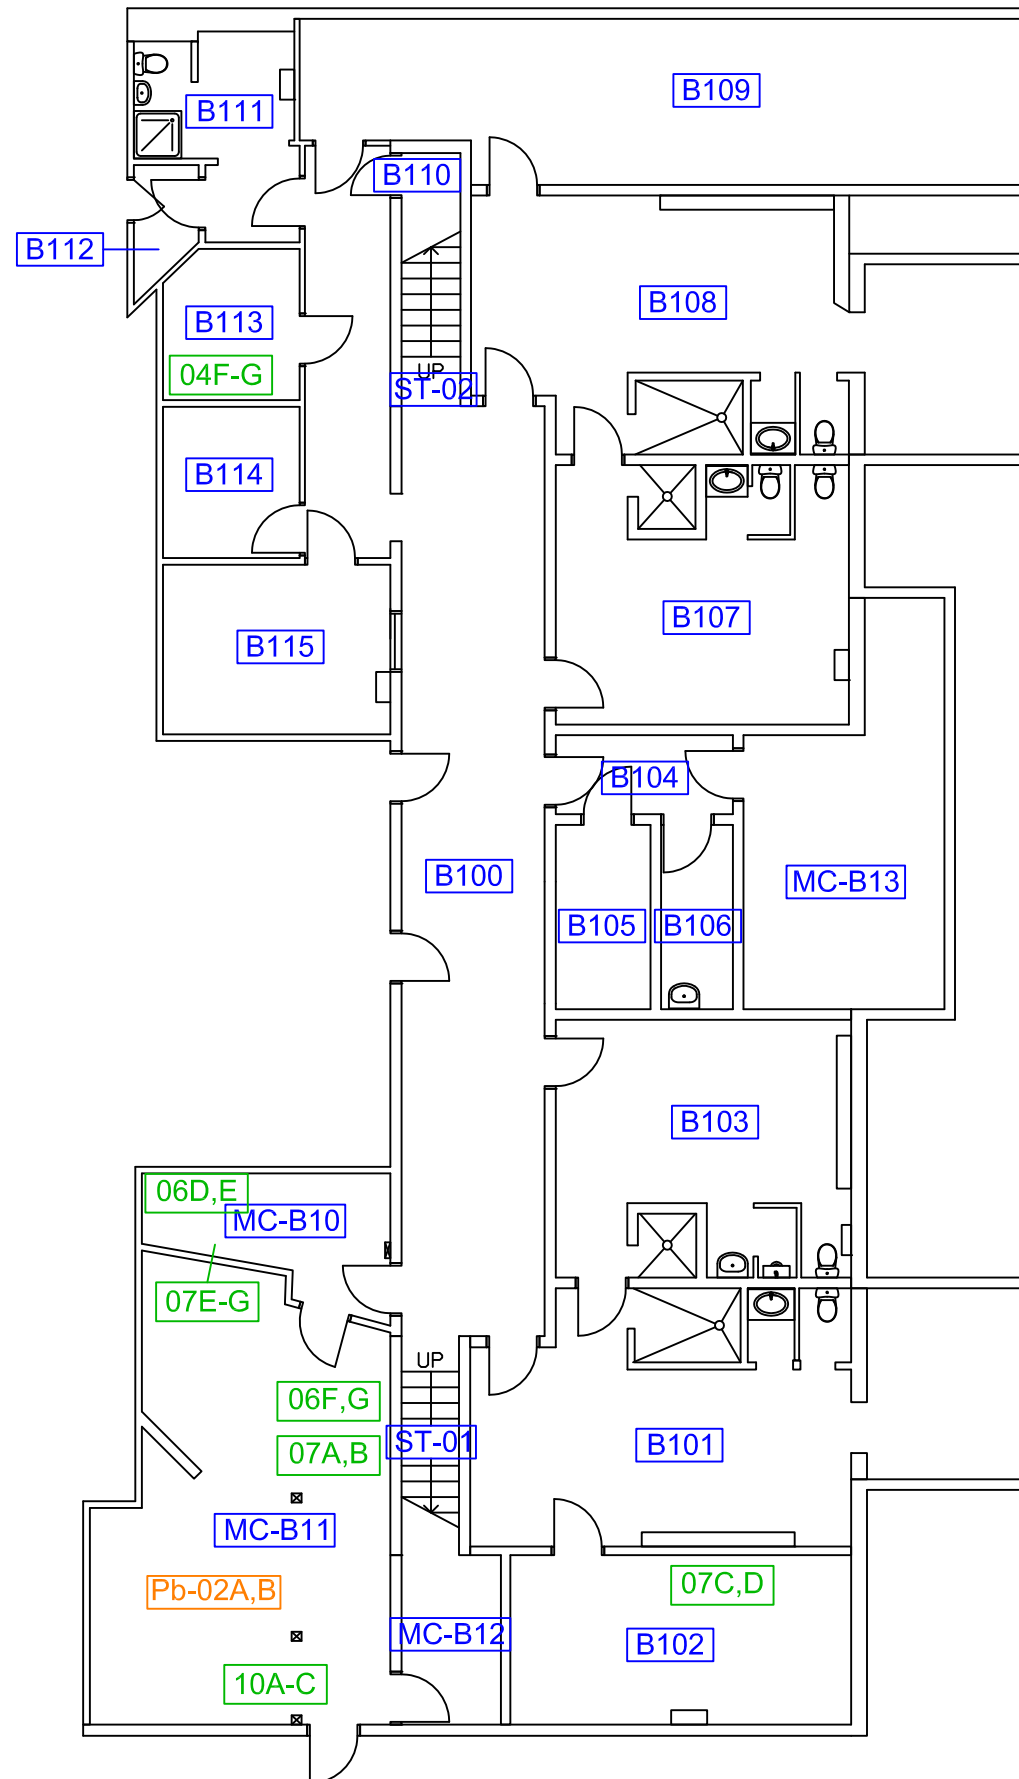
Figure 2

Basement Floor Plan
Locations of Designated Substances and
Hazardous Materials

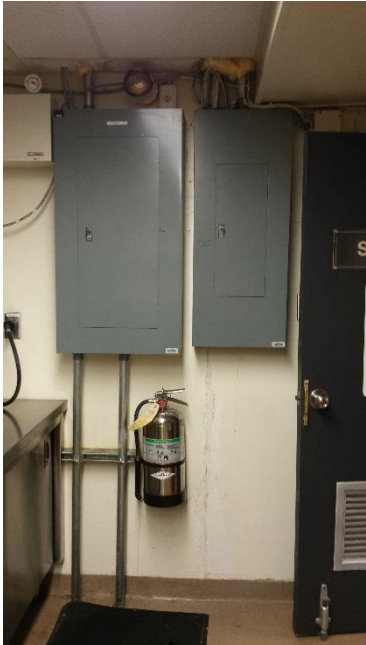
Photo No. 1.

Date: August 10, 2015	
Location: 1007 Snack Bar	
Description: 8 SF of water damage/suspect mould growth on non-asbestos drywall wall behind electrical panel.

Recommendations for Corrective Action – Asbestos, Lead, Mould					
Location Number	Location Name	Hazardous Material	Quantity and Type of Material	Recommended Action	High Level Abatement Cost
1007	Snack Bar	Mould	8 SF Water Damage/Suspect Mould on Non-Asbestos Drywall Wall	REMOVE (Level 1)	\$1 000
B110	Storage	Mould	9 SF Mould on Non-Asbestos Drywall Ceiling	REMOVE (Level 1)	\$1 000
*Estimated figures are inclusive of all costs (abatement, waste disposal, consultant inspection, reporting, etc.). Each item is estimated separately. Combining abatement items would result in significantly reduced costs.
