## **PRE-DEMOLITION DSS REPORT**

**55 JOHN STREET (NORTH SIDE)  
TORONTO, ONTARIO**

Project No. FE- 23-13156  
August, 2023

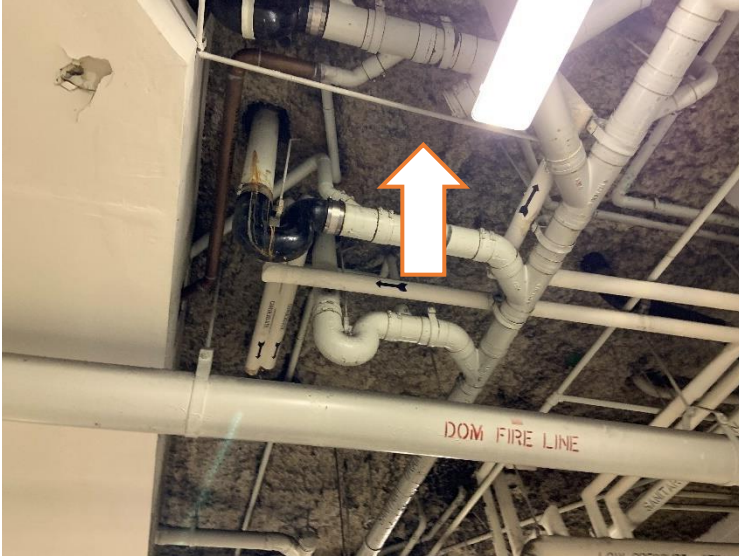
**Photo 1:**

Sprayed Fireproofing (SFP) was observed within the project area at Parking Level 1 during the survey. SFP was identified and sampled as part of the previous assessment surveys completed in 2010 and 2013 by ECOH. The previous reports confirmed that the SFP does not contain any asbestos.

View of the non-asbestos-containing SFP on the deck of the Parking Level adjacent to YMCA Kitchen.

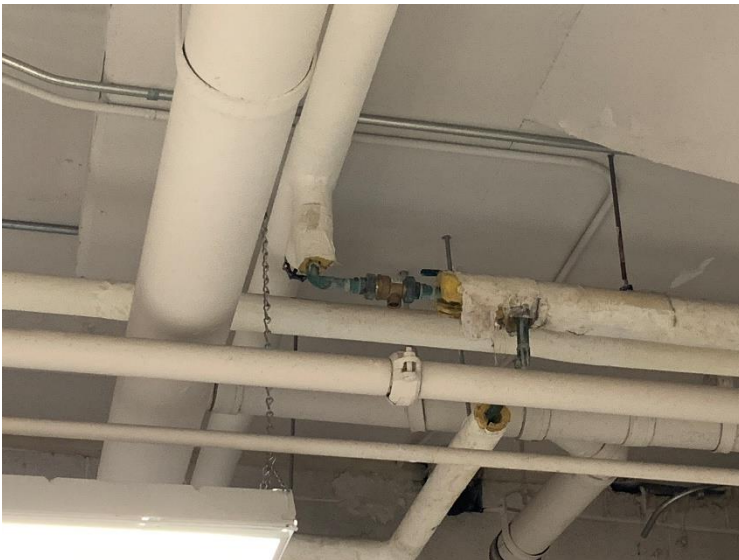
**Photo 2:**

The pipe systems observed throughout the project area are either not insulated or are insulated with fibreglass which is not suspected to contain asbestos.

Example of the fiberglass insulation pipe systems in Kitchen Storage Area (Loc. P1-33)

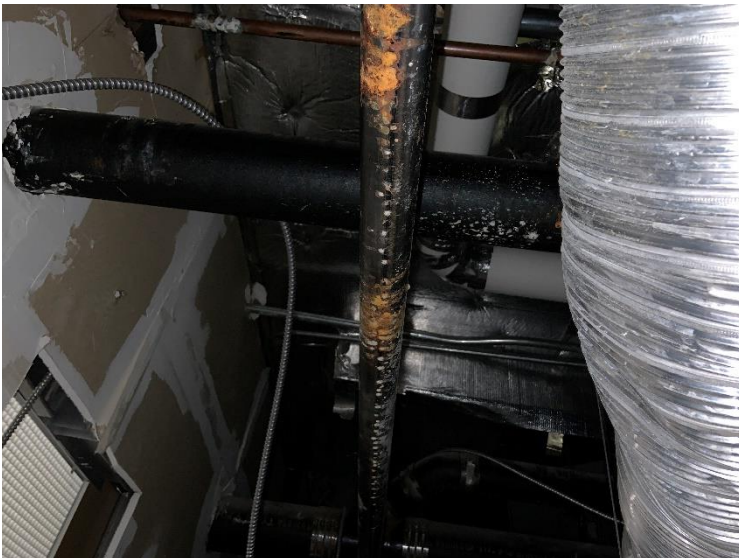
**Photo 3:**

Example of the non-insulated pipe system in the ceiling space in Men's Washroom (Loc. P1-32C).

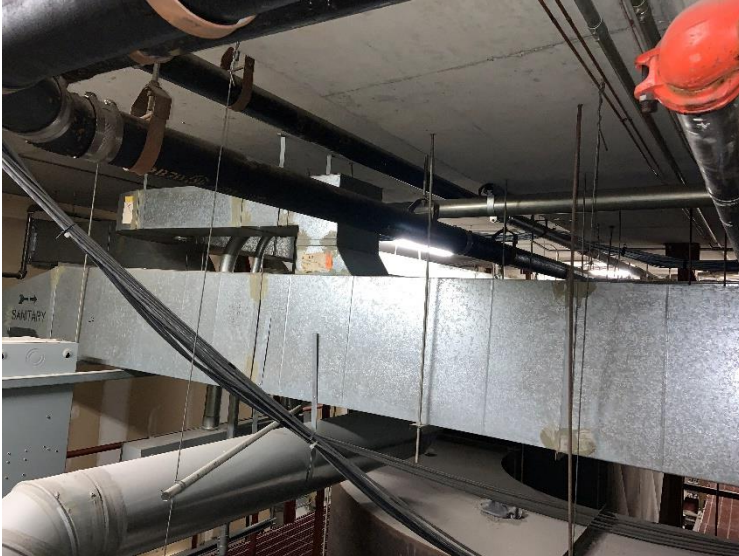
**Photo 4:**

Mechanical systems observed throughout the building are either not insulated or are insulated with fibreglass which is not suspected to contain asbestos.

Example of the non-insulated duct work in the ceiling space above the Kitchen (Loc. 1-20).

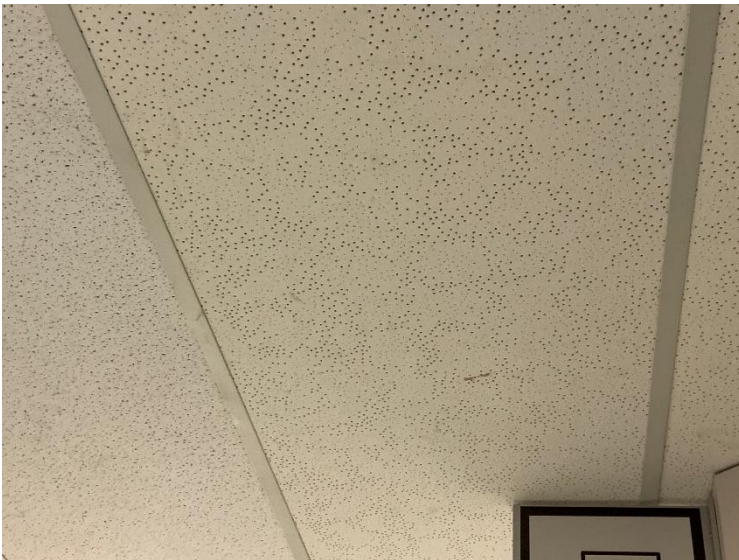
**Photo 5:**

View of the non-asbestos containing Ceiling Tile 10 (1.5'x5' Pinprick with Patterned Pinholes)

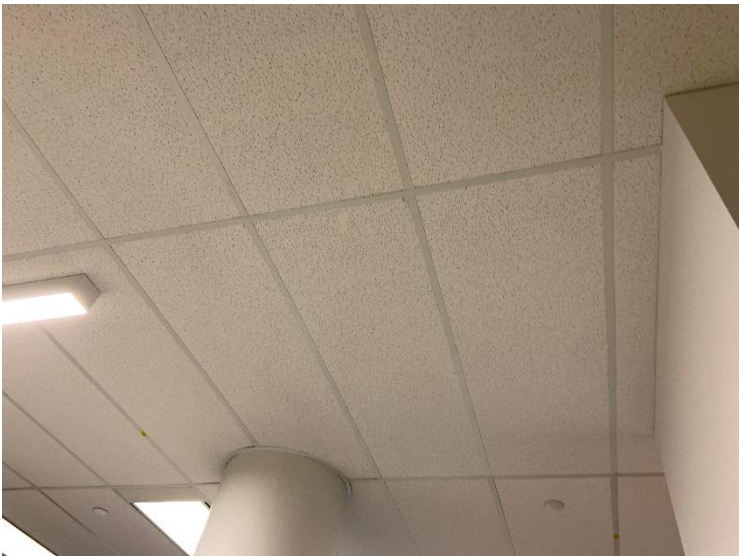
**Photo 6:**

View of the non-asbestos containing Ceiling Tile 9 (1.5'x5' Pinprick with Small Scattered Fissures)

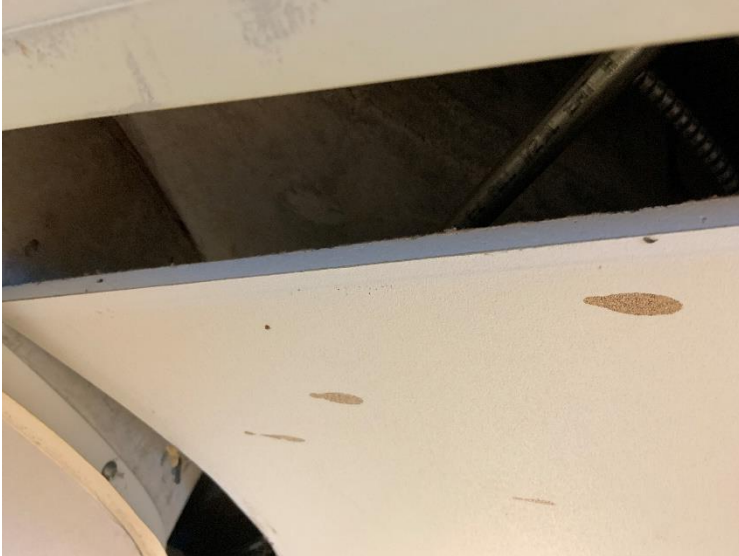
**Photo 7:**

View of the non-asbestos containing Ceiling Tile 11 (2'x4' Drywall Pieces) in Kitchen (Loc. 1-20). .

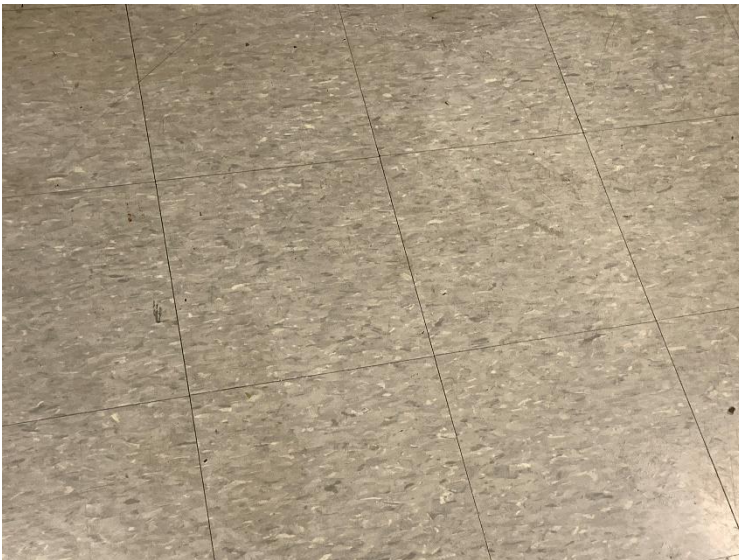
**Photo 8:**

View of the non-asbestos-containing VFT-1 12" x 12" (Grey with Dark Grey and White Marks) in the Men's Washroom (Loc. P1-32C)

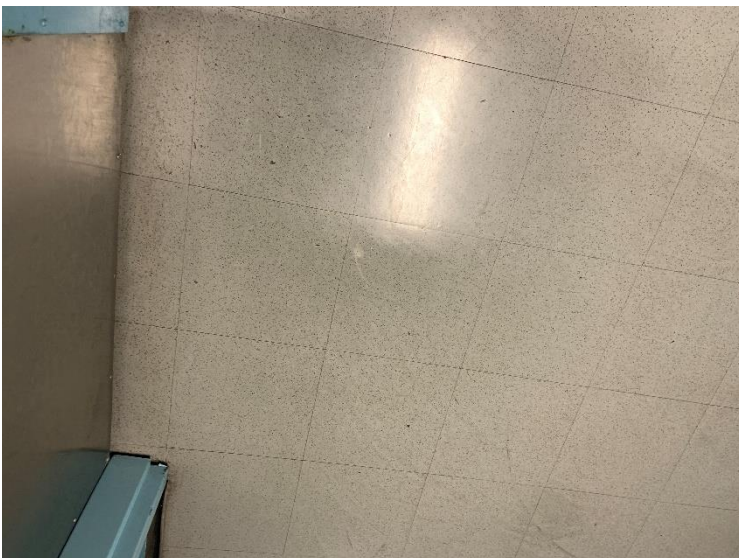
**Photo 9:**

View of the non-asbestos-containing VFT-2 (12" x 12" Beige with Black Dots) in Corridor (Loc. P1-06).

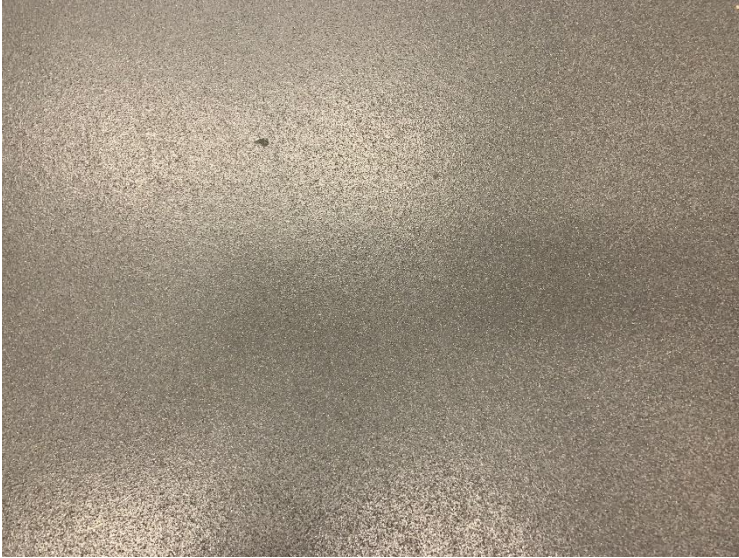
**Photo 10:**

View of the non-asbestos-containing VSF-16 (Blue with Black and Sparkle Dots) in Kitchen (Loc. 1-20)

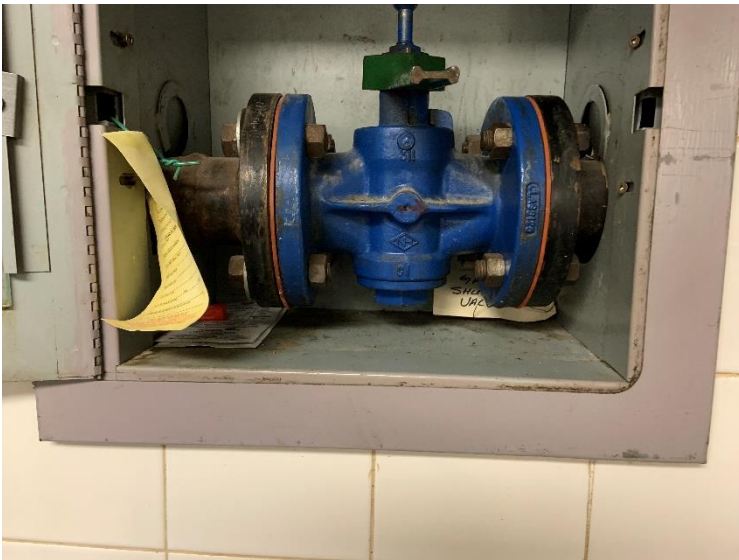
**Photo 11:**

Brown gaskets were observed in a valve of a pipe system in the kitchen during the survey. These materials were observed to be rubberized material and is expected to be non asbestos-containing.

View of the non-asbestos-containing gaskets in a valve within the Kitchen (Loc. 1-20).

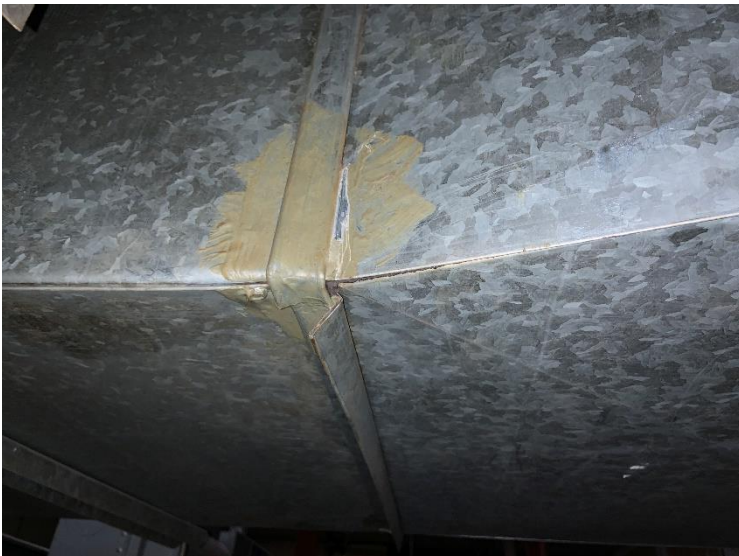
**Photo 12:**

Grey sealant was observed on the ductwork within the project area during the survey. The grey sealant was determined to be silicon-based. This material is known as non asbestos-containing.

View of the non-asbestos-containing silicon based sealant on ductwork in the ceiling space above Kitchen (Loc. 1-20).

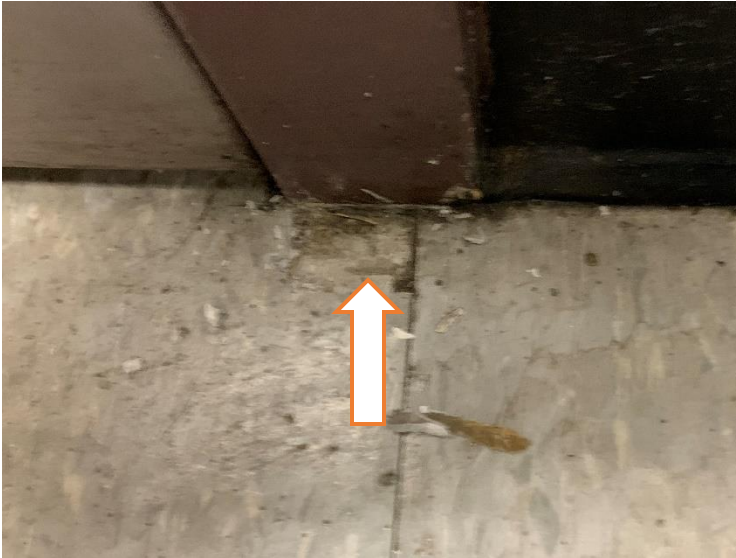
**Photo 13:**

Grey mastic was observed under the VFT1 within the project area during the survey. Three (3) samples of the grey mastic (23-1536-1 to 3), were collected and submitted for analysis. Asbestos was not identified in any submitted grey mastic samples.

Example of the non-asbestos-containing grey mastic under VFTs in Men's Change Room (Loc. 1-32a).

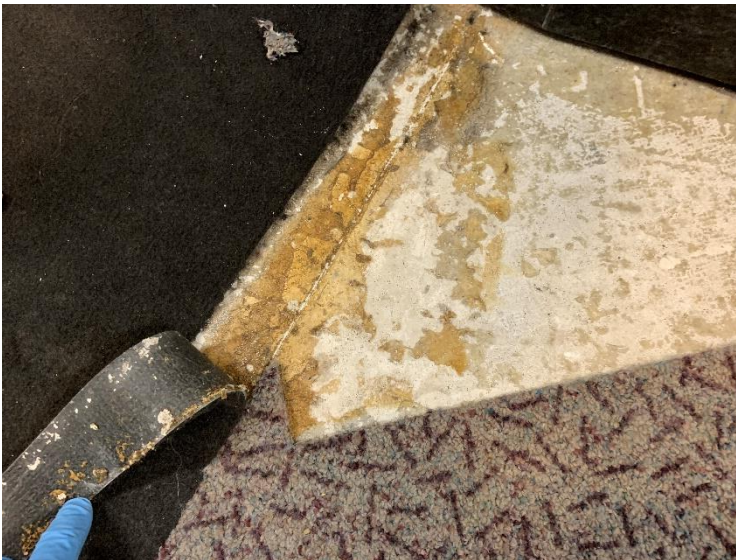
**Photo 14:**

Cream mastic was observed under the carpet tiles within the project area during the survey. Three (3) samples of the cream mastic (23-1536-18 to 20), were collected and submitted for analysis. Asbestos was not identified in any submitted cream mastic samples.

Example of the non-asbestos-containing cream mastic under the carpet in the Office (Loc. 1-23).

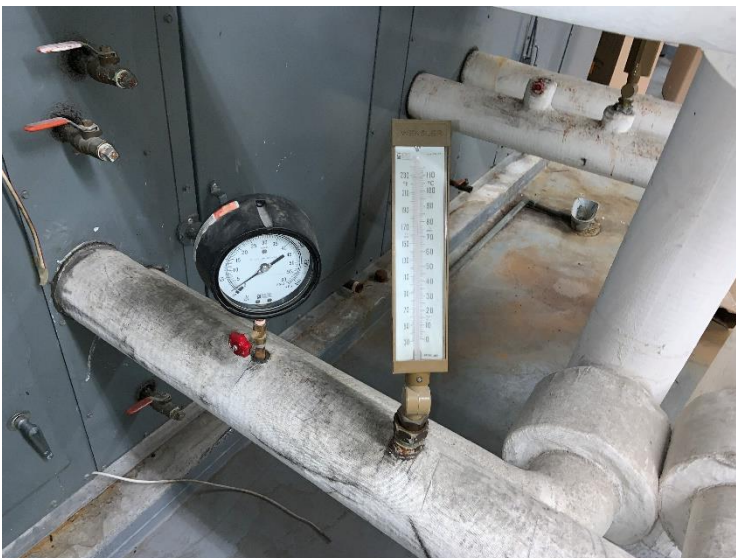
**Photo 15:**

Mercury-containing thermometers were observed in the mechanical room on the mezzanine level.

View of mercury-containing thermometer in mechanical room on the mezzanine level (Loc. M-01).

- If work activities affect the mercury containing thermometers, electrical equipment or fluorescent light bulbs, Fisher recommends that the presumed mercury-containing materials be removed and disposed of in accordance with O. Reg. 558/00.
