State of Good Repair Audits (Phase 23) Hazardous Substance Survey

for **William Bolton Arena**
City of Toronto
Parks, Forestry & Recreation Division
at Capital Projects Section
prepared July 18, 2008

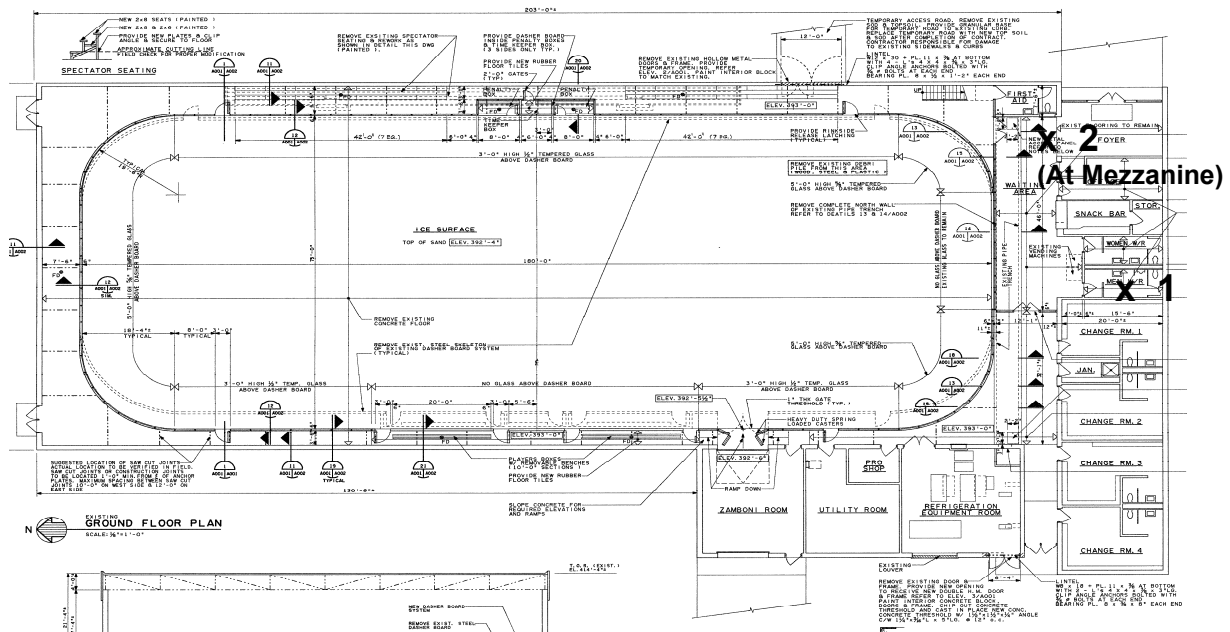
BILL BOLTON ARENA – SAMPLE LOCATION

Suspected asbestos containing materials were sampled from, refer to Appendix A: Plaster ceiling at Men's Washroom and the gypsum texture ceiling at the Mezzanine Office.

No asbestos materials were found within sampled materials. All piping within the building is insulated with fiberglass, PVC and foam materials where inspected.
