DESIGNATED SUBSTANCE SURVEY

**Bill Bolton Arena
40 Rossmore Road
Toronto, Ontario**

**City of Toronto
Parks, Forestry, and Recreation**

November 17, 2014

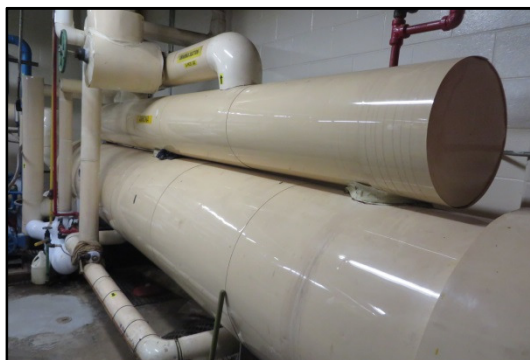
- Mechanical Piping Insulation

Mechanical pipe straight and fitting insulation was observed throughout the Survey Area and was observed to contain fibre glass material. Fibre glass is a non-asbestos containing material and thus was not sampled.

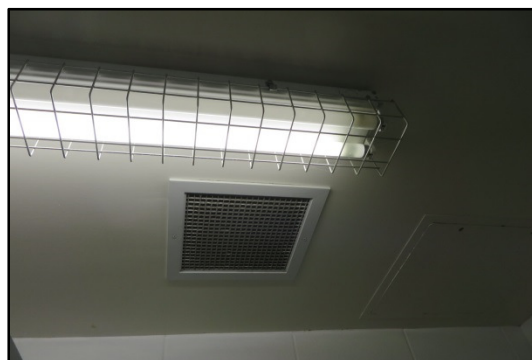
- Drywall Joint Compound

Plaster ceiling at Men's Washroom was replaced by a gypsum board ceiling. Gypsum texture ceiling at the Mezzanine's Office were sampled in the previous report and found not to contain asbestos. Additional samples were not taken as the material is not expected to contain asbestos, due to the age.

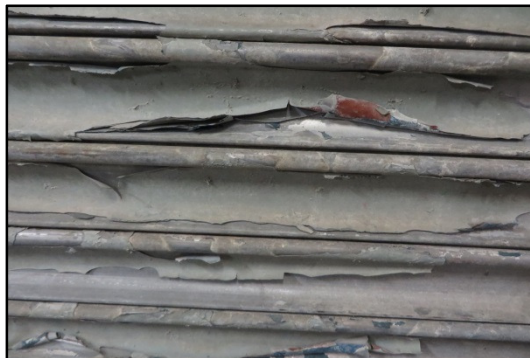
Lead Findings

Lead was found in the paint sample taken from the Zamboni Room. Lead may also be present in the soldered joints of copper piping found within this building.

Maintain paint finishes in good condition. Provide water testing to confirm the presence of lead from copper solder in the water.

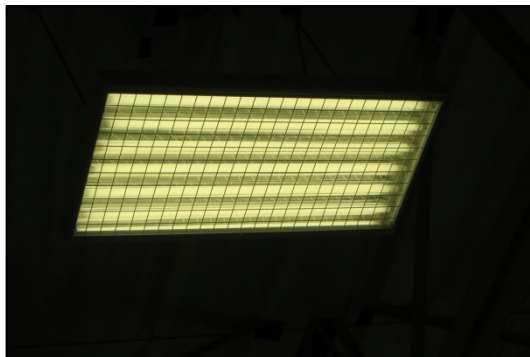
- Light Ballasts/Transformers

The building is illuminated using T-8 fluorescent and compact fluorescent bulbs. The ballasts are not expected to contain PCBs. The transformers are non-PCB type ballasts.
