Re: Designated Substances Assessment
Mathematics and Computers (MC), Building 17, Various Rooms, Renovation WR52912

Mathematics and Computers (MC), Building 17, Various Rooms WR52912
University of Waterloo

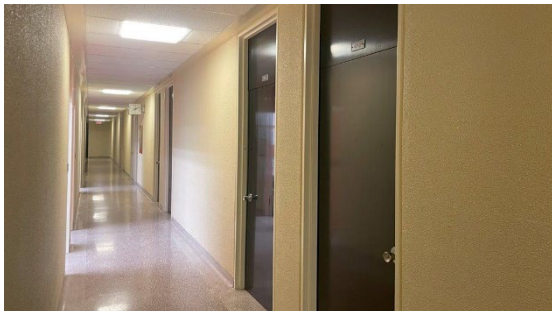
Photo 1: Entrances to office spaces, first floor corridor.

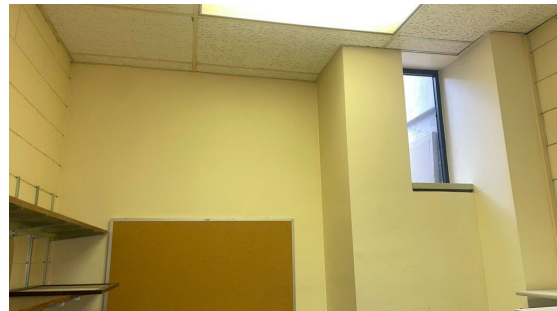
Photo 2: Typical finishes within first floor offices (Room #1038).

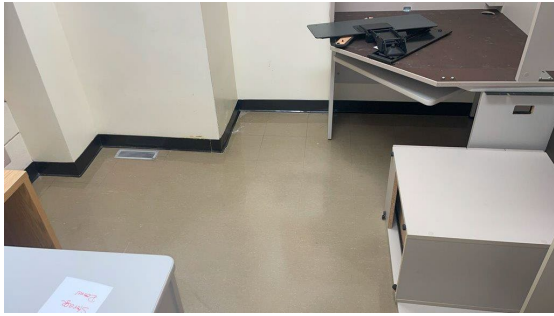
Photo 3: Typical finishes within first floor offices (Room #1033).

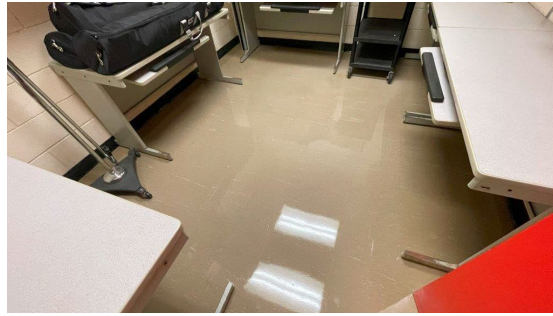
Photo 4: Typical finishes within second floor offices (Room #2024).

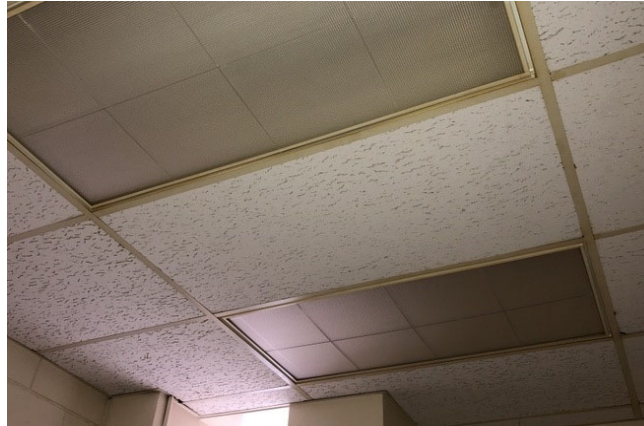
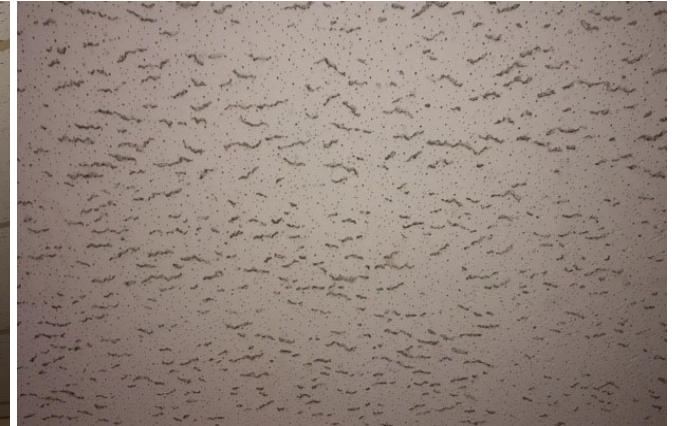
BCM # 1 CEILING OR LAY-IN TILES

Description: 24"x48", long length wavy fissure and pinhole pattern.

Lab Result: 0.75% Chrysotile

Comment: Ceiling tiles contain asbestos.

- Lay-in ceilings tiles - Remove following O.Reg. 278/05 Type 2 operations (using negative air pressure vented directly outdoors).

Location #	Area Description	Quantity	Condition	Damaged Qty.	Acc.	Vis.	Comments	Recommendation
--	Where Present	nq	good	0	C	Yes	Refer to Drawings 1, 2 and 3 for approximate locations of ceiling tiles observed.	Remove following O.Reg. 278/05 Type 2 operations (using negative air pressure vented directly outdoors).

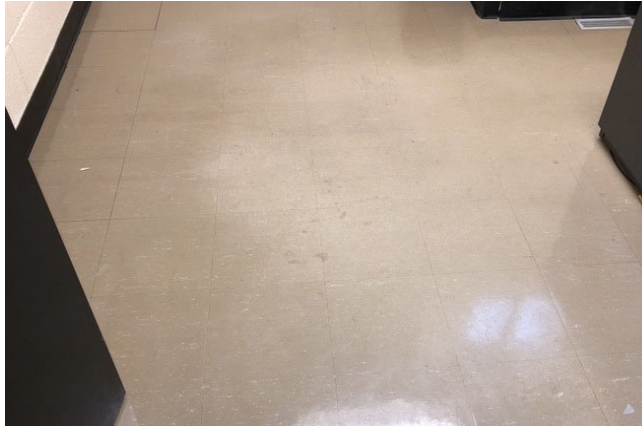
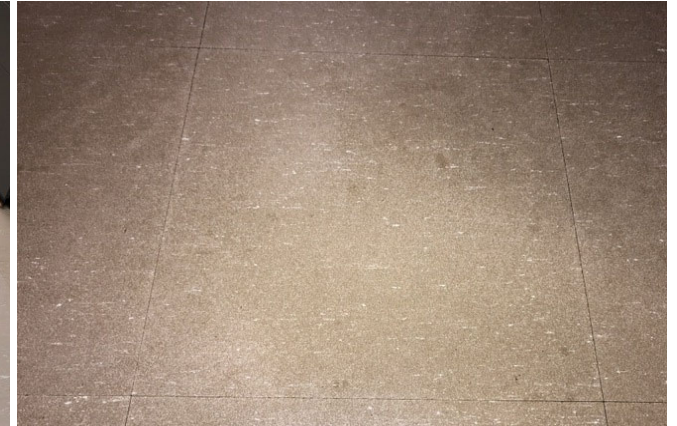
BCM # 2 VINYL FLOOR TILE & MASTIC

Colour: *Brown with white streaks*

Lab Result: *2.4% Chrysotile (tile), 0.5% Chrysotile (mastic)*

Comment: *Floor tiles and mastic (or glue) contain asbestos.*

- Vinyl floor tiles and mastic - remove floor tiles following O.Reg. 278/05 Type 1 operations (using hand-held non-powered tools, wetting the material). Remove mastic following O.Reg. 278/05 Type 2 operations using HEPA filtered grinding equipment. Negative air pressure (vented directly outdoors) is to be employed for Type 2 operations. Otherwise Type 3 operations apply.

Location #	Area Description	Quantity	Condition	Damaged Qty.	Acc.	Vis.	Comments	Recommendation
--	Where Present	nq	good	0	A	Yes	Refer to Drawings 1, 2 and 3 for approximate locations of floor tiles observed. Negative air pressure (vented directly outdoors) is to be employed for Type 2 operations.	Remove floor tiles following O.Reg. 278/05 Type 1 operations (using hand-held non-powered tools, wetting the material). Remove mastic following O.Reg. 278/05 Type 2 operations using HEPA filtered grinding equipment. Otherwise Type 3 operations apply.

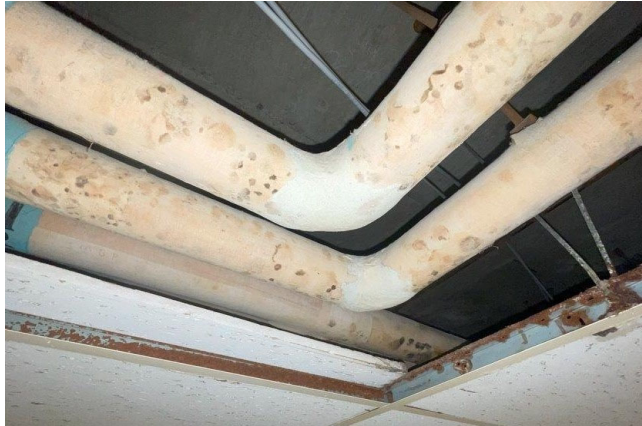
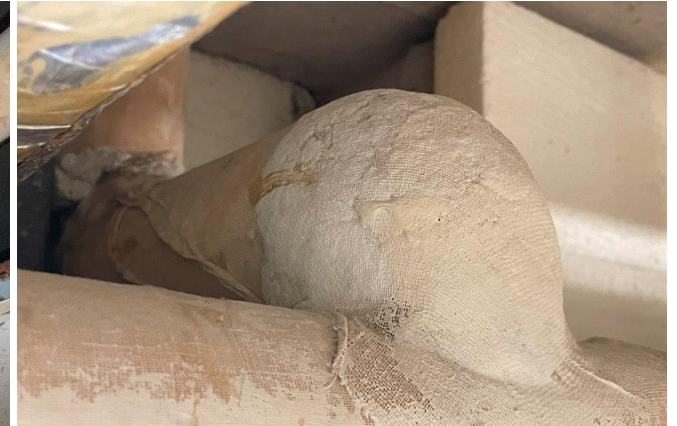
BCM # 3 PIPE INSULATION (PARGING CEMENT)

Description: Present on pipe fittings (i.e., elbows, hangers, etc.).

Lab Result: 70% Chrysotile

Comment: Parging cement contains asbestos.

- Pipe insulation (parging cement fittings) - Remove following O.Reg. 278/05 Glove Bag operations.
- If suspect asbestos-containing materials are uncovered during renovation work, work that may disturb the material should stop immediately. Samples of the materials should be collected and tested for asbestos content. Materials confirmed to contain asbestos should be removed prior to further disturbance in accordance with O.Reg. 278/05 work procedures. Alternatively, the suspect materials can be presumed to be asbestos-containing and removed following O.Reg. 278/05 work procedures.

Location #	Area Description	Quantity	Condition	Damaged Qty.	Acc.	Vis.	Comments	Recommendation
--	Where Present	~75 fittings	good	0	C	Yes	Refer to Drawings 1, 2 and 3 for approximate locations of pipe fittings observed. Concealed pipe fittings are likely present within wall cavities elsewhere.	Remove following O.Reg. 278/05 Glove Bag operations.

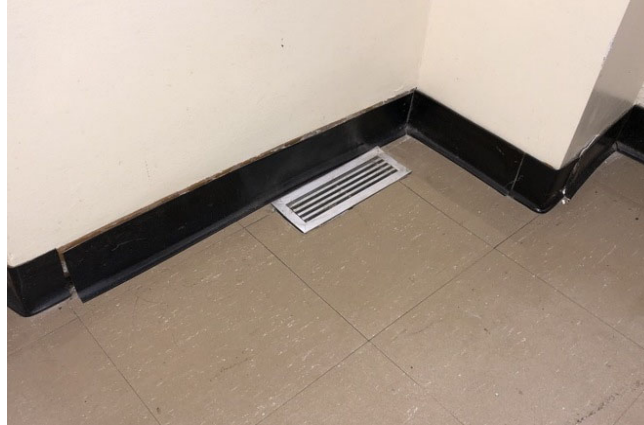
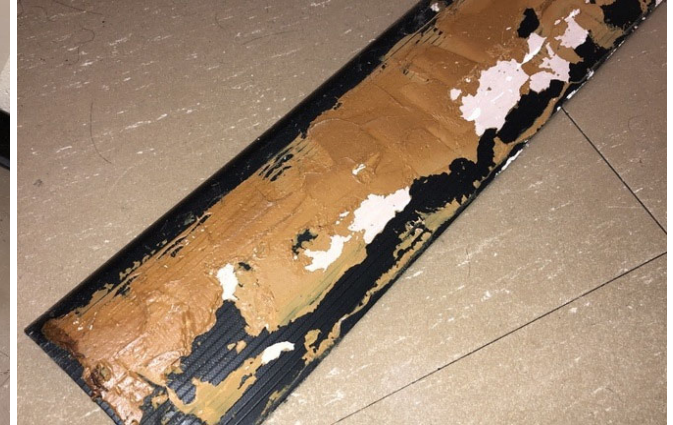
Comment: *Mastic (or glue) tested does not contain asbestos.*

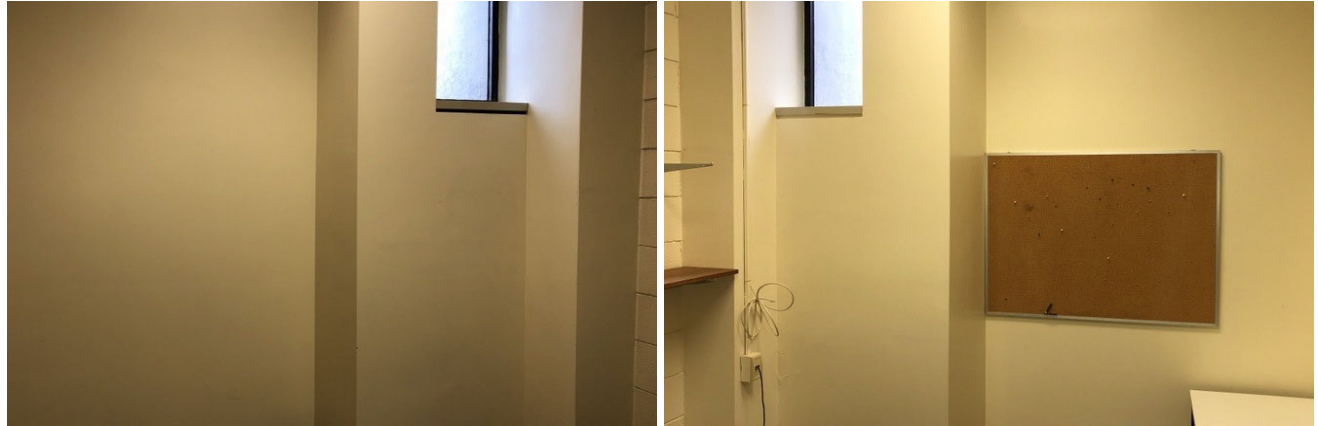
Comment: *Plaster previously tested does not contain asbestos.*

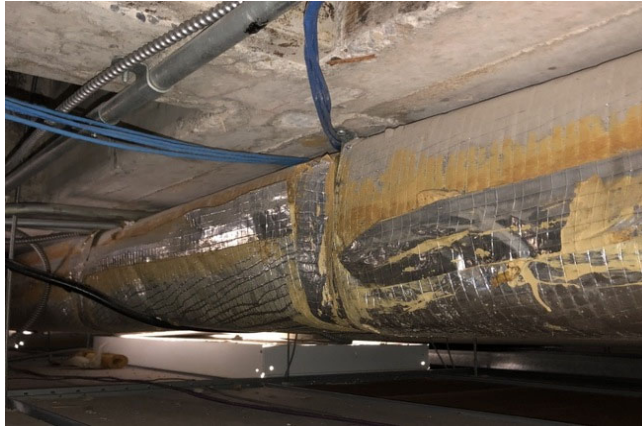
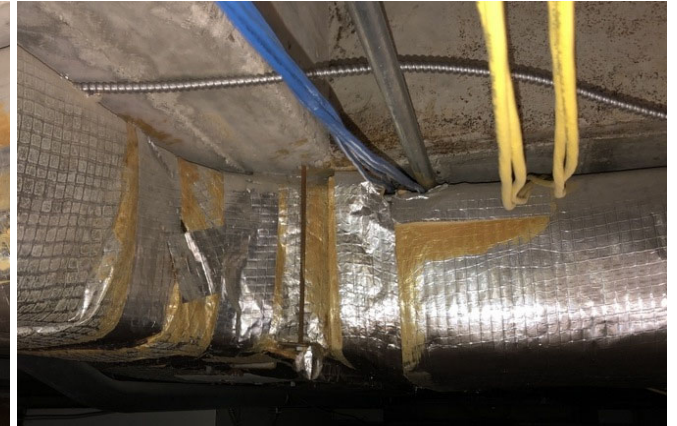
Comment: *Mastic previously tested does not contain asbestos.*

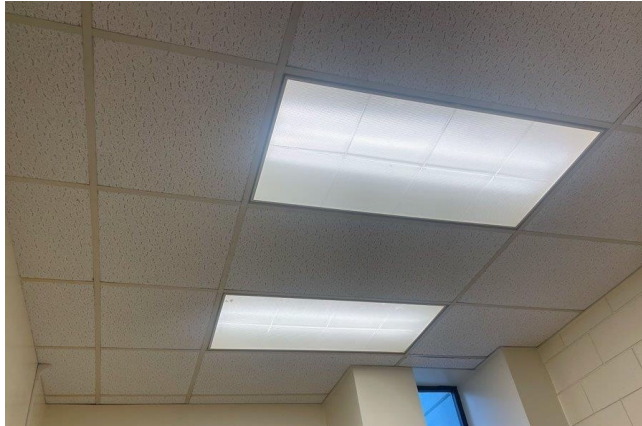
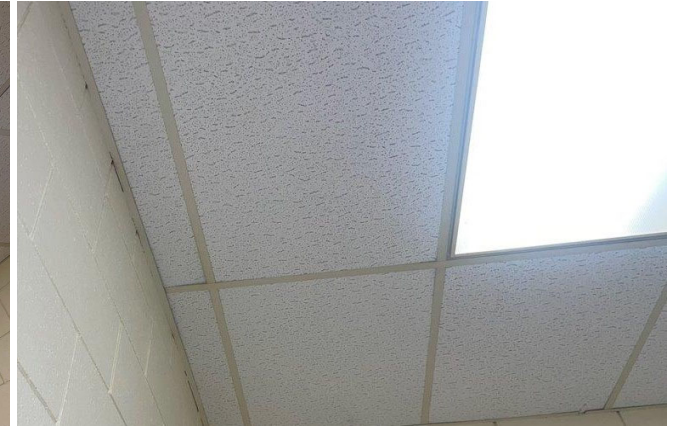
Description: 24"x48", widthwise fissure and random pinhole pattern, present in Rooms #1041 and 1042.

Comment: Ceiling tiles previously tested do not contain asbestos.

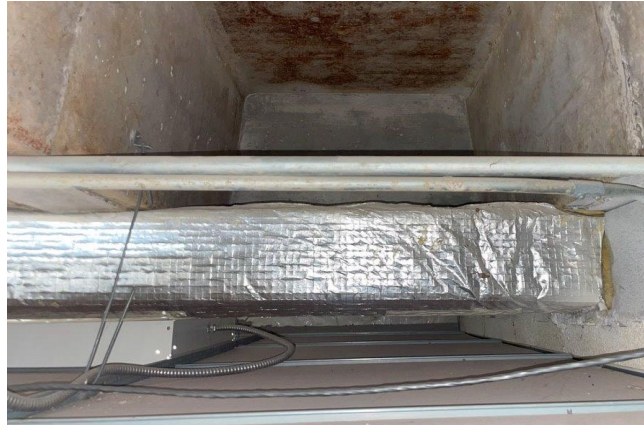
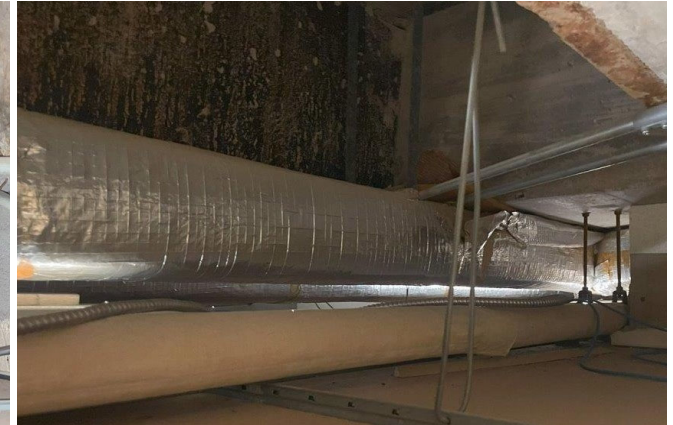
Comment: *Fibreglass insulation is not suspect to contain asbestos.*

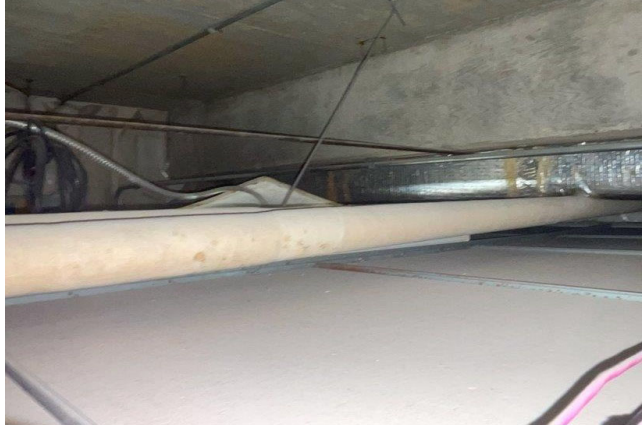
Comment: *Fibreglass insulation is not suspect to contain asbestos.*

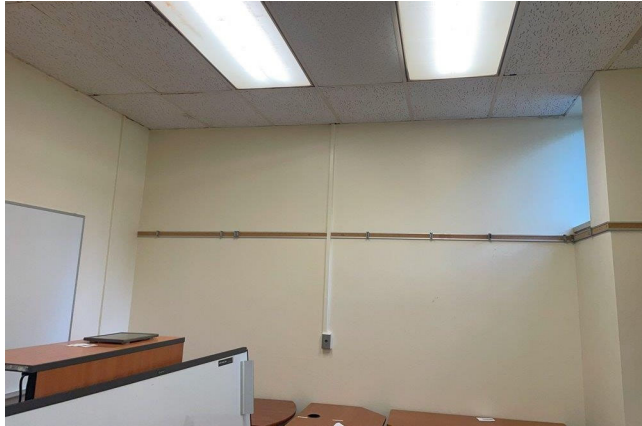
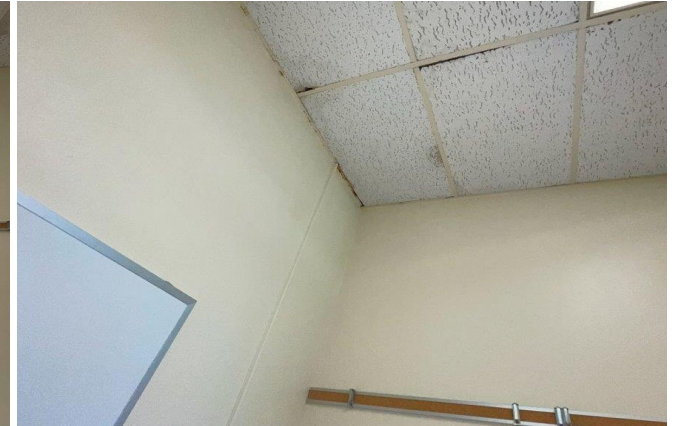
Comment: Drywall joint-fill compound previously tested do not contain asbestos.

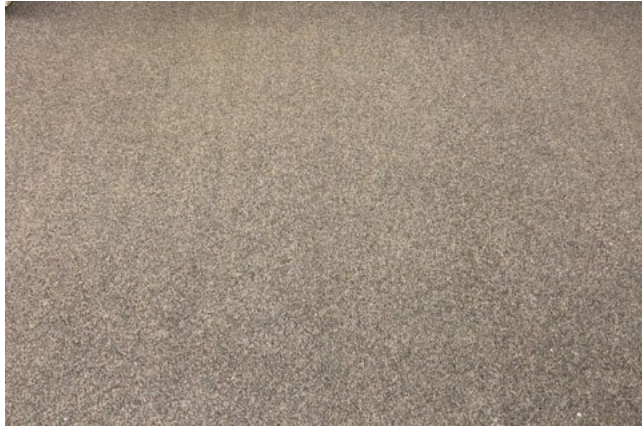
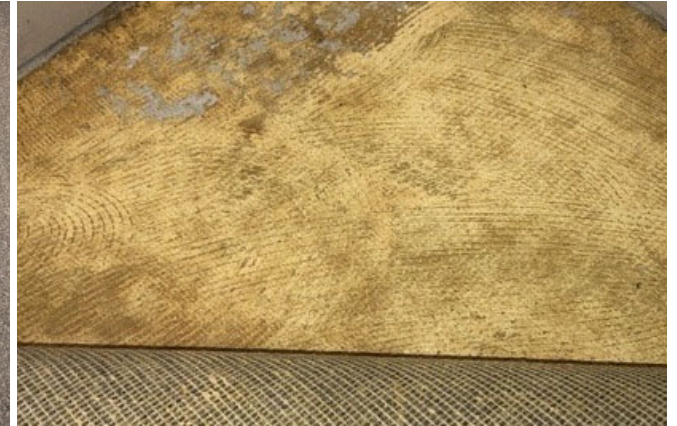
Comment: *Mastic (or glue) tested does not contain asbestos.*

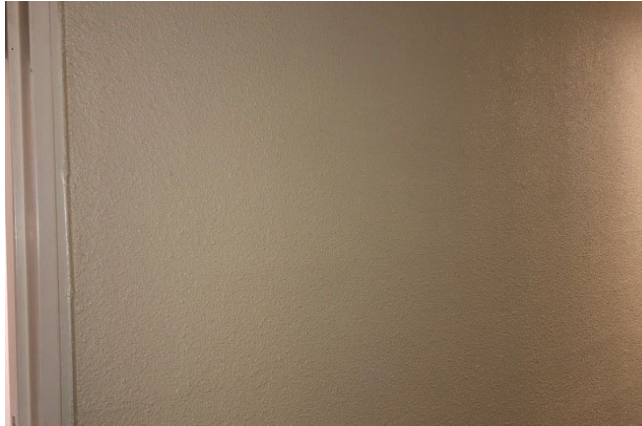
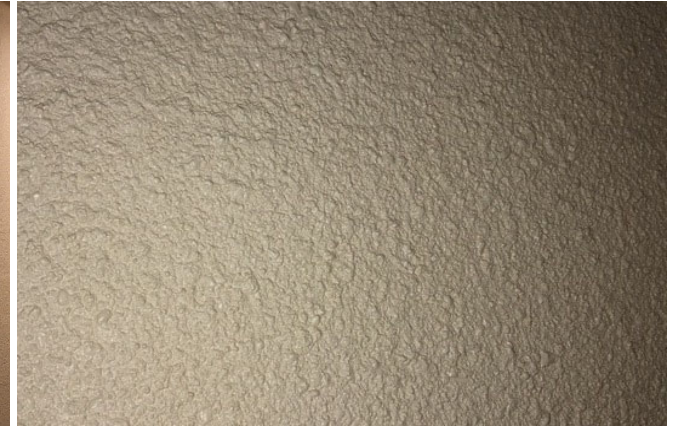
Comment: *Textured plaster previously tested does not contain asbestos.*

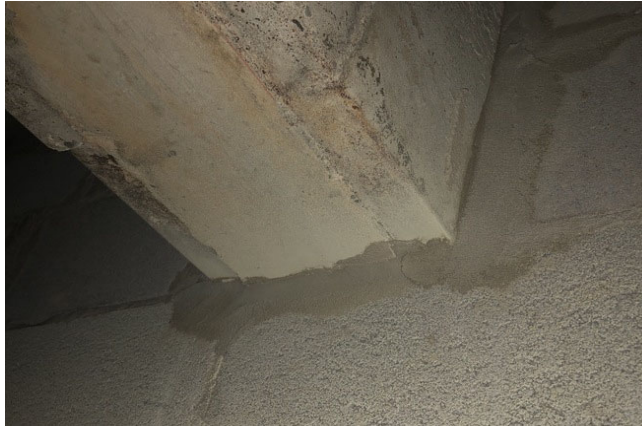
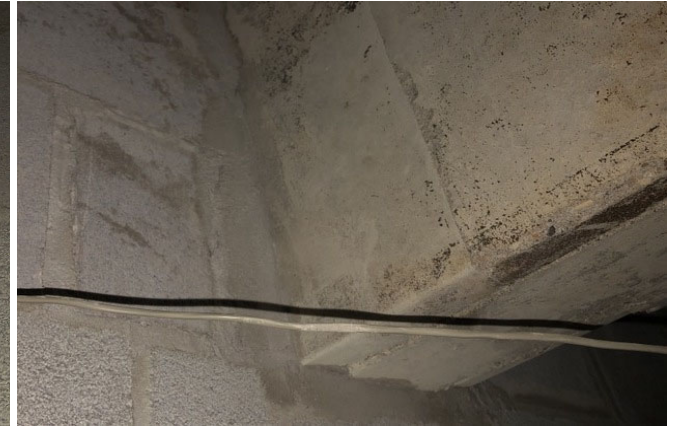
Comment: *Parging cement previously tested does not contain asbestos*
