DESIGNATED SUBSTANCES & HAZARDOUS MATERIALS SURVEY

Niagara Regional Police Services – Port Colborne
501 Fielden Avenue, Port Colborne, Ontario

SPL Project No: 10000949-230 (BLDG0068)
July 10, 2015

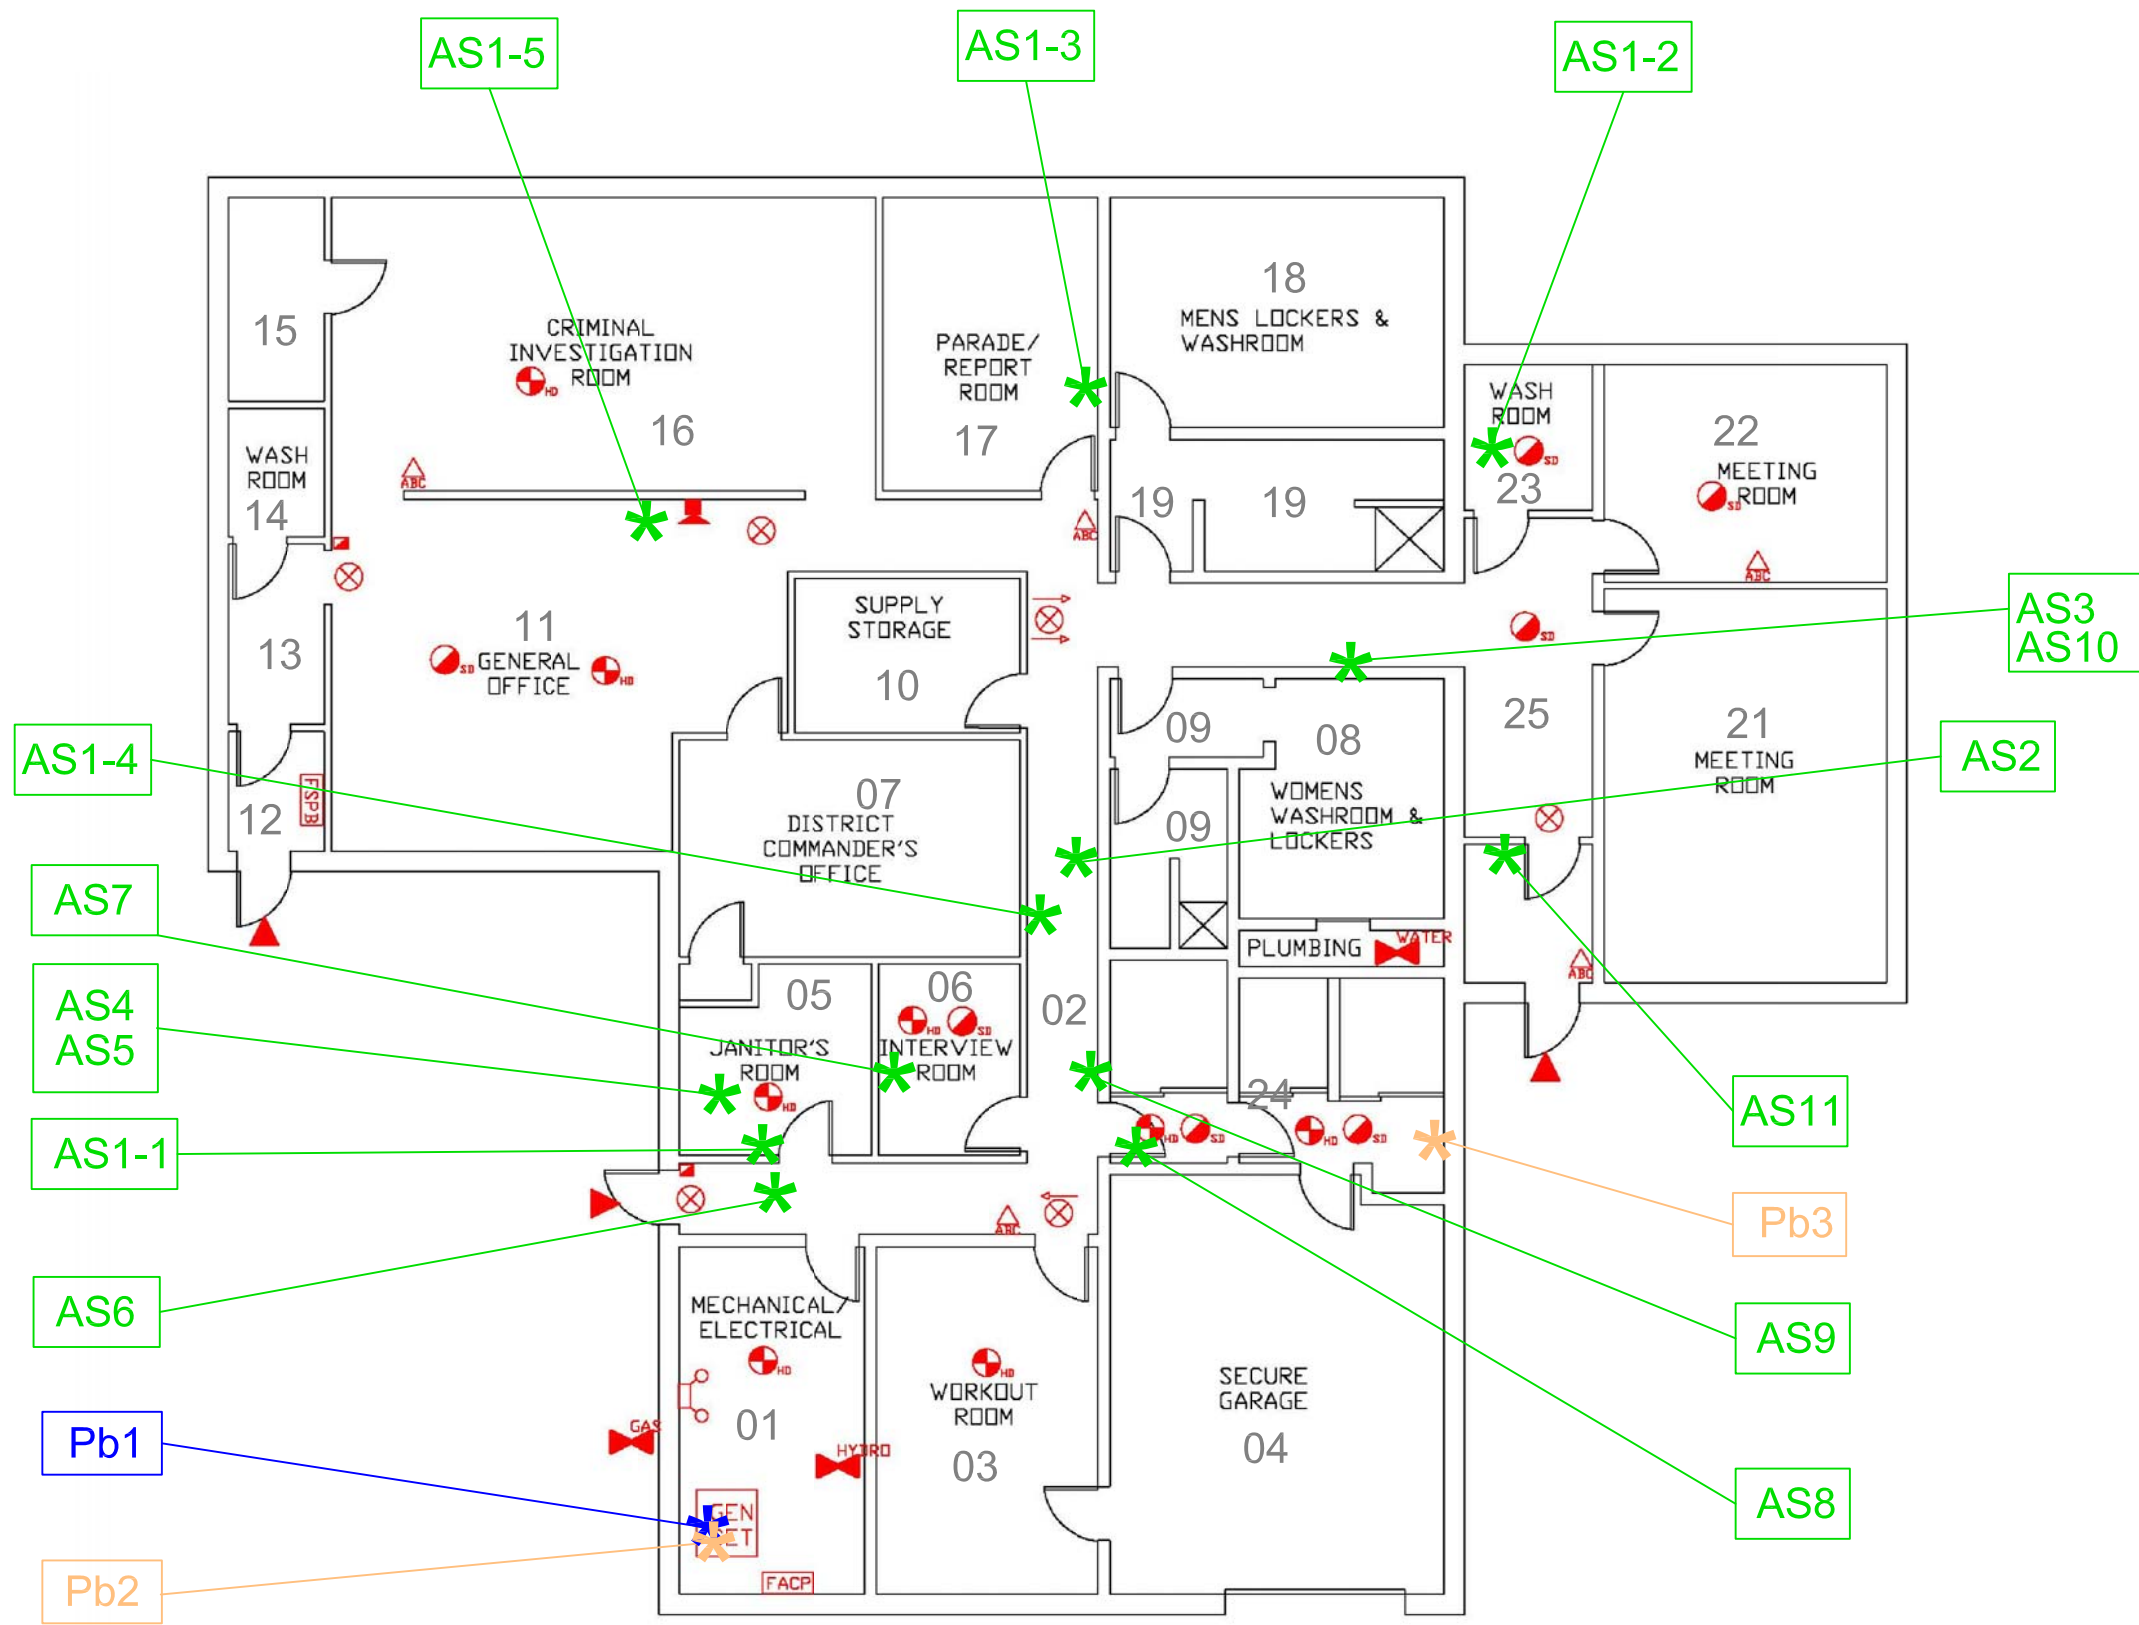
Analytical results are provided in **Appendix A**. Sample locations are provided in **Drawing 1** attached.

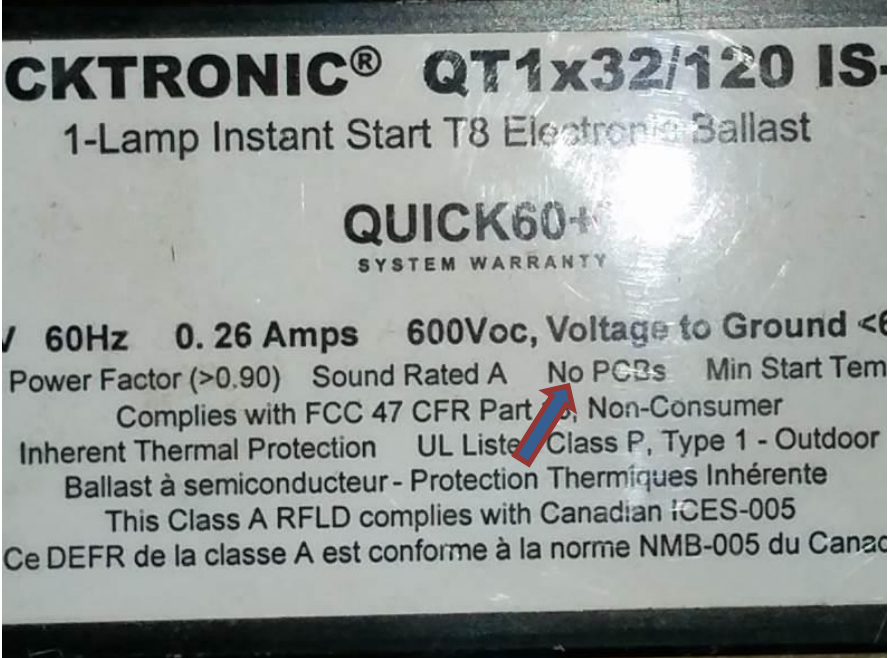
Photo No. 3

Date: December 1, 2014	
Description: View of fluorescent light ballast with "No PCBs" label.

The presence of mercury within assembled units (e.g. fluorescent light bulbs) should not be considered a hazard provided that the assembled units remain sealed and intact. Avoid direct skin contact with mercury and avoid inhalation of mercury vapour. Dispose of mercury following applicable legislative requirements.
