## **PRE-DEMOLITION DESIGNATED SUBSTANCE SURVEY**

Warehouse Building  
30 Newbridge Road, Toronto, ON

Project No. FE 23-13000R

June 6, 2023

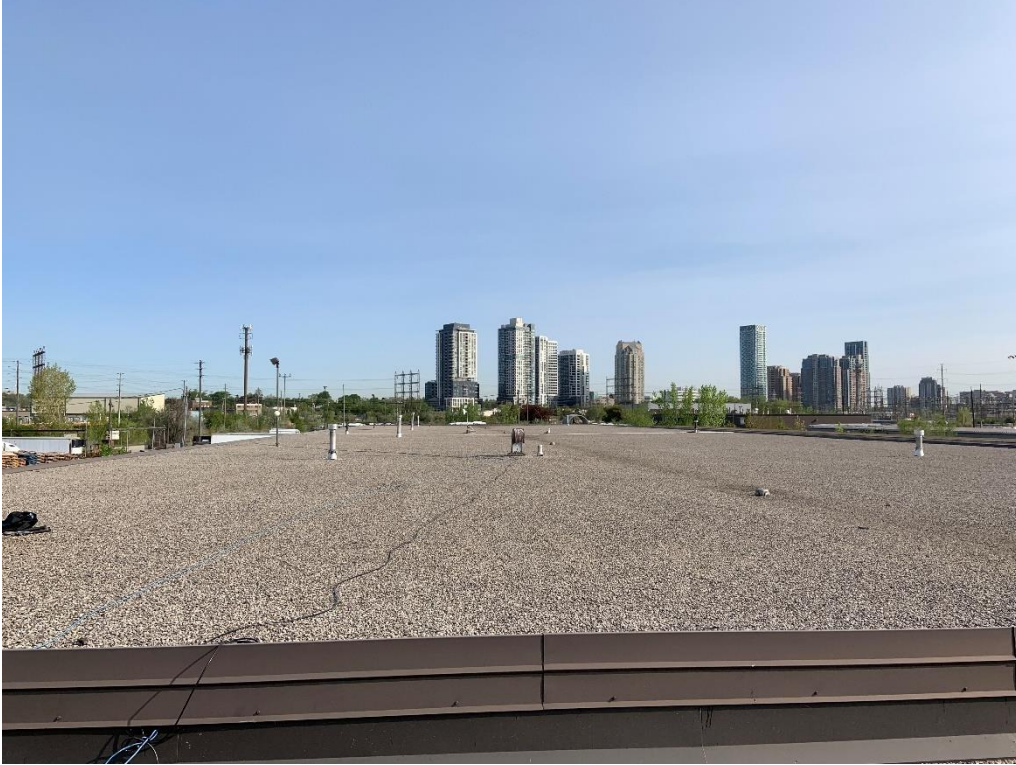
**Photo 1:** View of the roof surface of the north warehouse areas

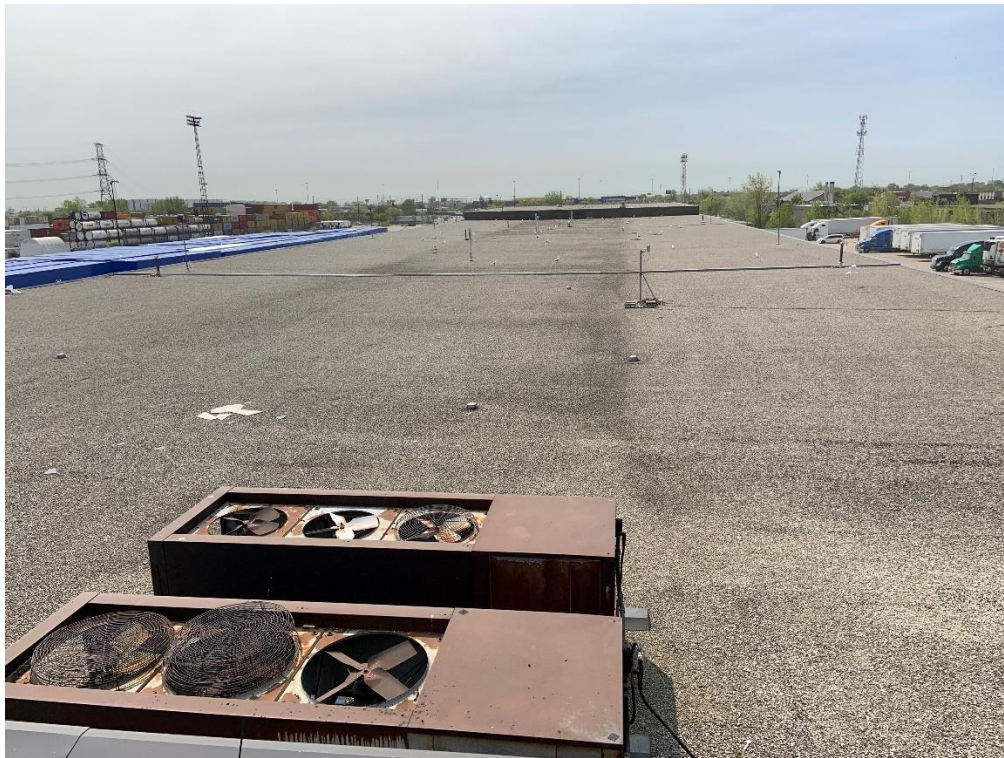
**Photo 2:** View of the of the roof surface of the south warehouse areas.

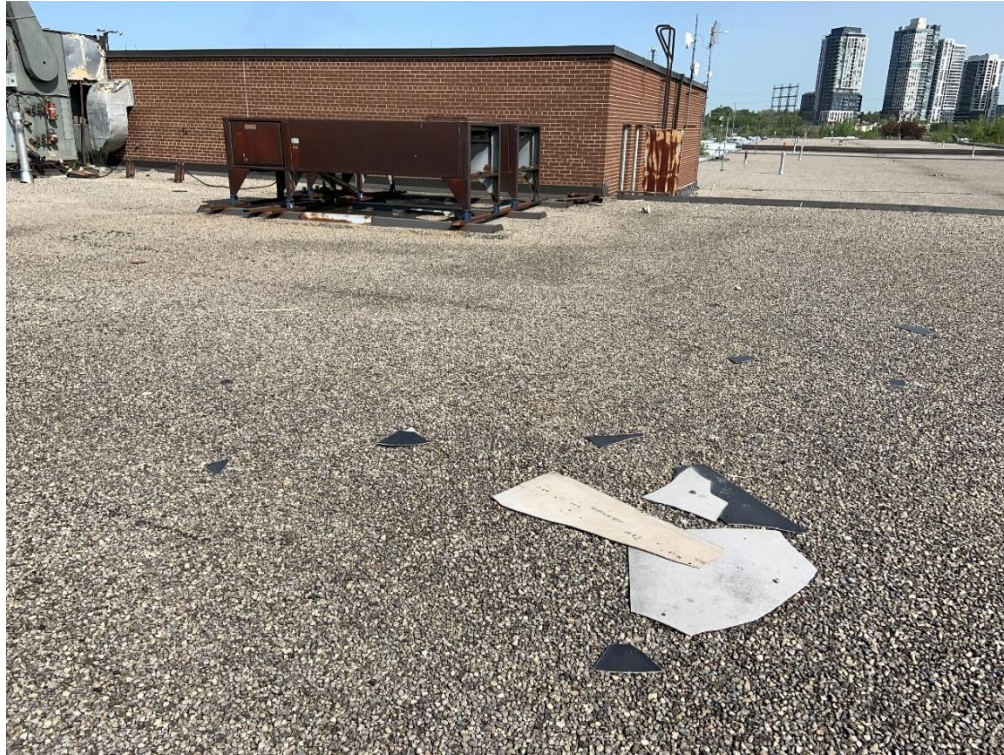
Transite Board was observed along the roof of the warehouse areas where the roof line changes height. During the current survey, three (3) Transite Board samples were collected and submitted for analysis. The results of analysis revealed that the Transite Board contains **5-25% Chrysotile asbestos**.

**Photo 3:** Pieces of damaged Transite Board observed on the roof.

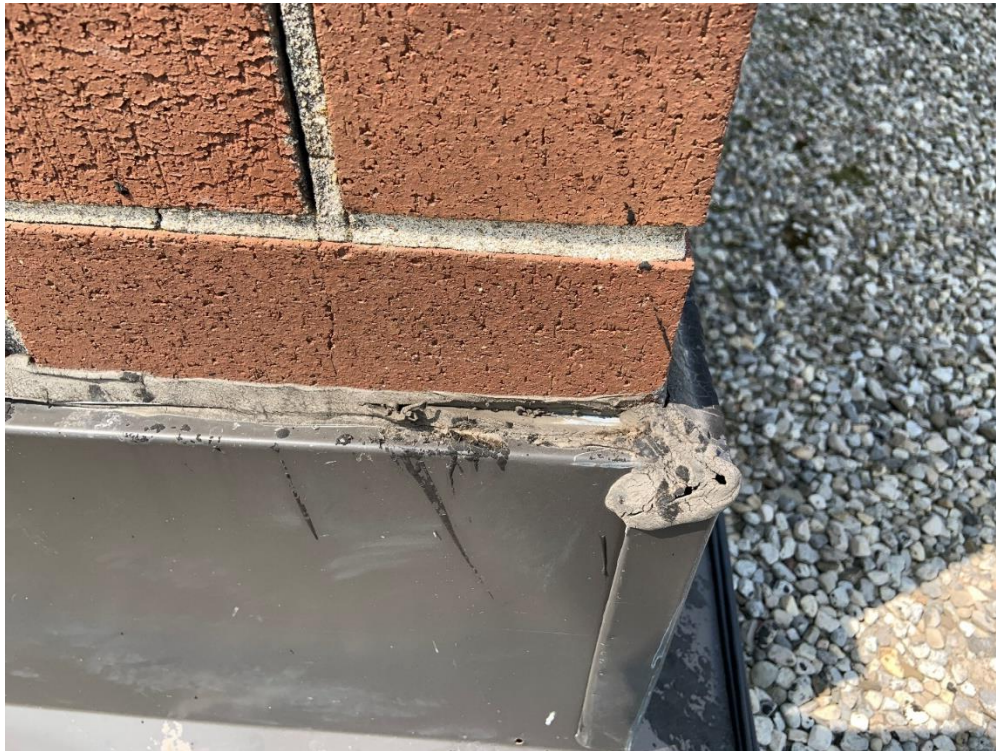
Dark grey caulking was found along the flashing on the roof and wall joints on the two-storey office building. During the current survey, three (3) samples of the dark grey caulking were collected and submitted for analysis. The results of analysis revealed that the dark grey caulking contains **0.5-5% Chrysotile asbestos**.

**Photo 4:** View of the asbestos-containing dark grey caulking along the flashing on the roof and wall joints.

- Removal of the dark grey caulking (approximately 1,000 linear feet) will require Type 1 asbestos abatement procedures, as per O. Reg. 278/05.
- Removal of parging cement found on pipe fittings (5 plus) will require Type 2 glove bag asbestos abatement procedures as per O. Reg. 278/05.
- Removal of Transite Pipe (approximately 60 linear feet) will require Type 1 asbestos abatement procedures, as per O. Reg. 278/05.
- Removal of Transite Board (approximately 5,000 square feet) will require Type 1 asbestos abatement procedures, as per O. Reg. 278/05.

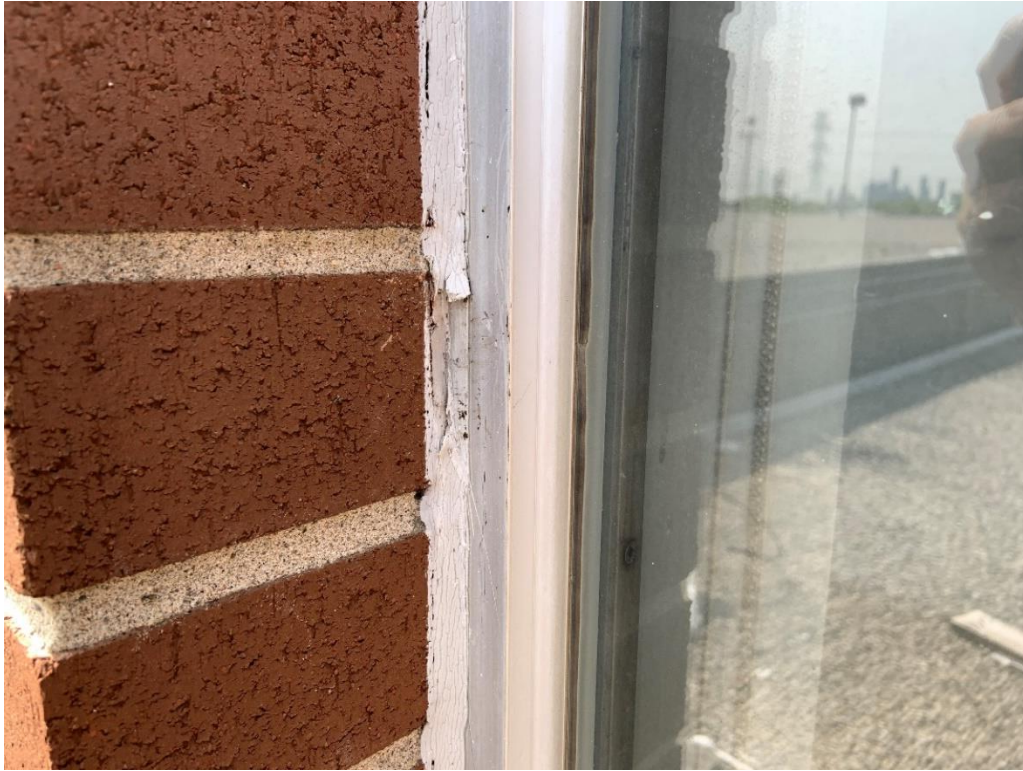
White caulking was found around the exterior of the windows and door frames of the two-storey office building. During the current survey, three (3) samples of the white caulking were collected and submitted for analysis. The results of analysis revealed that the white caulking contains **0.5-5% Chrysotile asbestos**.

**Photo 5:** View of the asbestos-containing white caulking around the exterior of the windows and door frames.

- Removal of the white caulking (approximately 3,000 linear feet) will require Type 1 asbestos abatement procedures, as per O. Reg. 278/05.
- Removal of the dark grey caulking (approximately 1,000 linear feet) will require Type 1 asbestos abatement procedures, as per O. Reg. 278/05.
- Removal of parging cement found on pipe fittings (5 plus) will require Type 2 glove bag asbestos abatement procedures as per O. Reg. 278/05.
- Removal of Transite Pipe (approximately 60 linear feet) will require Type 1 asbestos abatement procedures, as per O. Reg. 278/05.
- Removal of Transite Board (approximately 5,000 square feet) will require Type 1 asbestos abatement procedures, as per O. Reg. 278/05.

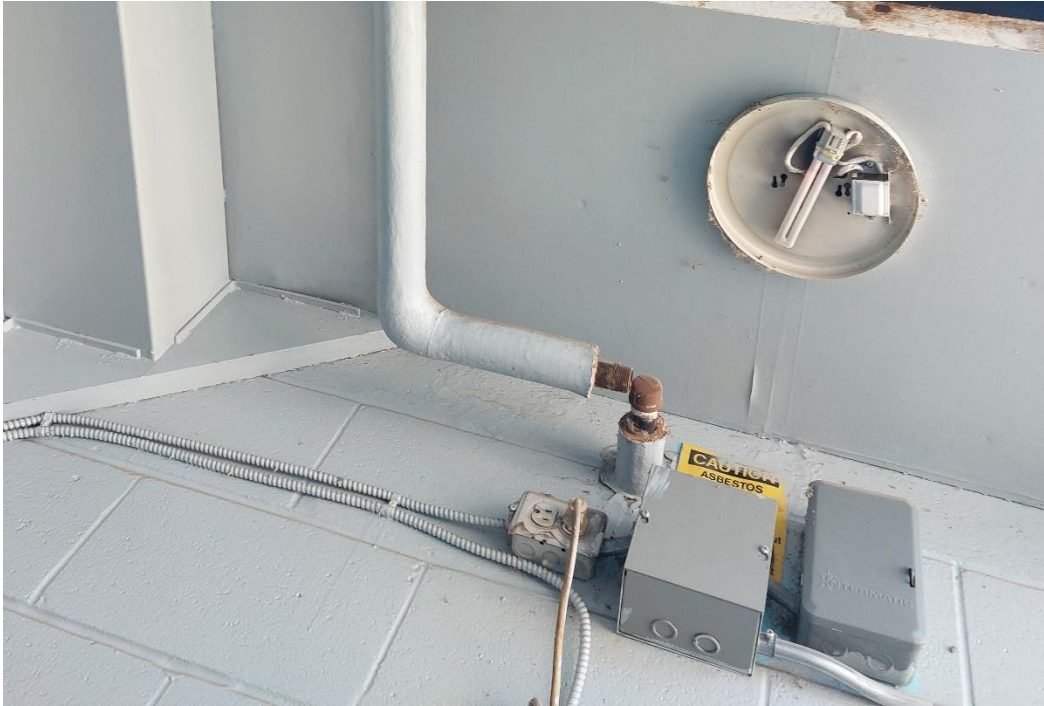
The previous report confirmed asbestos-containing mechanical insulation in the form of parging cement on pipe fittings are present at the Site, and observed within some areas of the building.

**Photograph 7:** View of the of the asbestos-containing parging cement fitting in stairwell 2-27.

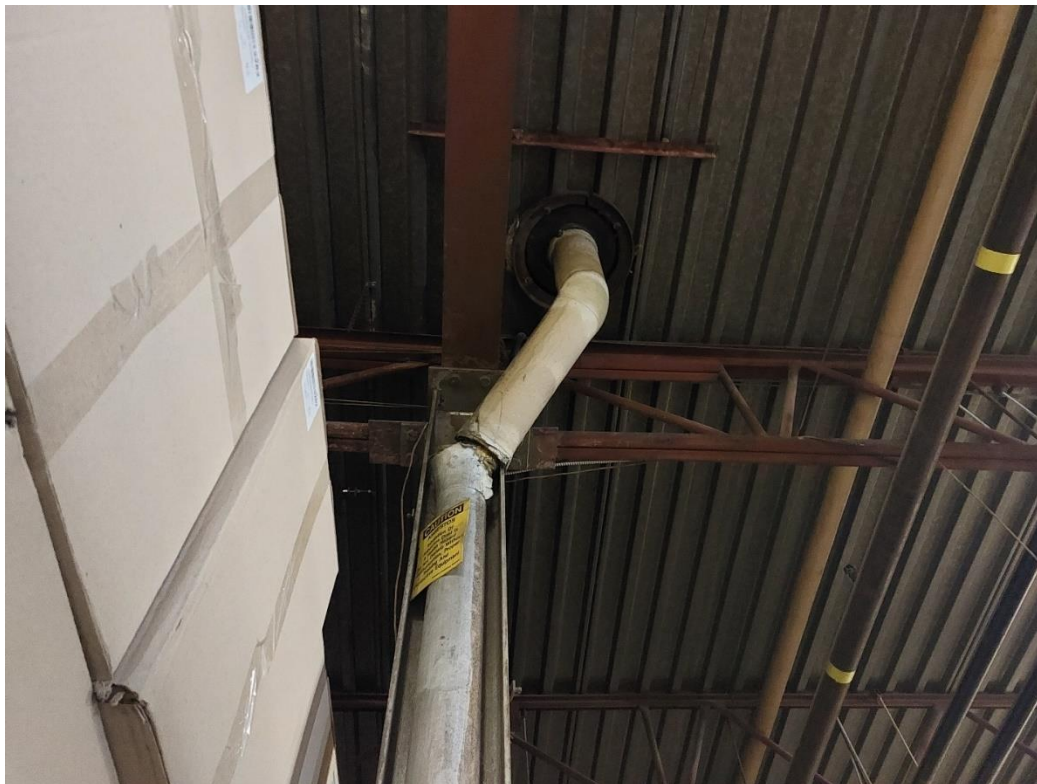
**Photo 8:** View of the of the asbestos-containing parging cement fitting in north warehouse 1-25.

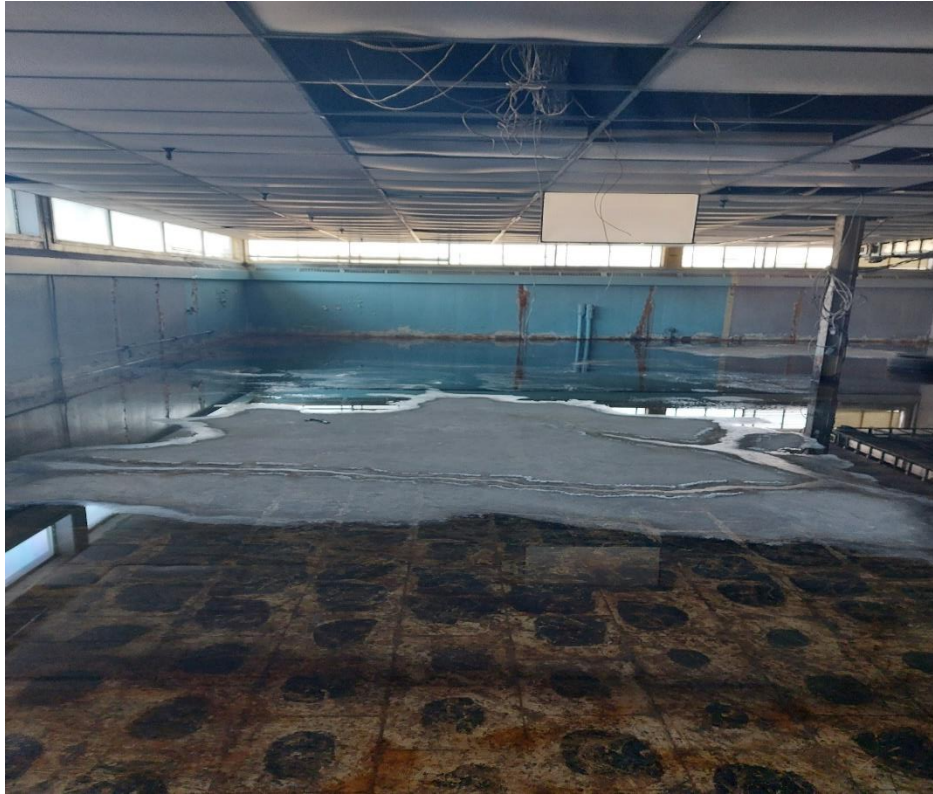
However, pooling water was noted on most of the floor area in the basement of the two-storey office building. At the time of the current survey, no mould growth was observed, although these conditions are favourable for mould growth. It would be recommended to remove and dispose of all water damaged porous materials. Remove the pooled water within the basement areas and provide sufficient ventilation to prevent any mould contamination.

**Photograph 9:** View of the pooled water in the basement of the two-storey office building.

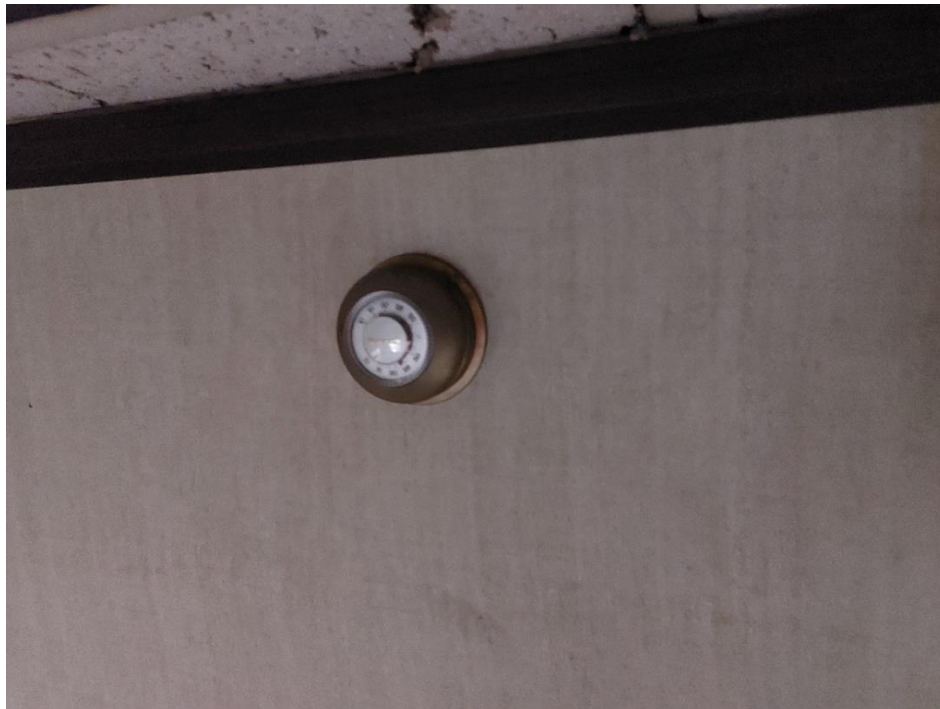
- Mercury is present as a vapour in fluorescent light bulbs.
- Mercury is presumed to be present as a component in electrical equipment.
- Mercury-containing thermostat controls were observed in the office building.

**Photograph 10:** View of a mercury-containing thermostat in the two-storey office building.

Fisher recommends that the presumed mercury-containing fluorescent light tubes and thermostats be removed and disposed of in accordance with O. Reg. 558/00

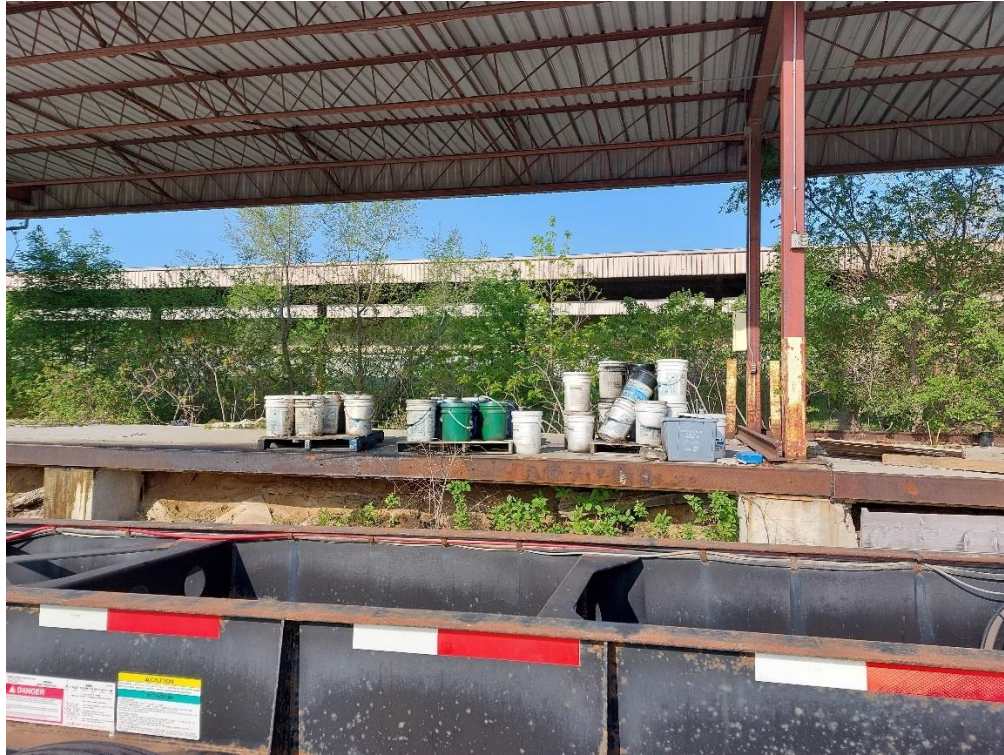
**Photograph 11:** View of the skids with pails of used oil located near the northeast portion of the site.

During the current survey, some skids with pails of used oil was noted near the northeast portion of the site. There was evidence that some of these containers leaked and impacted the nearby soils. It would be recommended to remove the impacted soil material from the Site.

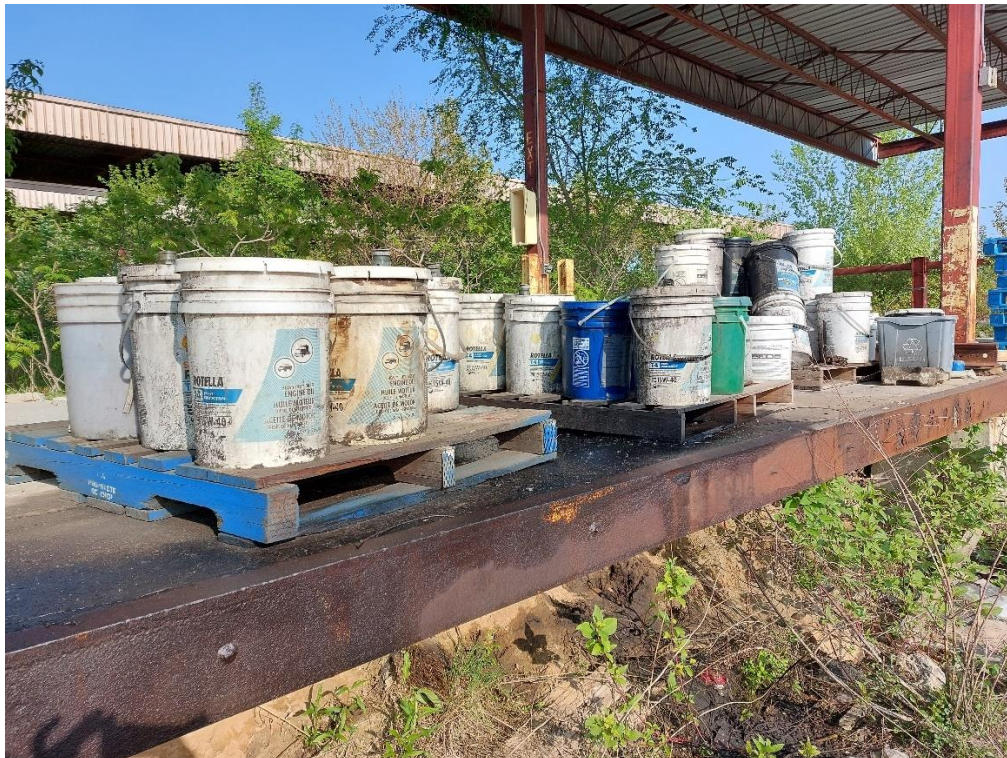
**Photograph 12:** View of the used oil leak on the concrete surface and impacts to the nearby soils.
