DESIGNATED SUBSTANCE SURVEY

WAREHOUSE 30 NEWBRIDGE ROAD

Toronto, Ontario

Fisher Environmental Ltd.
Project Number: FE-P 20-10475

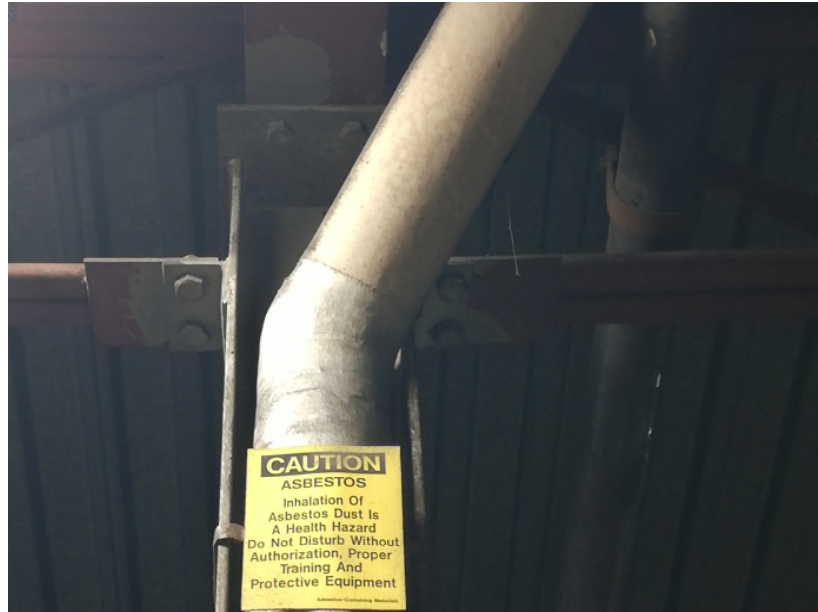
Rain leader in north
warehouse with
parging cement fitting

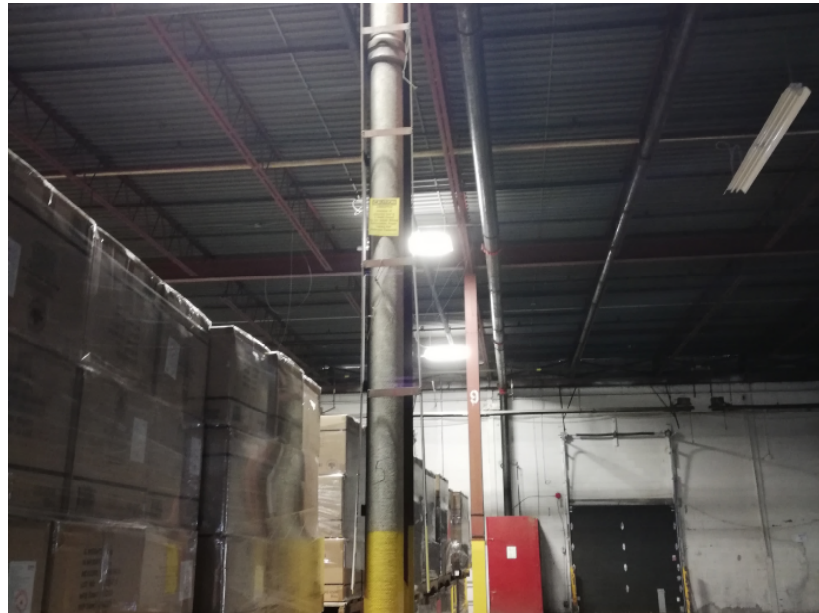
Transite Pipe Rain
leader in south
warehouse area

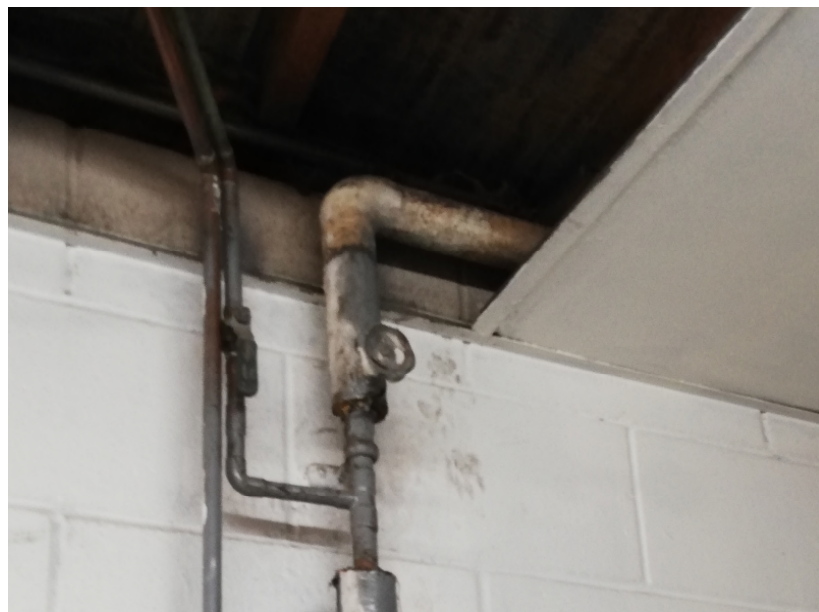
Water lines in the
washrooms with
parging cement fitting

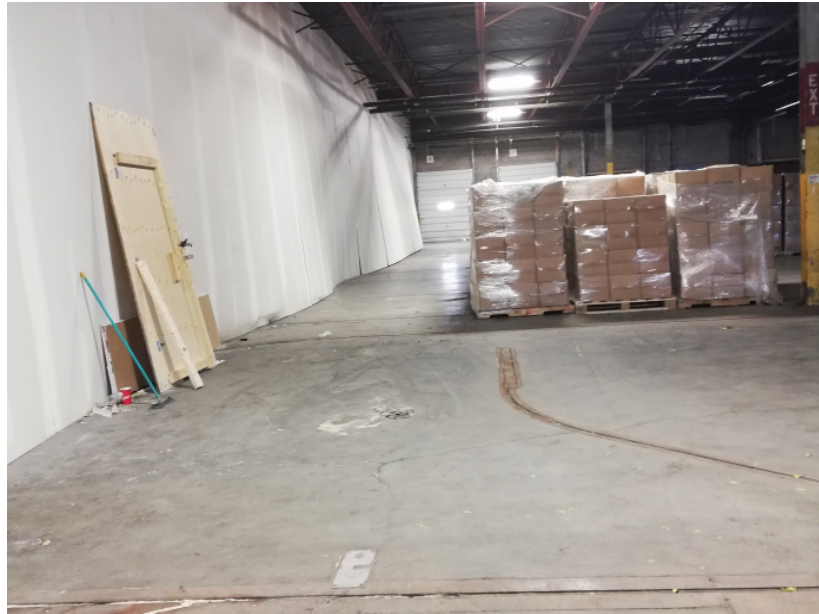
DJC sample location -
wall between north &
central warehouse

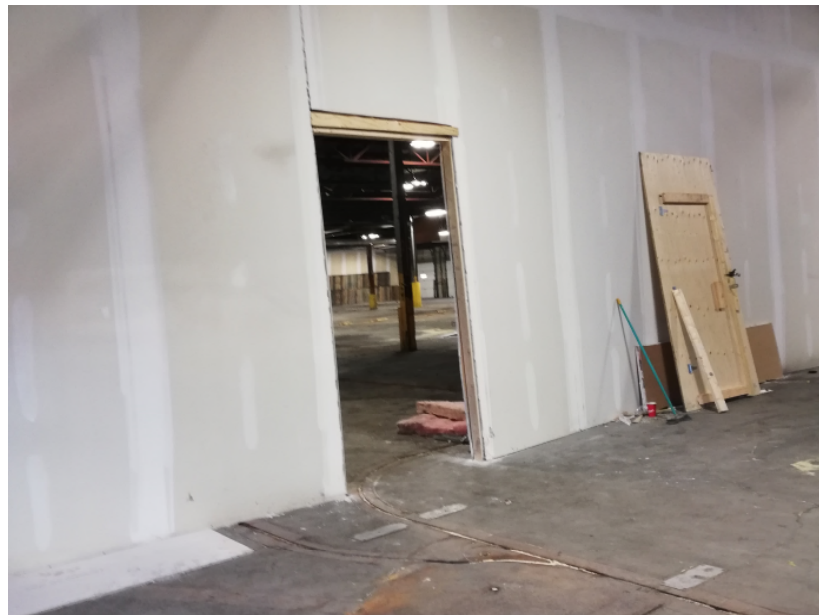
DJC sample location -
wall between north &
central warehouse

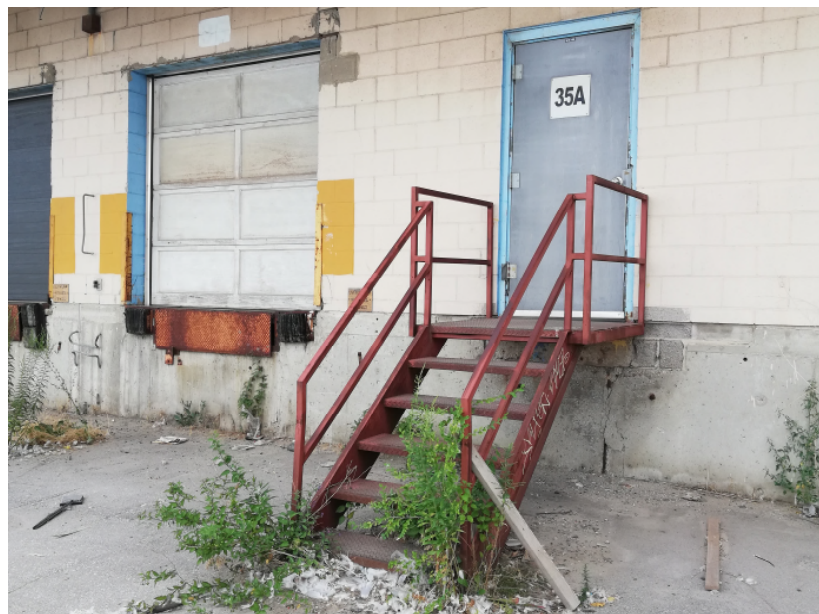
Exterior man-door
caulking sample
location
