January 22, 2021

Re: Designated Substance Sampling, 30 Newbridge Road, Toronto, ON

F.E. Job #: 21-5864
Project Name: Warehouse
Project ID: FE-P 21-10889
Date Sampled: 18-Jan-2021
Date Received: 20-Jan-2021
Date Reported: 22-Jan-2021
Location: 30 Newbridge Road
Toronto, ON

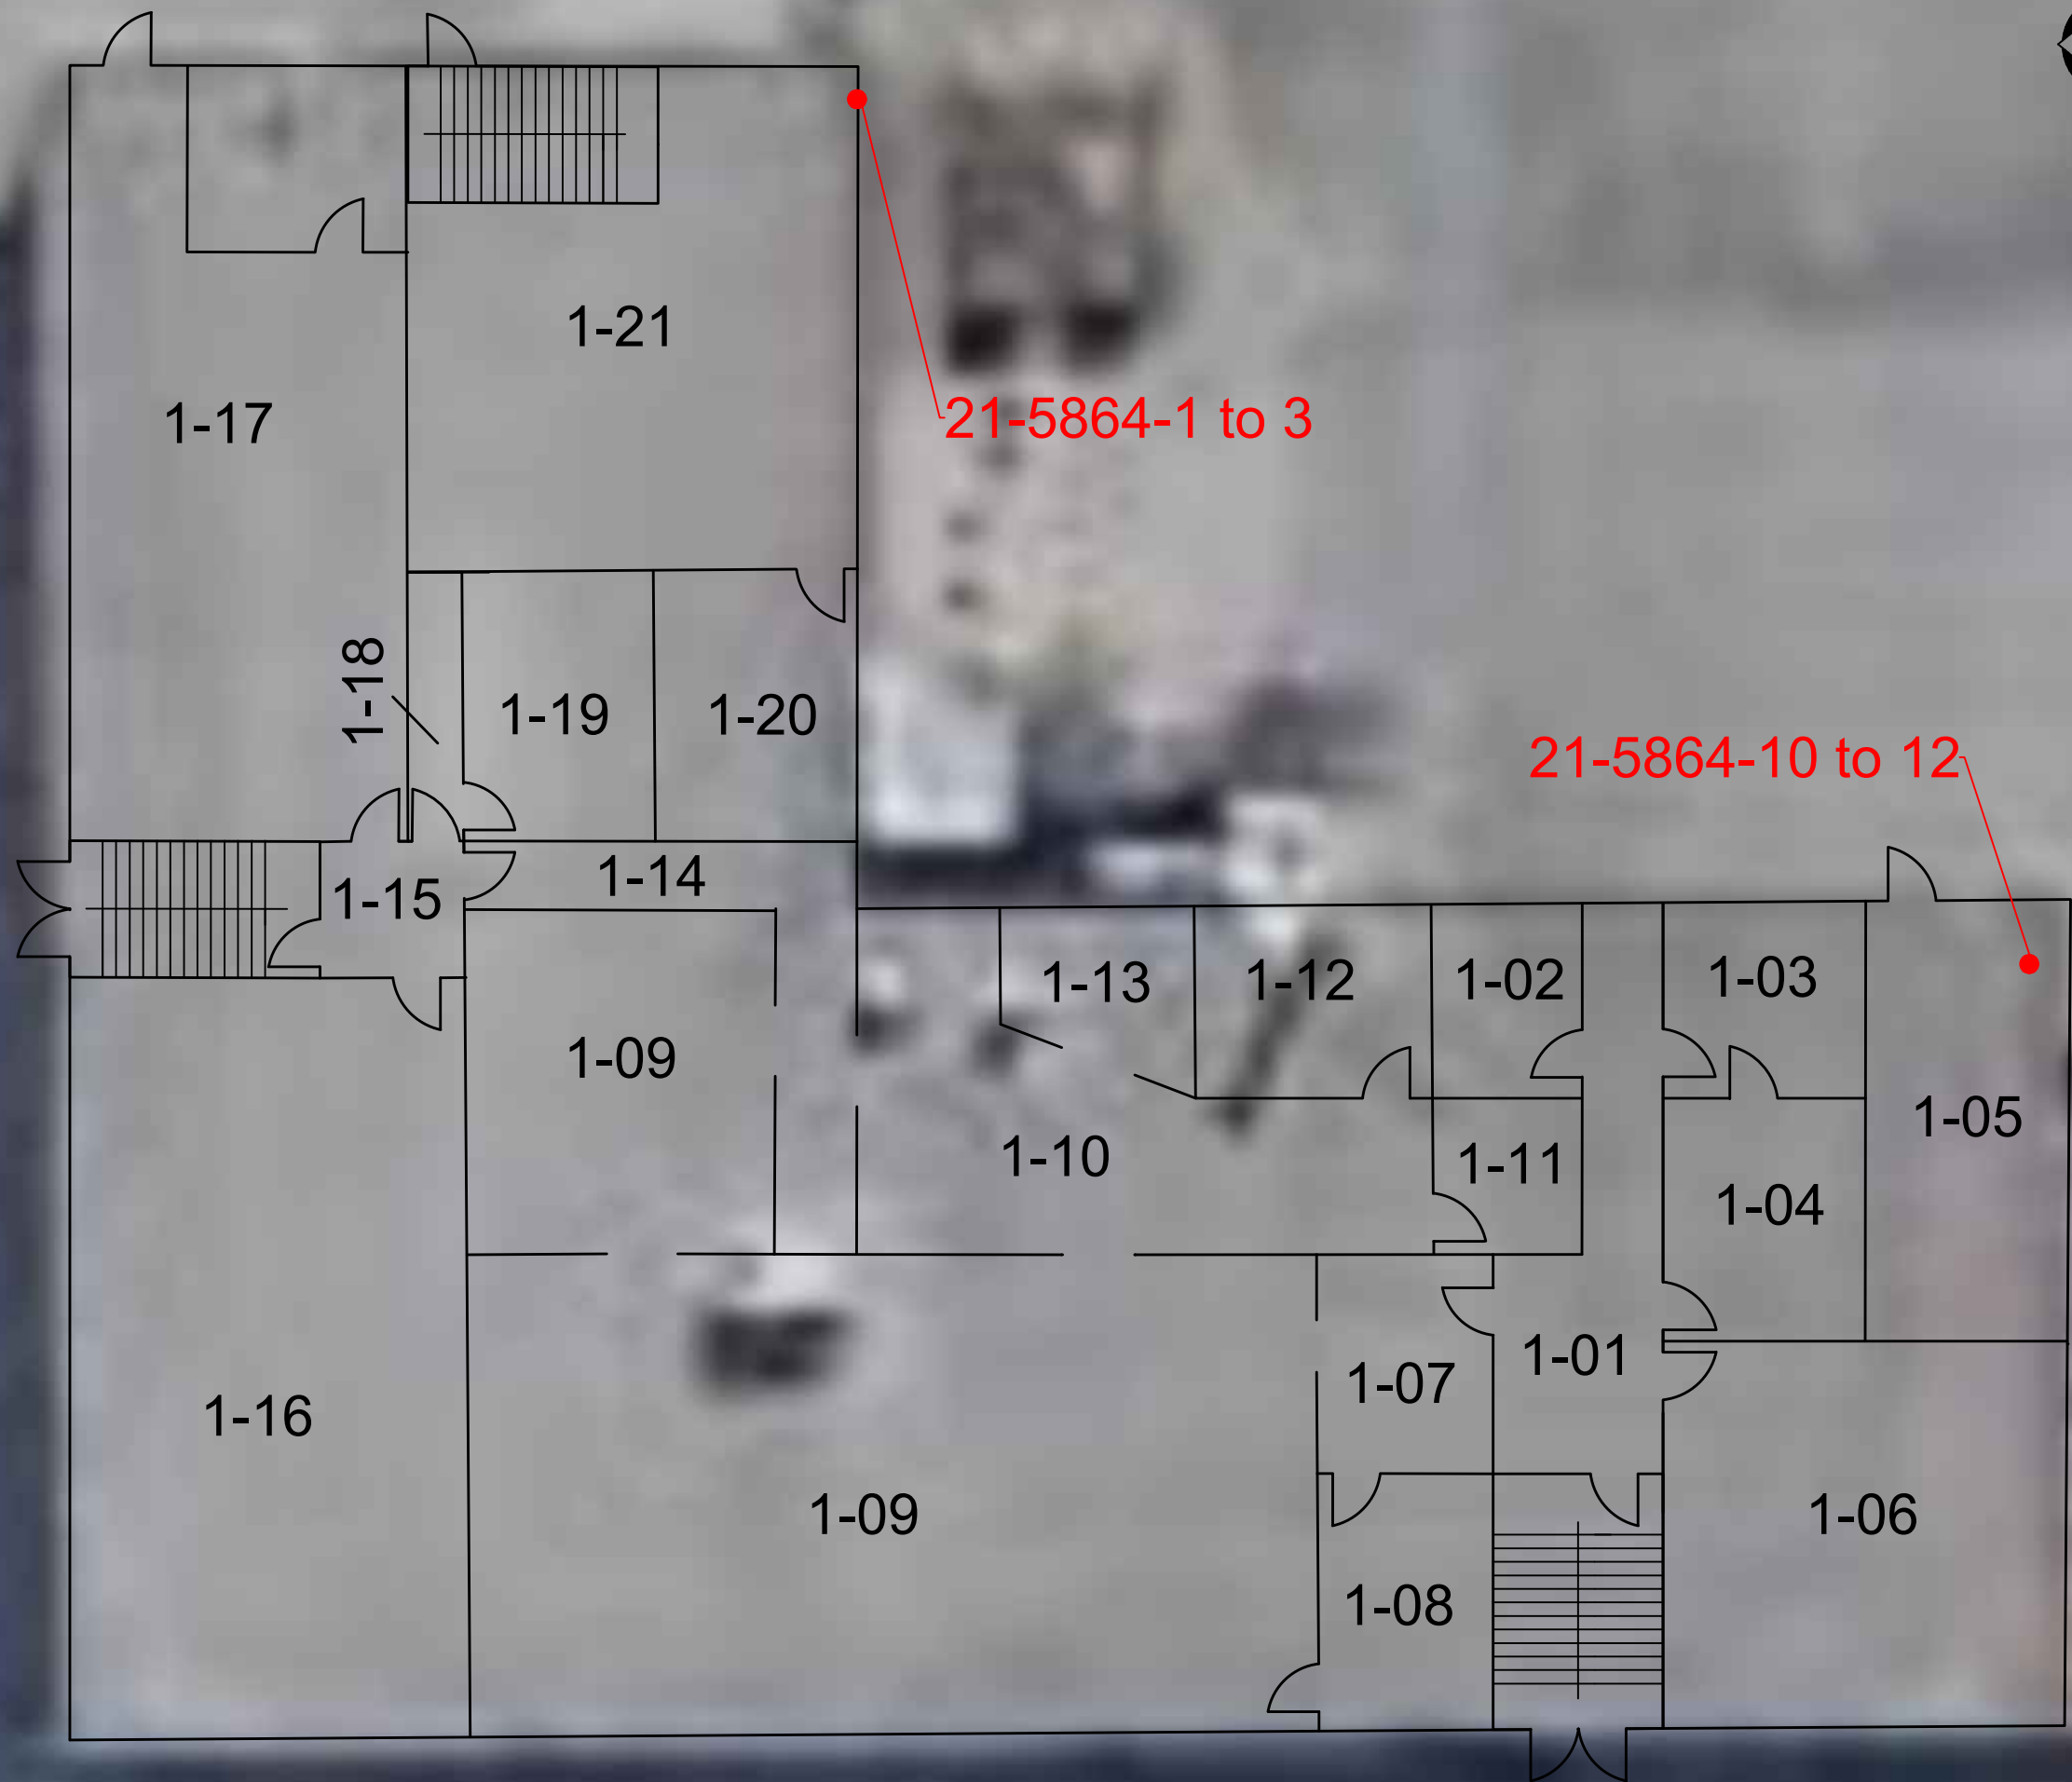
Figure 1

First Floor Plan
Asbestos Sample Locations

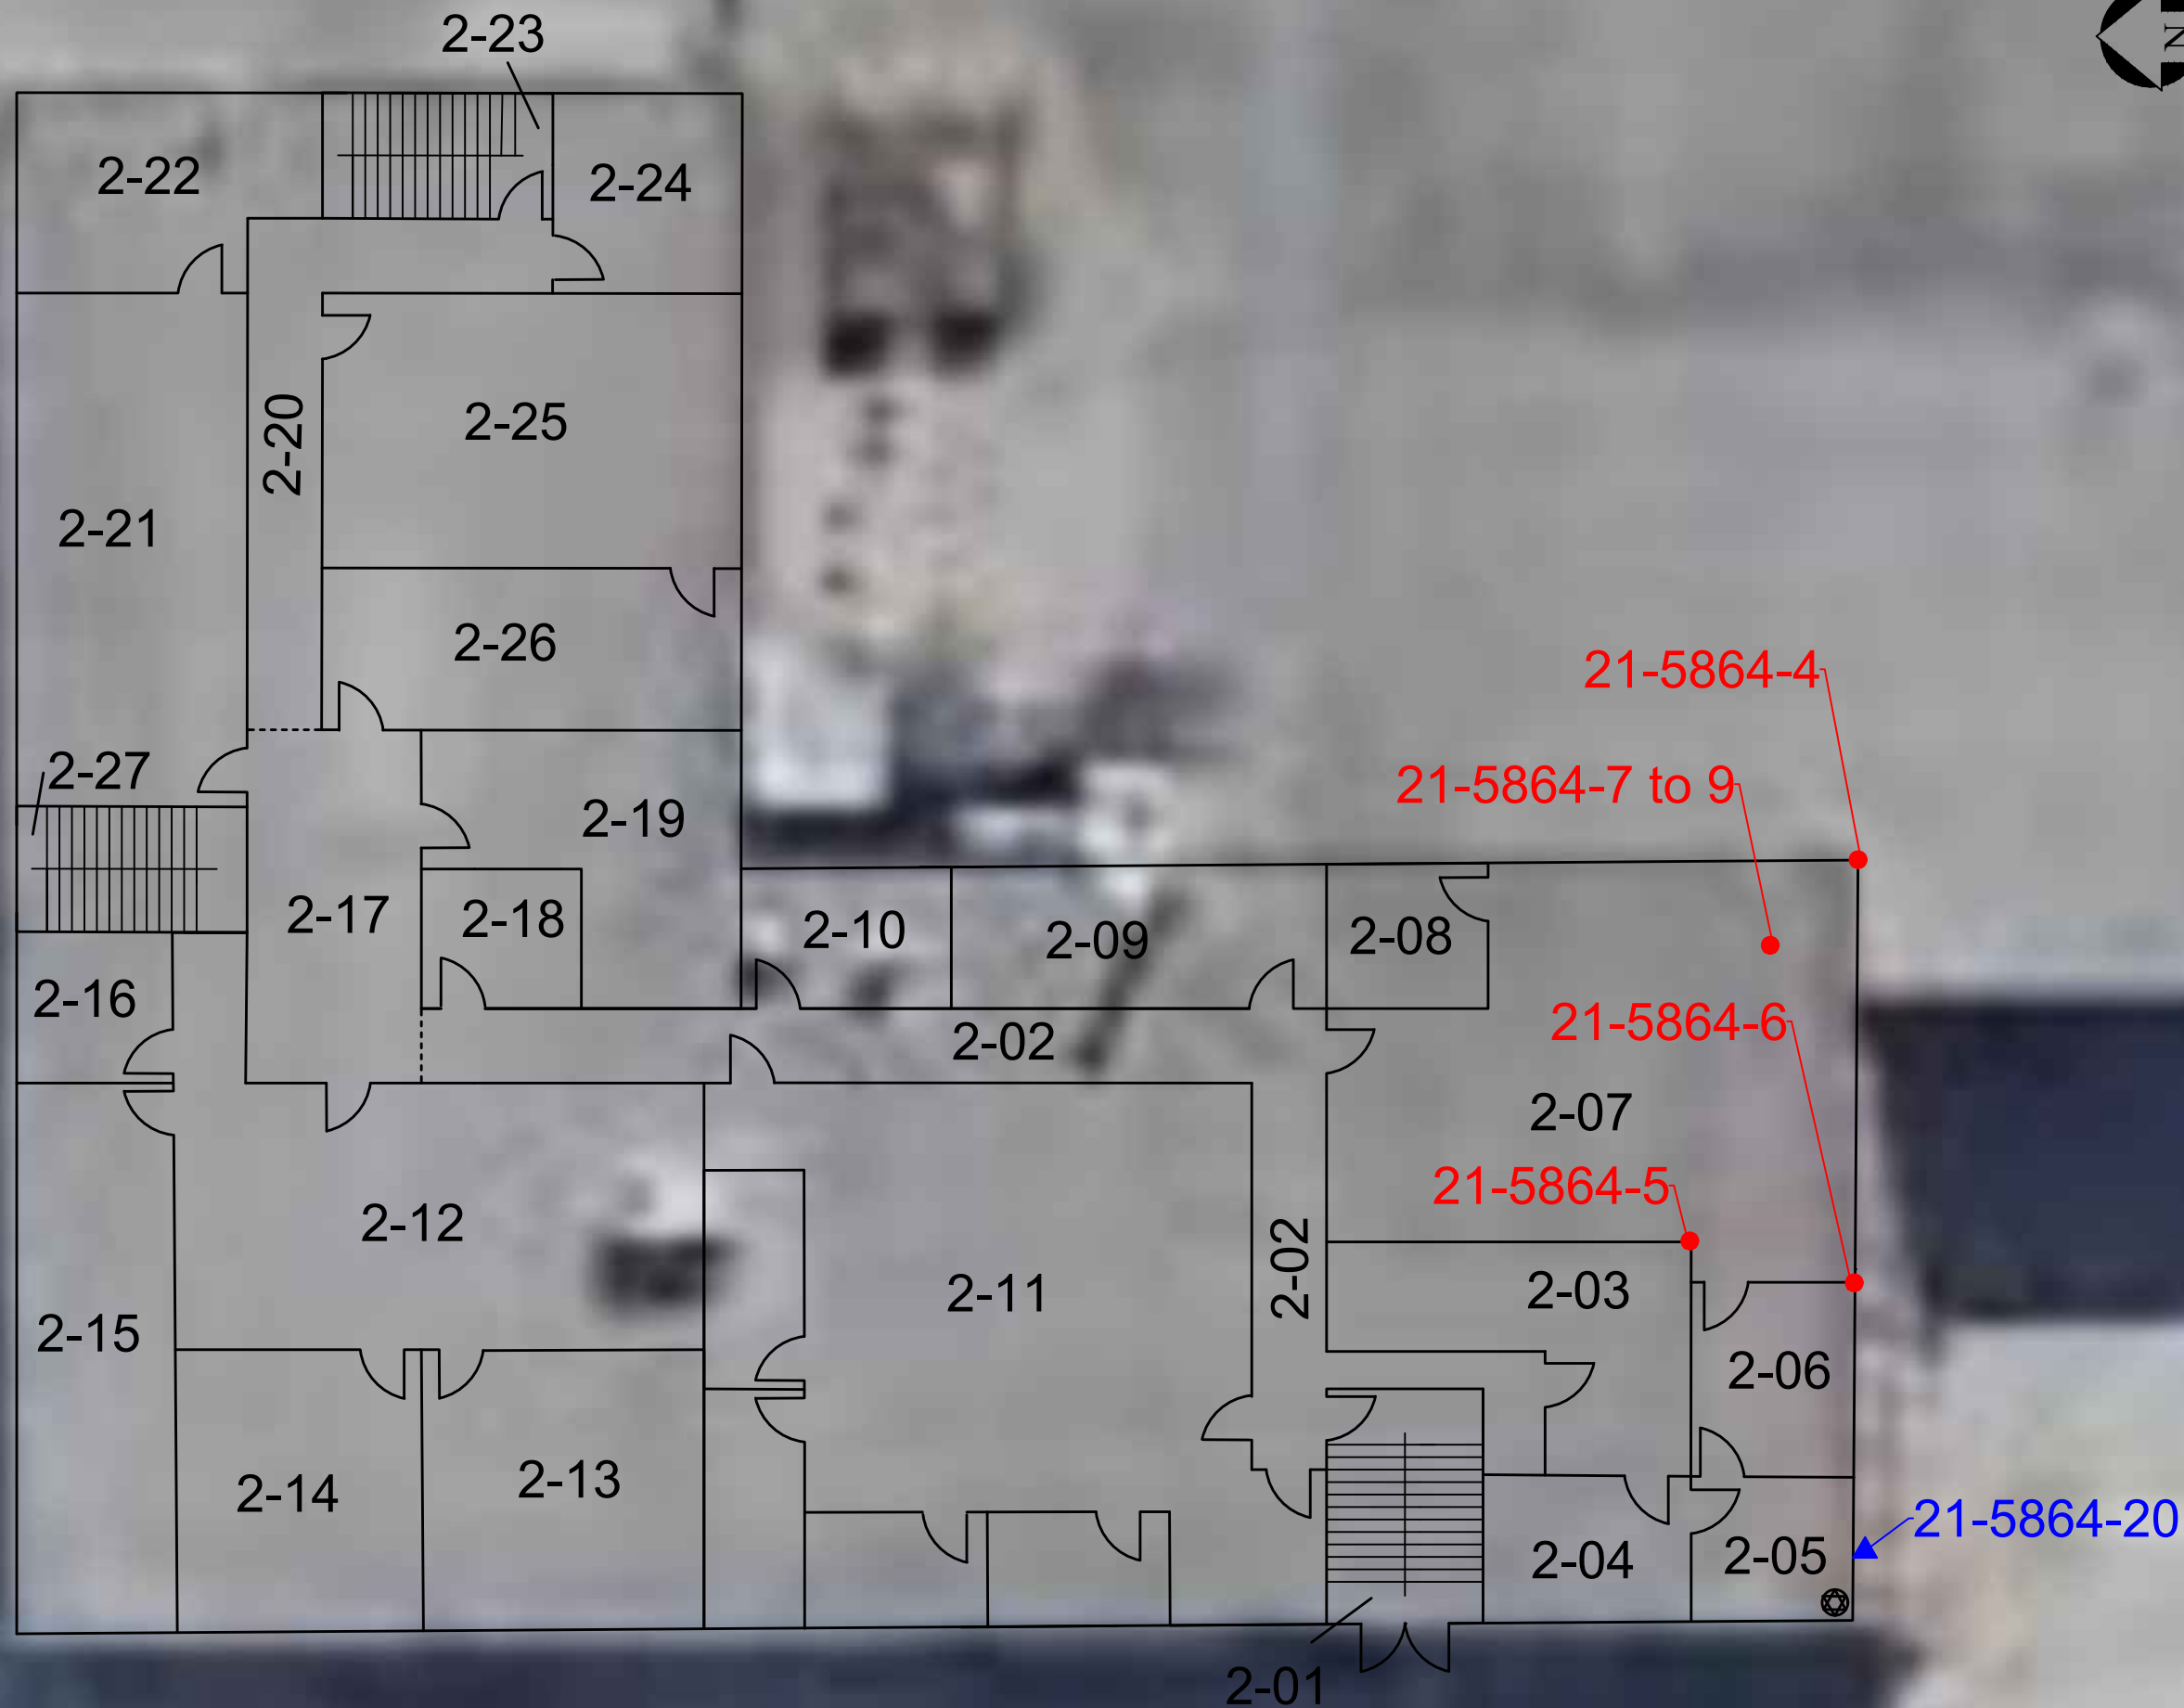
Figure 2

Second Floor Plan
Asbestos and Lead Sample Locations

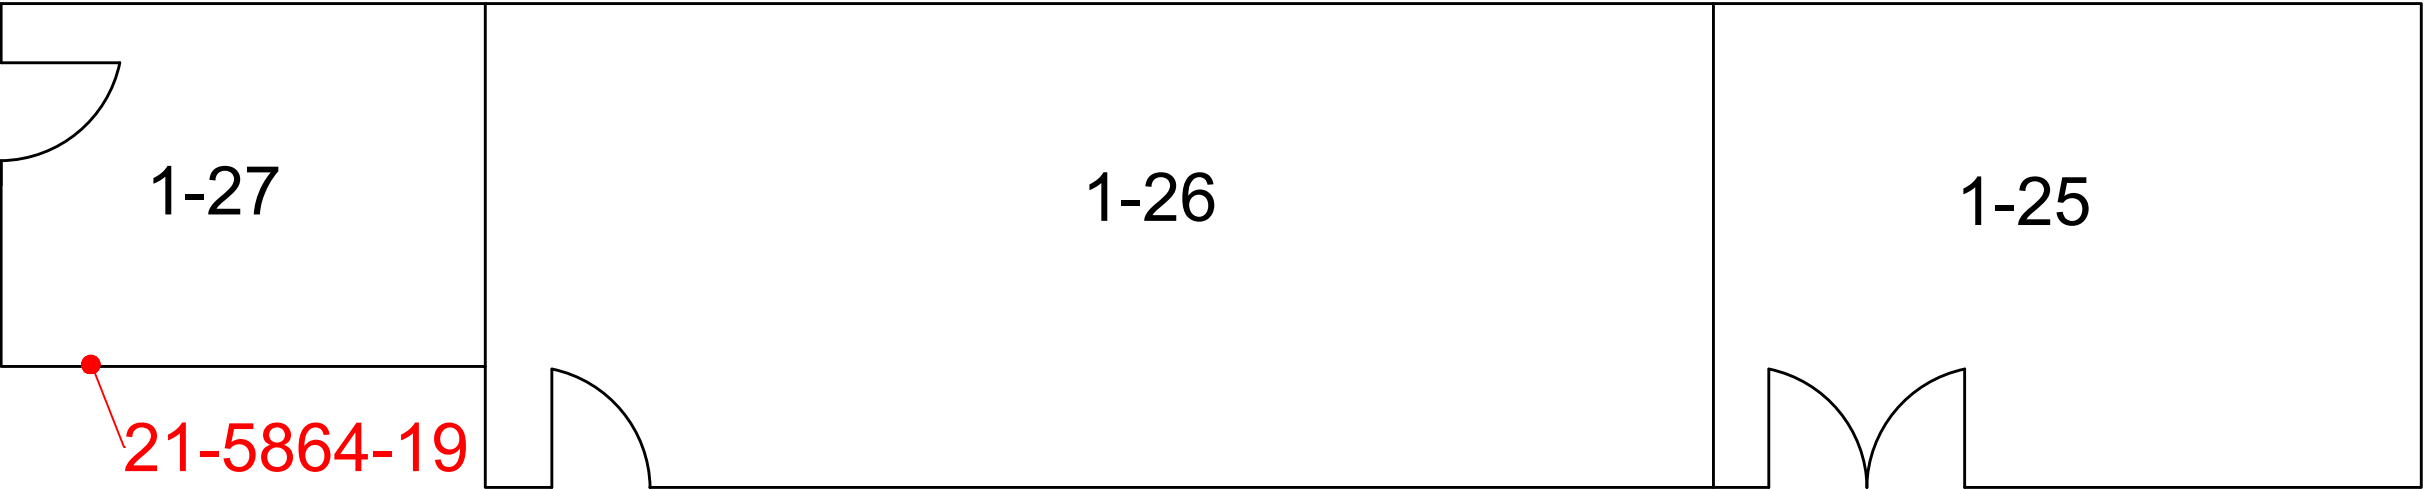
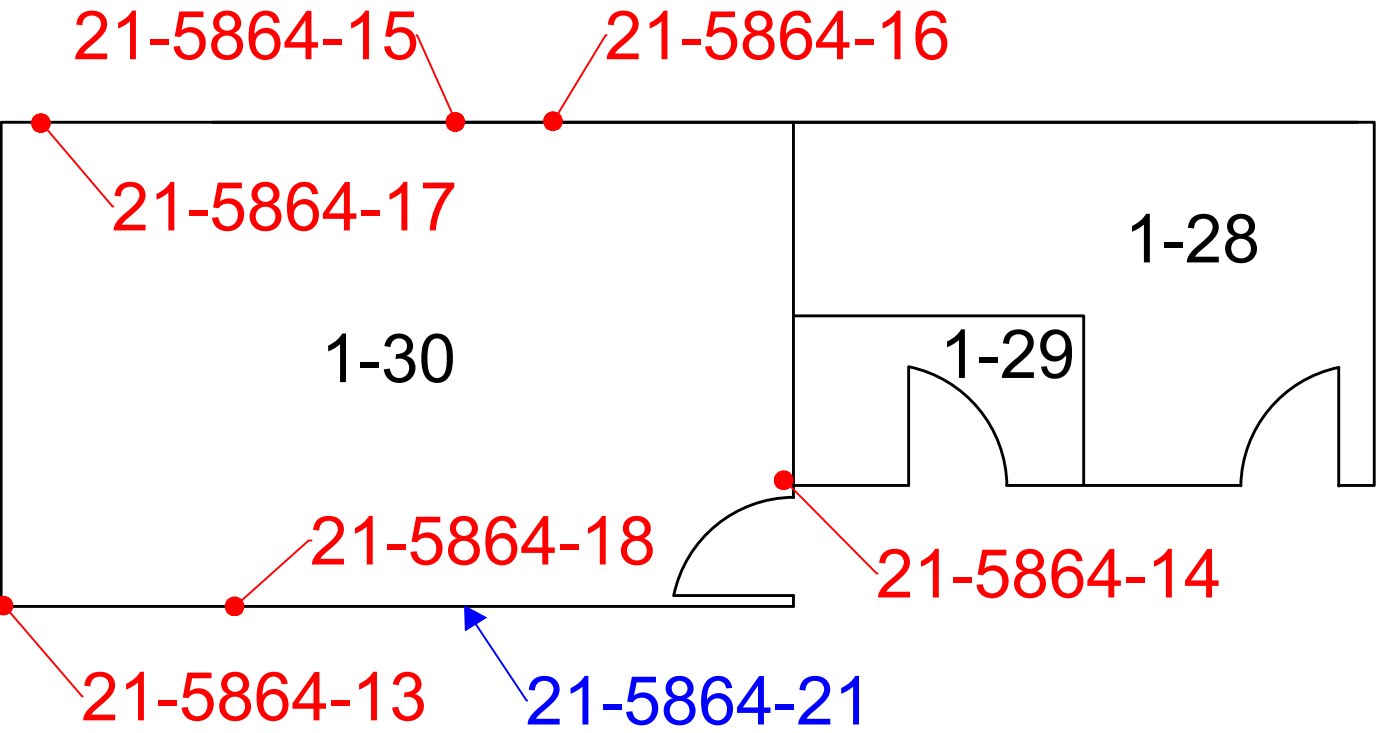
Figure3

Main Floor Plan Asbestos and Lead Sample Locations		
CLIENT: City of Toronto		
PROJECT NUMBER: FE-P 21-10889	DATE: January 2021	DRW BY: ZA
CAD FILE: FIG3	SCALE: Not to Scale	CHK BY: YH

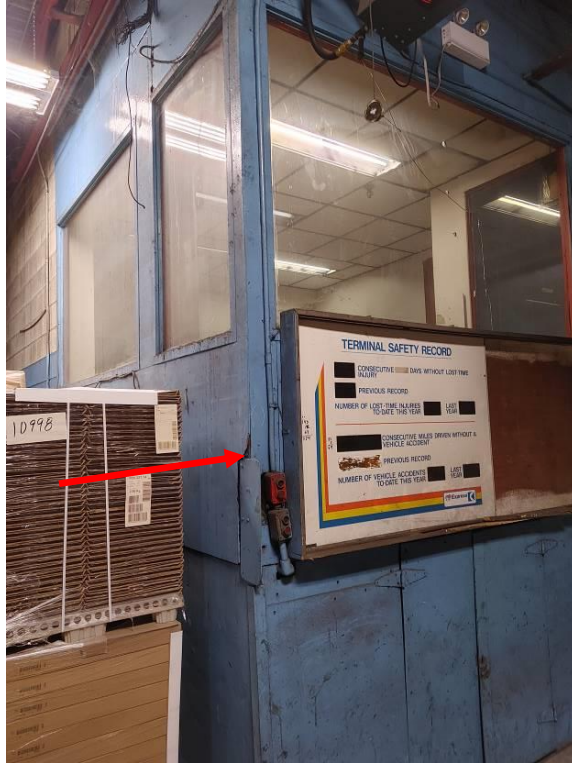
Ontario Regulation 278/05 ("O. Reg. 278/05") defines an "asbestos-containing" material as that with an asbestos content equal to or greater than 0.5% by weight. Laboratory analysis by PLM method determined the wall board in the north warehouse and drywall joint compound in the north office area to contain Chrysotile asbestos. All other suspected materials do not contain asbestos. No other materials suspected to contain asbestos were noted in the existing ACM inventory for the project scope area.

Photo 1 - Asbestos-Containing Wall Board found in the north warehouse.

Based on the observations and findings outlined above, Fisher recommends that the planned CCTV construction activities do not require asbestos abatement procedures.

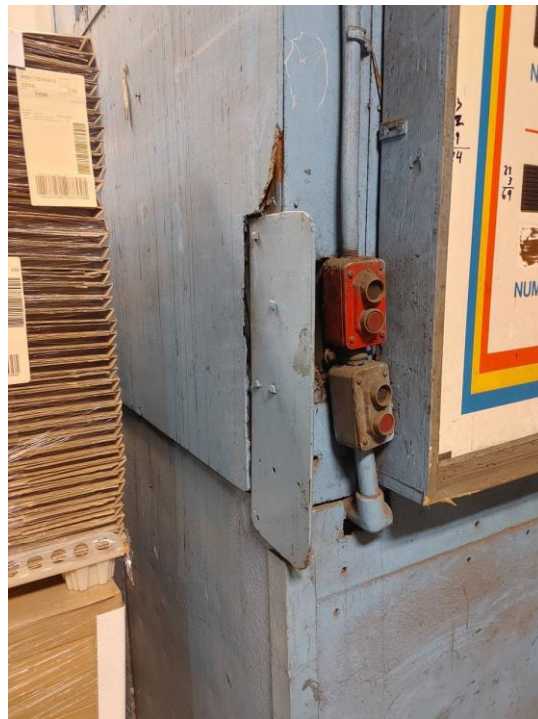
Photo 2 – Close up view of the Asbestos-Containing Wall Board.
