Limited Designated Substance Survey Report

Dunbarton High School (South Campus)

655 Sheppard Avenue, Pickering, Ontario

February 12, 2024
Parasol Project No: 13188

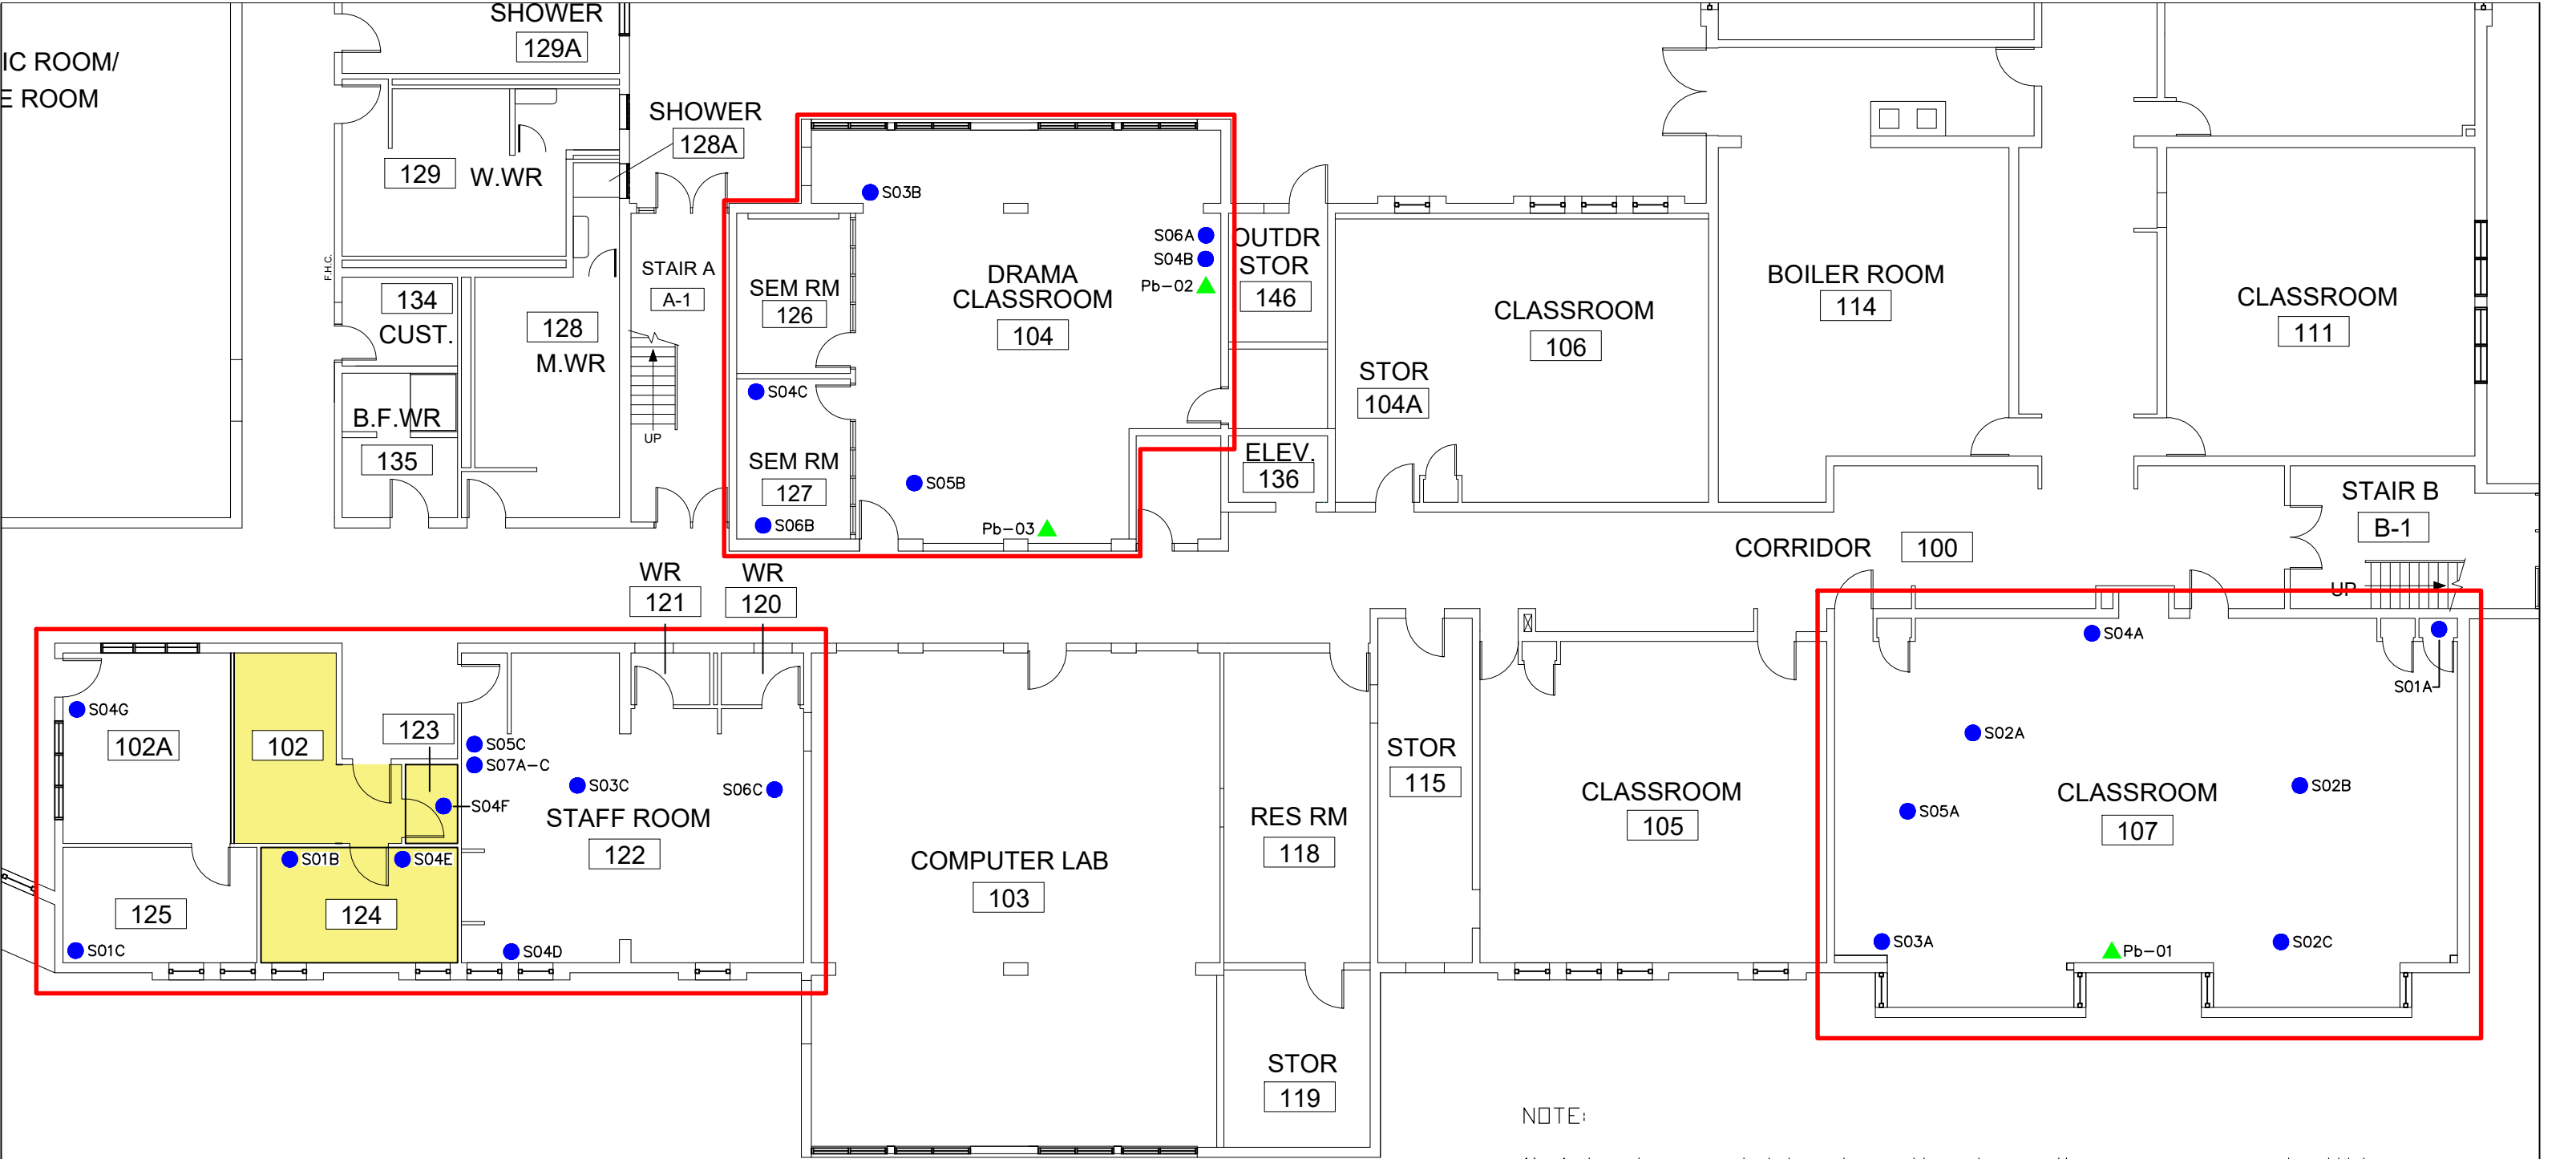
Site Drawing

1) Asbestos-containing transite pipe collars are present within the surveyed area. Specific locations of transite pipe collars are not illustrated.
