DESIGNATED SUBSTANCES AND HAZARDOUS BUILDING MATERIALS ASSESSMENT REPORT

Interior Alterations Project
Rooms 1-108, 1-114 and 1-115
Toronto Emergency Headquarters
4330 Dufferin Street
Toronto, Ontario

Safetech Project Number: 1-3230898

Date of Site Work: November 3, 2023
Date of Issue: November 15, 2023

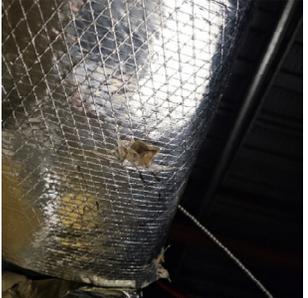
Sprayed and Loose Fill Insulating Materials	Location/Description	
Sprayed Fireproofing	None identified in subject areas.	
Sprayed Insulation	None identified in subject areas.	
Loose Fill / Vermiculite Insulation	None identified in subject areas. Interior portions of concrete block walls could not be assessed. However, it is not expected that these walls are insulated with loose fill or vermiculite insulation	
Thermal System Insulation	Location/Description	
Mechanical Pipe Insulation – Straights	Mechanical pipe fittings were observed to be not insulated.	
Mechanical Pipe Insulation – Fittings (elbows, valves, tees, hangars, etc.)	Mechanical pipe fittings were observed to be not insulated.	
HVAC Duct Insulation	Ducts were observed to be insulated with fiberglass insulation.
