Designated Substance Survey Report

Toronto Emergency
Headquarters, Paramedic
Station 53 & Parking Garage
4330 Dufferin Street,
Toronto, Ontario

December 6, 2023

Pinchin File: 309046.002

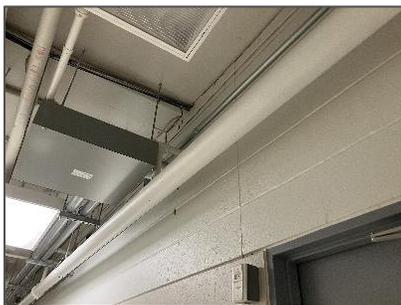
Uninsulated pipe – Corridor (Location B-001).

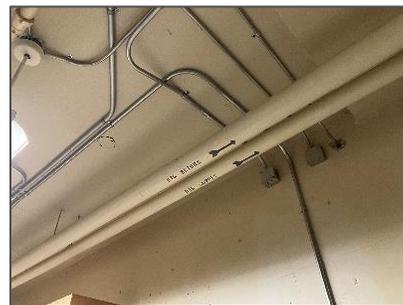
Pipes insulated with fibreglass and jacketed in paper– Cleaner Storage (Location B-004).

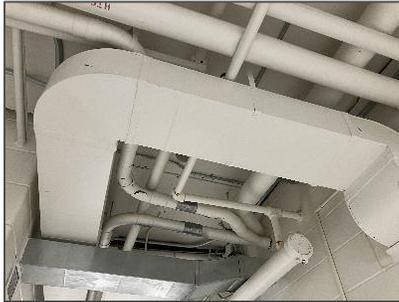
Uninsulated duct – Corridor (Location B-001).

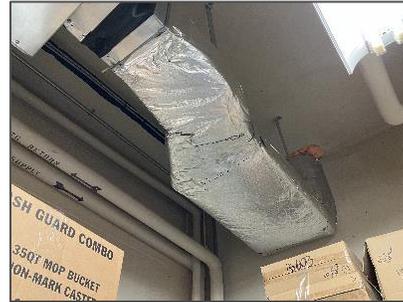
Duct insulated with fiberglass and jacketed in foil – Central Files Storage (Location B-007).

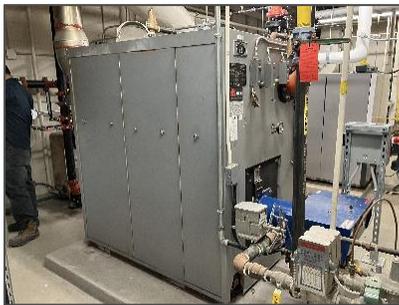
Uninsulated boiler – Boiler Room (Location B-014).

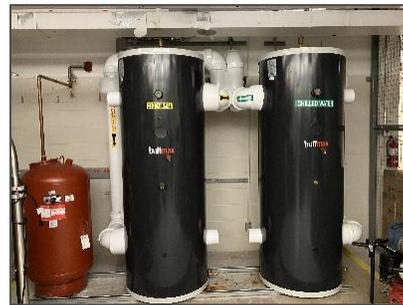
Hot water tanks insulated with fiberglass – Storage Cages (Location B-002).

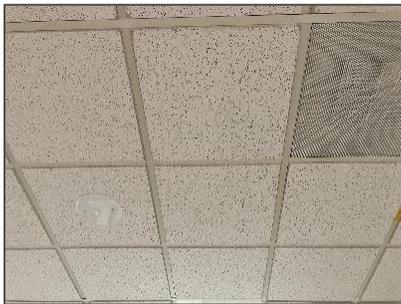
Non-asbestos acoustic ceiling tiles (ACT01).

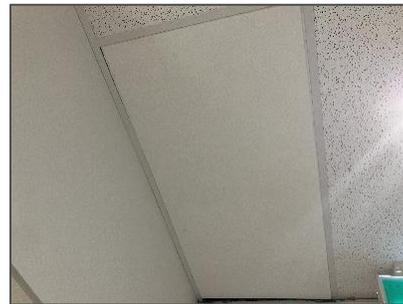
Non-asbestos acoustic ceiling tiles (ACT02).

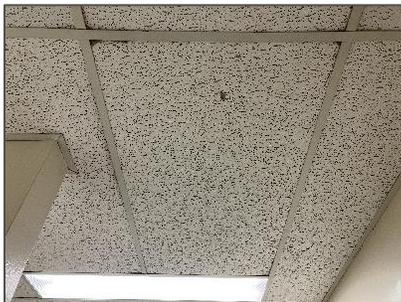
Non-asbestos acoustic ceiling tiles (ACT10).

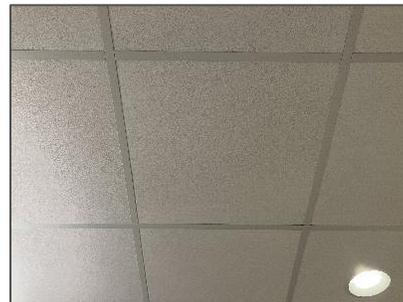
Non-asbestos acoustic ceiling tiles (ACT15).

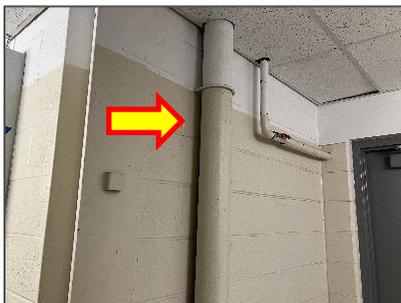
Cement (Transite) pipe, present as rainwater leaders throughout the building, presumed to contain asbestos based on visual observation. Transite is non-friable and in good condition.

Presumed asbestos-containing Transite pipe – Corridor
(Location 1-098).

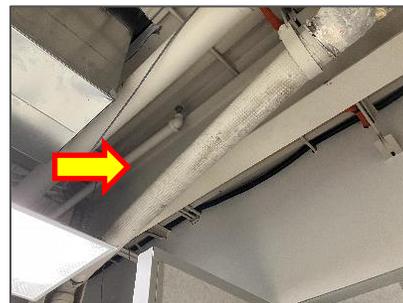
Presumed asbestos-containing Transite pipe – Men's /
Women's Change Room (Location 2-145).

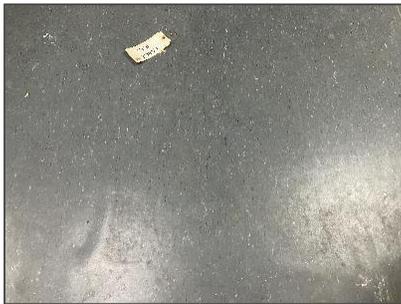
Non-asbestos vinyl sheet flooring (VSF01).

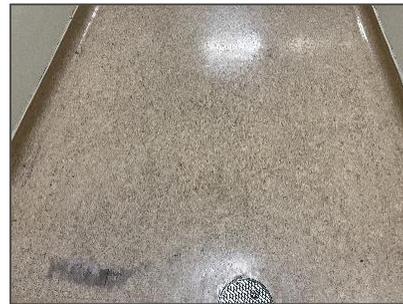
Non-asbestos vinyl sheet flooring (VSF02).

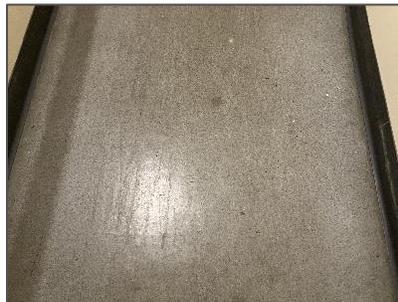
Non-asbestos vinyl sheet flooring (VSF03).

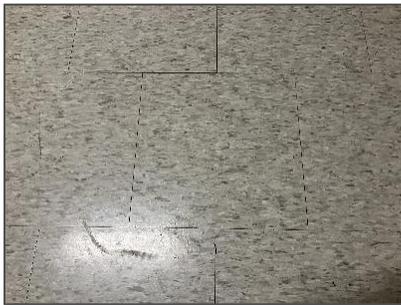
Non-asbestos vinyl floor tiles (VFT01).

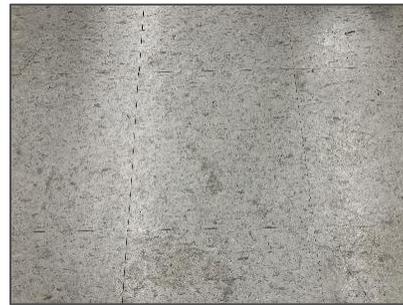
Non-asbestos vinyl floor tiles (VFT02).

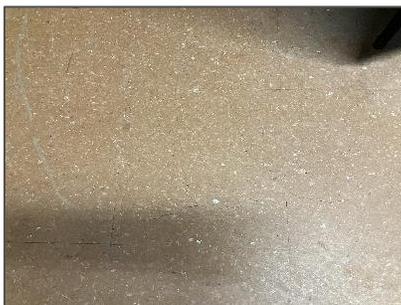
Non-asbestos vinyl floor tiles (VFT03).

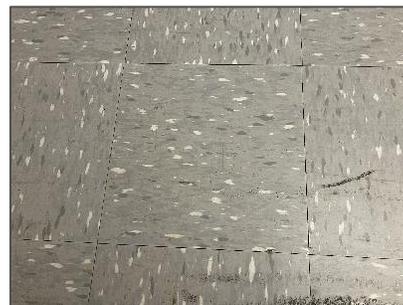
Non-asbestos vinyl floor tiles (VFT04).

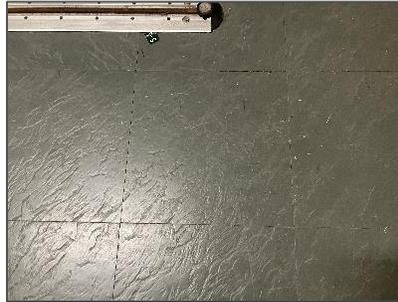
Presumed asbestos-containing vinyl floor tiles (VFT05).

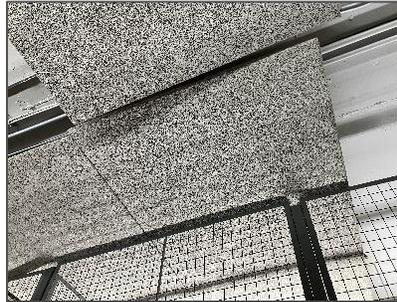
Tectum tiles, present as a ceiling finish in the Storage Cages (Location B-002), was previously sampled and does not contain asbestos (samples 11850-A-01-11A-C).

Non-asbestos tectum tiles – Storage Cages (Location B-002).
