**REVISED**  
**Designated Substance**  
**Re-Survey Report**

Toronto Emergency Medical  
Services Building 12  
330 Bering Avenue, Toronto, Ontario

June 19, 2024

Pinchin File: 340571.001

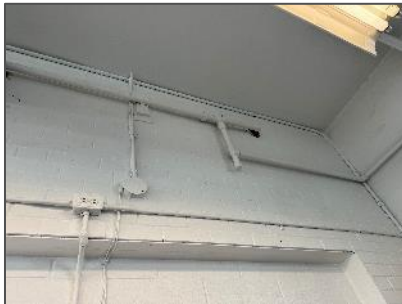
Uninsulated pipes – Storage Space (Location 1-01).

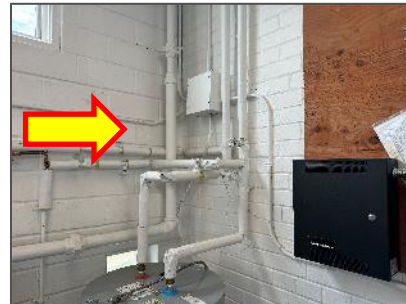
Pipes insulated with fibreglass and jacketed in paper – Storage Space (Location 1-01).

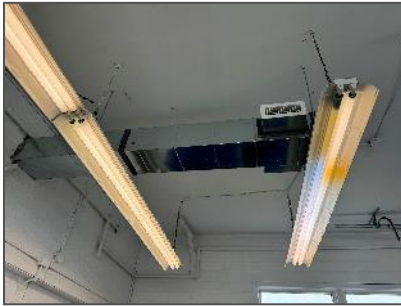
Uninsulated duct – Storage Space (Location 1-01).

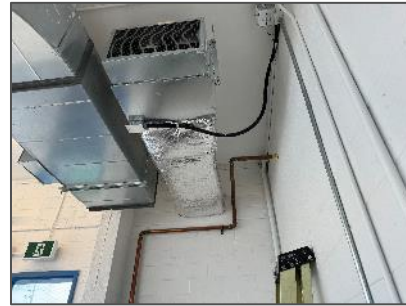
Duct insulated with fibreglass and jacketed in foil – Garage (Location 1-07).

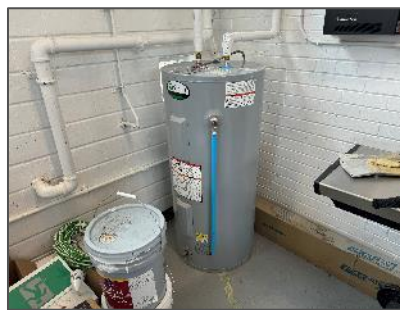
Hot water tank insulated with fibreglass and jacketed in metal – Storage Space (Location 1-01).

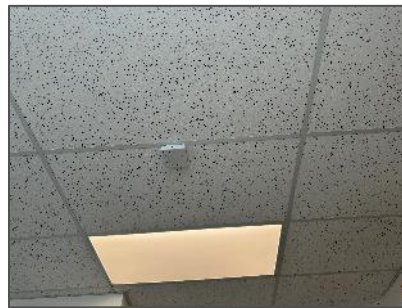
\*Ceiling tiles are presumed to be non-asbestos based on the date of manufacture determined from the date stamp applied to the top of the tiles. The tiles were manufactured after asbestos stopped being used in acoustic ceiling tiles.

Non-asbestos acoustic ceiling tiles (ACT01).

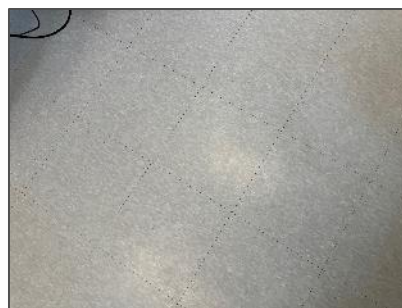
Vinyl floor tiles (VFT01: 12"x12", grey mosaic) were installed post-2020 and are presumed to be non-asbestos.

Non-asbestos vinyl floor tiles (VFT01).

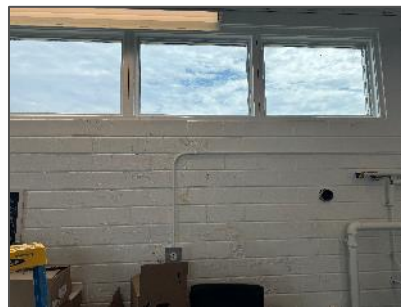
Sample Number	Colour, Substrate Description	Sample Location	Lead (%)
15-2558-01	White paint on masonry wall	Storage Space (Location 1-01)	<b>3.29</b>

Paints containing lead at concentrations above the City of Toronto action limit of 0.1% were observed in good condition (i.e. not flaking, peeling, or delaminating).

Lead-containing white paint on masonry wall – Storage Space (Location 1-01).

Disturbance of lead in paint and coatings (or other materials) during maintenance activities may result in over-exposure to lead dust or fumes. The need for work procedures, engineering controls and personal protective equipment will need to be assessed on a project-by-project basis and must comply with provincial standards or guidelines.

Performing an exposure assessment during work that disturbs lead in paints and coatings may be able to alleviate the use of some of the precautions specified by these standards or guidelines.

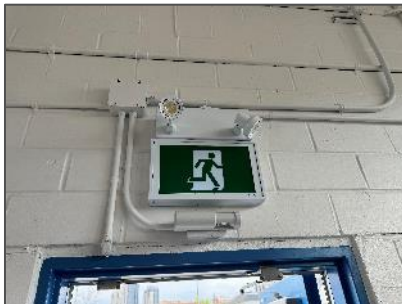
Lead-containing batteries may be present in emergency lighting.

Emergency lighting.

Lead-containing items should be recycled when taken out of service.

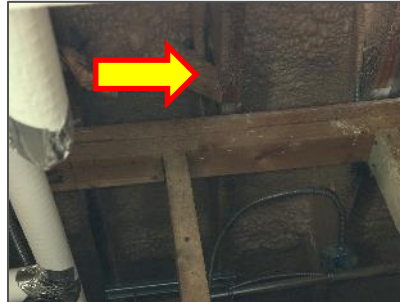
A foam insulation was observed on structural steel members within the assessed area during the reassessment. Based on the date of construction (1986) the foam insulation is not suspected to be UFFI.

Foam insulation on structural steel deck and joists – Crew Room (Location 1-02).
