Hazardous Building Materials Assessment (Pre-construction)

Membership and Guest Center
361A Old Finch Avenue,
Toronto, Ontario

September 8, 2022

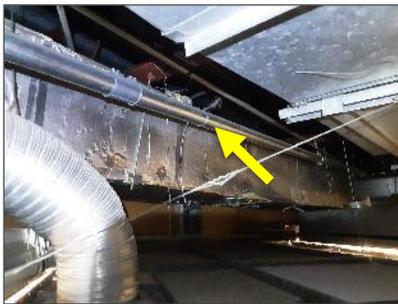
Uninsulated pipe, Membership and Guest Centre (HMIS Loc. 1).

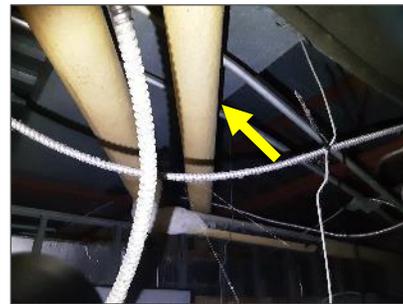
Fiberglass insulated pipe, Membership and Guest Centre (HMIS Loc. 1).

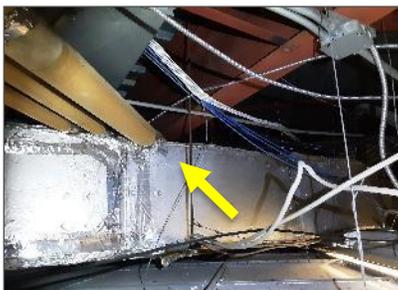
Foil-faced fiberglass insulated duct, Membership and Guest Centre (HMIS Loc. 1).

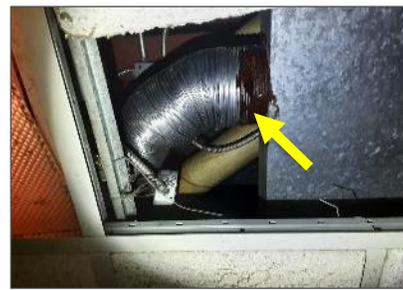
Red duct mastic, containing chrysotile asbestos, is present on seams / joints on ducts throughout the assessed area (samples S0012A-C).

Asbestos-containing red mastic is present on ducts seams/joint, Membership and Guest Centre (HMIS Loc. 1).

Remove asbestos-containing materials (ACM) prior to renovation, alteration, or maintenance if ACM may be disturbed by the work.

Asbestos-containing materials must be disposed of at a landfill approved to accept asbestos waste.

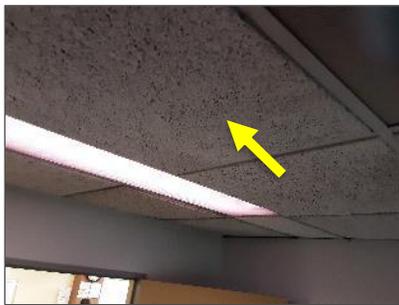
Non-asbestos ACT-01, 24"x48", lay-in, Textured finish
 Membership and Guest Centre (HMIS Loc. 1).

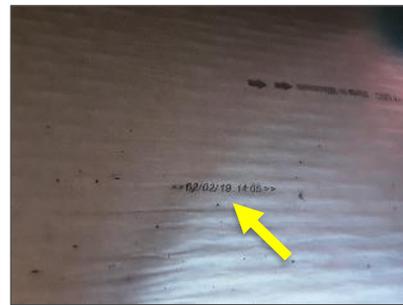
Ceiling tiles are presumed to be non-asbestos based on the date of manufacture determined from the date stamp applied to the top of the tiles. The tiles were manufactured after asbestos was stopped being used in acoustic ceiling tiles.

ACT1 - 24"x48", lay-in, manufacturing stamp date,
 Membership and Guest Centre (HMIS Loc. 1).

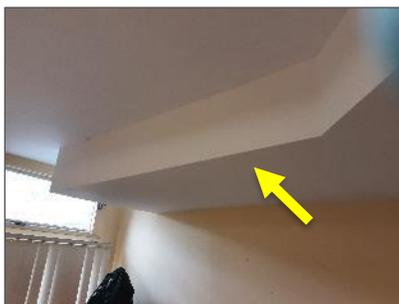
Non-asbestos drywall joint compound on bulkhead in GR
 Supervisor room S0005A-C, Membership and Guest Centre
 (HMIS Loc. 1).

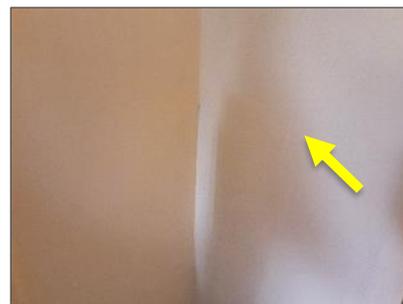
Non-asbestos drywall joint compound on partition walls in GR
 manger room S0001A-C, Membership and Guest Centre
 (HMIS Loc. 1).

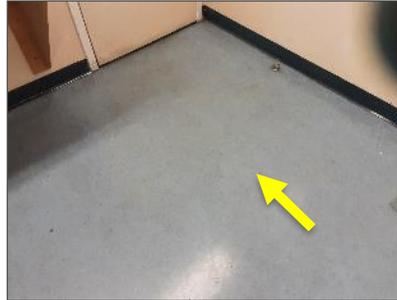
Non asbestos blue vinyl sheet flooring in accounting room S0006A-C, Membership and Guest Centre (HMIS Loc. 1).

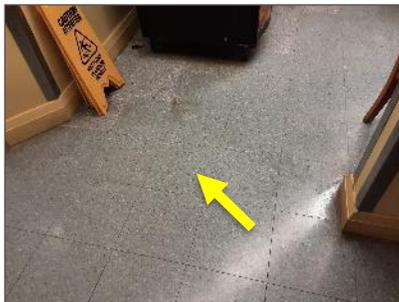
Non-asbestos VFT-01, 12"x12" light grey with white flakes, in C3 connection building, Membership and Guest Centre (HMIS Loc. 1).

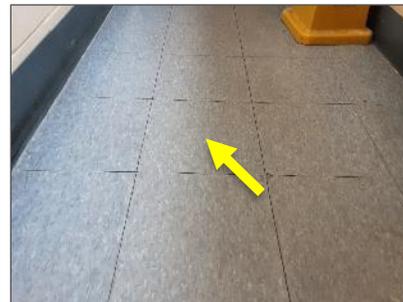
Non-asbestos VFT-02, 12"x12" light blue with white flakes in Lunch area, Membership and Guest Centre (HMIS Loc. 1).

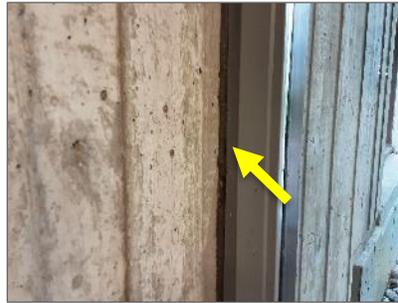
Black caulking at guest entrance exterior door frame does not contain asbestos (samples S0009A-C).

Non-asbestos black caulking on exterior guest entrance door frame, Membership and Guest Centre (HMIS Loc. 1).

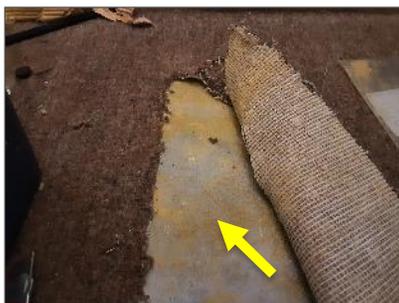
Non-asbestos yellow mastic under red carpet, Membership and Guest Centre (HMIS Loc. 1).

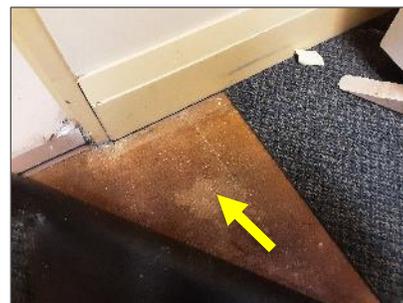
Non-asbestos yellow mastic under blue carpet in office areas, Membership and Guest Centre (HMIS Loc. 1).

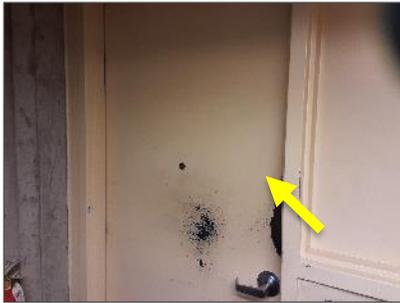
L0001, Yellow paint within insignificant lead content on metal door frame in office area, Membership and Guest Centre (HMIS Loc. 1).

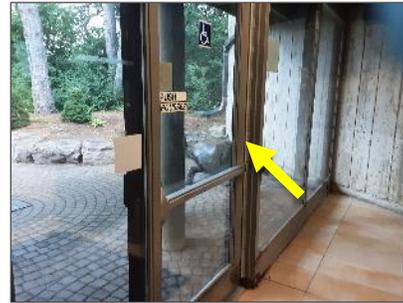
L0003, Grey paint with low-level lead content on metal door frame in guest entrance door, Membership and Guest Centre (HMIS Loc. 1).

For paints identified as having low levels of lead (i.e., less than the EACC guideline of 0.1% (1,000 mg/kg) for lead-containing paints but equal to or above 0.009% (90 mg/kg)) special precautions are not recommended unless aggressive disturbance (grinding, blasting, torching) is planned. Exposure from construction disturbance of paints containing lead less than 0.009% (90 mg/kg) is assumed to be insignificant.

Construction disturbance of lead in paint and coatings (or other materials) may result in exposure to lead dust or fumes and safe work procedures are required. Project specific work procedures, engineering controls and personal protective equipment will need to be assessed and developed as per applicable regulations and guidelines.

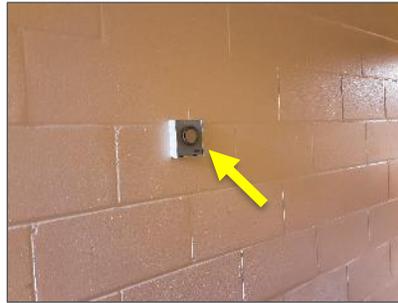
Mercury is present as a liquid in thermostats ampules.

Thermostat ampules is present in C3 connection building, Membership and Guest Centre (HMIS Loc. 1).

Do not break lamps. Recycle and reclaim mercury from fluorescent lamps and thermostats when taken out of service. Mercury is classified as a hazardous waste and must be disposed of in accordance with applicable regulations.

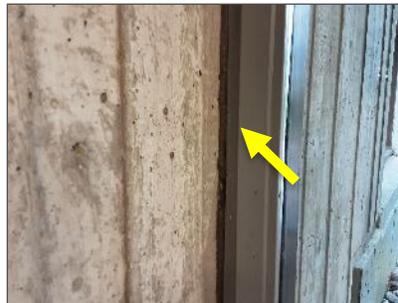
Black caulking is present at door frame (samples P0001) and contains <math><0.2\text{ mg/kg}</math> PCBs. The material is a non-PCB solid based on the threshold (50 mg/kg).

P0001, Non-PCB black caulking is present on metal door frame in guest entrance area, Membership and Guest Centre (HMIS Loc. 1).
