B20 Exterior Enclosure

B30 Roofing

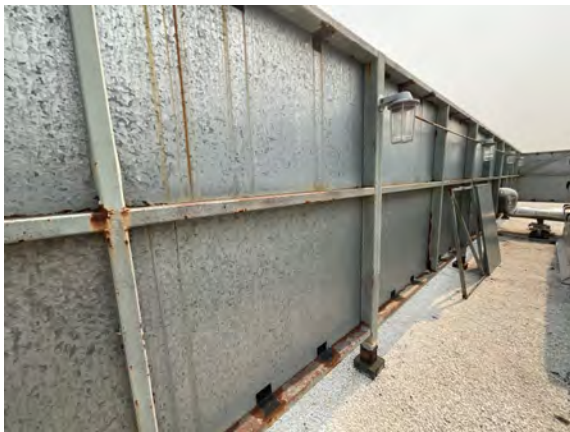
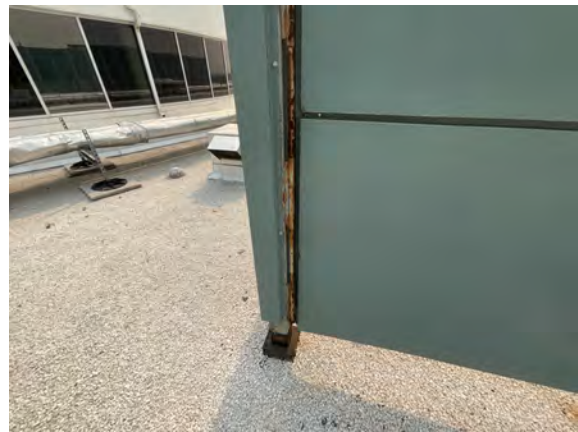
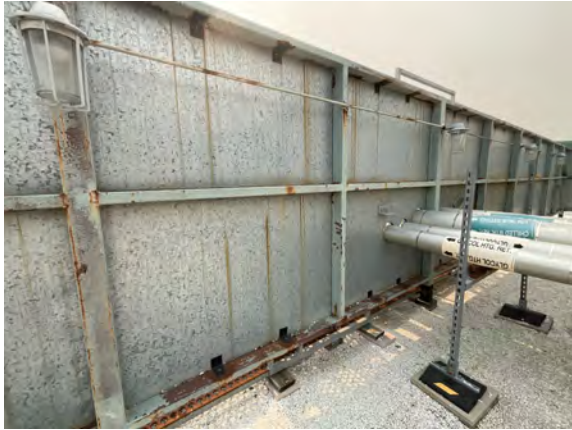
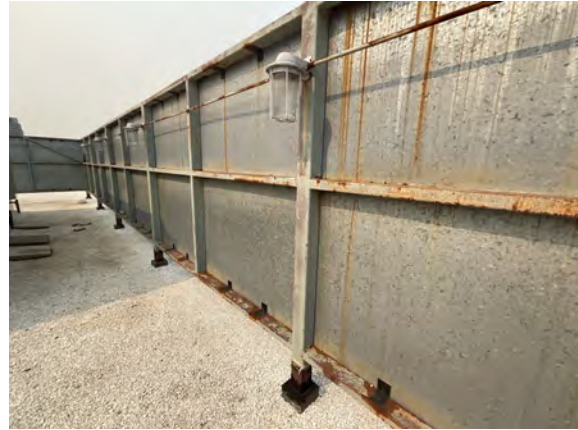
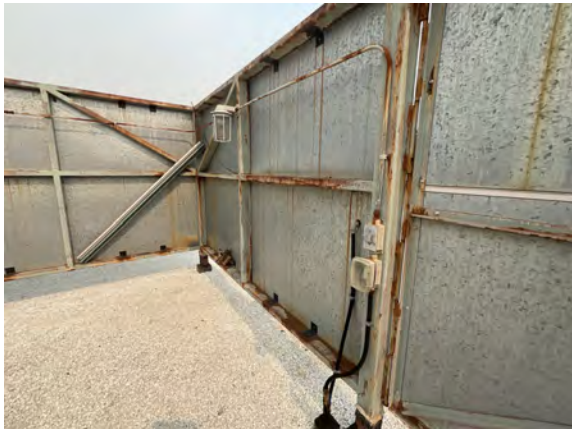
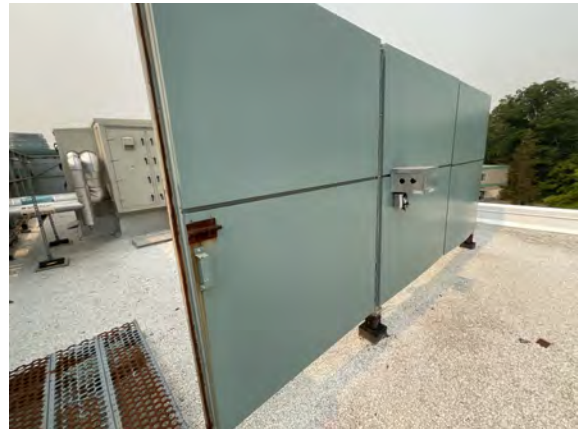
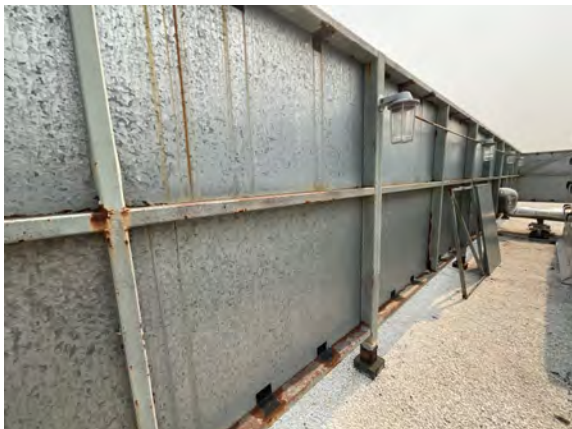
Element Description	
Name	B201005 - Exterior Louvers and Screens - Roof
Installation Year	1993
Condition	3 - Poor
Expected Useful Life	40 Years
Remaining Useful Life	1 Year
Renewal Year	2024
Quantity / Unit of Measure	165 / SM
Unit Cost	\$164.00
Difficulty / Regional / Soft Cost Factors	1.00 / 1 / 1.3
Element Cost	\$35,178.00
Imported System ID	----

Deficiencies observed or reported at the time of the assessment include extensive corrosion on the frames, panels and joints. The observed deterioration is anticipated to progress. Replacement is recommended.

Recommendations #1 - Exterior Louvers and Screens	
Type	Life Cycle Replacement
Year	2024
Cost	\$43,972.50
Imported Requirement ID	----

Replace Exterior Louvers and Screens

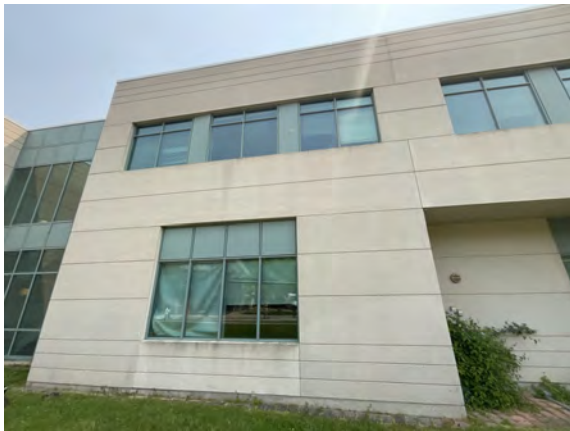
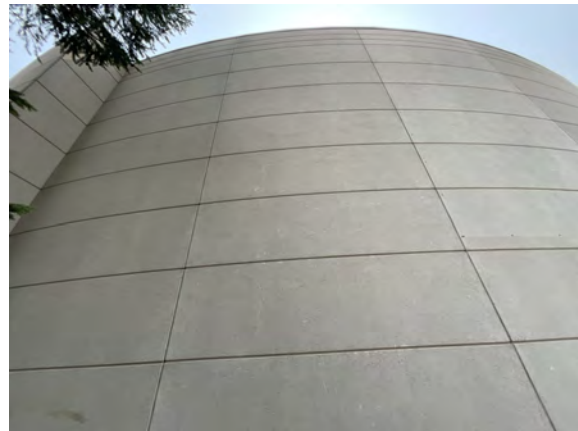
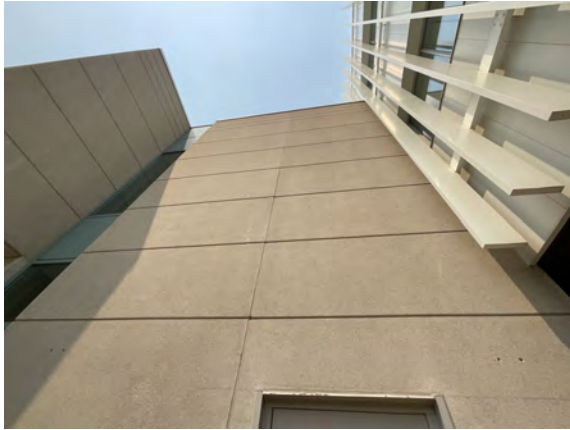
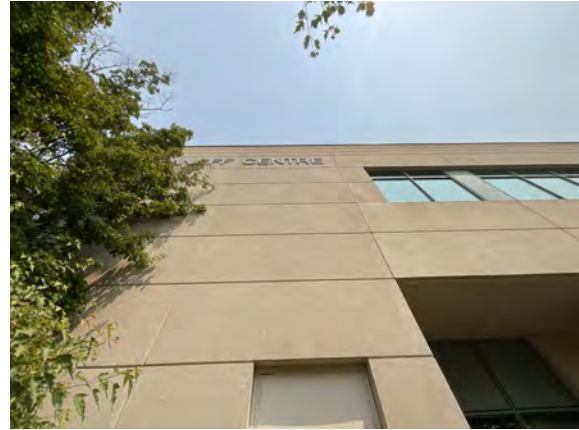
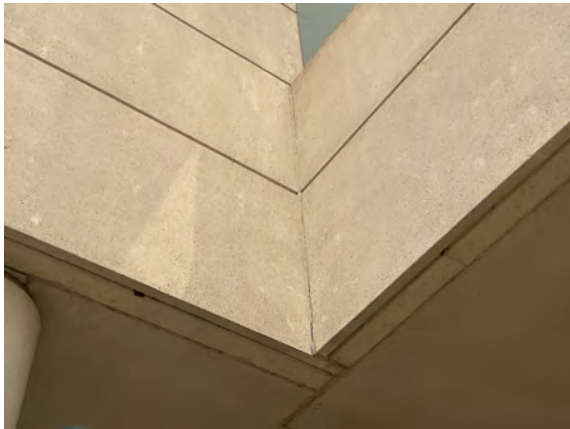
Element Description	
Name	B201027 - Pre-Cast / Cast in Place Wall Panels - All Elevations
Installation Year	1993
Condition	1 - Good
Expected Useful Life	75 Years
Remaining Useful Life	45 Years
Renewal Year	2068
Quantity / Unit of Measure	1365 / SM
Unit Cost	\$813.00
Difficulty / Regional / Soft Cost Factors	1.00 / 1 / 1.3
Element Cost	\$1,442,668.50
Imported System ID	SYS-450815

No major deficiencies were observed or reported. However, deteriorated sealant on precast panel wall joints was observed. Further deterioration may allow air and water leakage. Repair or replacement of the sealant is recommended. The replacement may require the removal and reinstatement of the backer rod.

Recommendations #1 - Pre-Cast / Cast in Place Wall Panels	
Type	Major Repair
Year	2023
Cost	\$28,800.00
Imported Requirement ID	----

Deteriorated sealant on precast panel wall joints was observed. Further deterioration may allow air and water leakage. Repair or replacement of the sealant is recommended. The replacement may require the removal and reinstatement of the backer rod.

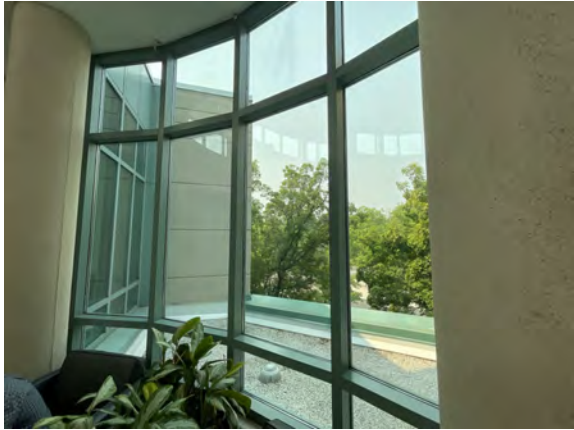
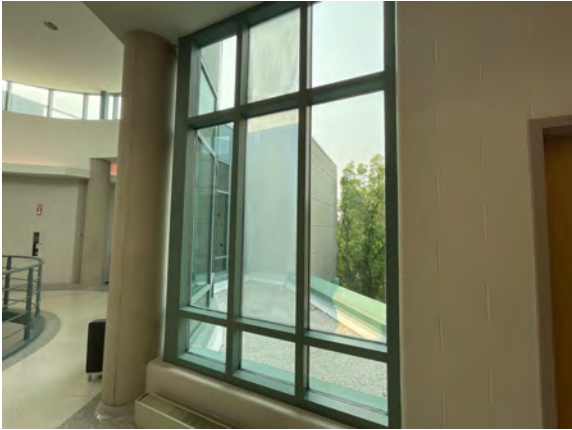
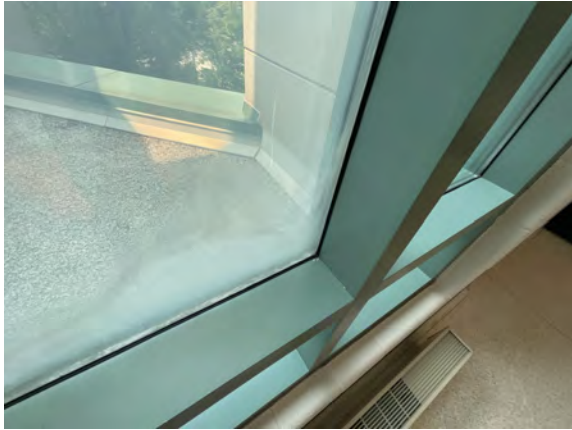
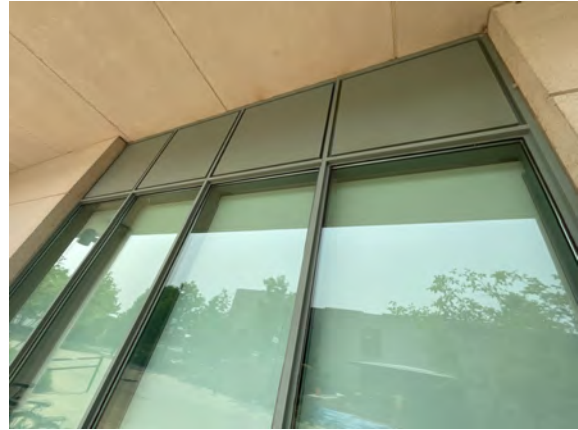
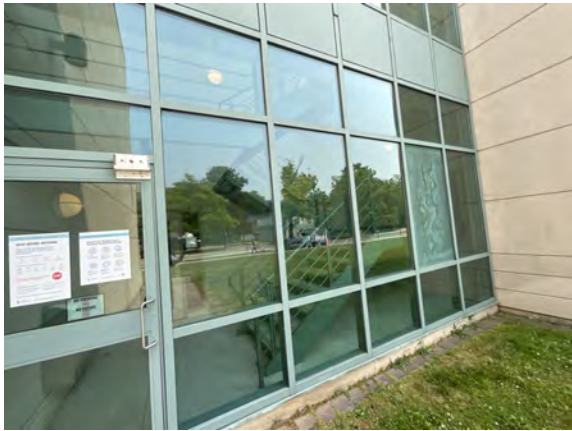
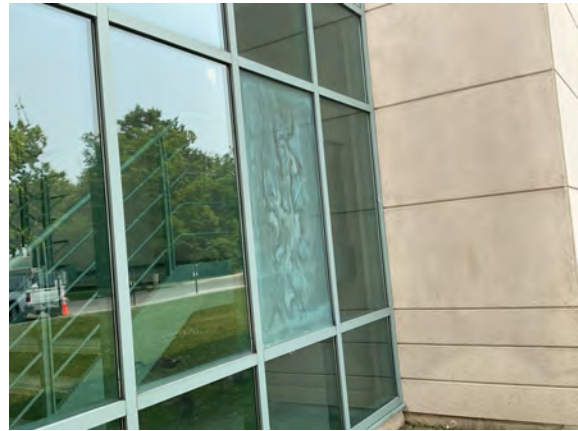
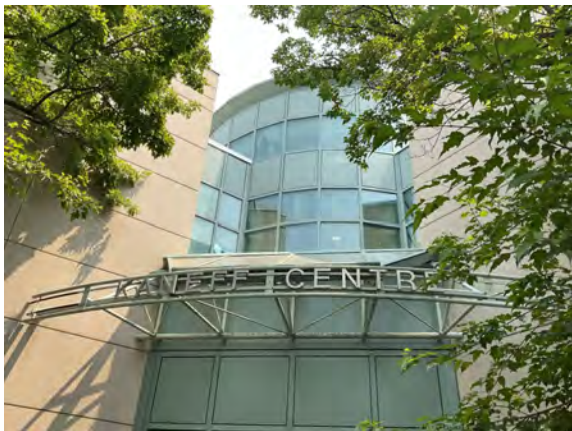
Name	B201030 - Windows / Curtain Walls - All Elevations
Installation Year	1993
Condition	1 - Good
Expected Useful Life	50 Years
Remaining Useful Life	20 Years
Renewal Year	2043
Quantity / Unit of Measure	141 / SM
Unit Cost	\$1,045.00
Difficulty / Regional / Soft Cost Factors	1.00 / 1 / 1.3
Element Cost	\$191,548.50
Imported System ID	SYS-451210

No major deficiencies were observed or reported. However, condensate between the IGU plate glass suggesting failed glazing seals were observed at isolated locations. Repair or replacement of the affected windows is recommended.

Recommendations #1 - Windows / Curtain Walls	
Type	Major Repair
Year	2023
Cost	\$38,200.00
Imported Requirement ID	----

Condensate between the IGU plate glass suggesting failed glazing seals were observed at isolated locations. Repair or replacement of the affected windows is recommended.

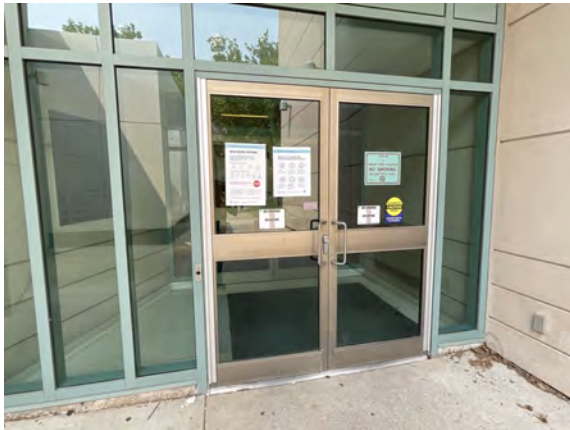
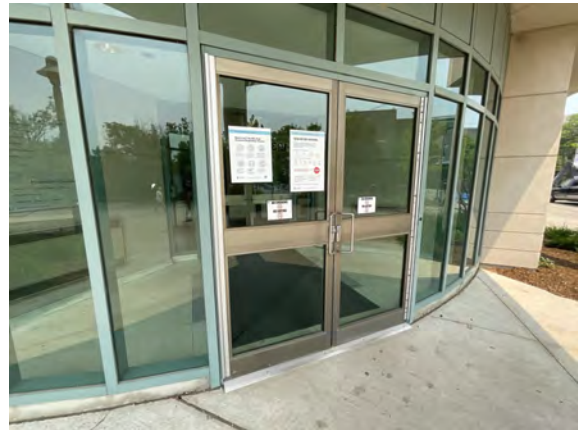
Element Description	
Name	B203005 - Glazed Doors - Single - North and South Elevation
Installation Year	1993
Condition	3 - Poor
Expected Useful Life	25 Years
Remaining Useful Life	0 Years
Renewal Year	2023
Quantity / Unit of Measure	6 / Each
Unit Cost	\$4,646.00
Difficulty / Regional / Soft Cost Factors	1.00 / 1 / 1.3
Element Cost	\$36,238.80
Imported System ID	SYS-450819

Deficiencies observed or reported at the time of the assessment include operational issues with the doors. Replacement is recommended.

Recommendations #1 - Glazed Doors - Single	
Type	Life Cycle Replacement
Year	2023
Cost	\$45,298.50
Imported Requirement ID	----

Replace Glazed Doors - Single

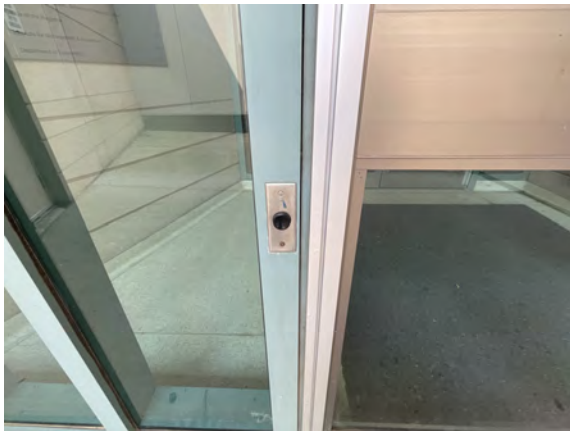
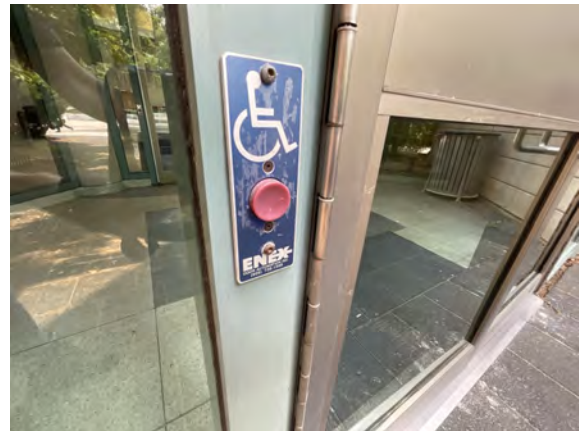
Element Description	
Name	B203008 - Automatic Door Openers (Exterior) - Entrances
Installation Year	1993
Condition	3 - Poor
Expected Useful Life	15 Years
Remaining Useful Life	0 Years
Renewal Year	2023
Quantity / Unit of Measure	4 / Each
Unit Cost	\$4,646.00
Difficulty / Regional / Soft Cost Factors	1.00 / 1 / 1.3
Element Cost	\$24,159.20
Imported System ID	----

Deficiencies observed or reported at the time of the assessment include worn door operators and openers. The door operators may not comply with accessibility design guidelines. Replacement is recommended.

Recommendations #1 - Automatic Door Openers (Exterior)	
Type	Life Cycle Replacement
Year	2023
Cost	\$30,199.00
Imported Requirement ID	----

Replace Automatic Door Openers (Exterior)

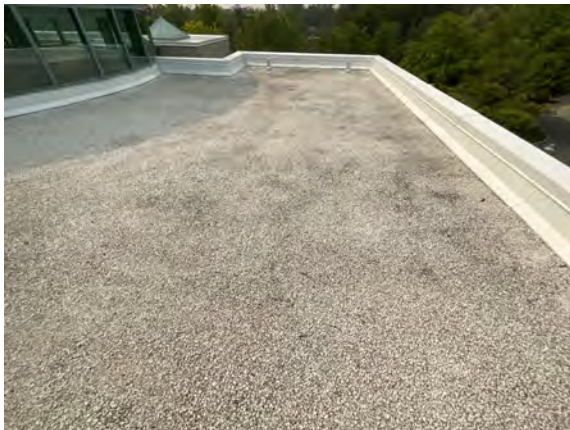
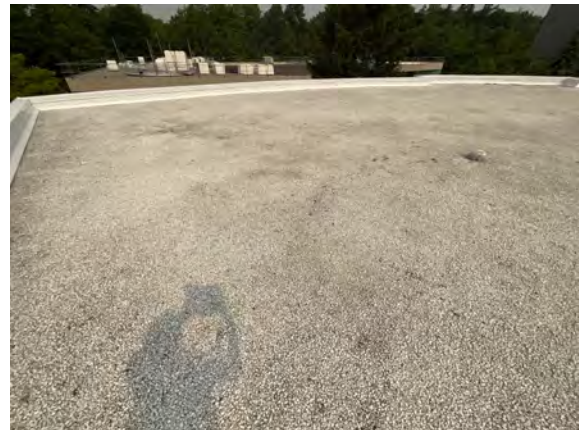
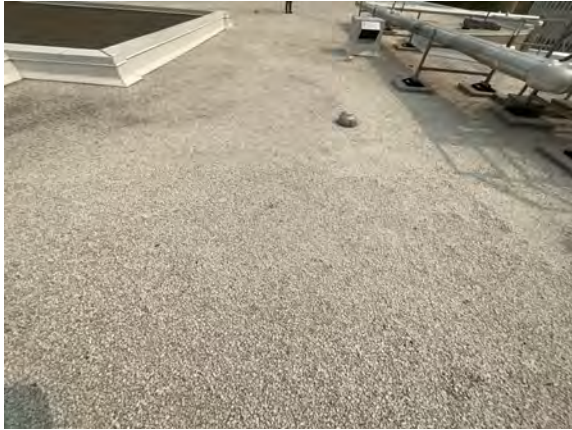
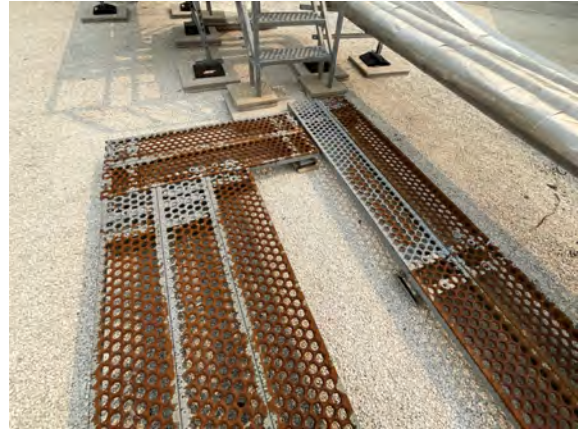
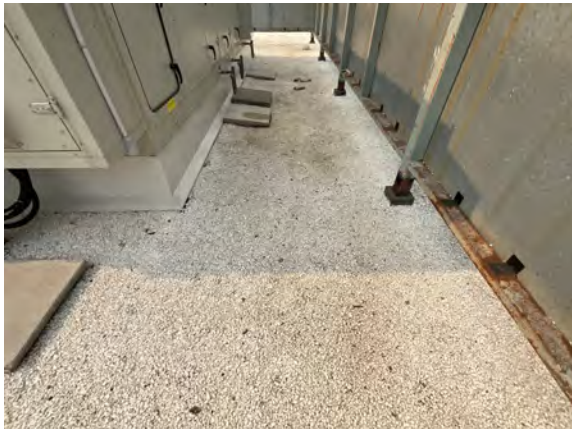
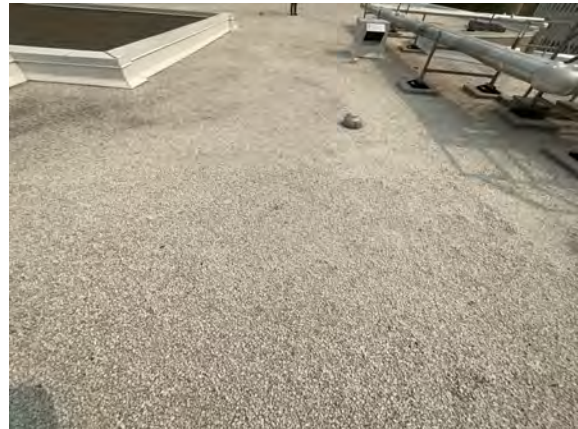
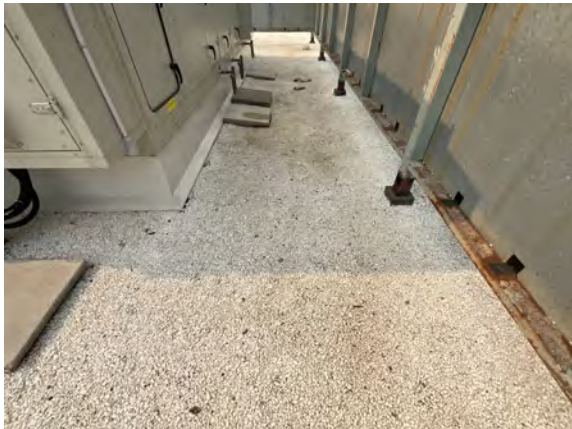
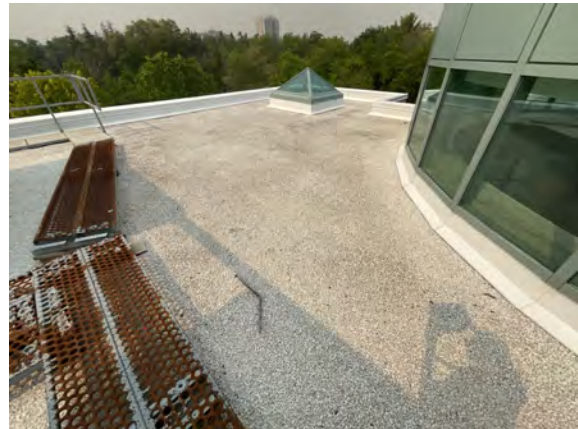
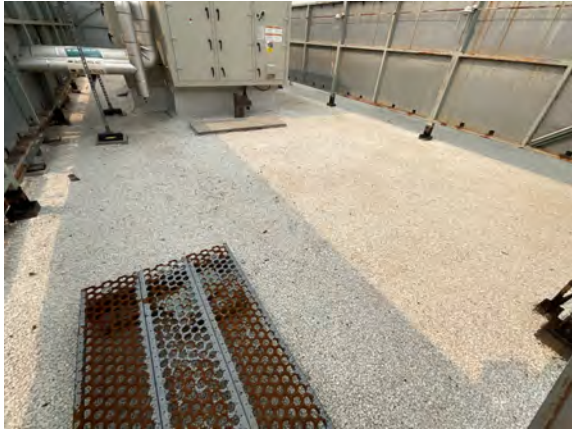
Element Description	
Name	B301021 - Conventional - Built-Up Roof - All Roof Sections
Installation Year	2021
Condition	1 - Good
Expected Useful Life	22 Years
Remaining Useful Life	20 Years
Renewal Year	2043
Quantity / Unit of Measure	2019 / SM
Unit Cost	\$314.00
Difficulty / Regional / Soft Cost Factors	1.00 / 1 / 1.3
Element Cost	\$824,155.80
Imported System ID	SYS-450821

No major deficiencies were observed or reported. According to the provided information roof was replaced in 2021. However, extensive corrosion on the metal grating walkways was observed. Replacement of the walkways is recommended.

Recommendations #1 - Conventional - Built-Up Roof	
Type	Major Repair
Year	2023
Cost	\$10,000.00
Imported Requirement ID	----

Extensive corrosion on the metal grating walkways was observed. Replacement of the walkways is recommended.

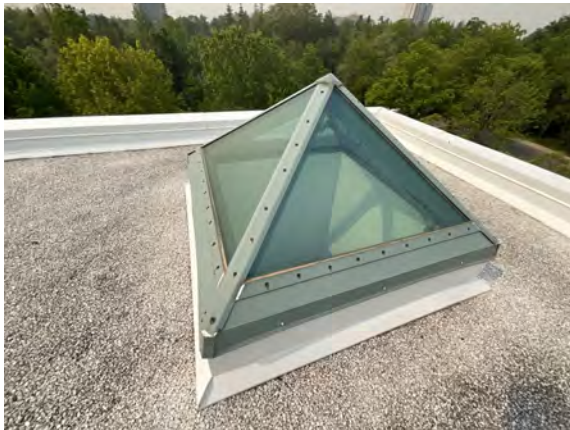
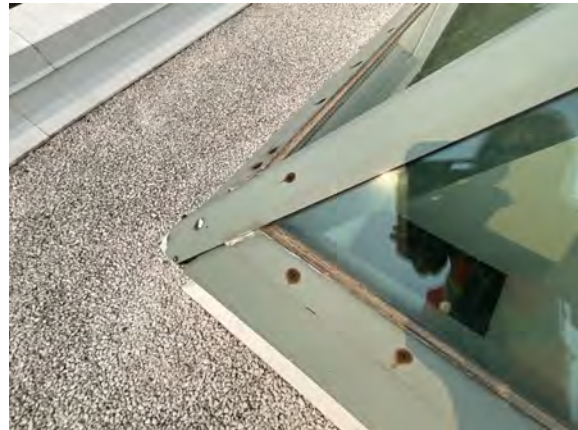
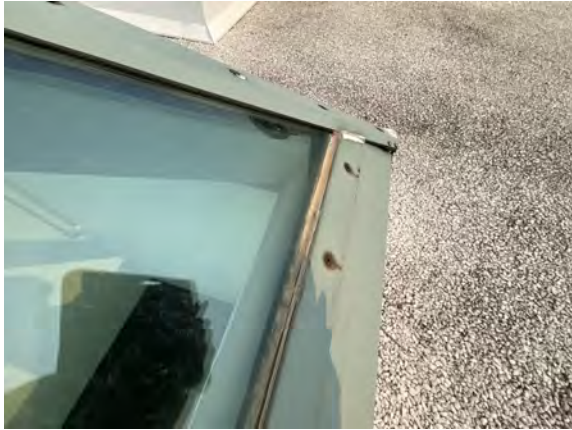
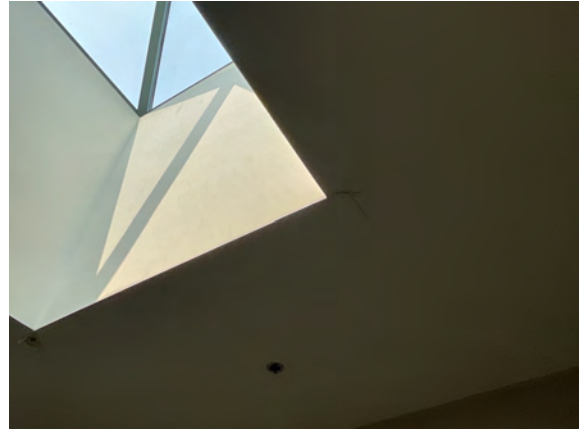
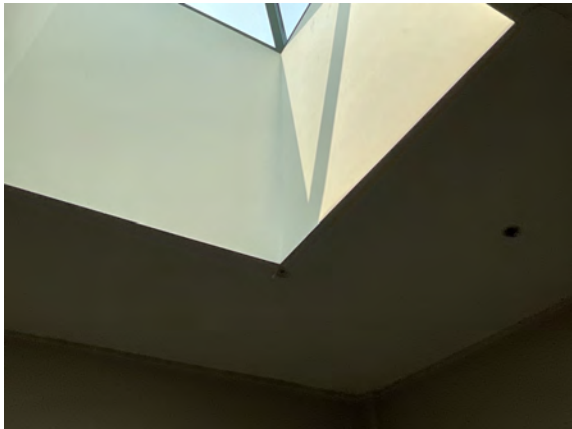
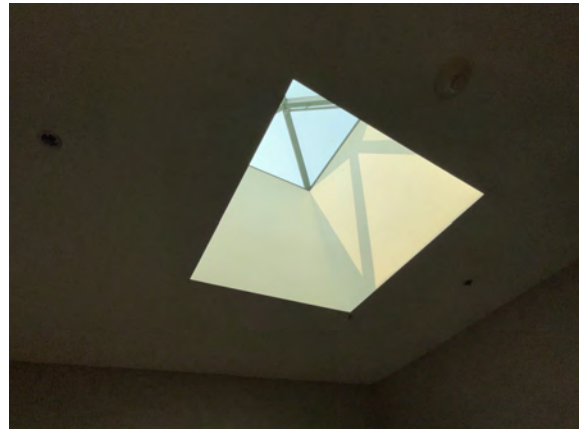
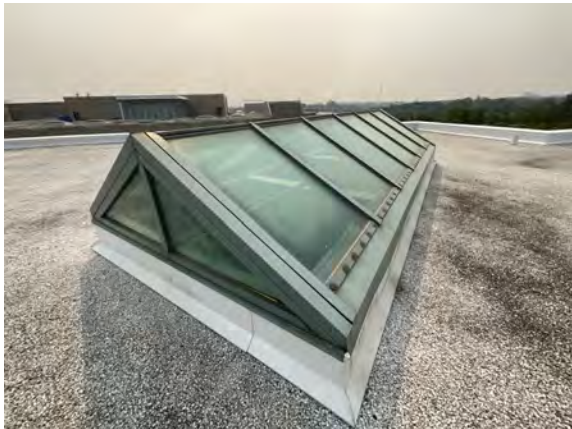
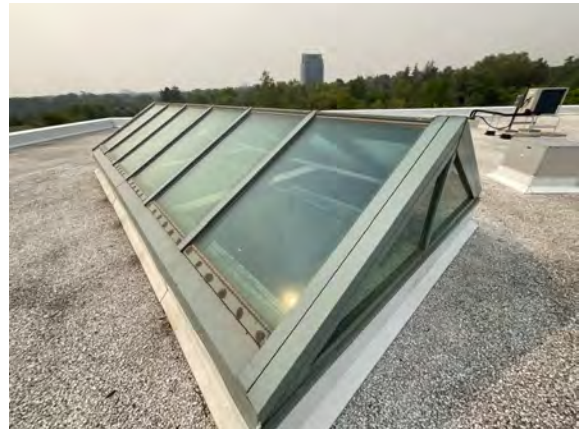
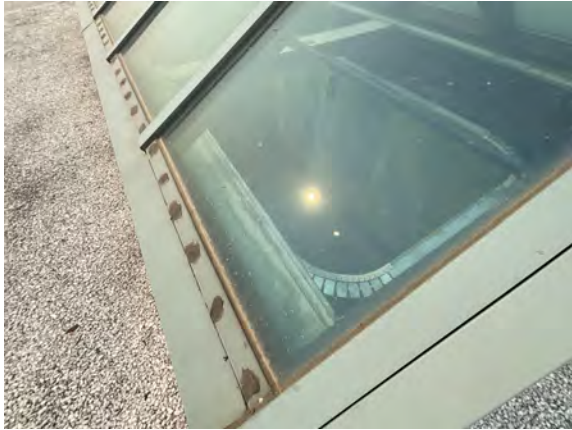
Element Description	
Name	B302021 - Skylights - Stair 247 and Corridor 216V
Installation Year	1993
Condition	3 - Poor
Expected Useful Life	25 Years
Remaining Useful Life	1 Year
Renewal Year	2024
Quantity / Unit of Measure	17 / SM
Unit Cost	\$1,742.00
Difficulty / Regional / Soft Cost Factors	1.00 / 1 / 1.3
Element Cost	\$38,498.20
Imported System ID	SYS-450955

Deficiencies observed or reported at the time of the assessment include deteriorated glazing seals (cracks, debonding). Peeling paint and stains, suggesting water infiltration were observed on the interior gypsum ceiling in stairway 247. Replacement is recommended.

Recommendations #1 - Skylights	
Type	Life Cycle Replacement
Year	2024
Cost	\$48,122.75
Imported Requirement ID	----

Replace Skylights
