Tree Inventory and Arborist Report

**CASSIE CAMPBELL
COMMUNITY CENTRE
FIELD HOCKEY DOME**

City File Number: PRE-2023-0128

July 22, 2024

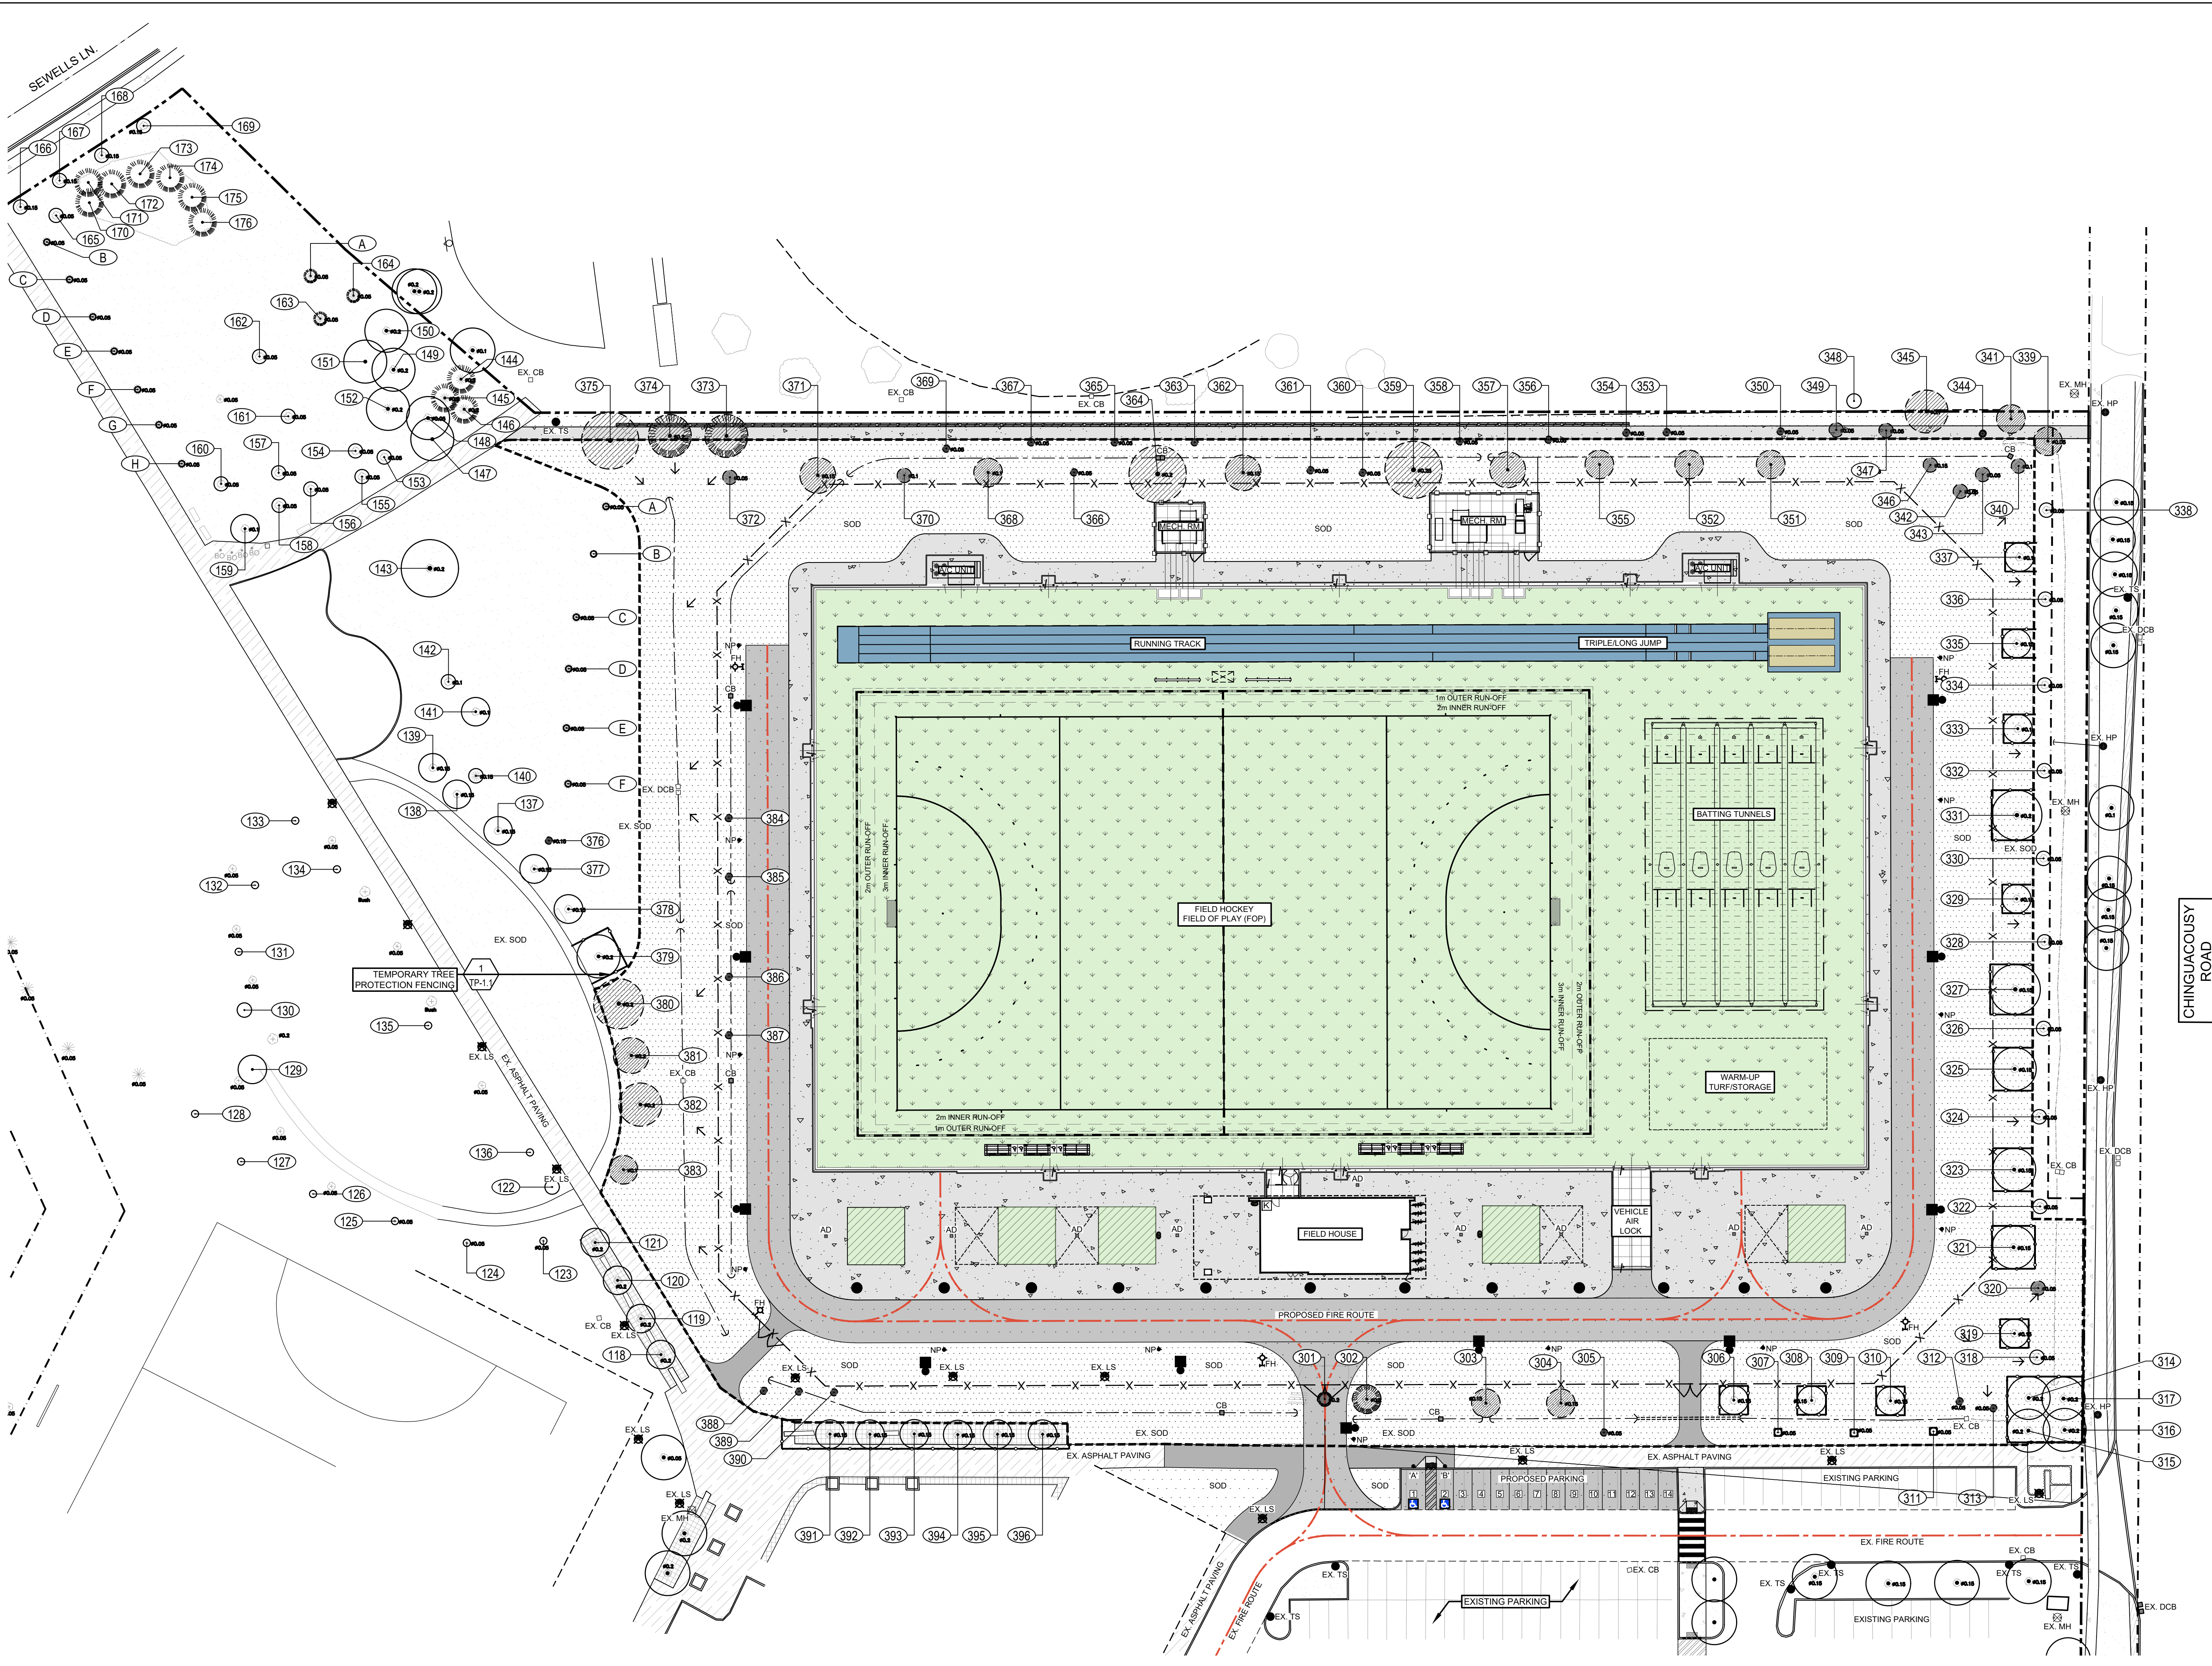
drawing title
**TREE INVENTORY,
PRESERVATION &
REMOVALS PLAN**

A total of 169 trees were tagged and inventoried. There are 60 trees to be removed and 109 trees to be preserved. See TREE INVENTORY, PRESERVATION & REMOVALS PLAN Drawing TP-1 by Landscape Planning Limited dated April 2024.
