## **Hazardous Building Materials Assessment (Pre-construction)**

Third Floor Security Offices  
Union Station  
65 Front Street West, Toronto,  
Ontario

September 16, 2024

Pinchin File: 346672.000

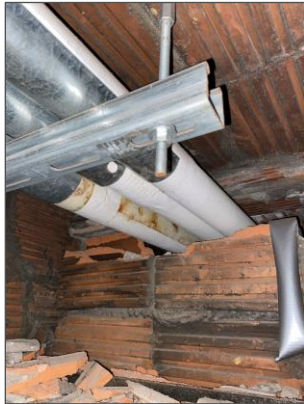
Preformed block insulated piping within East Corridor  
(Location 9)

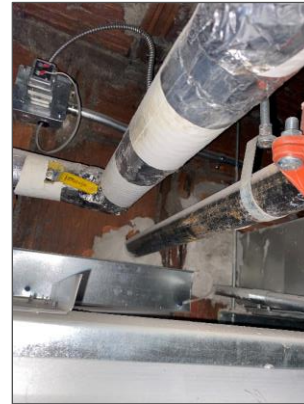
Remaining pipes within the assessed area are either uninsulated or insulated with non-asbestos fibreglass.

Non-asbestos pipe insulation with foil fittings.

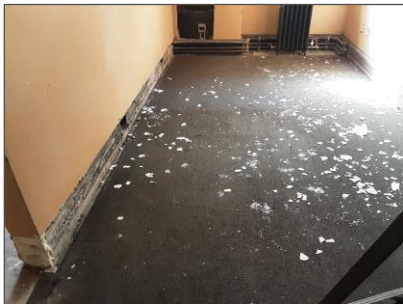
**Levelling compound, containing chrysotile asbestos,** is present beneath the carpet within Locations 5, 6 and 7 (samples S0005A-C).

Carpet floor concealing asbestos-containing levelling compound in Location 5

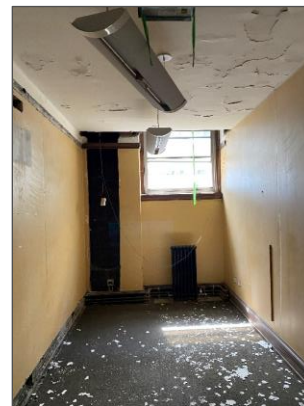
Carpet floor concealing asbestos-containing levelling compound in Location 6

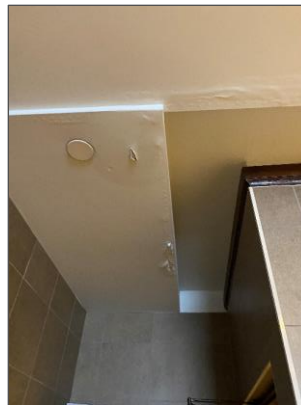
Visible water staining is present on drywall ceiling within the Women's Washroom (Location 3).

Visible water damage on drywall within Women's Washroom (Location 3)

Mould growth / water damage was noted in areas affected by the planned work. Retain a qualified consultant to perform an intrusive investigation to determine the full extent of hidden mould growth.
