67 Adelaide Street East

Interior Demolition

PRE-RENOVATION DESIGNATED SUBSTANCES AND HAZARDOUS MATERIALS SURVEY

**ECO Project No.: 26341
February 17, 2021**

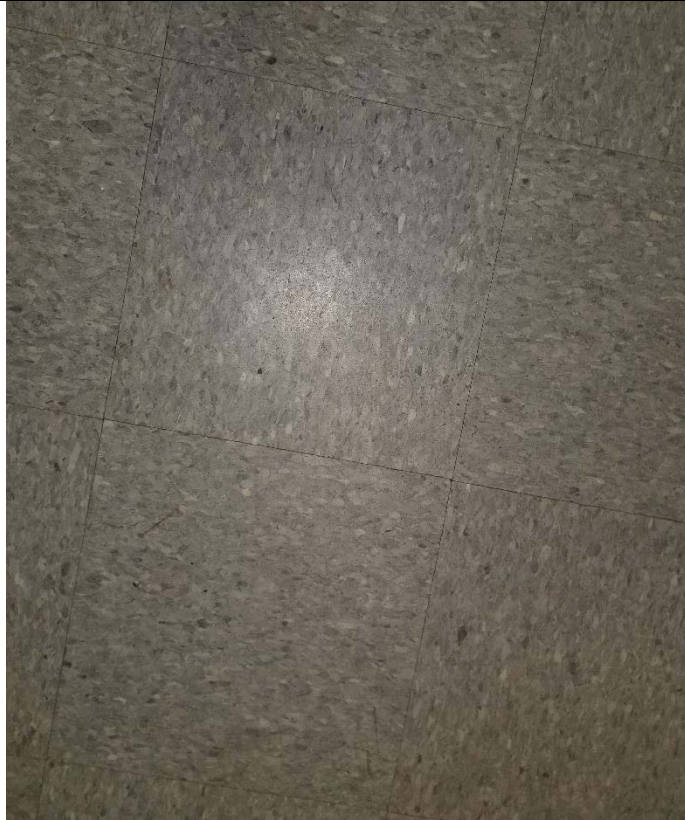
Photo No. 2.

Various locations within
Project Area

*These materials were
previously sampled and
determined to be non-
asbestos.*

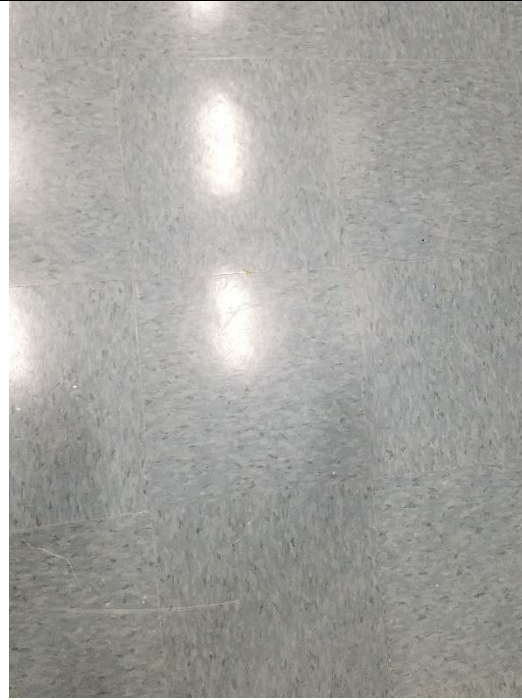
Photo No. 4.

Loc. #2-09 (Crafts Room (#205))

These materials were previously sampled and determined to be non-asbestos.

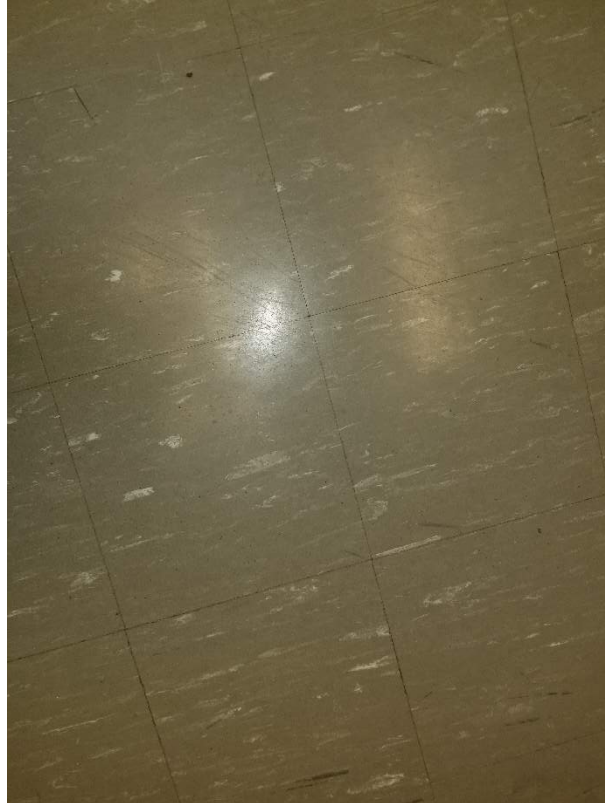
Photo No. 6.

Loc. #2-15 (Exam
Room)

*These materials were
previously sampled and
determined to be non-
asbestos.*

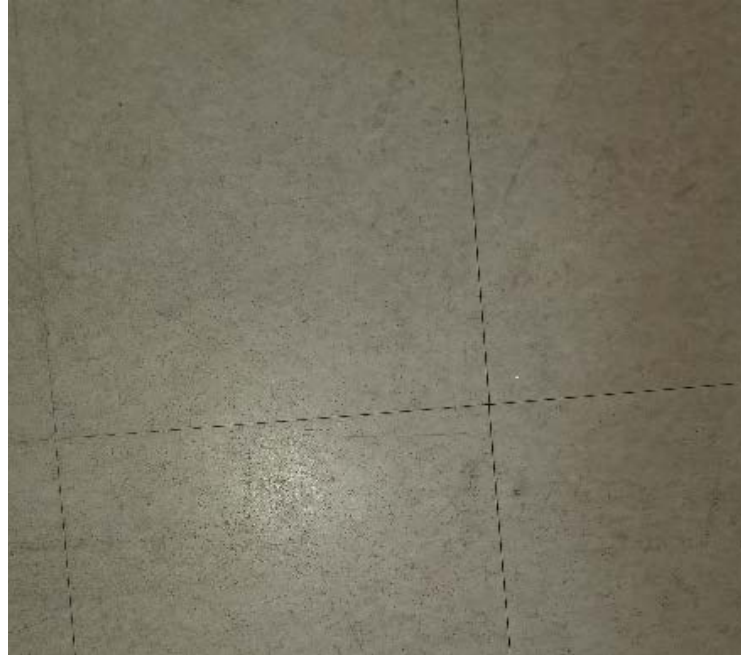
Photo No. 8.

Loc. #1-01 (Foyer)

*These materials were
previously sampled and
determined to be non-
asbestos.*

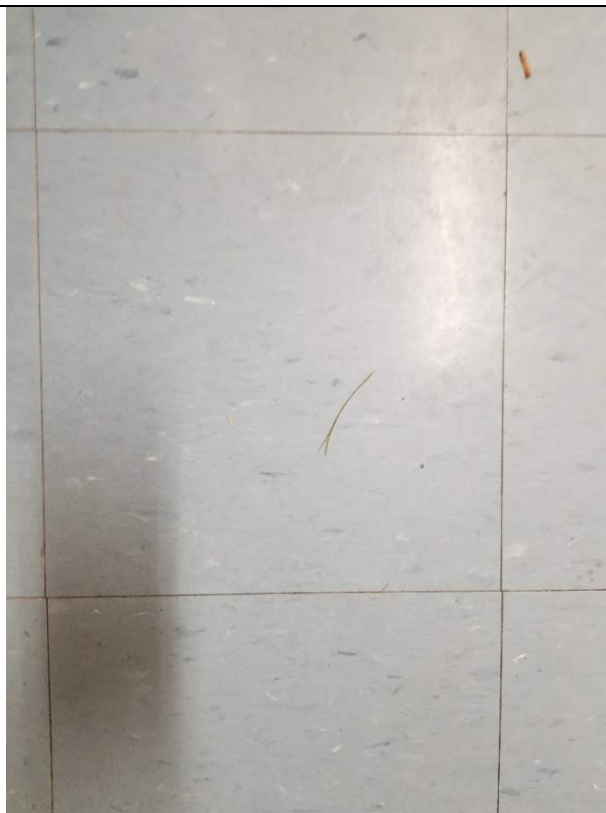
Photo No. 9.

Date: February 3, 2021	
Description:	
<p>Vinyl Floor Tile</p> <p>VFT09 – 12"x12" Light Grey and White Marble Pattern</p> <p>Loc. #1-08 (Meeting Room 1)</p> <p><i>These materials were sampled and determined to be non-asbestos.</i></p>

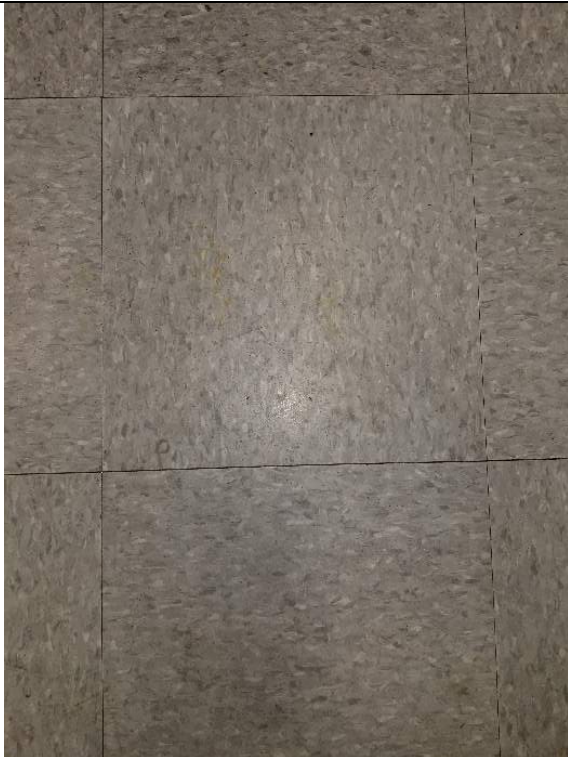
Photo No. 10.

Date: February 3, 2021	
Description:	
<p>Vinyl Floor Tile</p> <p>VFT10 – 12"x12" Blue-Grey Marble Pattern</p> <p>Loc. #3-14 (Office)</p> <p><i>These materials were sampled and determined to be non-asbestos.</i></p>

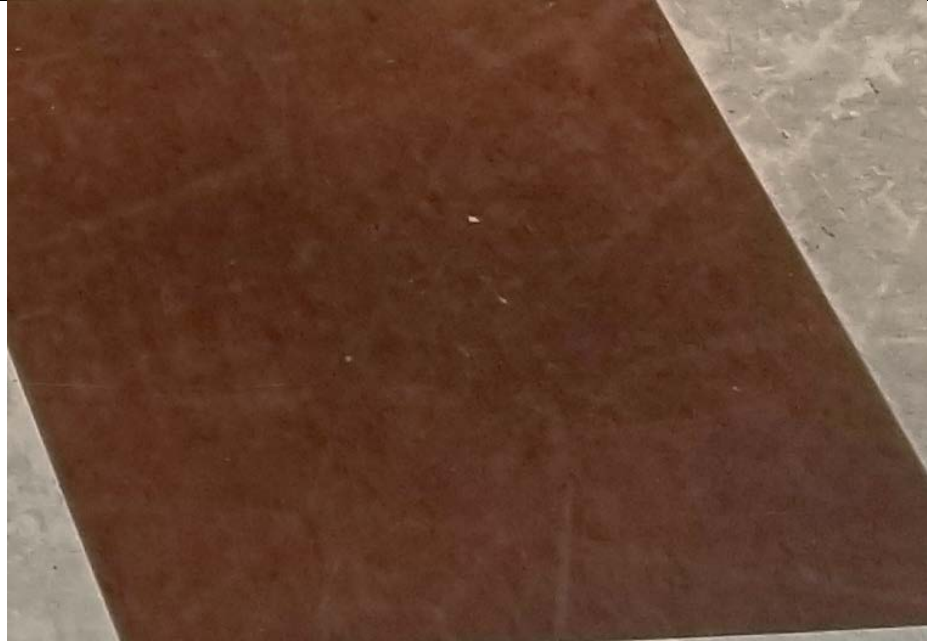
Photo No. 12.

Loc. #3-02
(Lunchroom)

*These materials were
sampled and
determined to be non-
asbestos.*

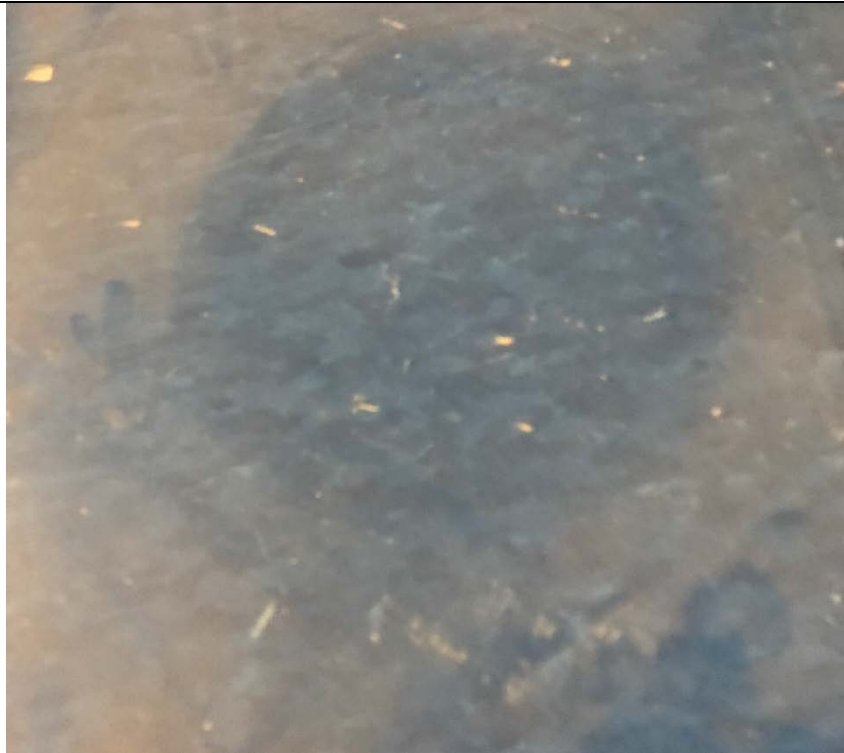
Photo No. 14.

Loc. #3-02
(Lunchroom)

*These materials were
sampled and
determined to be non-
asbestos.*

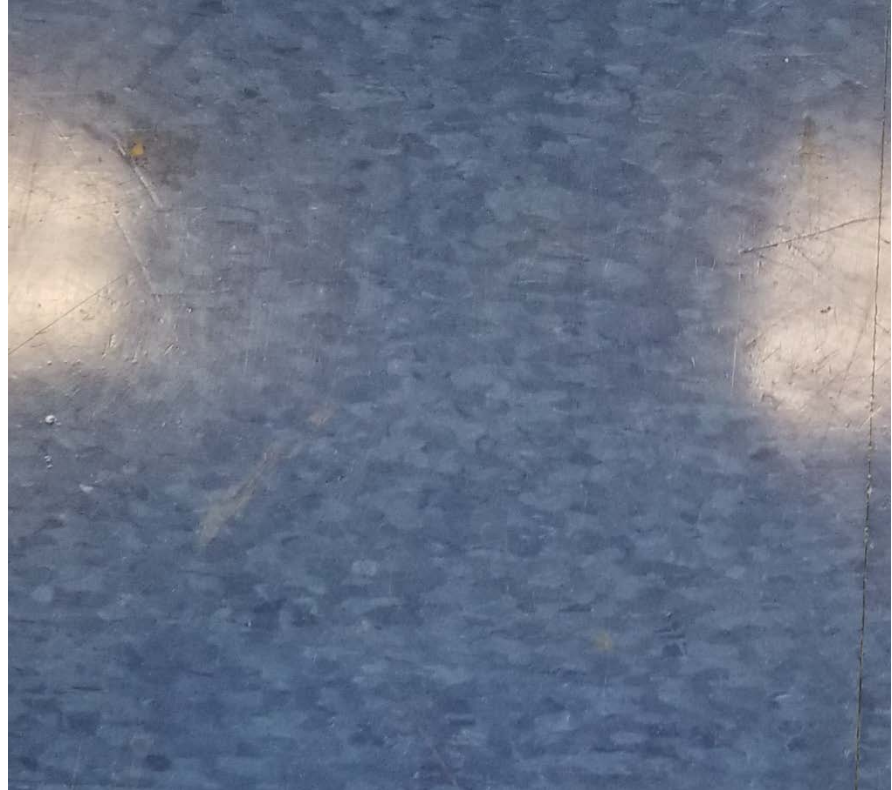
Photo No. 16.

Loc. #3-02
(Lunchroom)

These materials were sampled and determined to be non-asbestos.

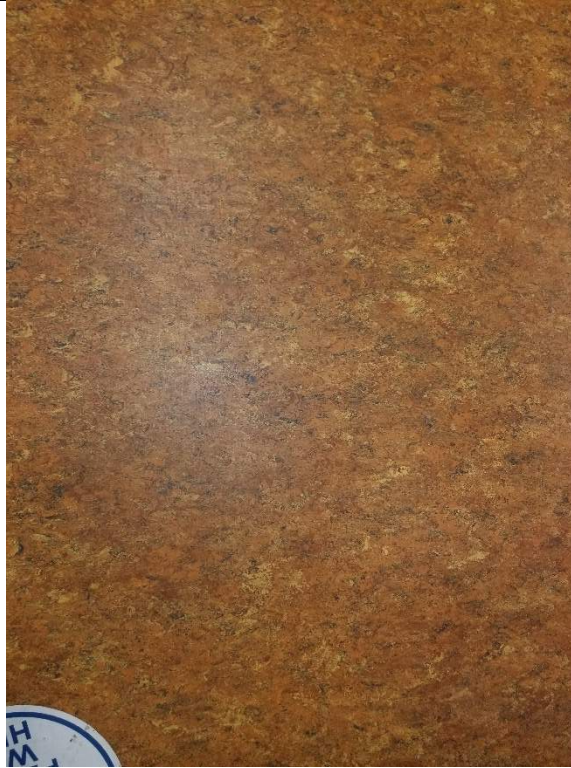
Photo No. 18.

Various Locations
within Project Area

*These materials were
previously sampled and
determined to be non-
asbestos.*

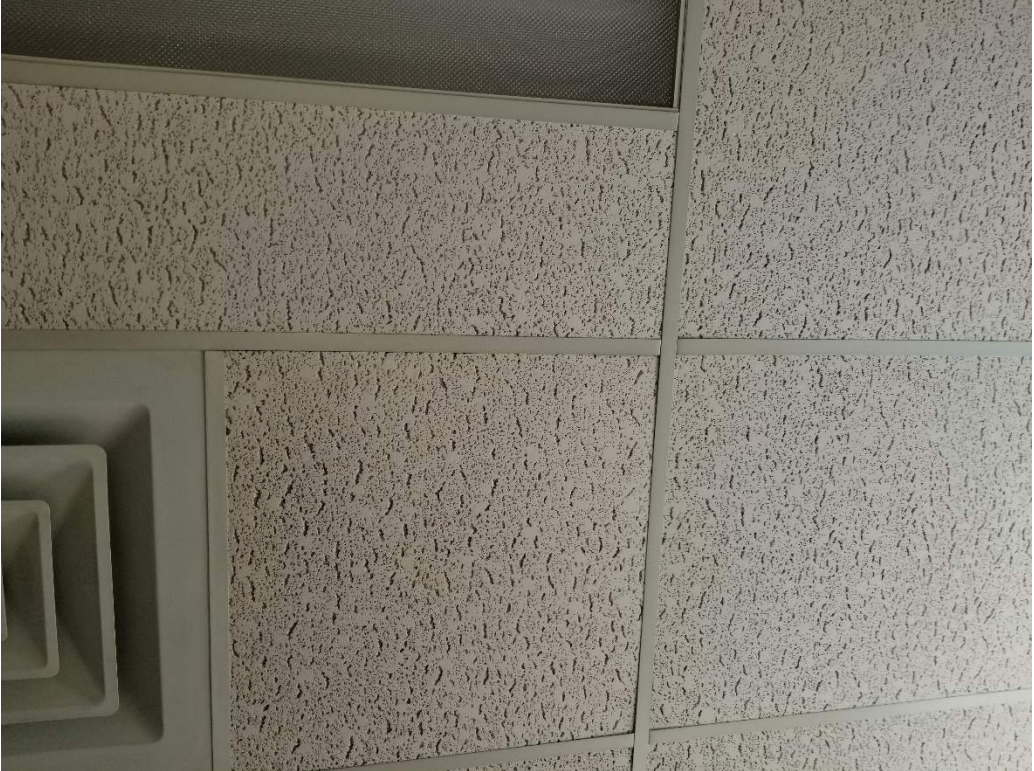
<p>Photo No. 20.</p> <p>Date: February 3, 2021</p> <p>Description:</p> <p>Acoustic Ceiling Tile</p> <p>ACT02 – 24”x48” Lay-In Fleck and Pinhole</p> <p>Various locations within Project Area</p> <p><i>These materials were previously sampled and determined to be non-asbestos.</i></p>	 
---	--

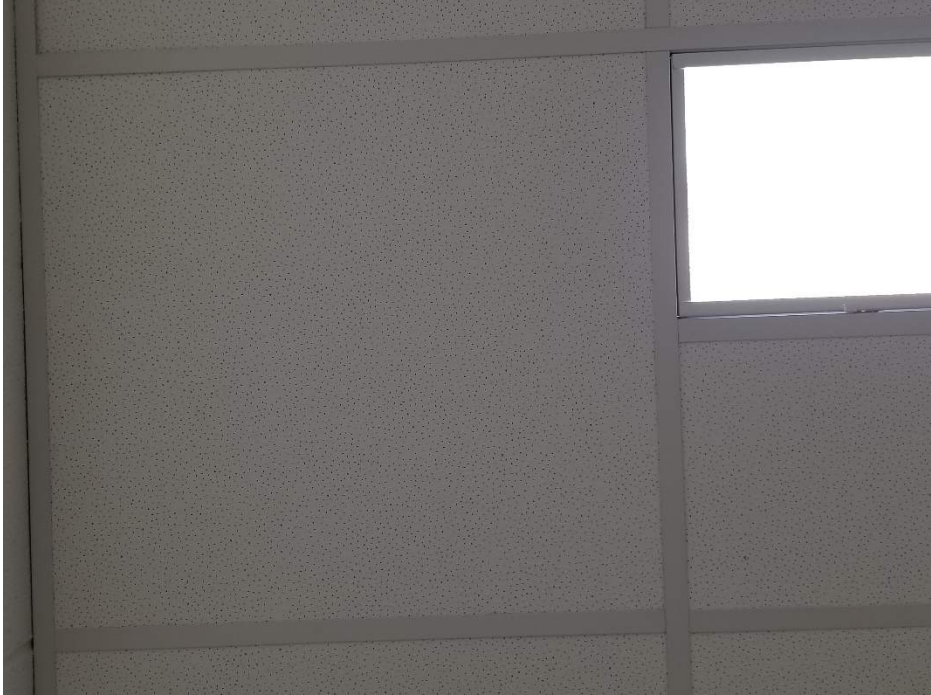
Photo No. 21.

Date: February 3, 2021	
Description:	
<p>Acoustic Ceiling Tile</p> <p>ACT03 – 24”x48” Lay-In Pinprick</p> <p>Various locations within Project Area</p> <p><i>These materials were previously sampled and determined to be non-asbestos.</i></p>

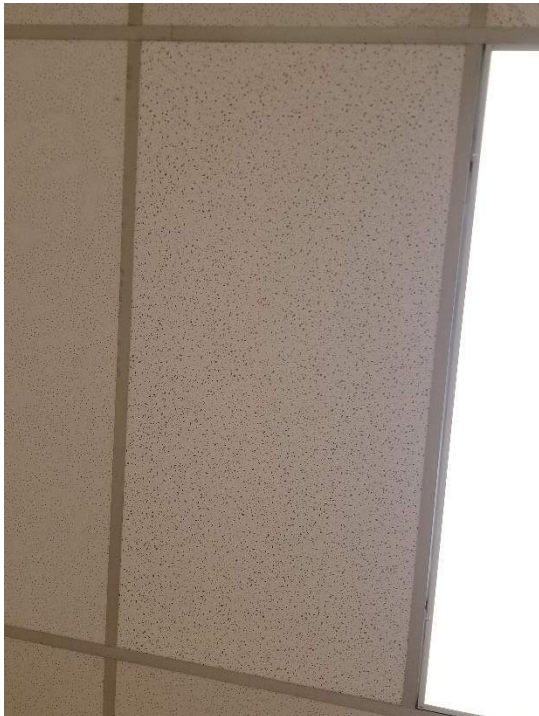
Photo No. 22.

Date: February 3, 2021	
Description:	
<p>Acoustic Ceiling Tile</p> <p>ACT04 – 24”x48” Lay-In Pinprick and Fissure</p> <p>Various locations within Project Area</p> <p><i>These materials were previously sampled and determined to be non-asbestos.</i></p>

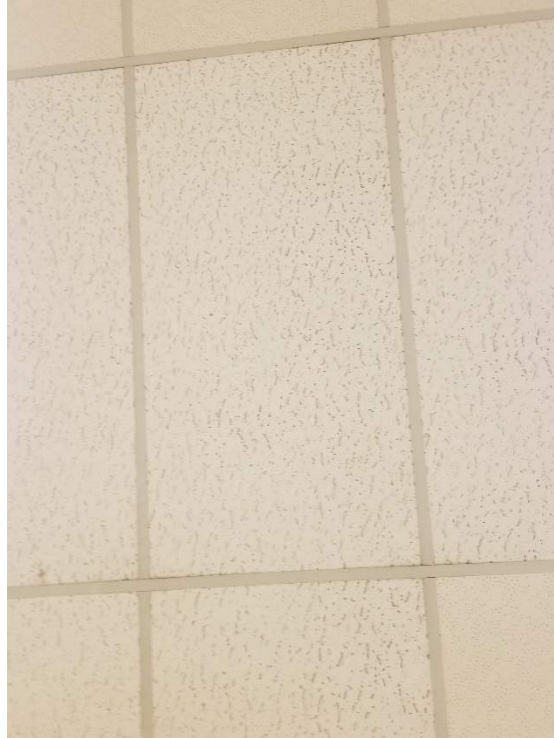
Photo No. 24.

Loc. #3-02
(Lunchroom)

These materials were inaccessible (i.e. too high) at time of assessment. These materials are presumed to be asbestos-containing.

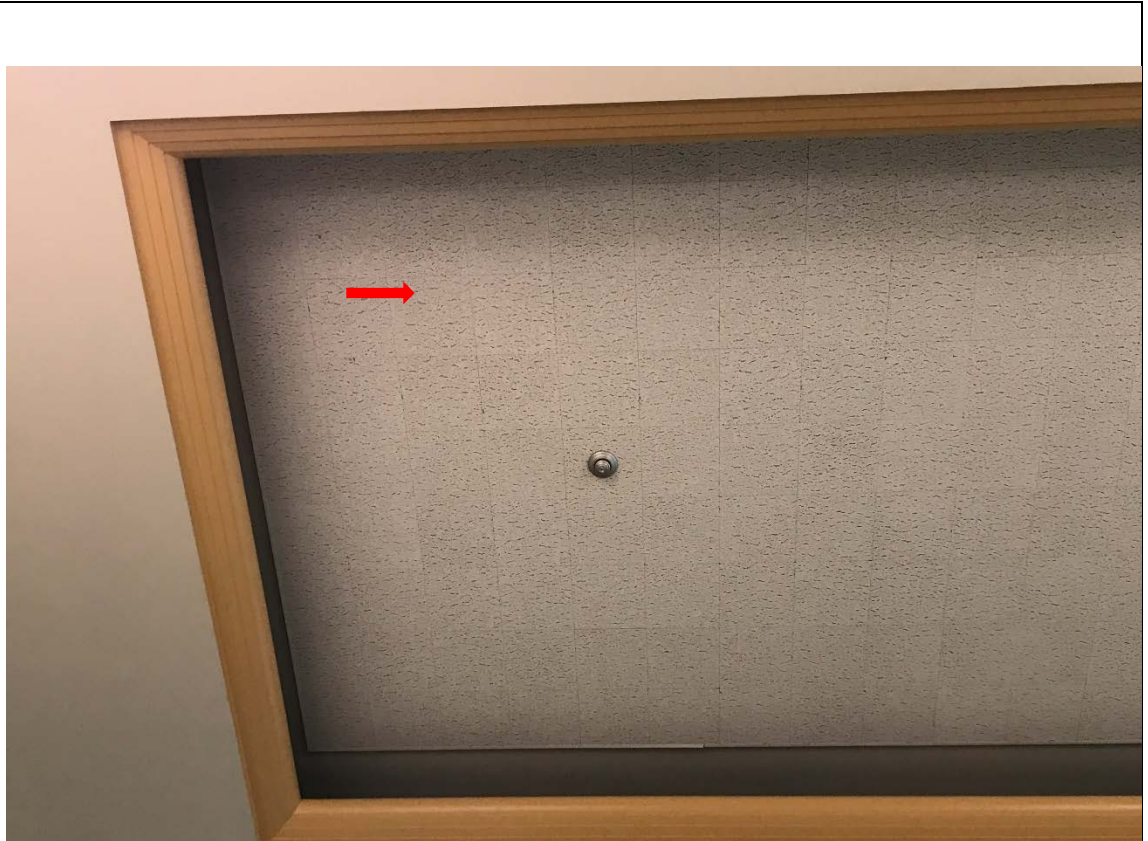
Photo No. 26.

Loc. #3-08 (Office)

These materials were sampled and determined to be non-asbestos.

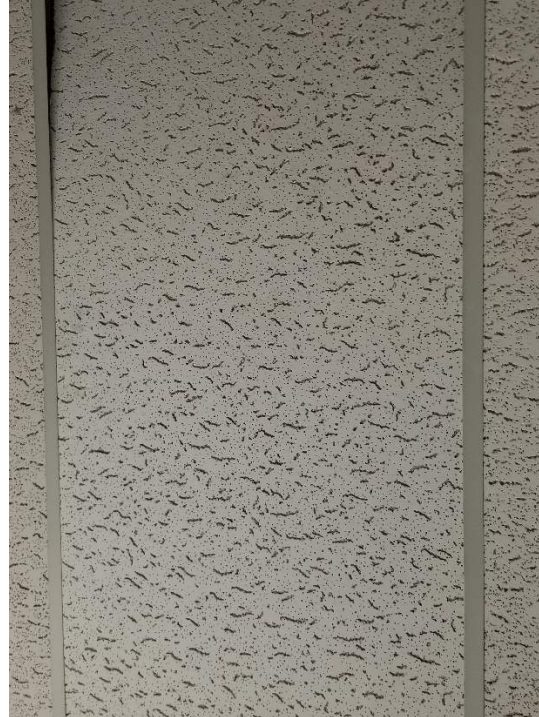
Photo No. 28.

Loc. #2-09 (Crafts Room (#205))

These materials were determined to be non-asbestos due to presence of date stamp on back of tile (Date Stamp: 04/15/1997).

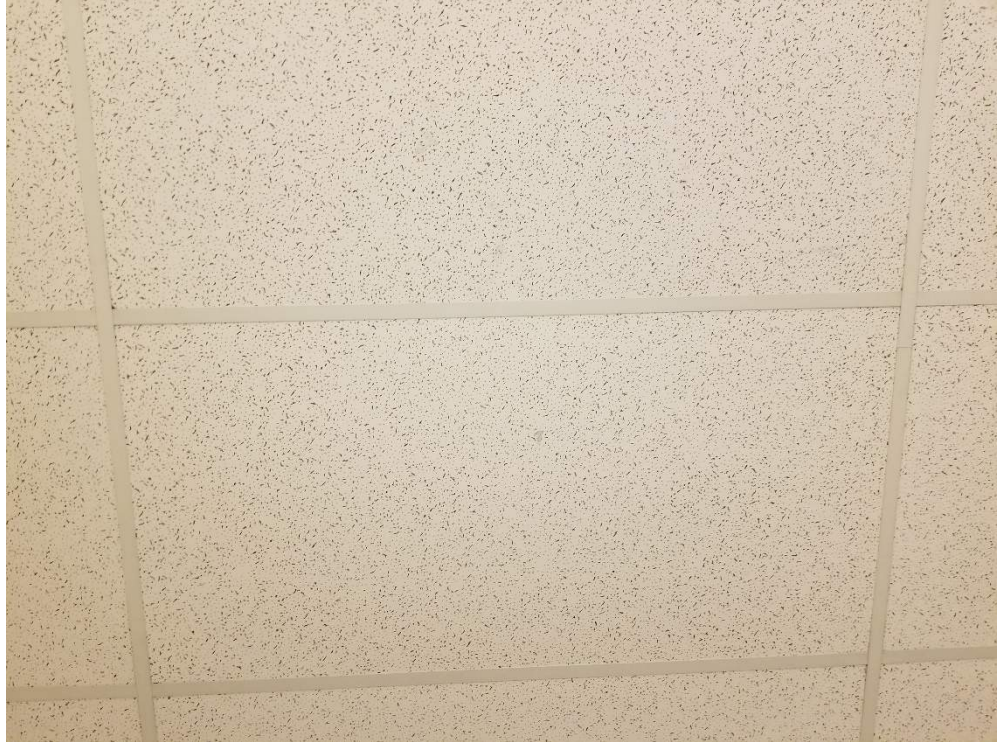
Photo No. 30.

Various locations within
Project Area

*These materials were previously sampled and determined to be **asbestos-containing (40% Chrysotile)**.*

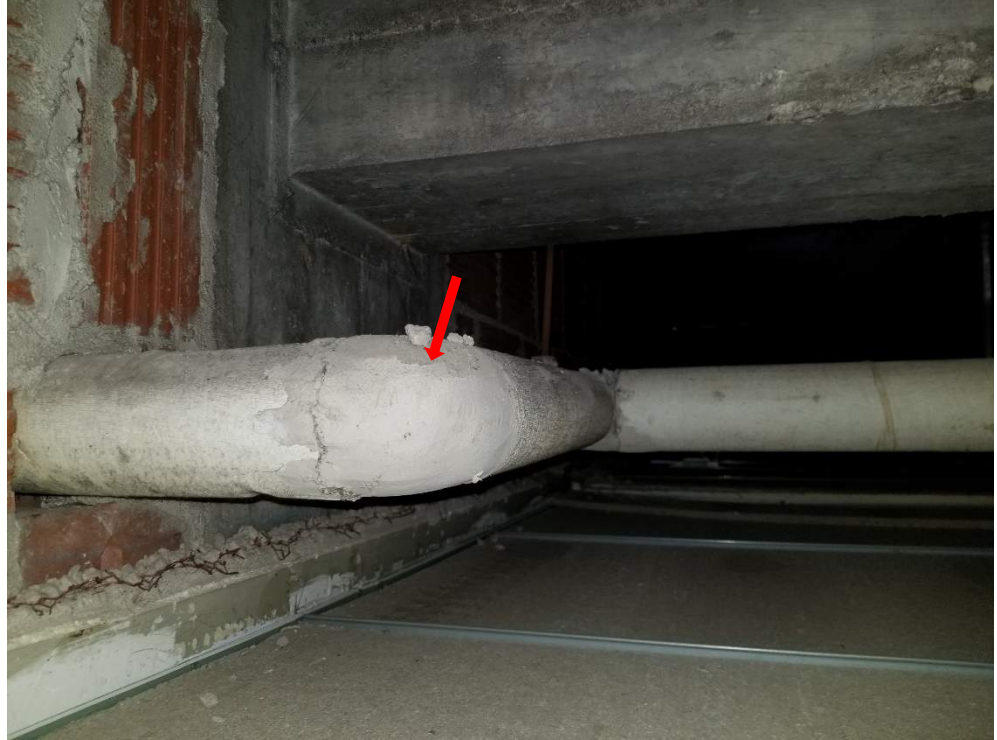
Photo No. 32.

Loc. #1-17 (Electrical
Room)

*These materials were
previously sampled and
determined to
**asbestos-containing
(60% Chrysotile).***
