DESIGNATED SUBSTANCES AND HAZARDOUS BUILDING MATERIALS ASSESSMENT REPORT

Interior & Exterior Renovation Project
Tomken Twin Arena
4495 Tomken Road
Mississauga, Ontario
L4W 1J9

Safetech Project Number: 1-3220120

Date of Issue: March 2, 2022

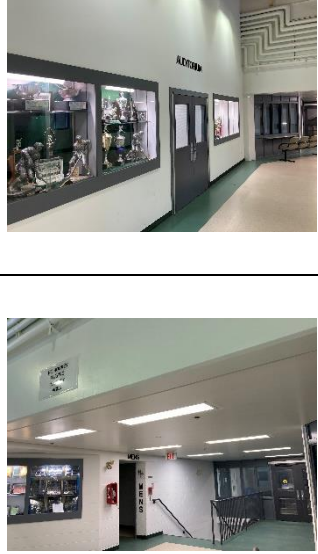
<p>Drywall Joint Compound</p>	<p>Drywall joint compound was observed in the subject building. Bulk samples were collected during the assessment and results of analysis confirmed that this building material is not asbestos-containing. Refer to sample set 1 in Table 3.</p>

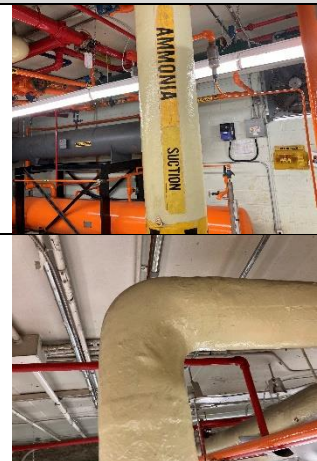
<p>Misc. Materials</p>	<p>Location/Description</p>	
<p>Piping</p>	<p>Pipes in the Refrigeration Room G41 were found to be made of fiberglass and therefore would not contain asbestos.</p>
