December 16, 2024

**Re: Hazardous Building Materials Assessment (Pre-construction)**  
Roof Sections A, B, C, D, and E and Specified Interior Areas  
Courtice Secondary School, 1717 Nash Road, Courtice, Ontario  
Pinchin File: 348218.007

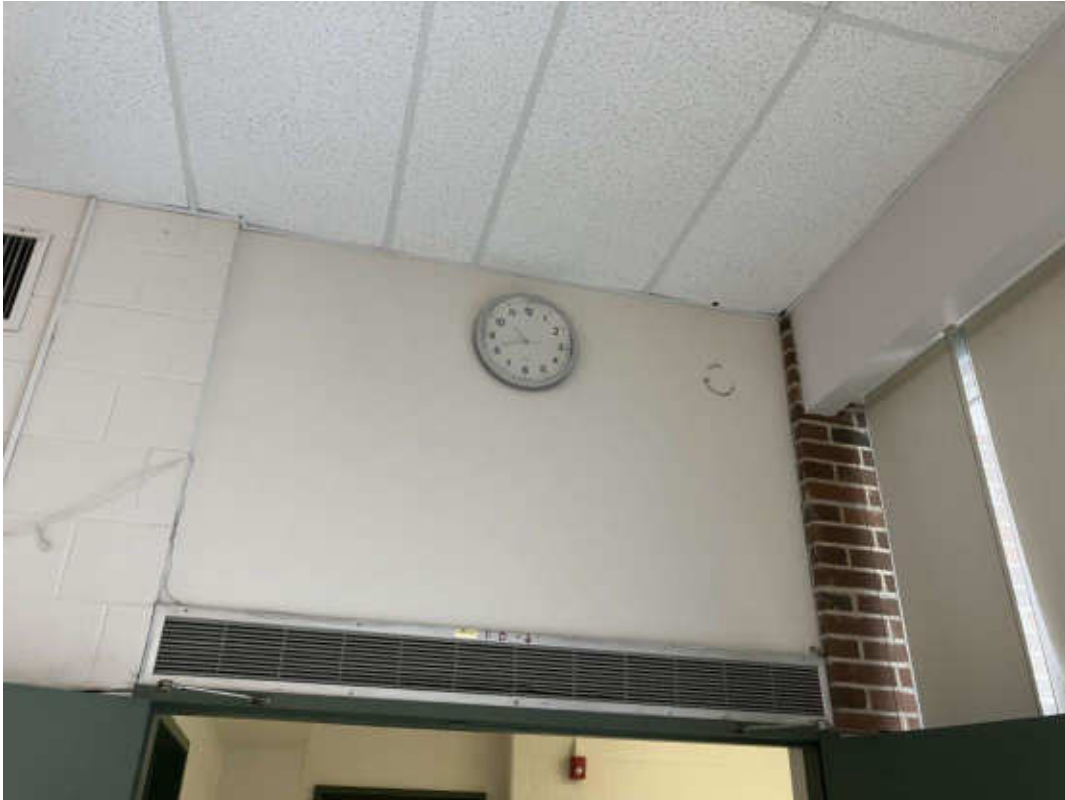
V0032 (Non-asbestos), Wall, Plaster, Cafeteria (Location #: 103)  
above doors and as bulkheads for windows

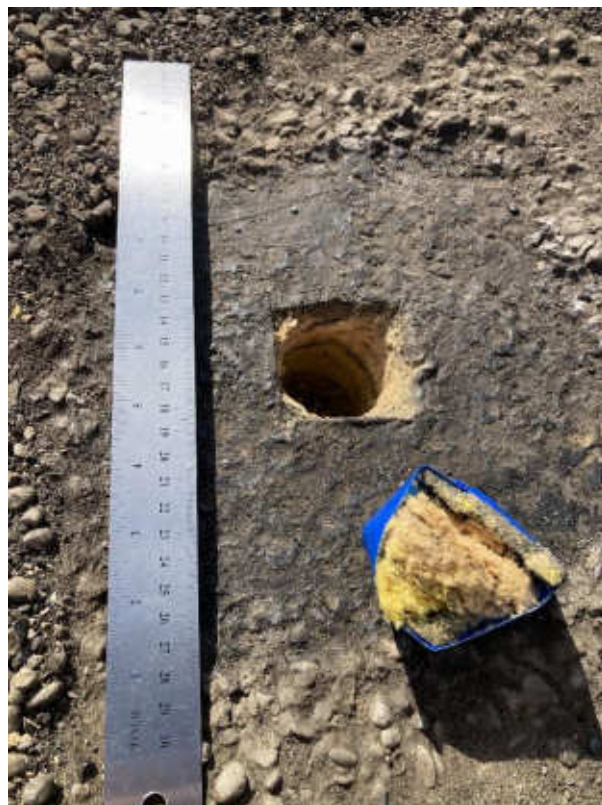
S1014B (Confirmed Asbestos), Roof materials, Roof B (Location #: 210)

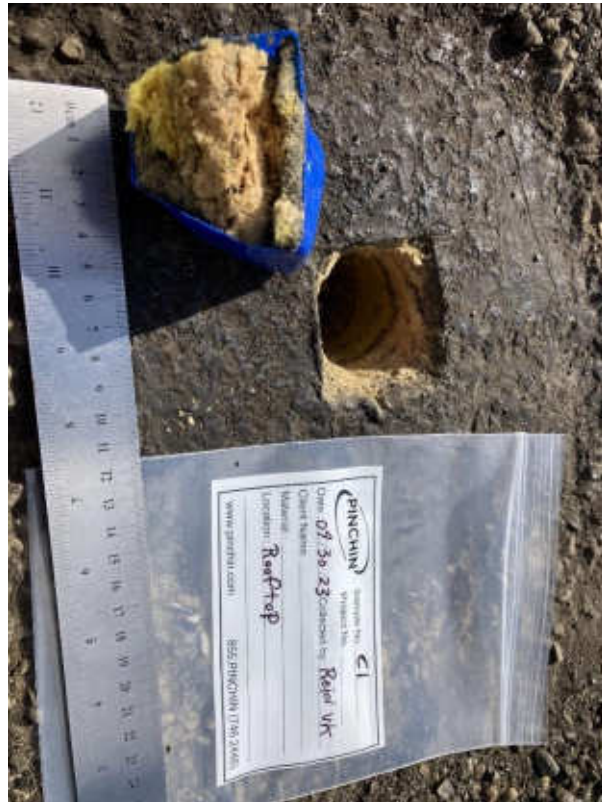
S1014C (Confirmed Asbestos), Roof materials, Roof C (Location #: 211)

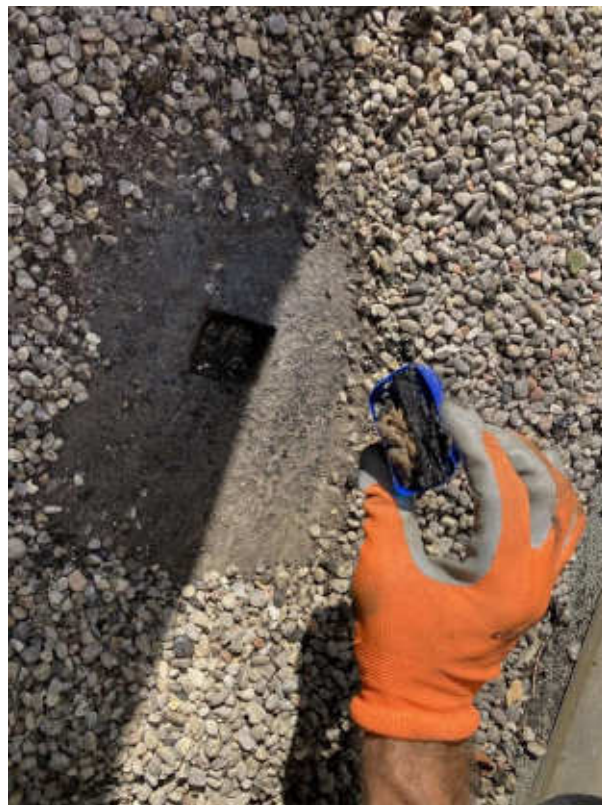
S1015A (Non-asbestos), Roof materials, Roof A (Location #: 209)

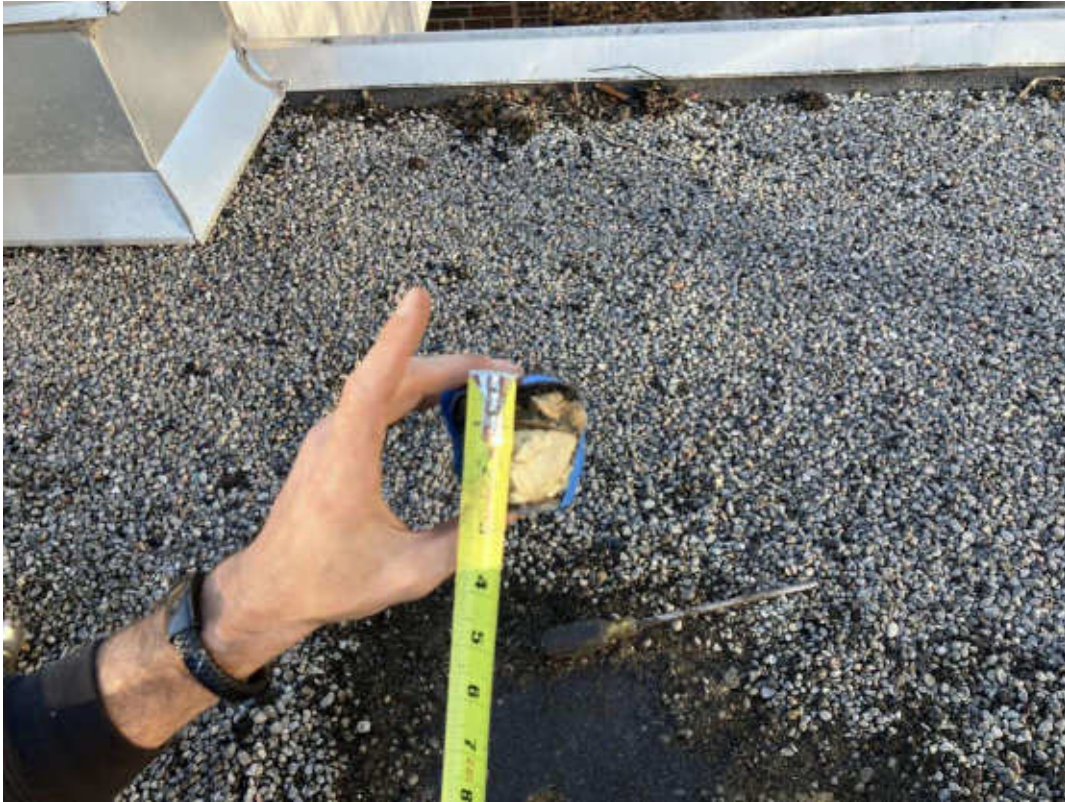
S1019A (Non-asbestos), Roofing materials, Roof E (Location #: 214)

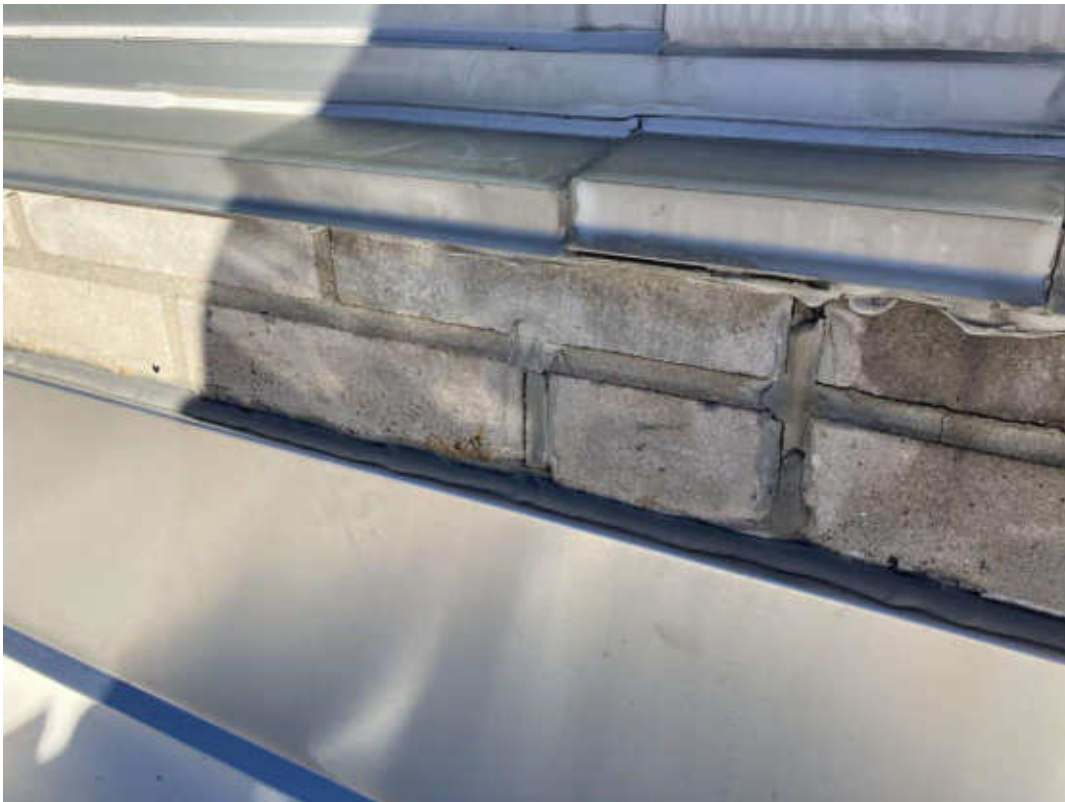
S1020A (Non-asbestos), Grey caulking on flashing, Roof D (Location #: 213)

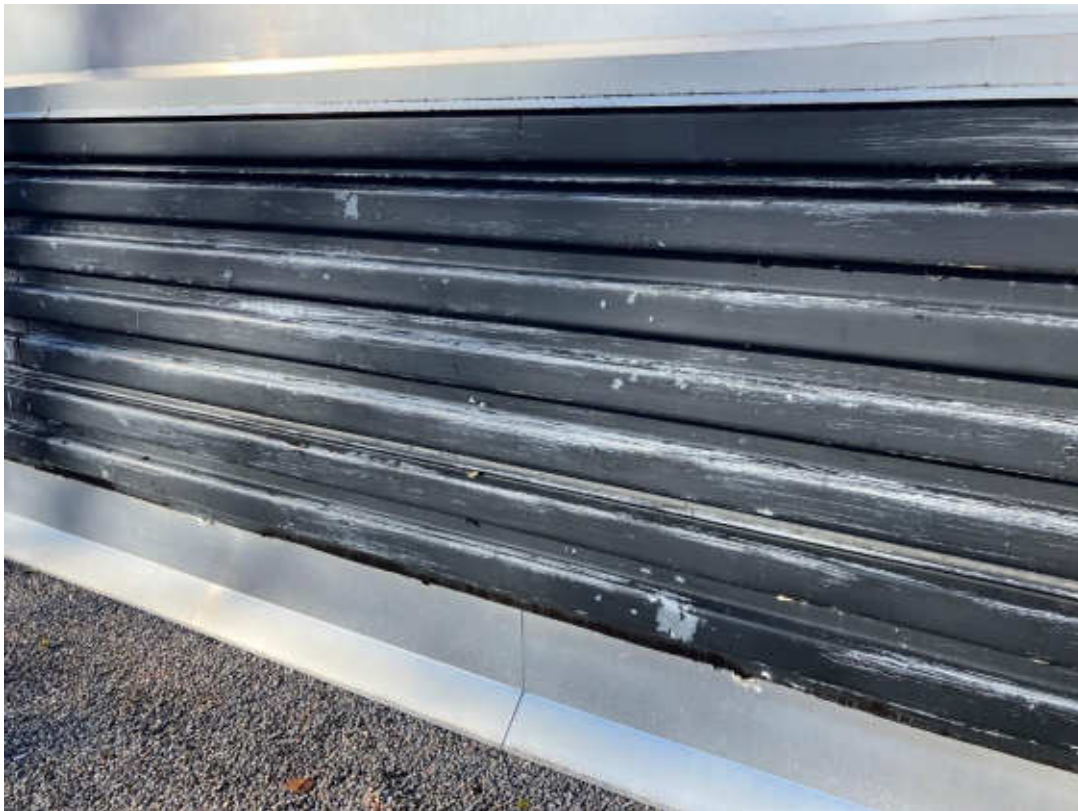
Sample Number	Material Description	Concentration	Confirmed Hazard	Total Quantity Present	Material Specific Notes
L0039	Black paint	0.53%	Yes	200 SF	On metal siding on exterior of rooftop mechanical penthouse

L0039 (Lead) Lead-based paint on metal on exterior of Mechanical Penthouse

Items painted with paints containing elevated levels of lead may be a hazardous waste. Test lead-painted materials for leachable lead and other metals prior to disposal. Metallic components coated with lead paint do not require leachate testing and can be disposed of as non-hazardous construction and demolition (C&D) waste.
