## 2024 REASSESSMENT PROGRAM CORRECTIVE ACTIONS REPORTING FORM

**Consulting Firm:** Fisher Engineering Limited

**Building Address:** 400 The West Mall, Toronto

**Building Name:** Wesburn Manor

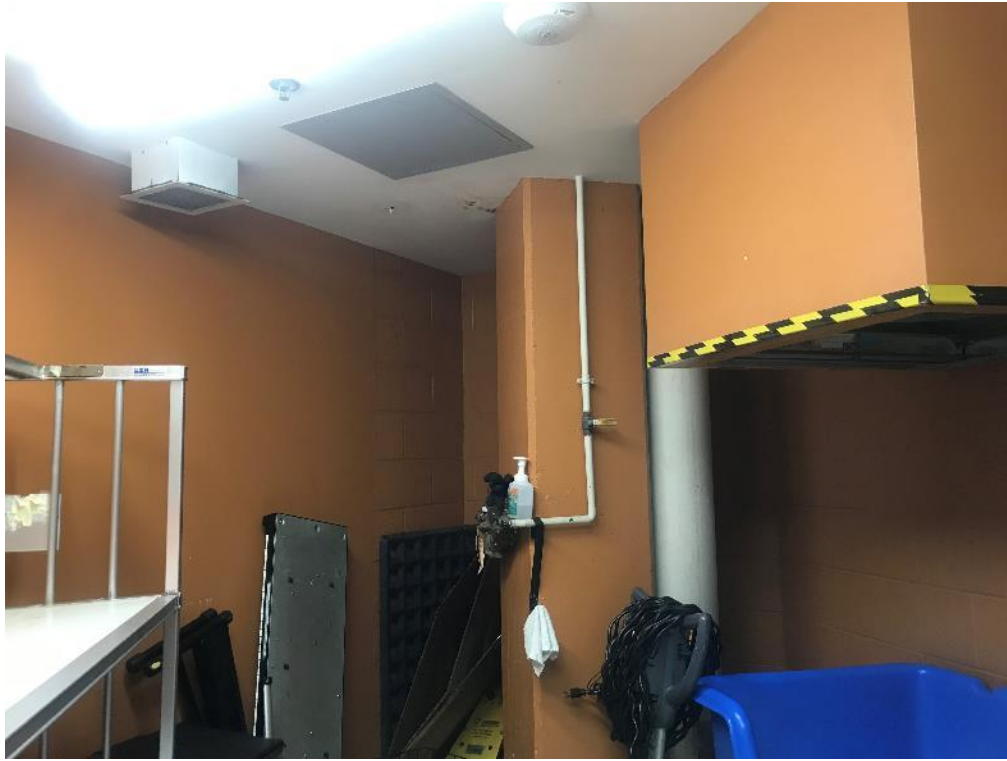
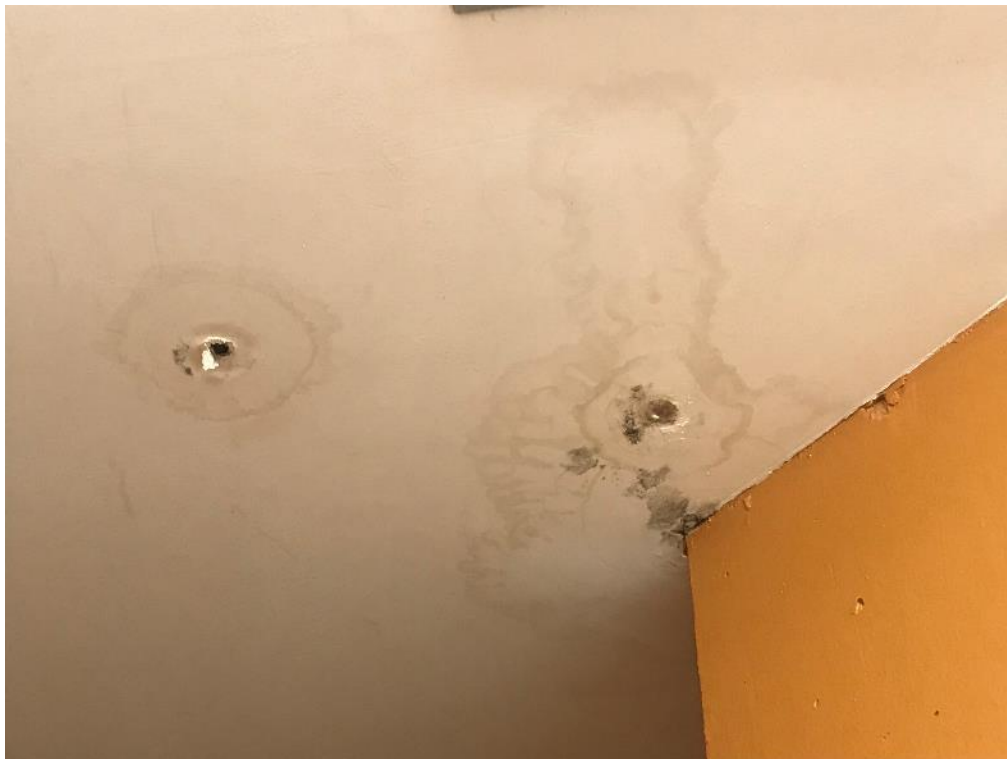
**Photos 1, 2 – View of mould growth on non-asbestos containing drywall ceiling in Soiled Linen, 1-025.**

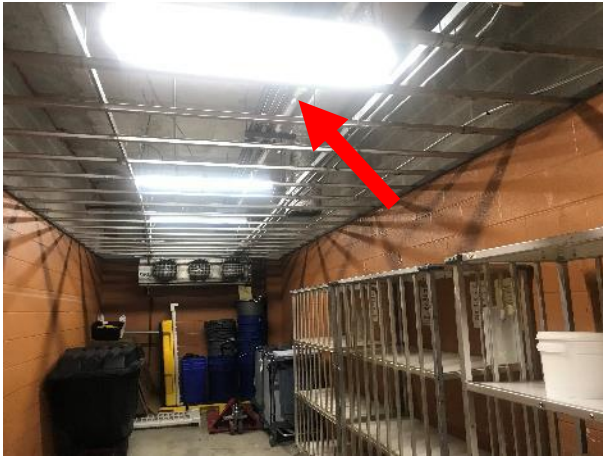
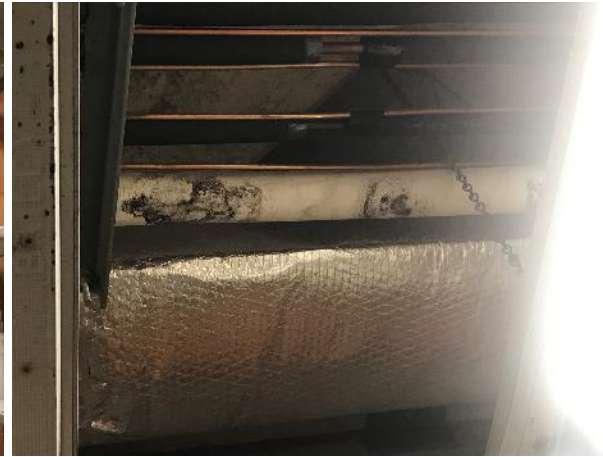
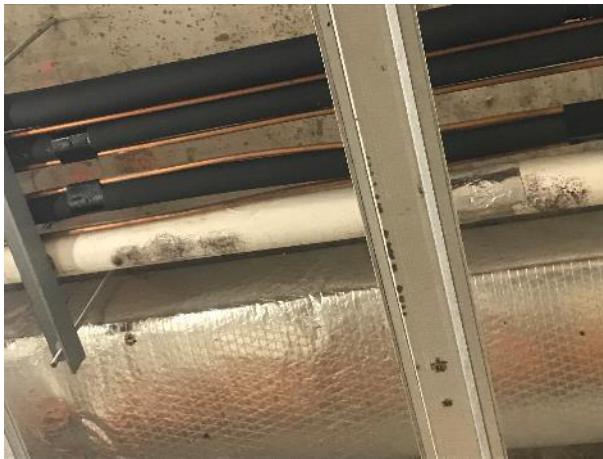
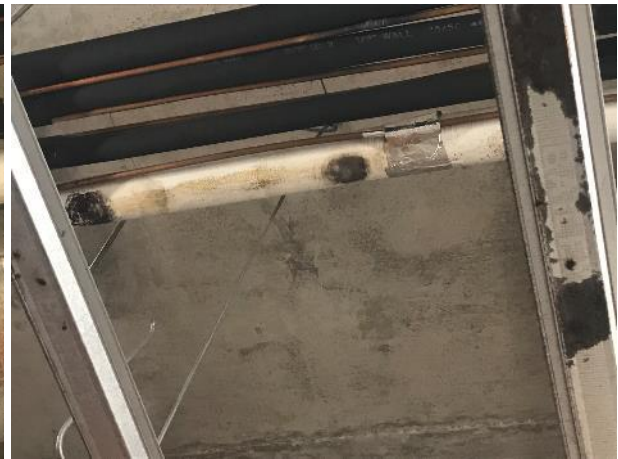
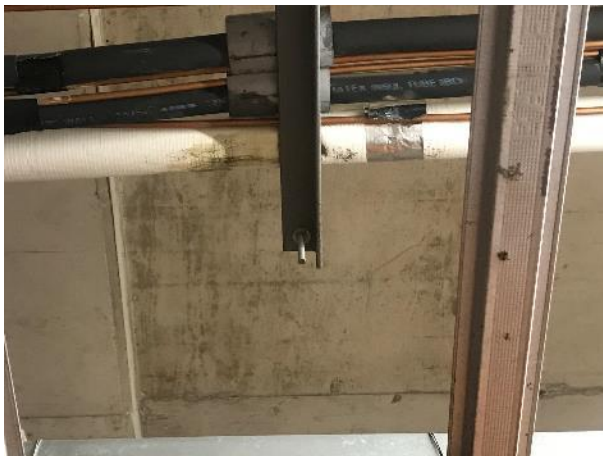
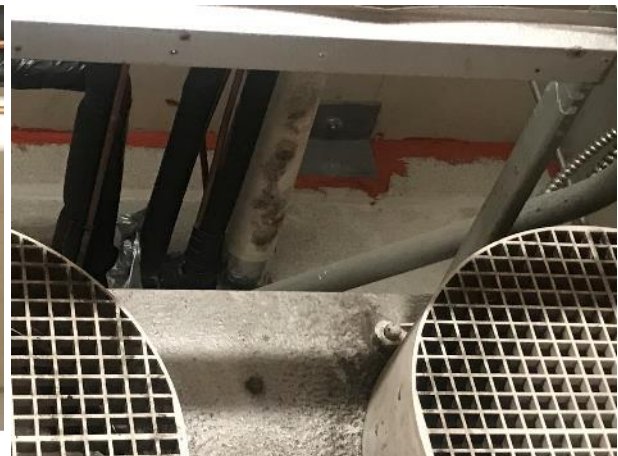
**Photos 3 to 8 – View of mould growth on fibreglass pipe insulation in Garbage Room, 1-026.**

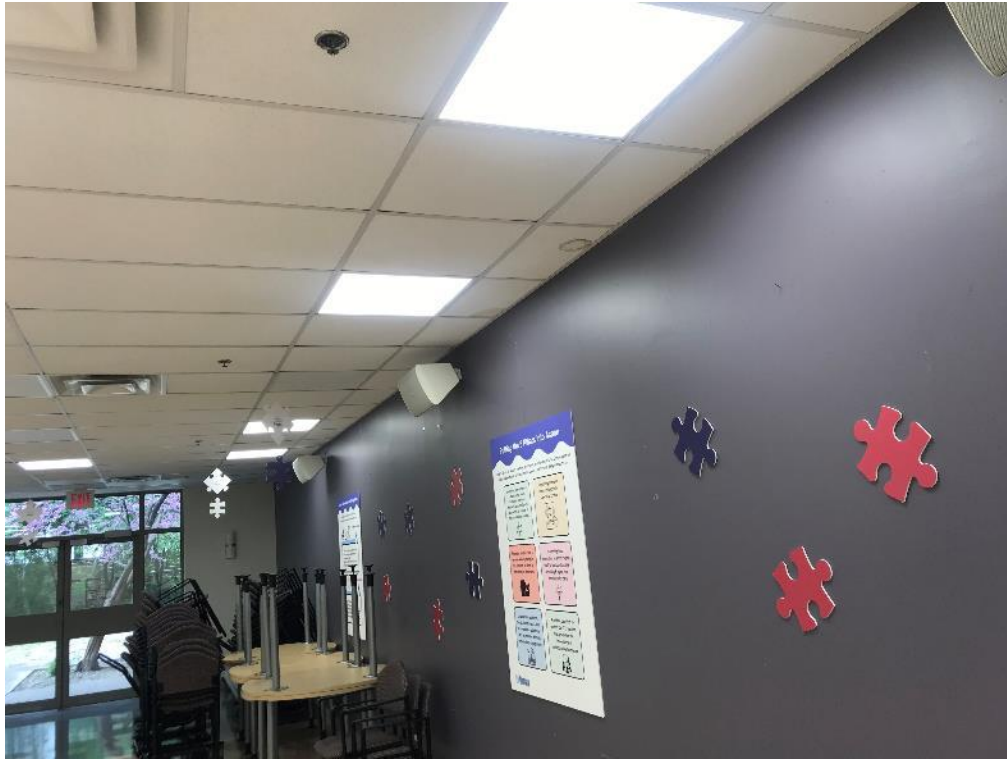
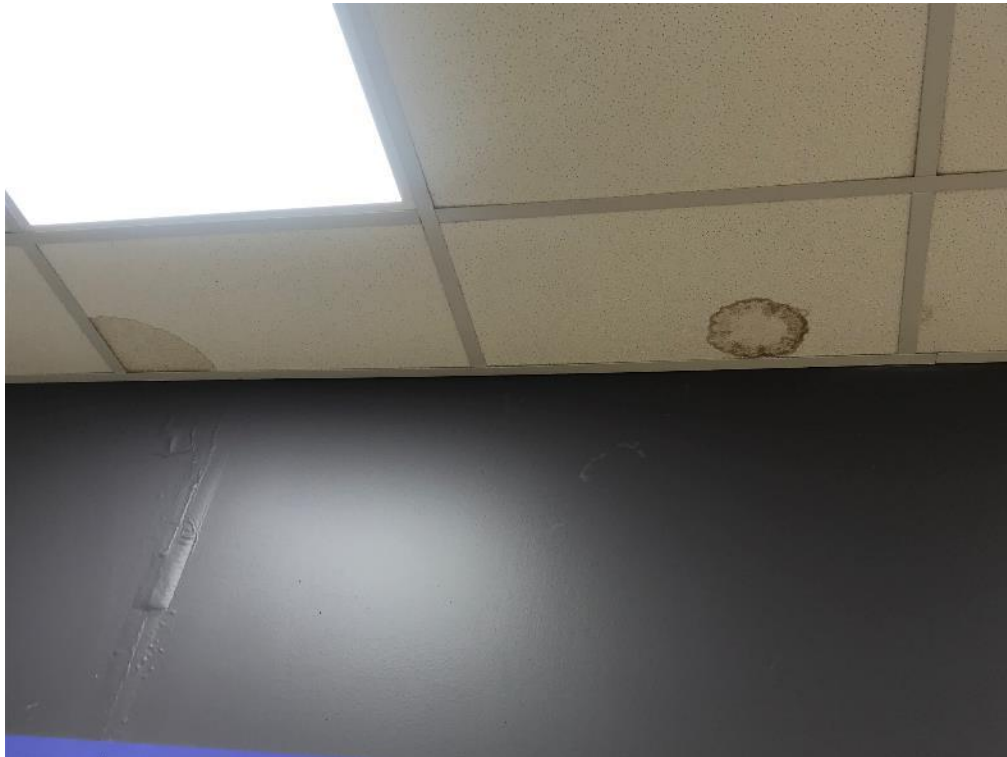
**Photos 9, 10** – View of water staining on non-asbestos containing ceiling tiles in Town Hall, 1-065.

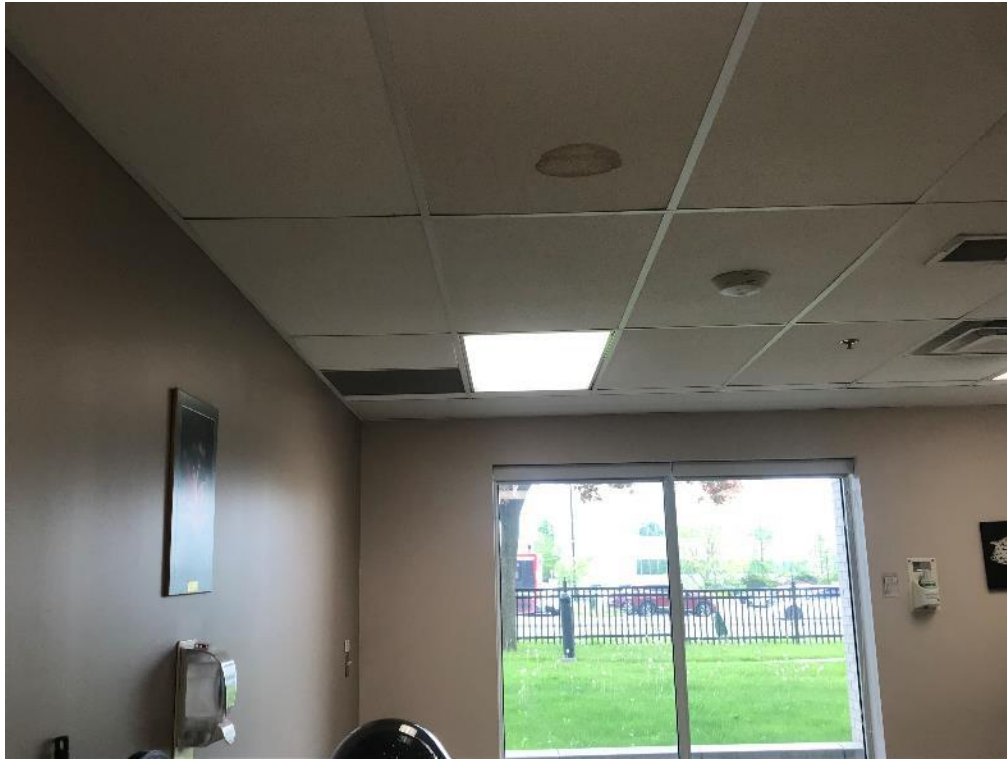
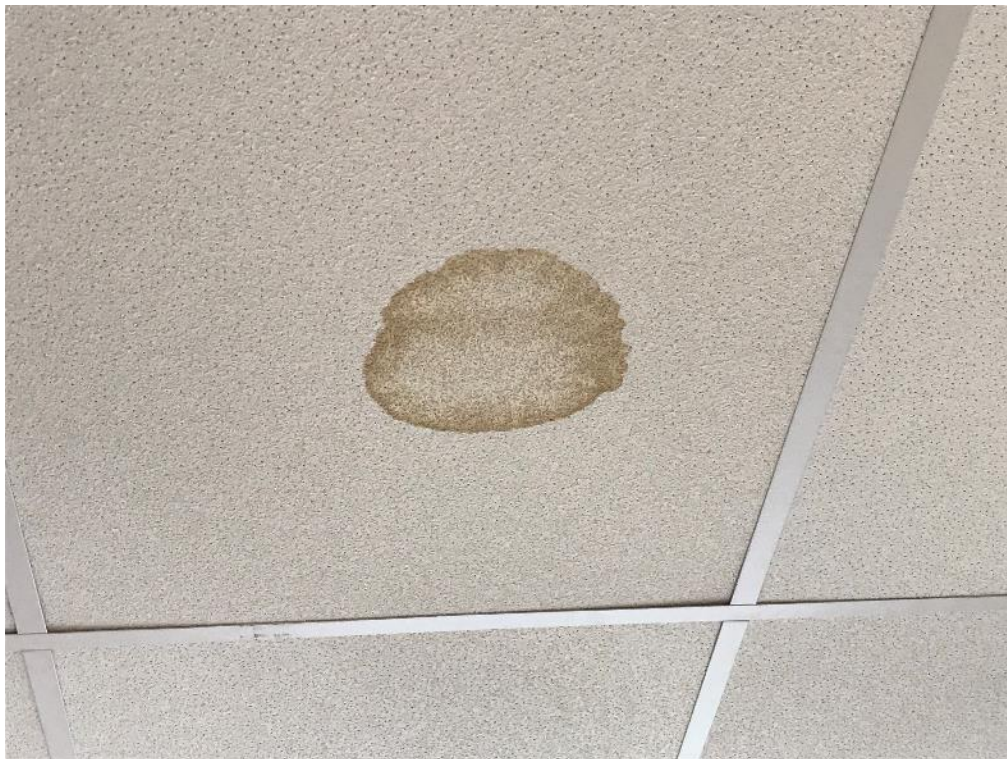
**Photos 11, 12 – View of water staining on non-asbestos containing ceiling tile in Beauty Salon, 1-043.**

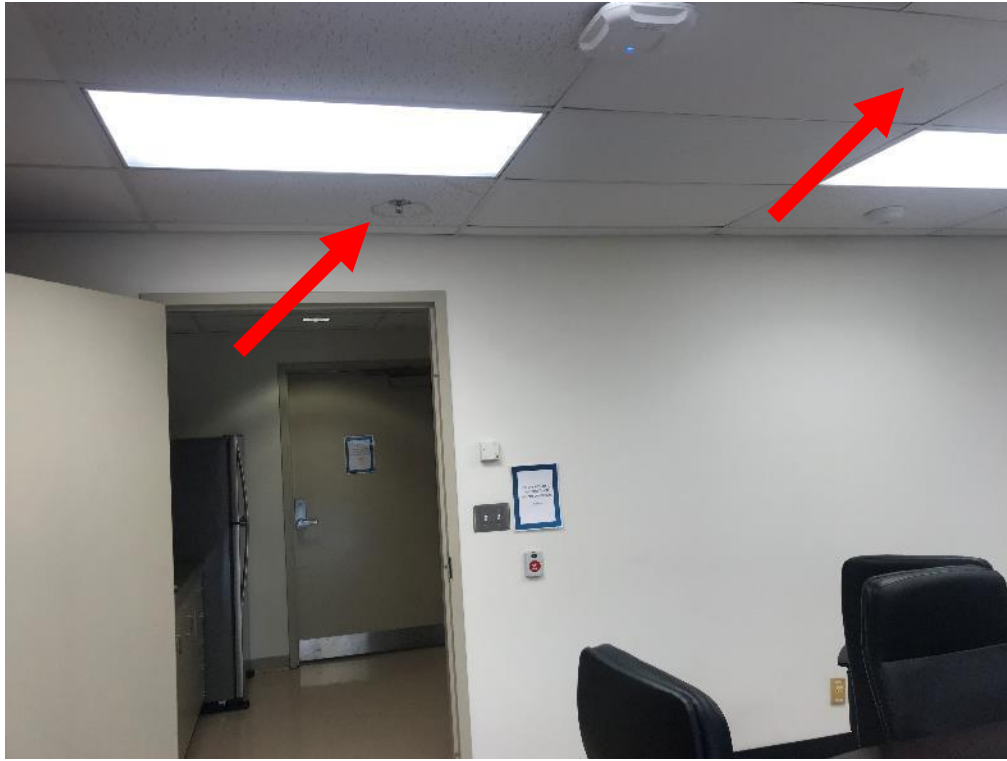
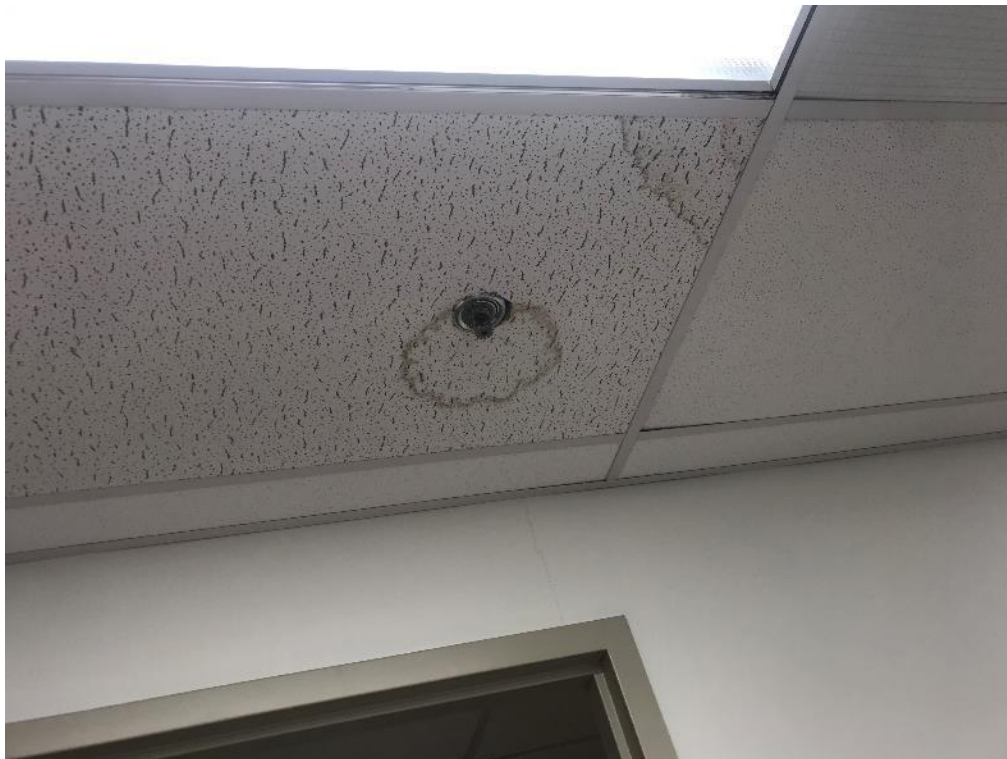
**Photos 13, 14 – View of water staining on non-asbestos containing ceiling tile in Meeting Room, 1-048.**

<b>Description of Recommended Work</b> (i.e. quantity of damage, type of damaged material, repair / removal operation)	<b>Location(s) of Work</b> (i.e. location number, location name)
Visible mould growth on non-asbestos containing drywall ceiling (approximately 1 SF). <b>Remove following Level 1 Mould Remediation Procedure.</b>	Soiled Linen, 1-025
Visible mould growth on fibreglass pipe insulation (approximately 25 LF). <b>Remove following Level 1 Mould Remediation Procedure.</b>	Garbage Room, 1-026
Water staining on two (2) non-asbestos containing ceiling tiles. <b>Remove following Level 1 Mould Remediation Procedure.</b>	Town Hall, 1-065
Water staining on one (1) non-asbestos containing ceiling tile. <b>Remove following Level 1 Mould Remediation Procedure.</b>	Beauty Salon, 1-043
Water staining on two (2) non-asbestos containing ceiling tiles. <b>Remove following Level 1 Mould Remediation Procedure.</b>	Meeting Room, 1-048

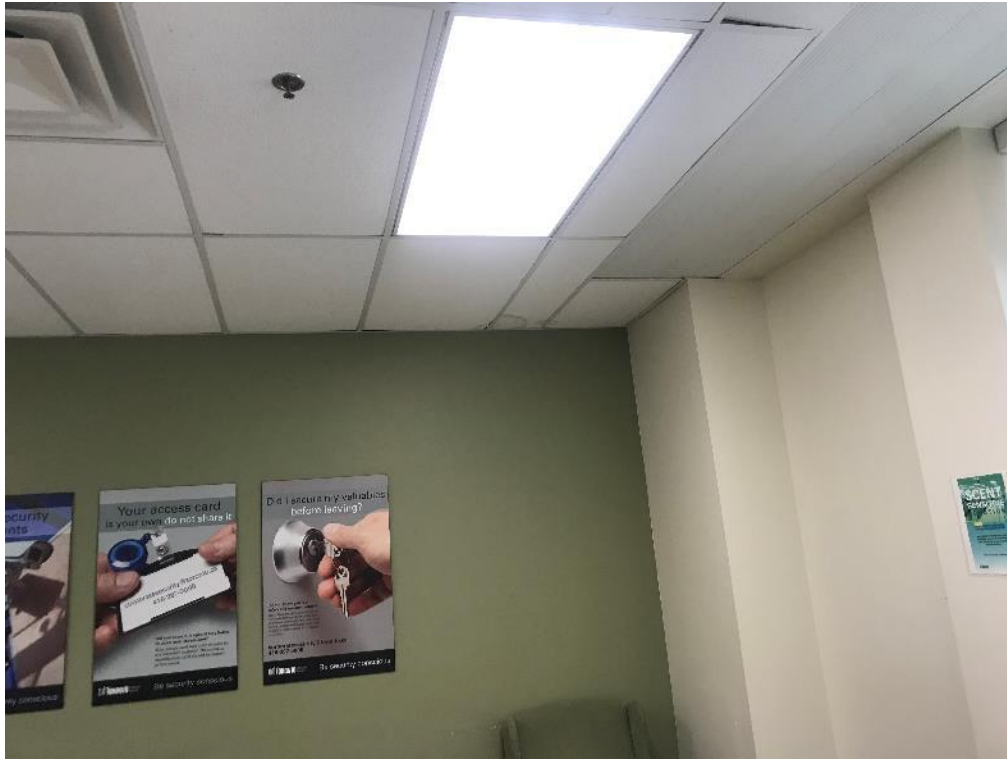
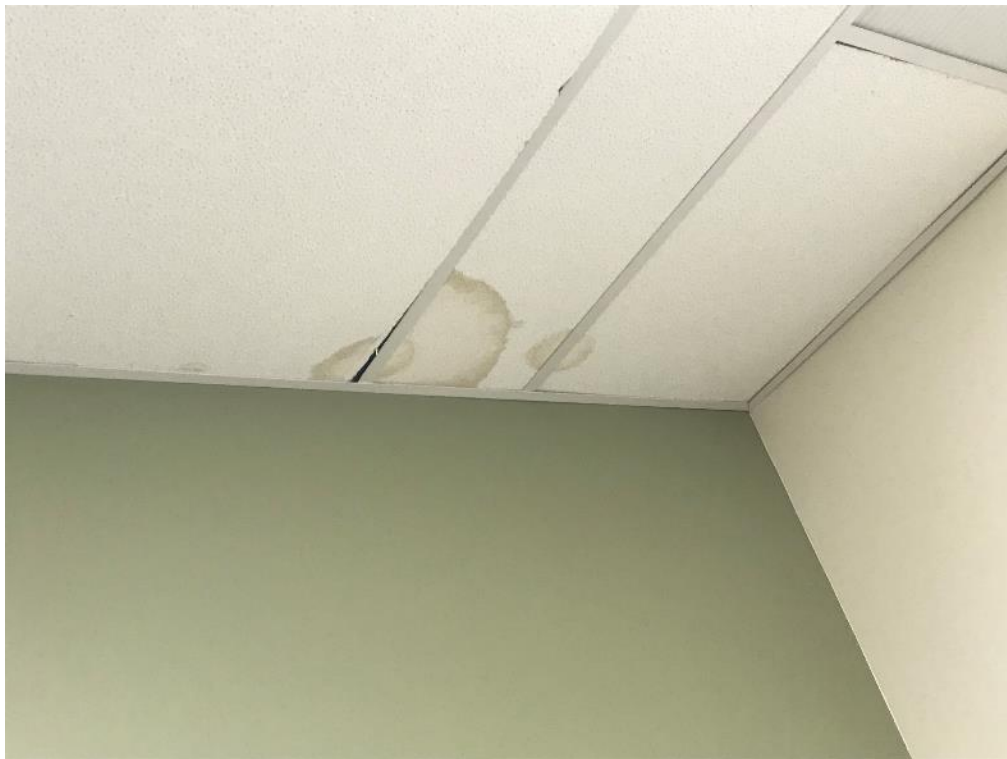
**Photos 15, 16 – View of water staining on non-asbestos containing ceiling tiles in Staff Lounge, 1-064.**

Water staining on three (3) non-asbestos containing ceiling tiles. <b>Remove following Level 1 Mould Remediation Procedure.</b>	Staff Lounge, 1-064
Water staining on one (1) non-asbestos containing ceiling tile. <b>Remove following Level 1 Mould Remediation Procedure.</b>	Chapel, 1-068

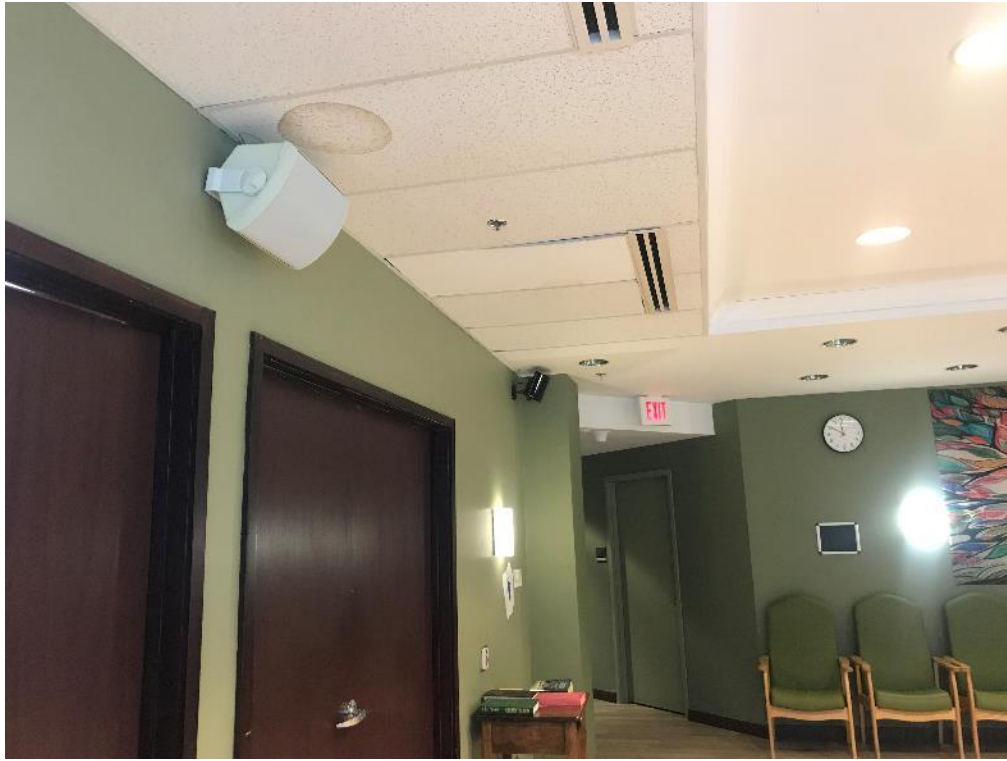
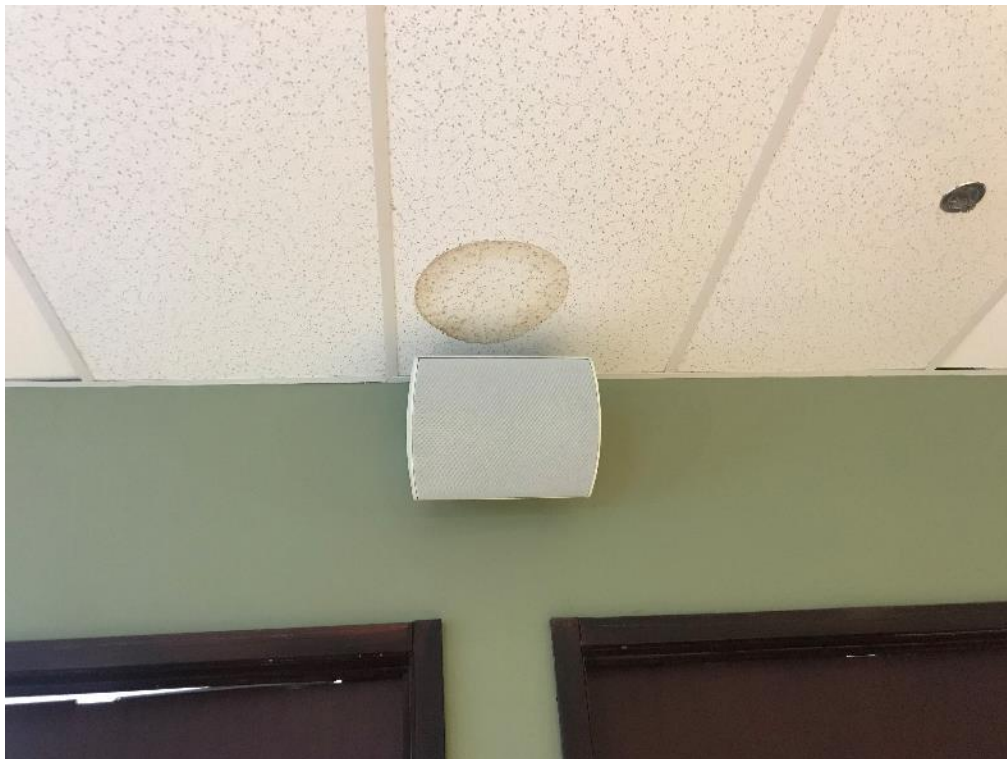
**Photos 17, 18 – View of water staining on non-asbestos containing ceiling tile in Chapel, 1-068.**

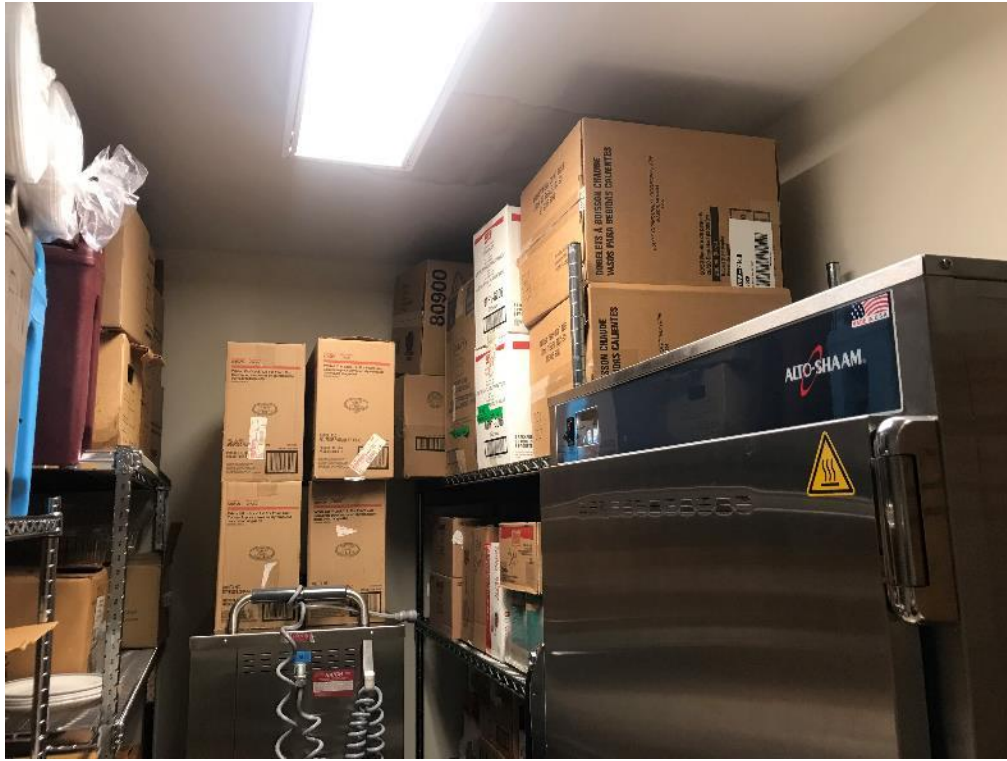
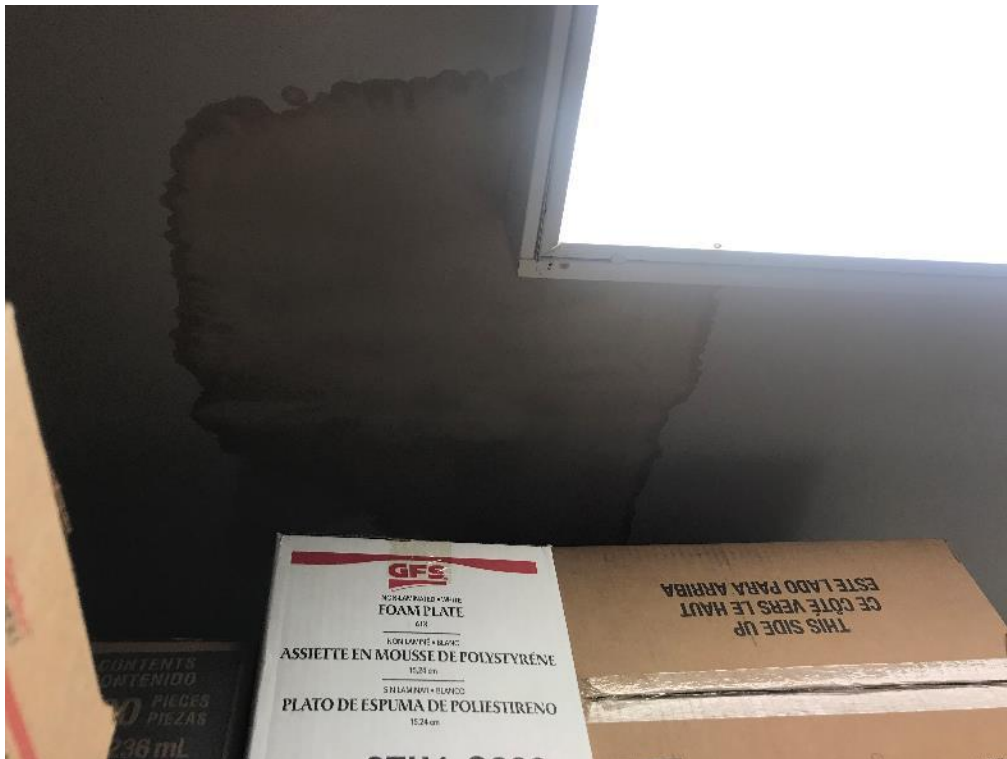
**Photos 19, 20 - View of water staining on non-asbestos containing drywall ceiling in Storage, 4-099.**

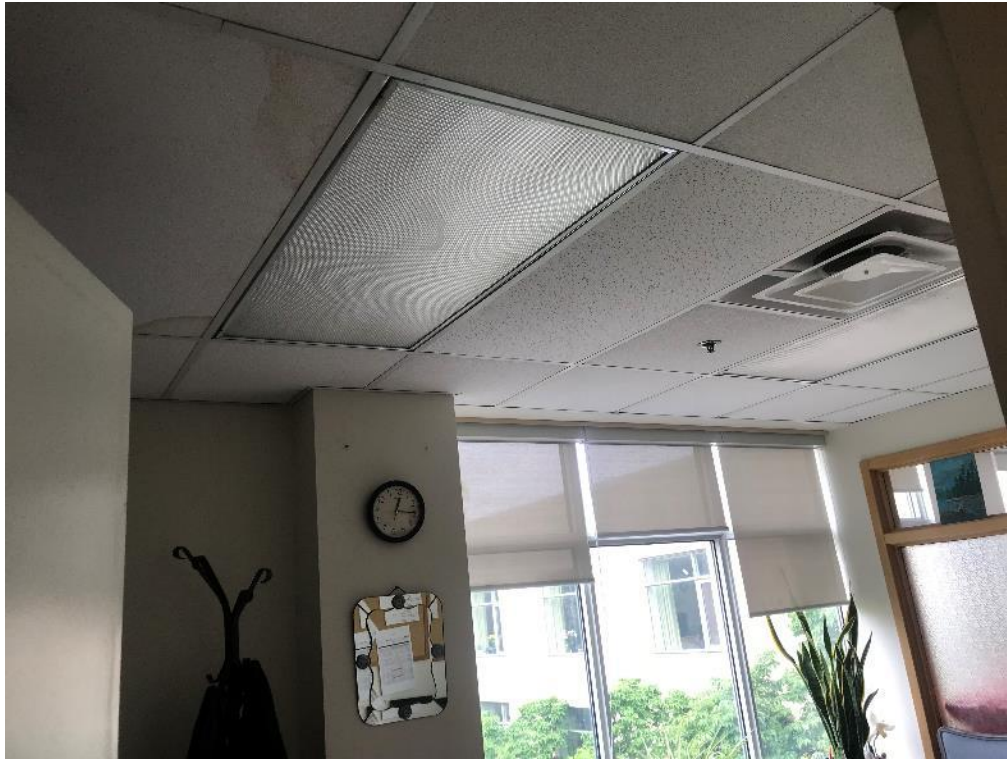
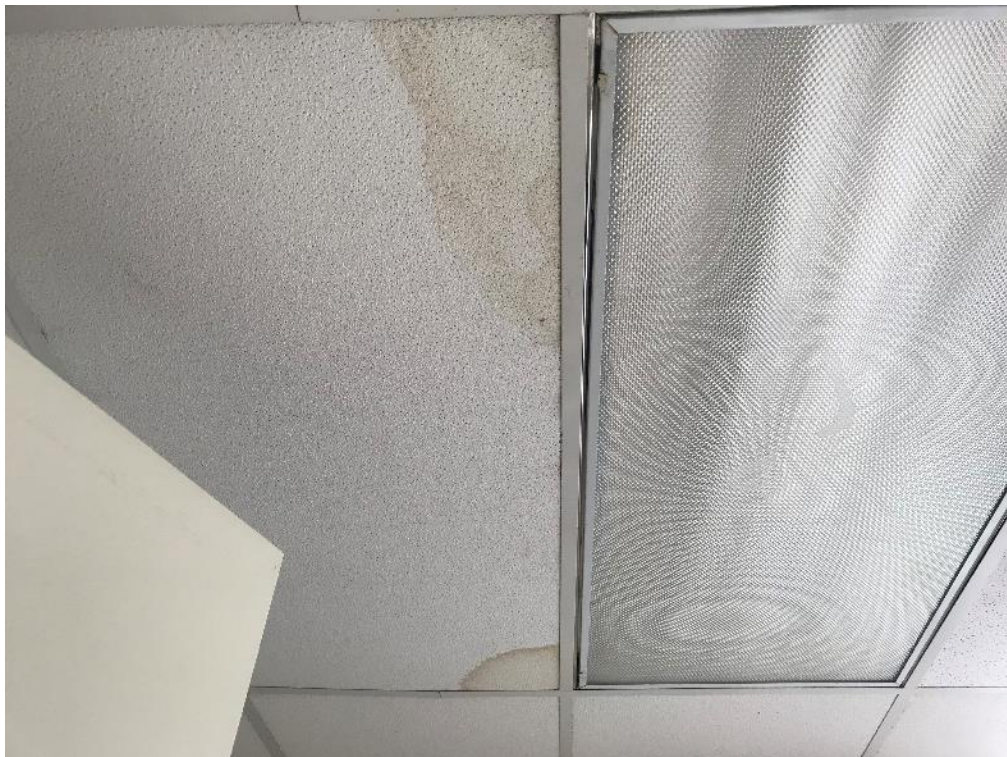
**Photos 21, 22 – View of water staining on non-asbestos containing ceiling tiles in Office, 4-026.**

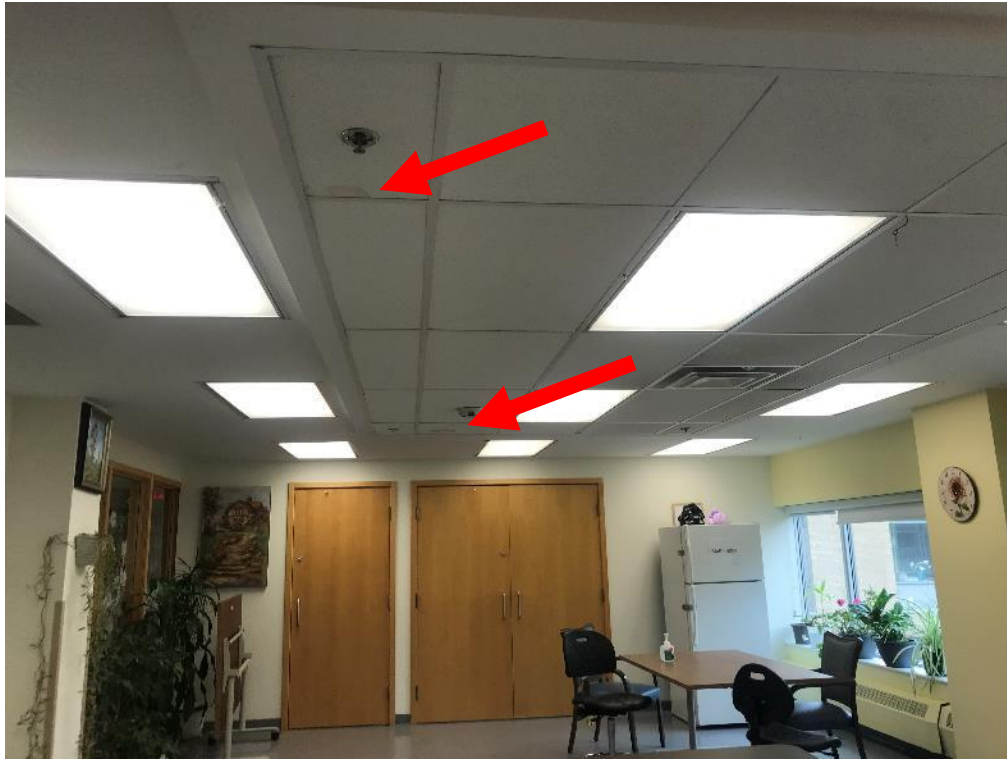
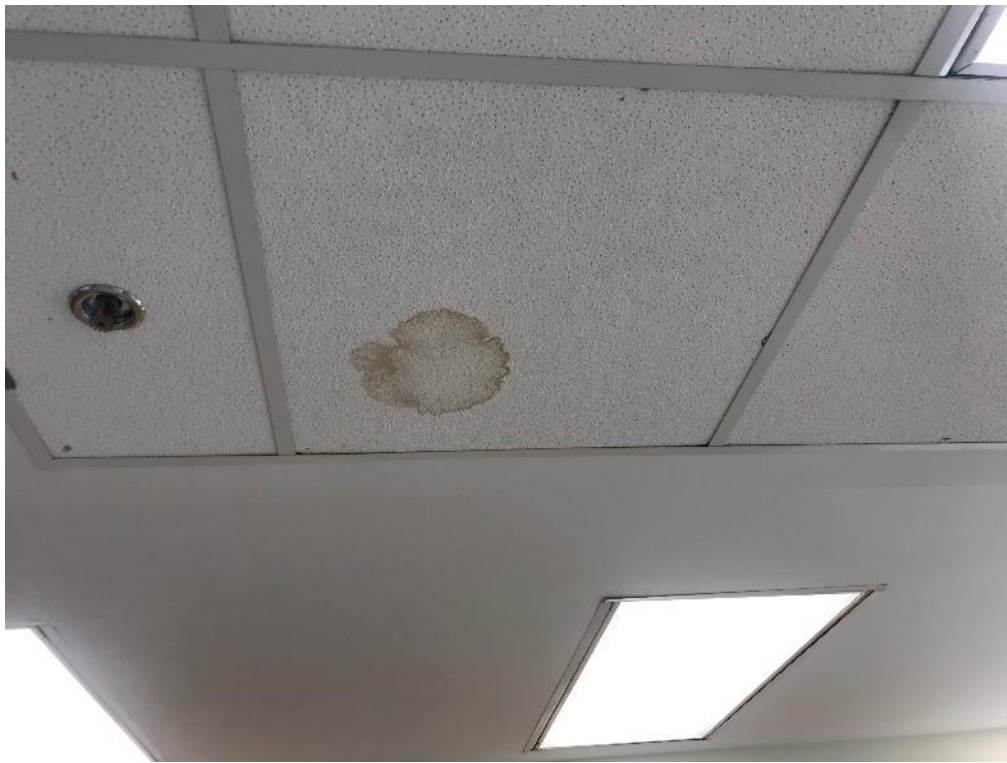
**Photos 23, 24** – View of water staining on non-asbestos containing ceiling tiles in Program Centre, 4-047.

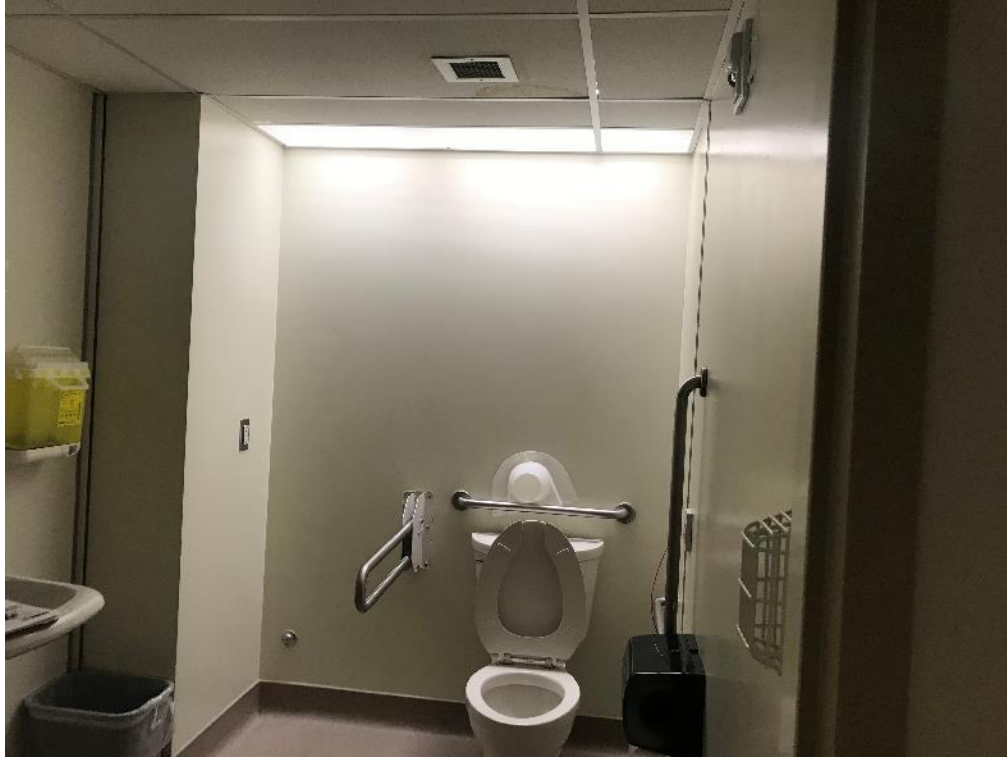
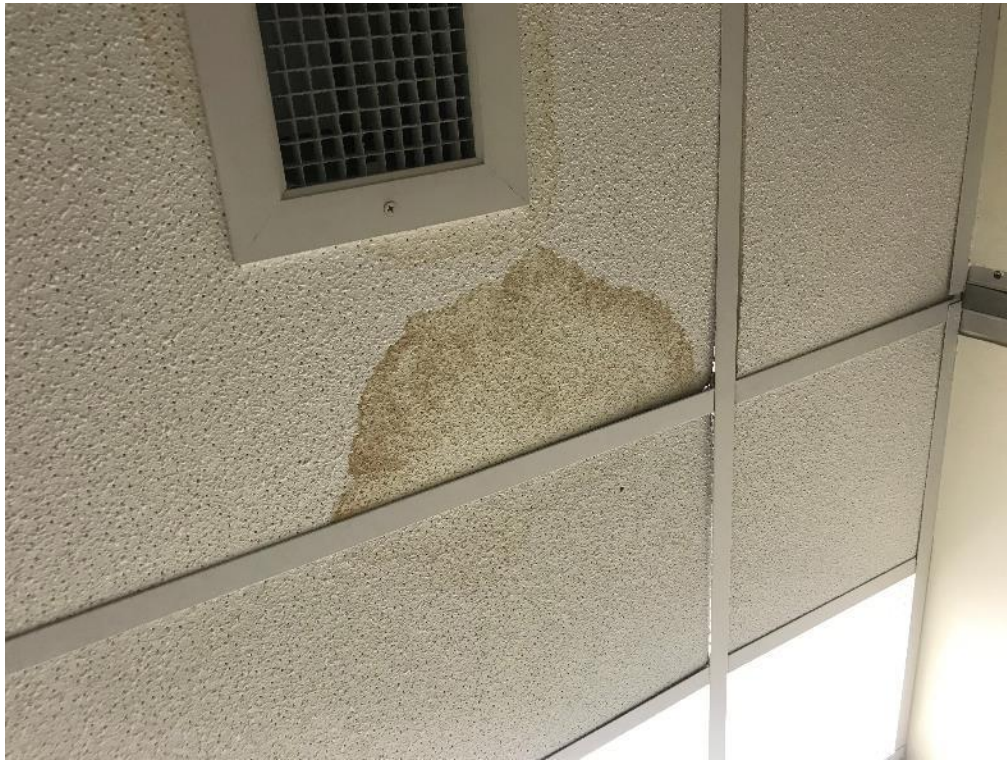
**Photos 25, 26 – View of water staining on non-asbestos containing ceiling tiles in Washroom, 4-053.**

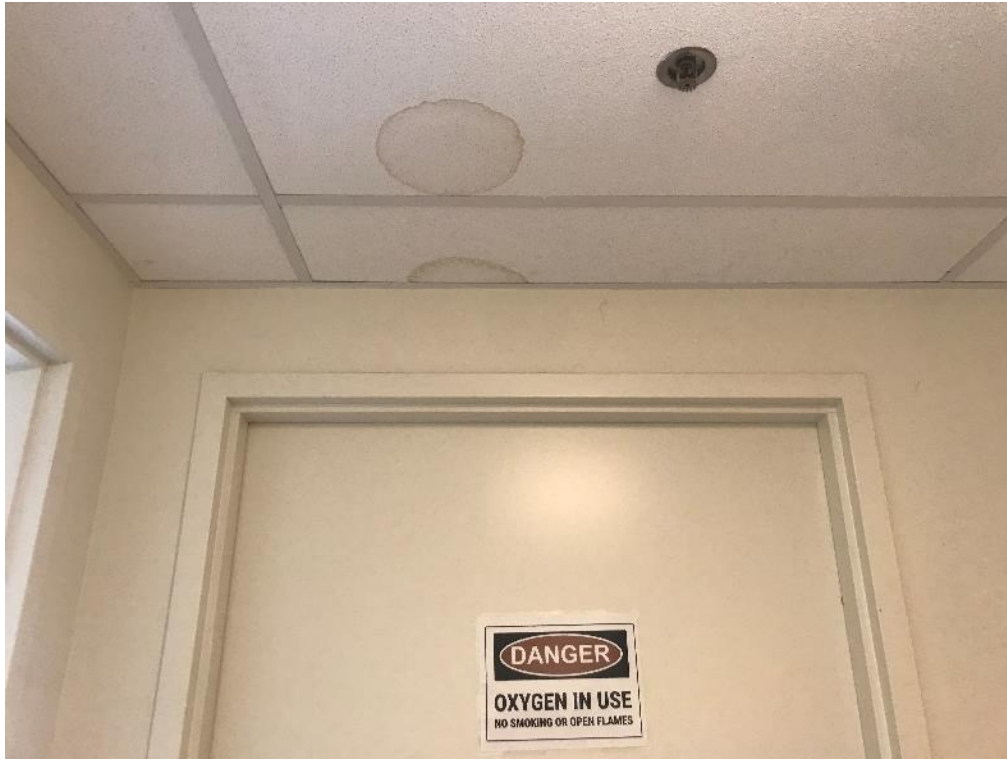
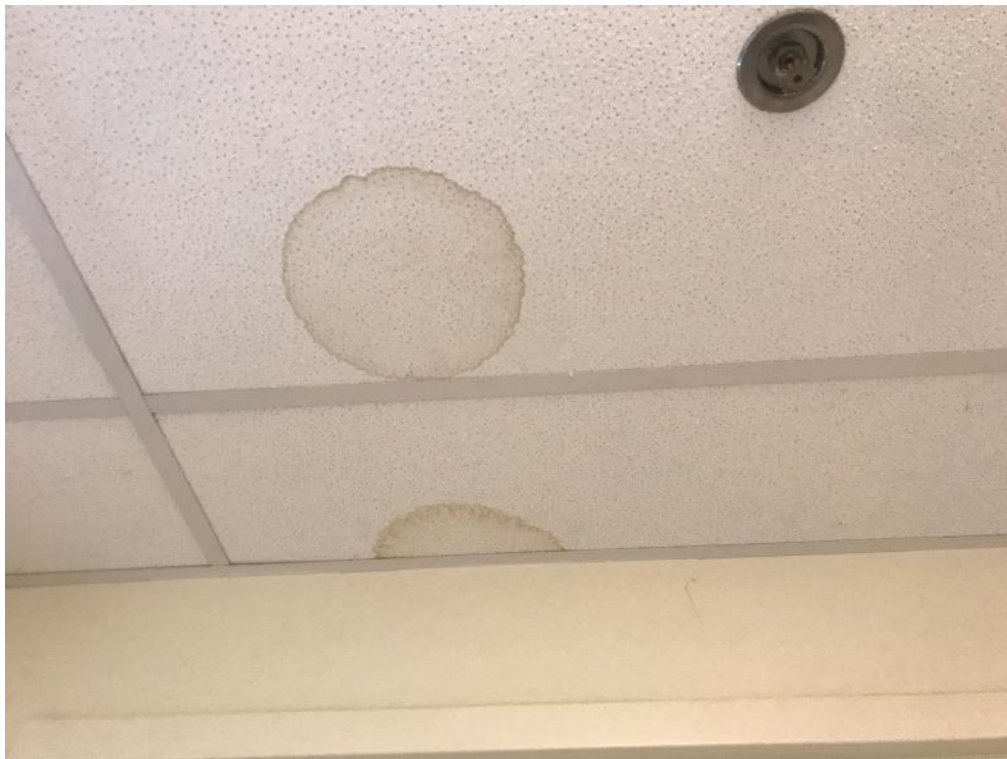
**Photos 27, 28** – View of water staining on non-asbestos containing ceiling tiles in the North Corridor, 4-098.

<b>Description of Recommended Work</b> (i.e. quantity of damage, type of damaged material, repair / removal operation)	<b>Location(s) of Work</b> (i.e. location number, location name)
Water staining on non-asbestos containing drywall ceiling, (approximately 4 SF). <b>Remove following Level 1 Mould Remediation Procedure.</b>	Storage, 4-099
Water staining on two (2) non-asbestos containing ceiling tiles. <b>Remove following Level 1 Mould Remediation Procedure.</b>	Office, 4-026
Water staining on two (2) non-asbestos containing ceiling tiles. <b>Remove following Level 1 Mould Remediation Procedure.</b>	Program Centre, 4-047
Water staining on two (2) non-asbestos containing ceiling tiles. <b>Remove following Level 1 Mould Remediation Procedure.</b>	Washroom, 4-053
Water staining on two (2) non-asbestos containing ceiling tiles. <b>Remove following Level 1 Mould Remediation Procedure.</b>	North Corridor, 4-098

**\*In reference to Level I Mould Abatement work outlined above – we believe Fisher does not need to be present for the removal of the impacted ceiling tiles. We also recommend further investigation to the cause of water ingress and rectified prior to re-installment of new ceiling tile.**
