Corridor Ceiling & Accessibility Renovation Project

Orchard Park Secondary School

Designated Substance Audit Report

Revised January 23, 2025

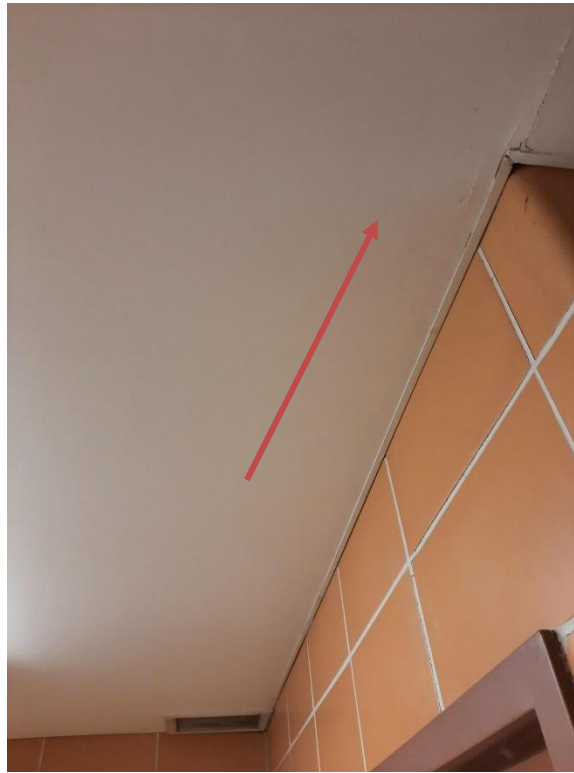
Photograph No. 1 – Drywall was observed on the ceiling of Washroom 1059.1059A, and 1059B. The compound was sampled (S02A,B,C) and is asbestos-containing.

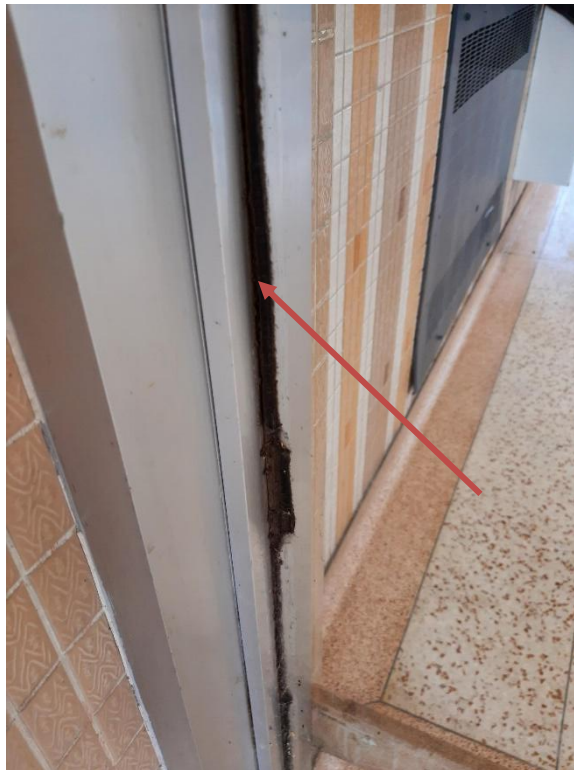
Photograph No. 2 – A small amount of black glazing was observed on the windows at the main entrance. The black glazing was sampled (S06A,B,C) and is asbestos-containing.

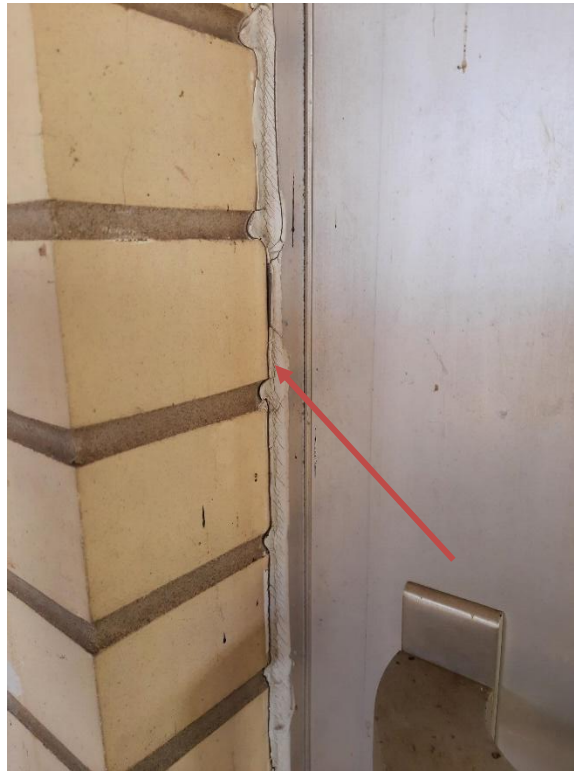
Photograph No. 3 – White sealant was observed on the exterior of the main entrance and was sampled (S08A,B,C). The white sealant is asbestos-containing. It was also analyzed for PCB content (PCB-2) and is non-PCB.

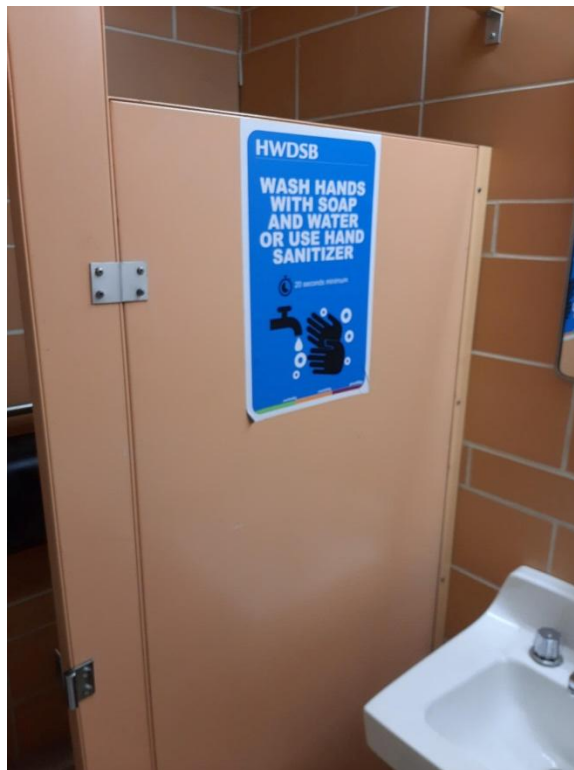
Photograph No. 4 – The orange paint observed on the stalls within Washroom 1059 was sampled (LP02) and is lead-containing.

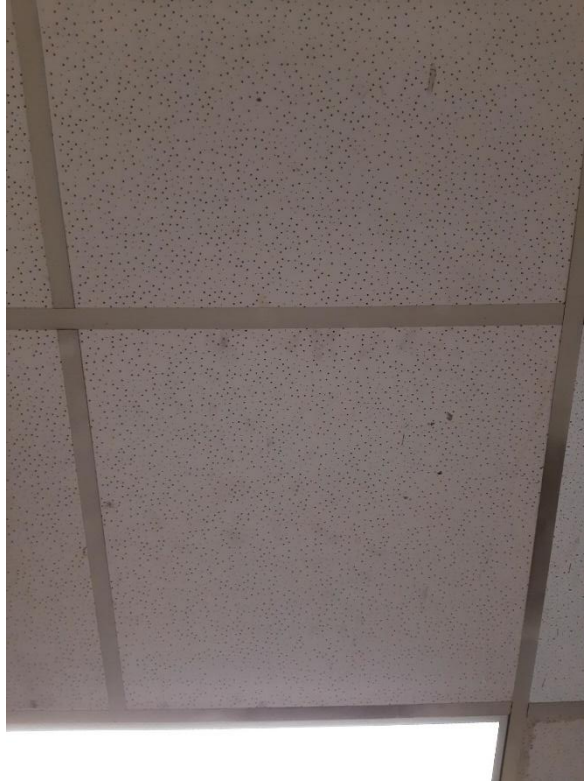
Photograph No. 5 – 2'x2' Random pinhole ceiling tile was observed within the main corridor and was sampled (S03A,B,C). The ceiling tile is non-asbestos.

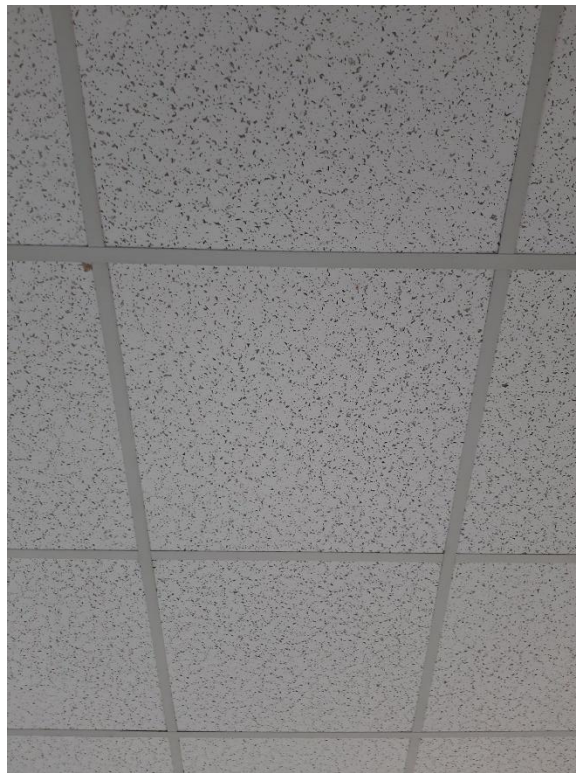
Photograph No. 6 – 2'x2' Small fissure random pinhole ceiling tile was observed within the main corridor and was sampled (S04A,B,C). The ceiling tile is non-asbestos.

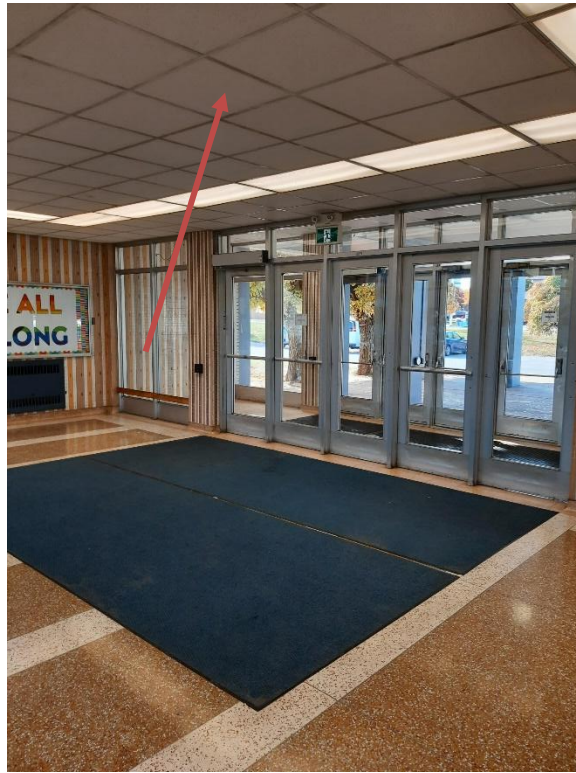
Photograph No. 7 – 2'x2' Dimple pattern random pinhole ceiling tile was observed in the main entrance lobby and was sampled (S05A,B,C). The ceiling tile is non-asbestos.

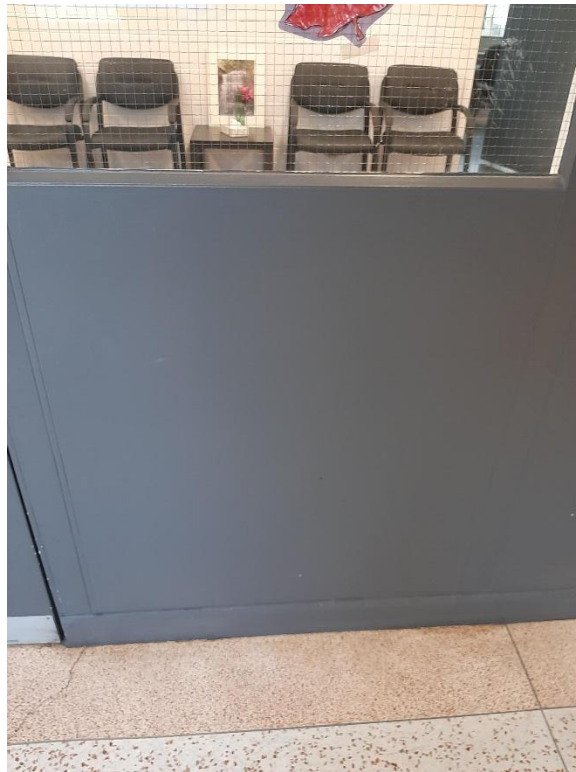
Photograph No. 8 – Grey paint was observed on the main office doors/frames and was sampled (LP05). The paint is low level lead-containing.
