PRE-RENOVATION DESIGNATED SUBSTANCES AND HAZARDOUS MATERIALS SURVEY

**TORONTO WATER OFFICES
95 THE ESPLANADE
TORONTO, ON**

ECOH Project No.: 29001
January 10, 2025

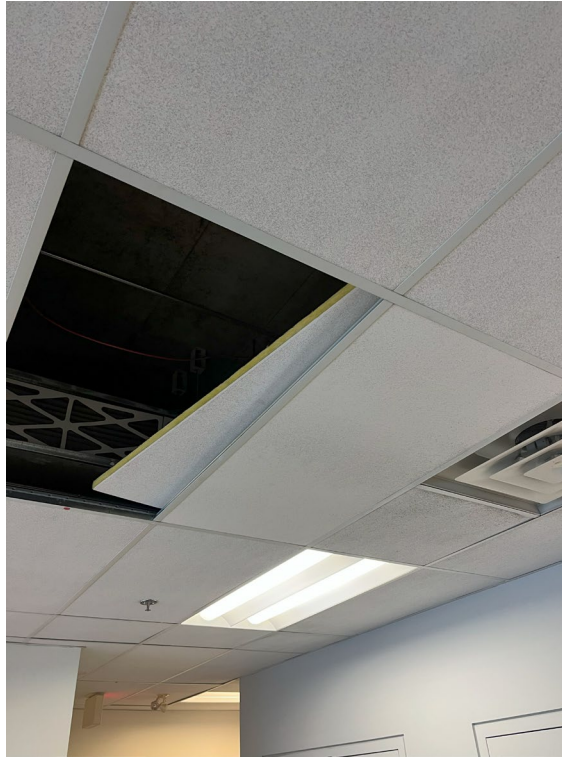
Non-asbestos fiberglass ceiling tiles (CT1).

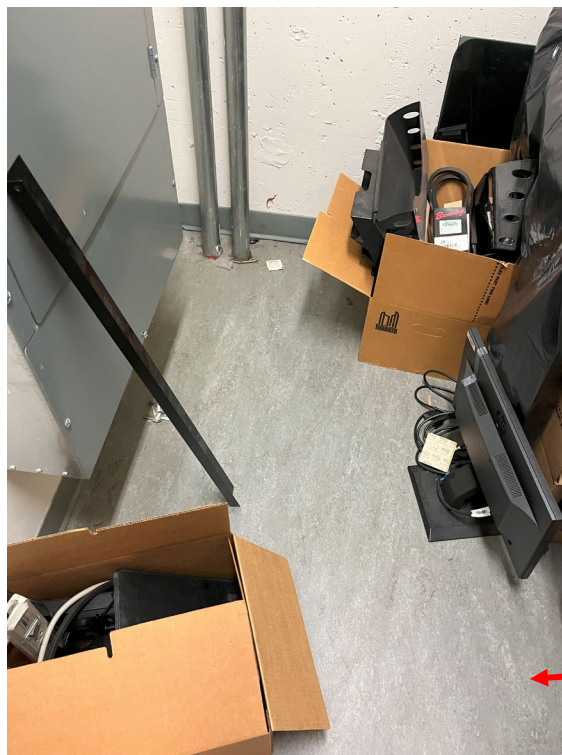
Photo No. 2.

Non-asbestos vinyl sheet flooring (VSF3).

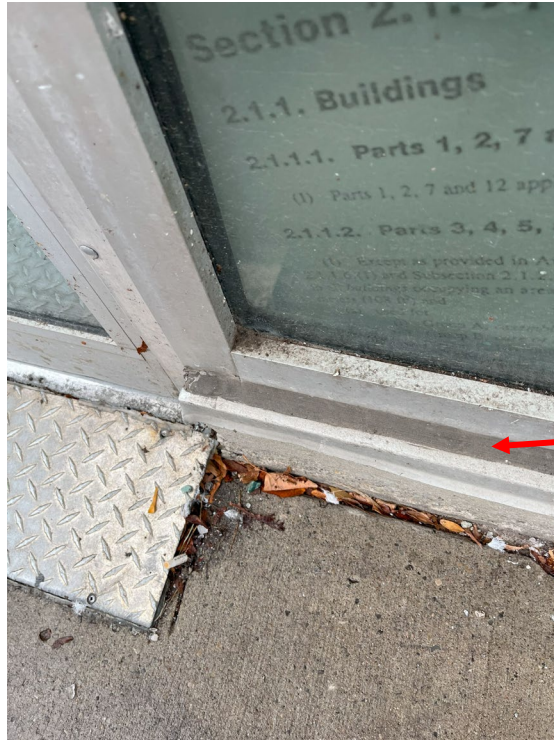
Non-asbestos grey
window caulking.

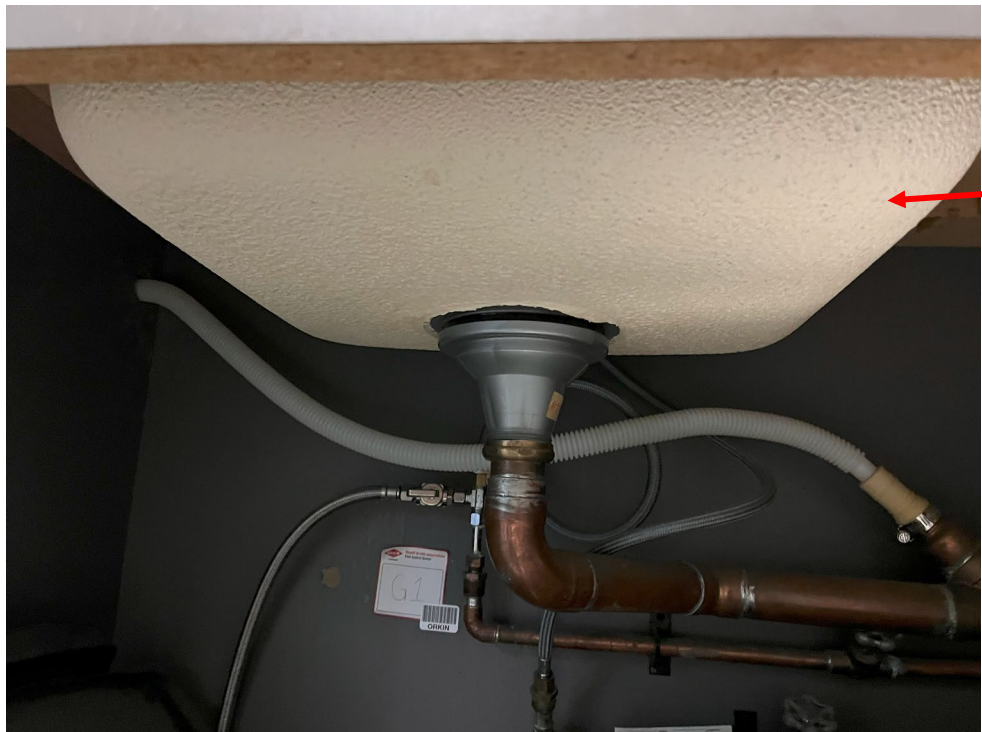
Photo No. 4.

Non-asbestos sink
mastic.
