APPENDIX B: DEFICIENCY PHOTOS

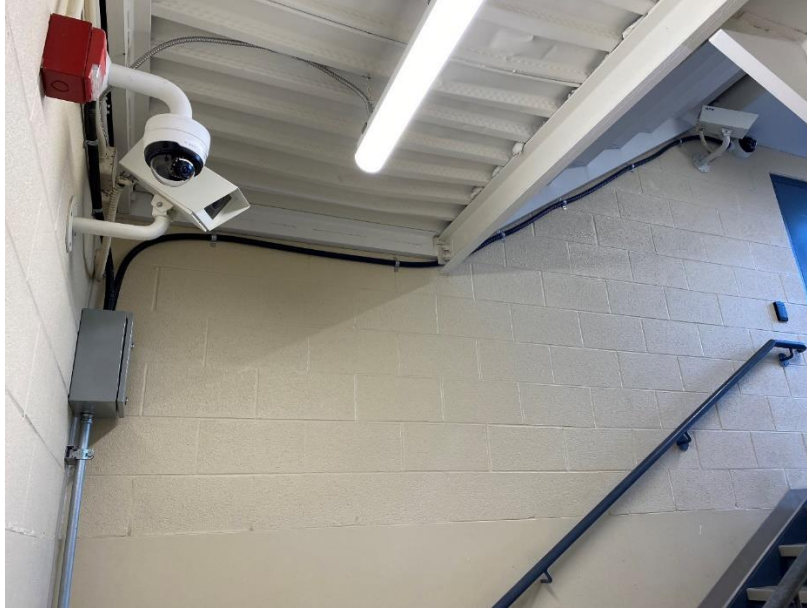
Picture 1: Black Flexible Conduit from Junction Box to Camera at the door
Location: Basement Stair #2
Drawing Reference: DWG 504 Note 14

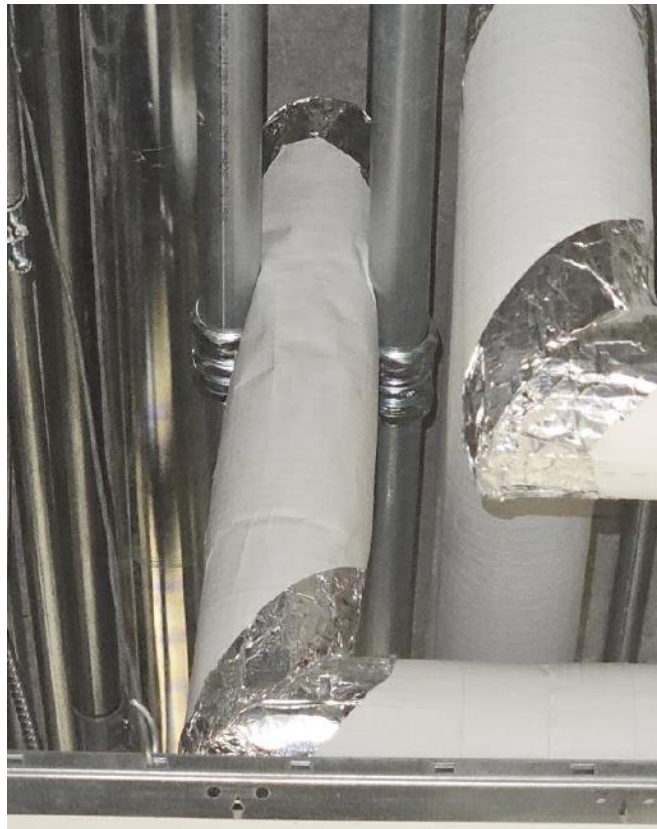
Picture 2: Existing Conduit installed against Plumbing Pipe
Location: Basement Corridor
Drawing Reference: DWG 504 Note 15

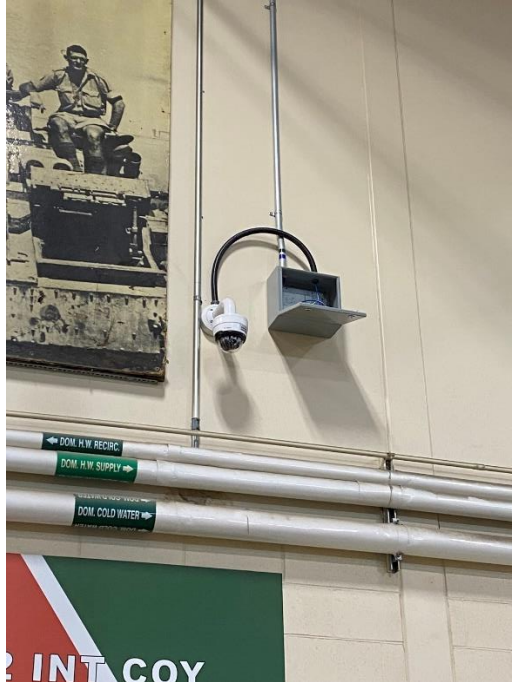
Picture 3: Junction Box Placed in the Incorrect Orientation
Location: First Floor Above Double Doors to C164
Drawing Reference: DWG 505 Note 20

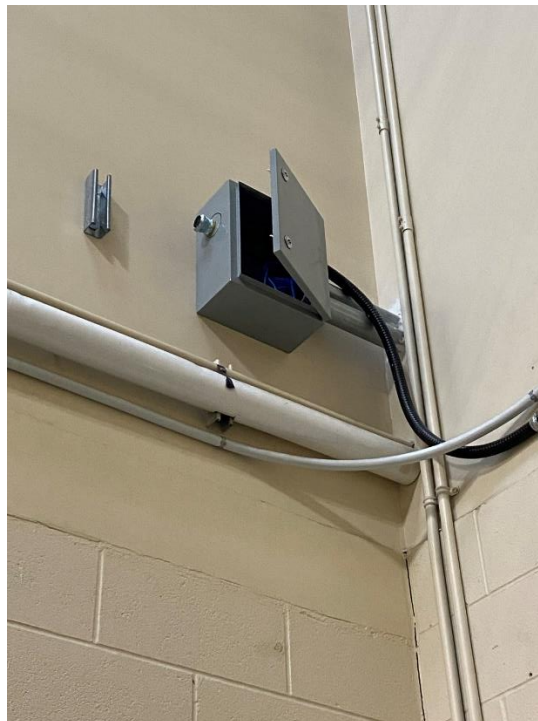
Picture 4: Junction Box with Punchout
Location: First Floor Corridor by C168
Drawing Reference: DWG 505 Note 18

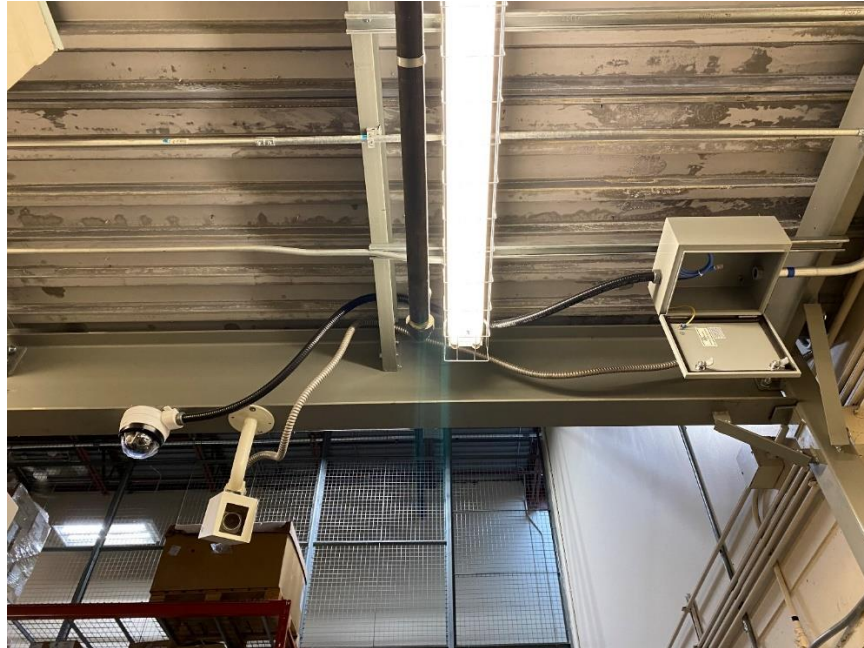
Picture 5: Black Flexible Conduit from Junction Box to Camera
Location: First Floor C156
Drawing Reference: DWG 505 Note 19

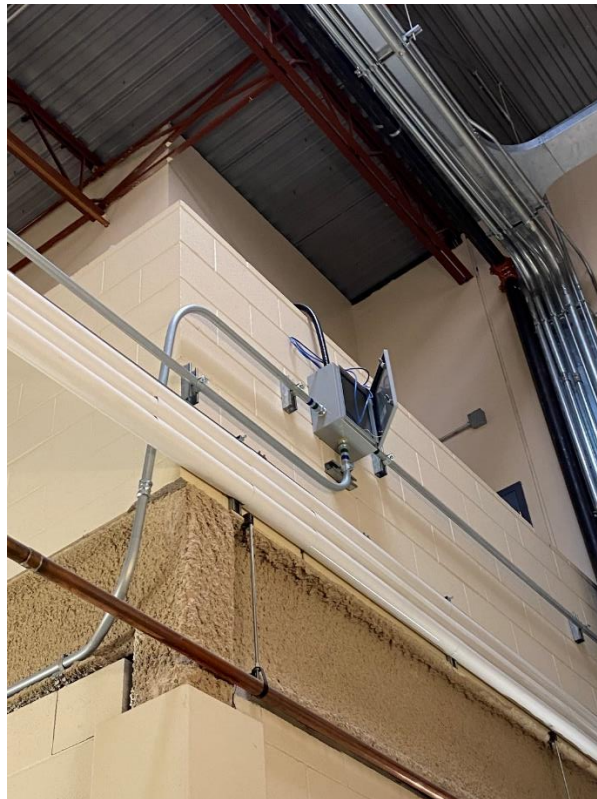
Picture 6: Black Flexible Conduit from Junction Box to Camera
Location: First Floor Exterior Stair Corridor Wall by B140
Drawing Reference: DWG 505 Note 19

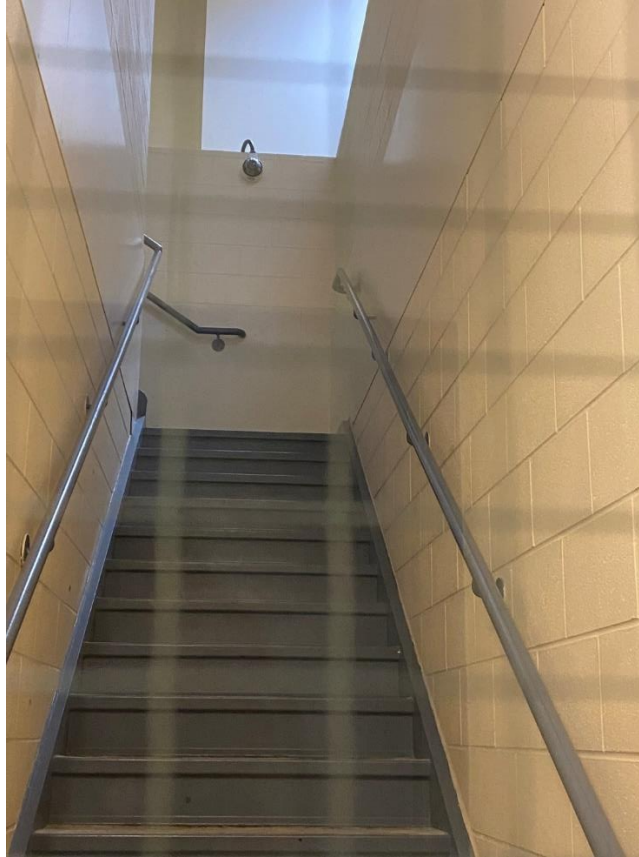
Picture 7: Black Flexible Conduit from Junction Box to Camera
Location: First Floor Interior Stair Corridor Wall by B140
Drawing Reference: DWG 505 Note 19

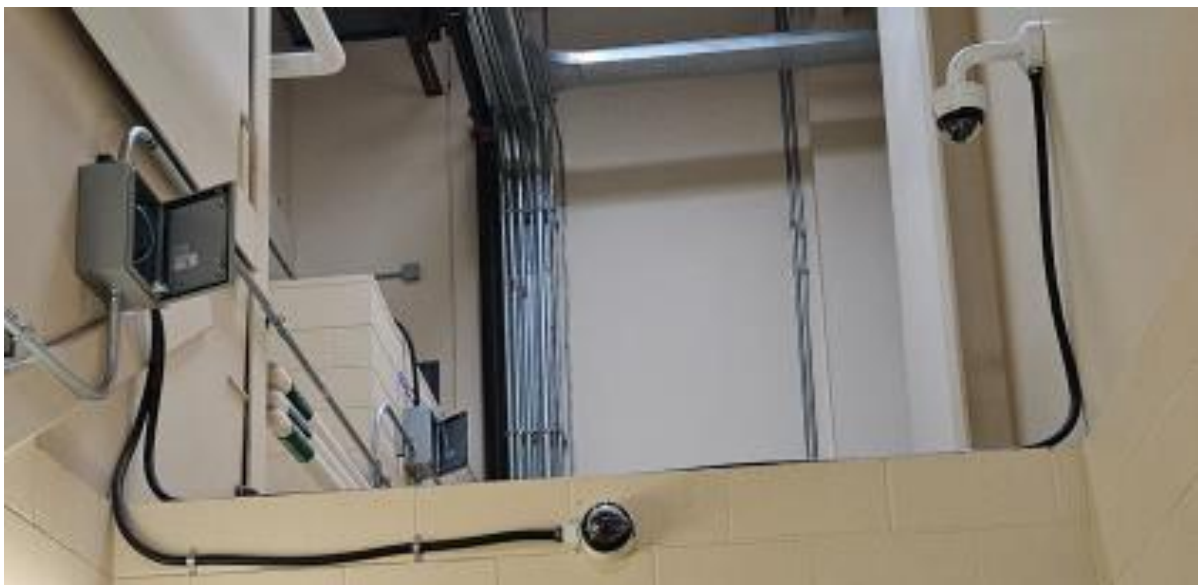
Picture 8: Black Flexible Conduit from Junction Box to Camera
Location: First Floor Double Doors by C174B
Drawing Reference: DWG 505 Note 19

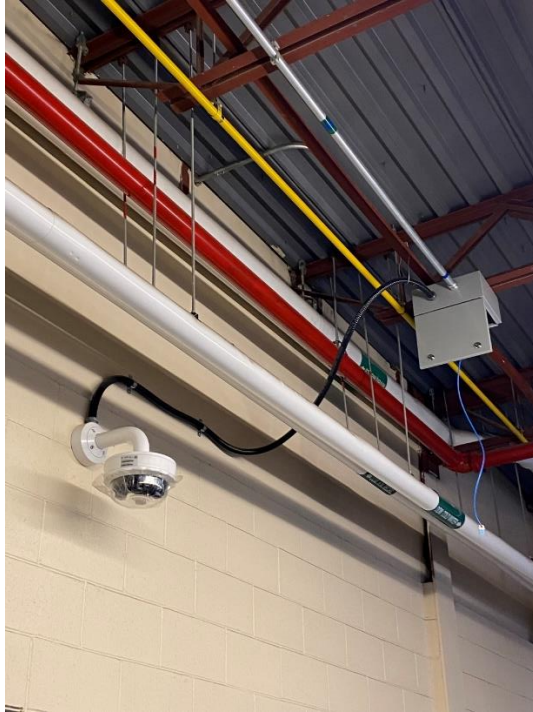
Picture 9: Black Flexible Conduit from Junction Box to Camera
Location: First Floor Loading Dock
Drawing Reference: DWG 505 Note 19

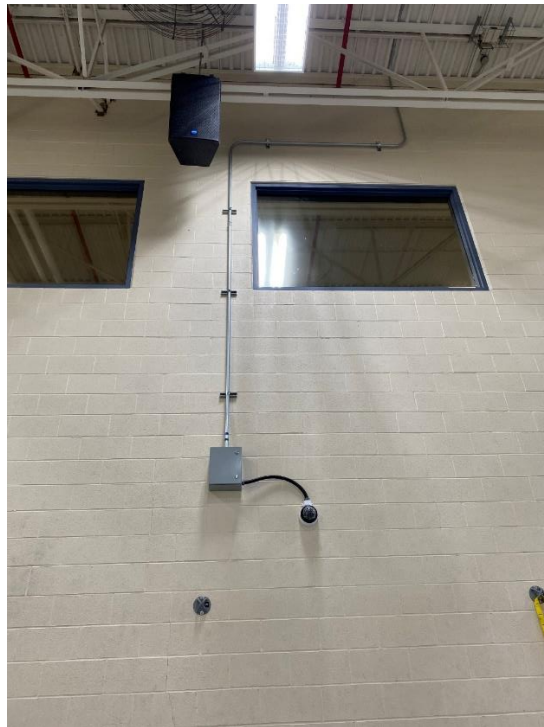
Picture 10: EMT Conduit Installation
Location: First Floor Drill Hall
Drawing Reference: DWG 506 Note 13

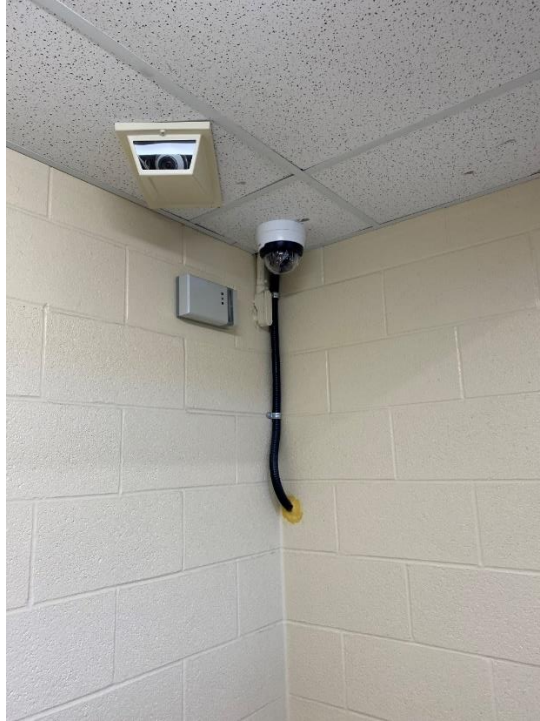
Picture 11: Black Flexible Conduit from Junction Box to Camera
Location: First Floor Stair #2
Drawing Reference: DWG 506 Note 14

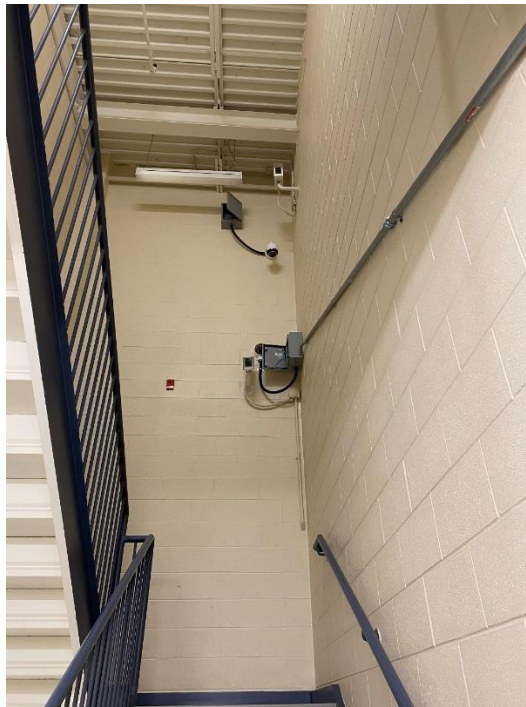
Picture 12: Black Flexible Conduit from Junction Box to Camera
Location: 2nd Floor Stair #4
Drawing Reference: DWG 507 Note 13

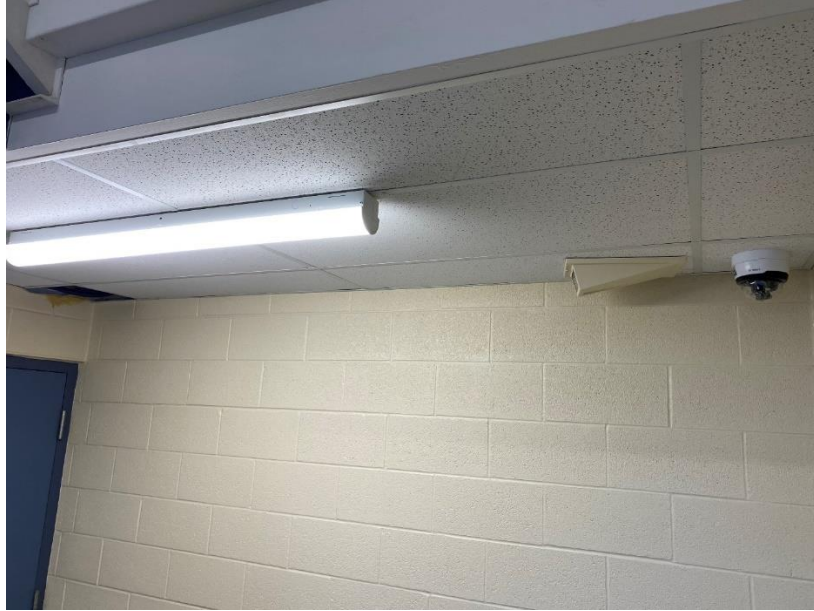
Picture 13: Flex Conduit Not Connected to Camera
Location: 2nd Floor Stair #3
Drawing Reference: DWG 507 Note 12

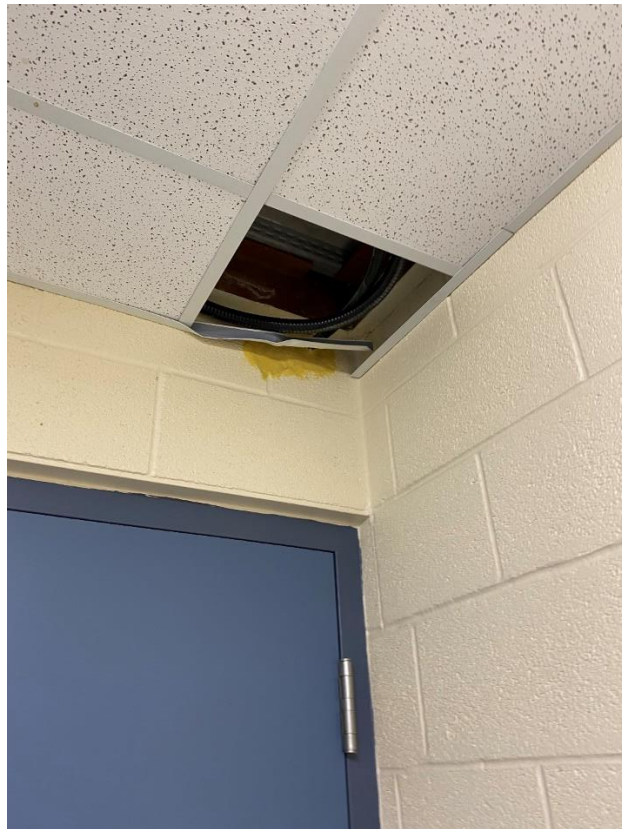
Picture 14: Flex Conduit Not Connected to Camera
Location: 2nd Floor Stair #3
Drawing Reference: DWG 507 Note 12

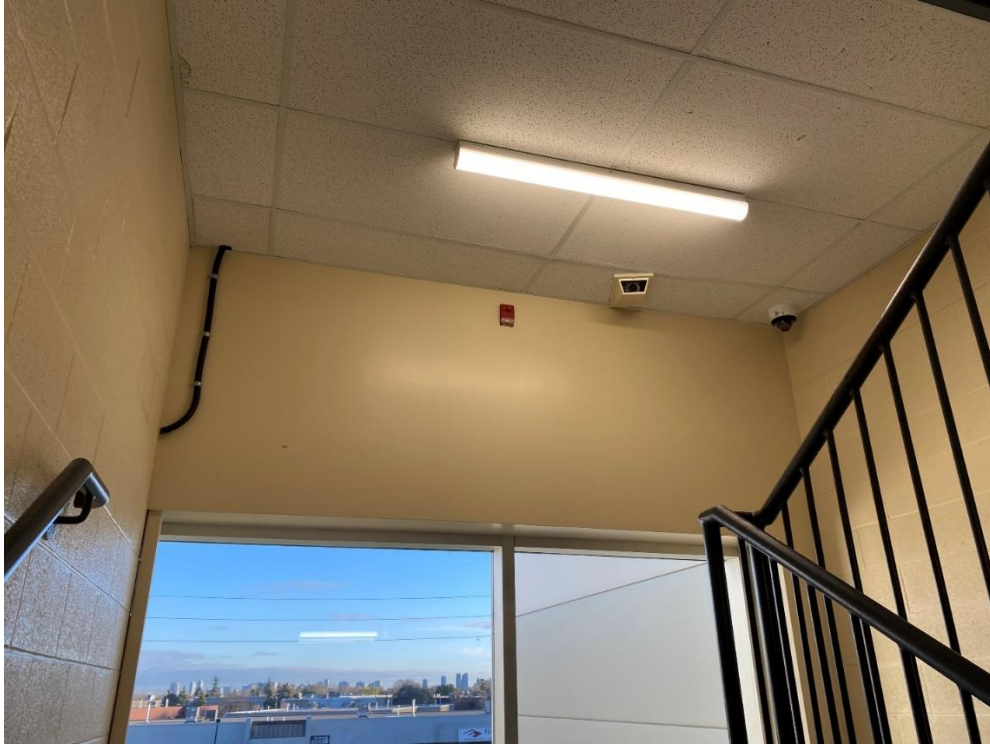
Picture 15: Black Flexible Conduit from Junction Box to Camera
Location: 2nd Floor Stair #2
Drawing Reference: DWG 507 Note 13

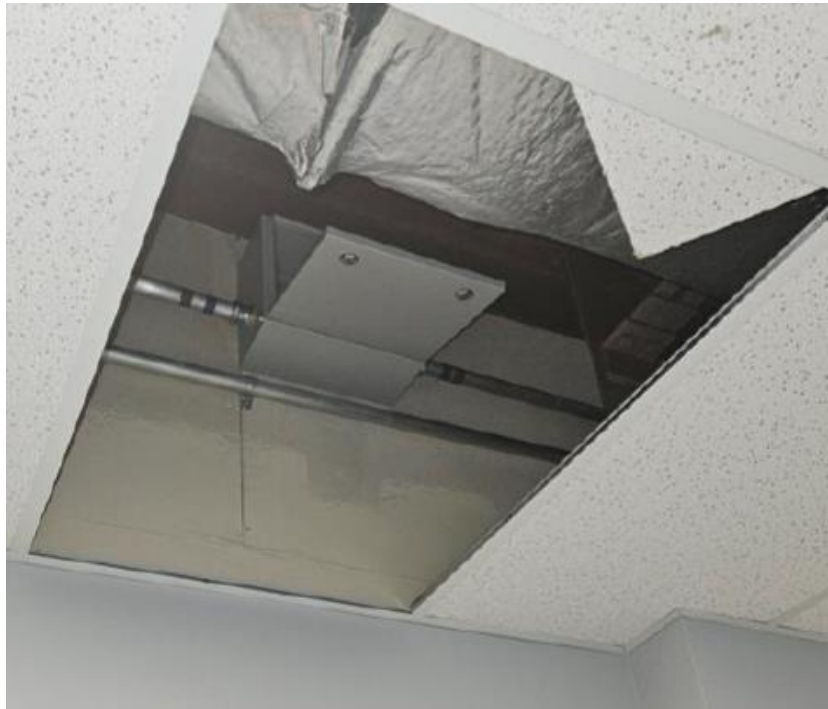
Picture 16: Incorrect Junction Box Orientation
Location: 3rd Floor Corridor
Drawing Reference: DWG 508 Note 16
