# Limited Designated Substance Survey Report

Ajax High School

105 Bayly Street East, Ajax, Ontario

April 11, 2022  
Parasol Project No: 13030

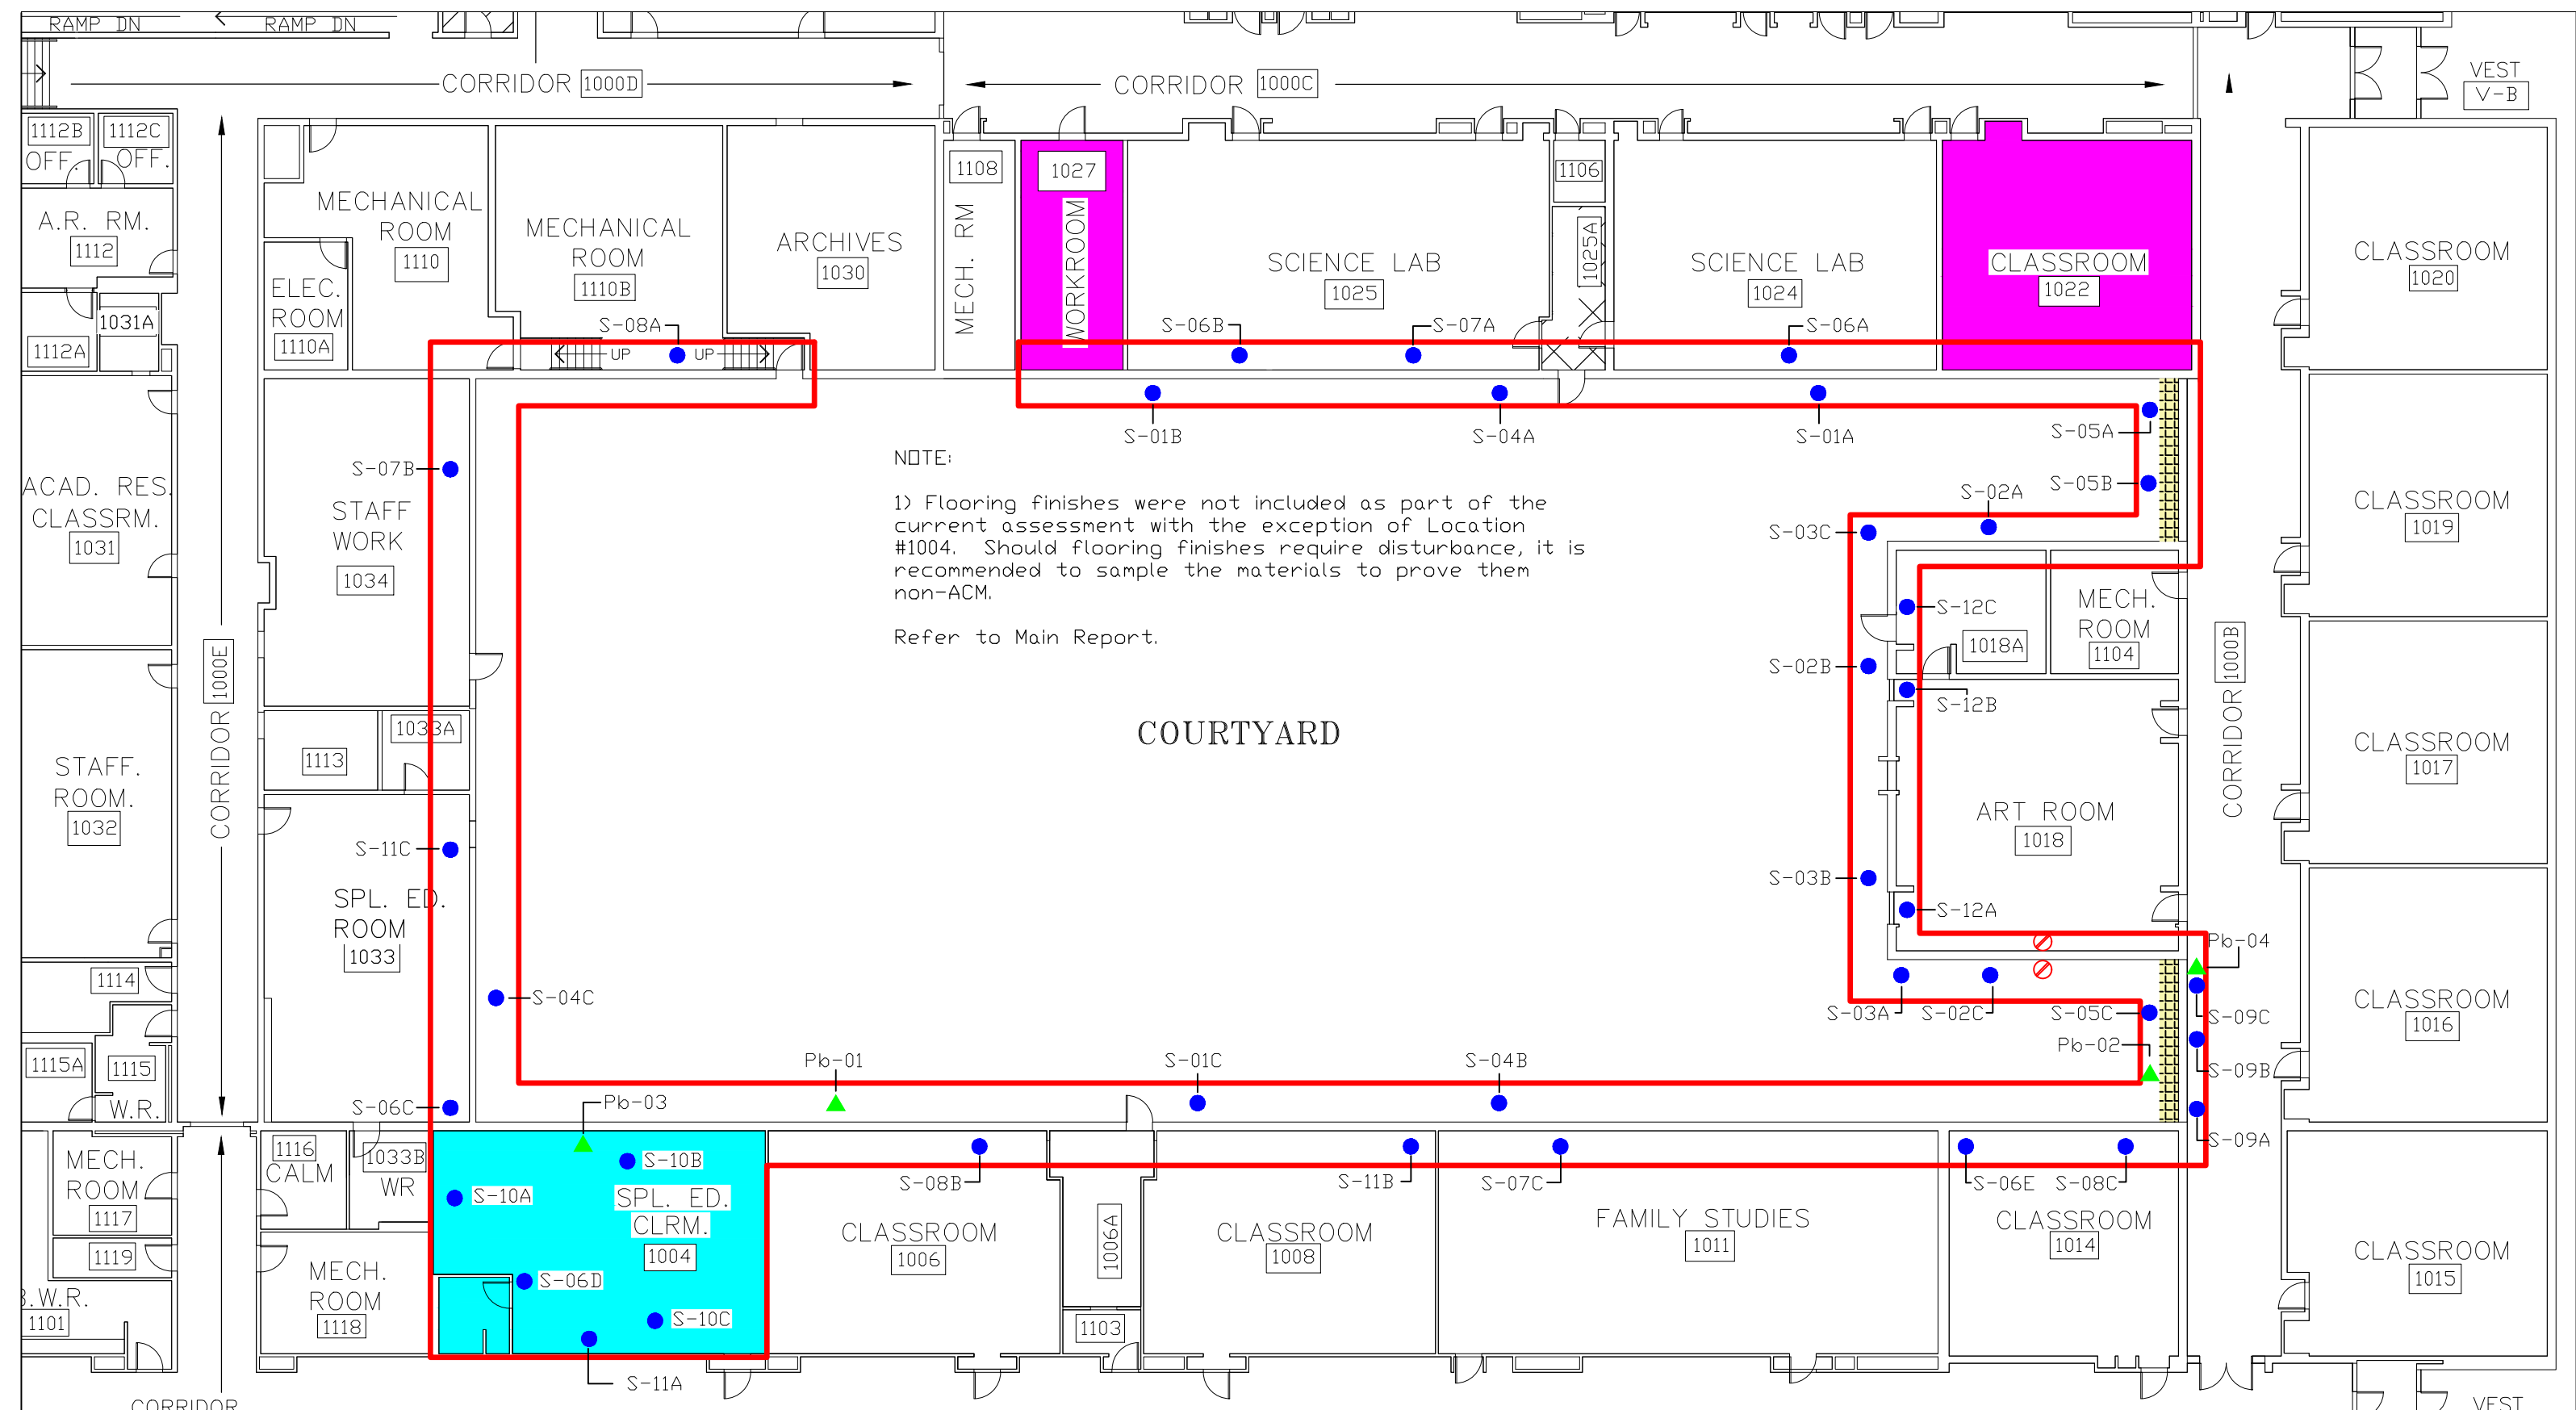
DRAWING NO	DSR-01
SCALE	NTS
DATE	April 11, 2022

NOTE:  
 1) Flooring finishes were not included as part of the current assessment with the exception of Location #1004. Should flooring finishes require disturbance, it is recommended to sample the materials to prove them non-ACM.  
 Refer to Main Report.
