DESIGNATED SUBSTANCES AND HAZARDOUS BUILDING MATERIALS ASSESSMENT REPORT

Demolition Project
1615 Dufferin Street
Toronto, Ontario

Safetech Project Number: 1-3240937

Date of Site Work: December 18, 2024
Date of Issue: January 13, 2025

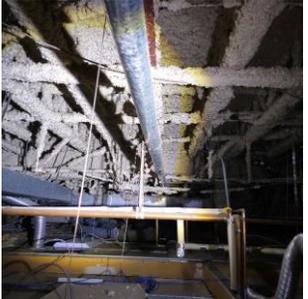
Sprayed and Loose Fill Insulating Materials	Location/Description	
Sprayed Fireproofing	<p>Sprayed fireproofing was observed in the subject building. Based on the existing report the material is considered to be not asbestos-containing.</p> <p>Confirmatory bulk samples were collected during the assessment and results of analysis confirmed that this building material is not asbestos-containing. Refer to sample set 24 in Table 2.</p>

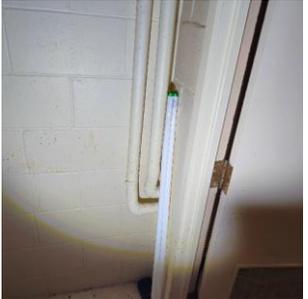
Sprayed Insulation	None identified in subject building.	
Loose Fill / Vermiculite Insulation	None identified in subject building. Interior portions of concrete block walls could not be assessed. However, it is not expected that these walls are insulated with loose fill or vermiculite insulation	
Thermal System Insulation	Location/Description	
Mechanical Pipe Insulation – Straights	Mechanical pipe straight were observed to be either insulated with fiberglass insulation or not insulated.

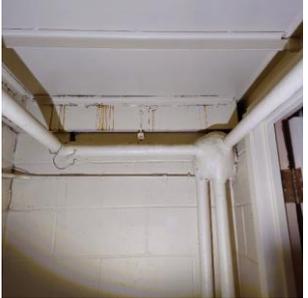
Mechanical Pipe Insulation – Fittings (elbows, valves, tees, hangars, etc.)	Pipe fitting insulation was observed in the subject building. Based on the existing report this building material contains 60% chrysotile asbestos. Refer to the location, condition, friability, and estimated quantity in Appendix A.

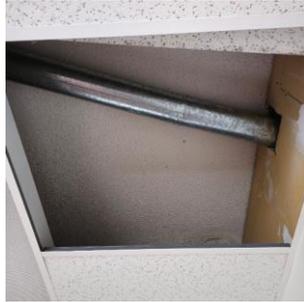
Other Mechanical Equipment Insulation	None identified in subject building.	
Architectural Finishes & Finishing Materials	Location/Description	
Sprayed Texture / Stucco Finishes	<p>Texture Finish on ceilings was observed in the subject building. Based on the existing report this building material contains 3% chrysotile asbestos. Refer to the location, condition, friability, and estimated quantity in Appendix A.</p>

Texture Coat: Analysis of the texture coat indicates that this material contains 1.5% chrysotile asbestos. Therefore, the texture coat is considered to be asbestos-containing and specific measures and procedures are required to be followed during renovation or demolition projects that have the potential to disturb this material. Texture coat identified to be asbestos-containing is recommended to be treated as friable ACM since disturbance of this material typically results in significant degradation and subsequent dust/debris generation that cannot be adequately controlled through wetting. Therefore, removal or disturbance of 1 square metre or less of texture coat should be conducted following Type 2 operations. If more than 1 square metre of texture coat is to be removed or disturbed then work should be conducted following Type 3 operations.

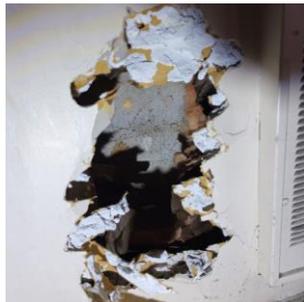
Plaster Finishes	<p>Grey Plaster on Exterior Wall Backing (in wall cavity) was observed in the subject building. Bulk samples were collected during the assessment and results of analysis confirmed that this building material is not asbestos-containing. Refer to sample set 22 in Table 2.</p>

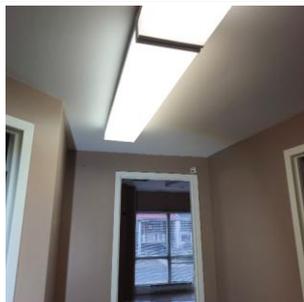
Drywall Joint Compound	<p>Drywall joint compound was observed on drywall walls and ceiling finishes in the subject building. Based on the existing report the material is considered to be not asbestos-containing.</p> <p>Confirmatory bulk samples were collected during the assessment and results of analysis confirmed that this building material is not asbestos-containing. Refer to sample set 23 in Table 2.</p>

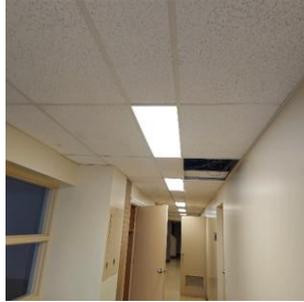
Ceiling Tiles	Location/Description	
Lay-in Acoustic Ceiling Tiles	<p>CT1 - 2'x4' Small Fissures and Pinholes was observed in the subject building. Based on the existing report the material is considered to be not asbestos-containing.</p> <p>Confirmatory bulk samples were collected during the assessment and results of analysis confirmed that this building material is not asbestos-containing. Refer to sample set 44 in Table 2.</p>

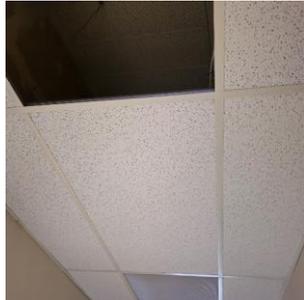
<p>Lay-in Acoustic Ceiling Tiles</p>	<p>2'x4' Small Fissures and Pinholes was observed in the subject building. Based on the date stamp (06/21/05) observed on the back of the ceiling tiles, the tiles are expected to be not asbestos-containing.</p>

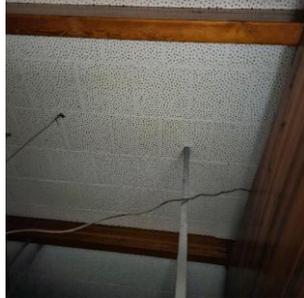
<p>Glued-on Acoustic Ceiling Tiles</p>	<p>1'x1' ceiling tile – medium and large pinholes were observed in the subject building. Bulk samples were collected during the assessment and results of analysis confirmed that this building material is not asbestos-containing. Refer to sample set 1 in Table 2.</p>

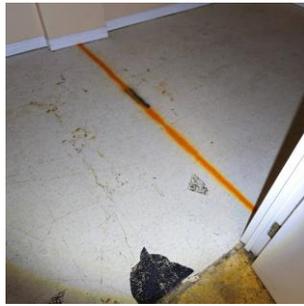
Vinyl Floor Tiles	<p>VFT10 - 12"x12" White with Grey Smudges was observed in the subject building. Based on the existing report the material is considered to be not asbestos-containing.</p> <p>Confirmatory bulk samples were collected during the assessment and results of analysis confirmed that this building material is not asbestos-containing. Refer to sample set 26 in Table 2.</p>

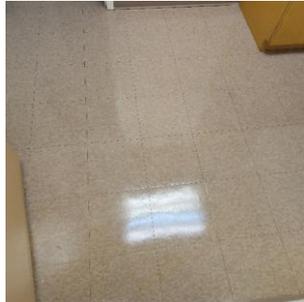
<p>VFT3 - 12"x12" Pink with Light Pink and Dark Pink Smudges was observed in the subject building. Based on the existing report the material is considered to be not asbestos-containing.</p> <p>Confirmatory bulk samples were collected during the assessment and results of analysis confirmed that this building material is not asbestos-containing. Refer to sample set 28 in Table 2.</p>

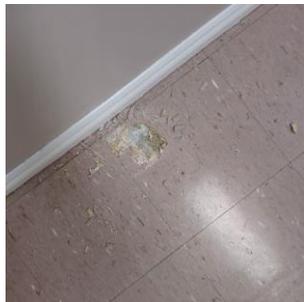
<p>Underlying Beige Vinyl Floor Tiles were observed in the subject building. Bulk samples were collected during the assessment and results of analysis confirmed that this building material is not asbestos-containing. Refer to sample set 29 in Table 2.</p>

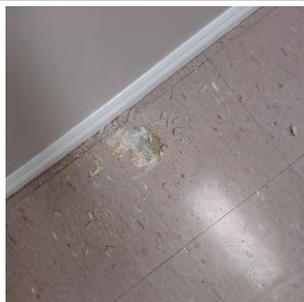
<p>VFT5 - 12"x12" Purple with White and Dark Purple Smudges was observed in the subject building. Based on the existing report the material is considered to be not asbestos-containing.</p> <p>Confirmatory bulk samples were collected during the assessment and results of analysis confirmed that this building material is not asbestos-containing. Refer to sample set 30 in Table 2.</p>

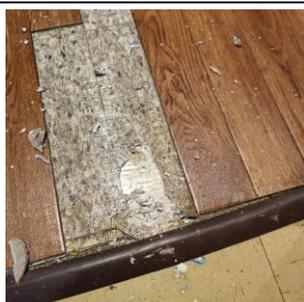
<p>Underlying White Vinyl Floor Tiles (Bottom Layer) were observed in the subject building. Bulk samples were collected during the assessment and results of analysis confirmed that this building material is not asbestos-containing. Refer to sample set 33 in Table 2.</p>

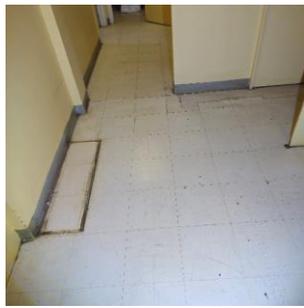
Vinyl Floor Tiles	<p>FT9 - 12"x12" White with Blue Streaks was observed in the subject building. Based on the existing report the material is considered to be not asbestos-containing.</p> <p>Confirmatory bulk samples were collected during the assessment and results of analysis confirmed that this building material is not asbestos-containing. Refer to sample set 35 in Table 2.</p>

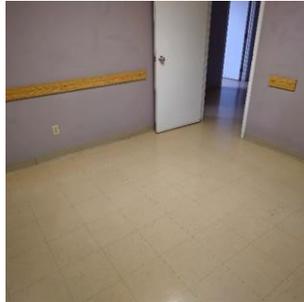
<p>VFT4 - 12"x12" Beige with White and Brown Smudges was observed in the subject building. Based on the existing report the material is considered to be not asbestos-containing.</p> <p>Confirmatory bulk samples were collected during the assessment and results of analysis confirmed that this building material is not asbestos-containing. Refer to sample set 37 in Table 2.</p>

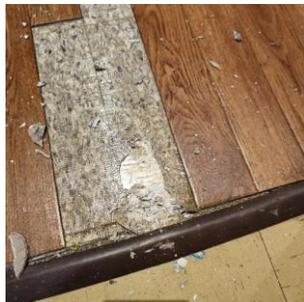
<p>VFT1 - 12"x12" Brown with White and Black Smudges (Under Wood Floor)was observed in the subject building. Based on the existing report the material is considered to be not asbestos-containing.</p> <p>Confirmatory bulk samples were collected during the assessment and results of analysis confirmed that this building material is not asbestos-containing. Refer to sample set 39 in Table 2.</p>

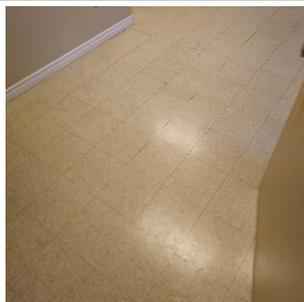
<p>VFT11 - 12"x12" White and Brown Smudges was observed in the subject building. Based on the existing report the material is considered to be not asbestos-containing.</p> <p>Confirmatory bulk samples were collected during the assessment and results of analysis confirmed that this building material is not asbestos-containing. Refer to sample set 41 in Table 2.</p>

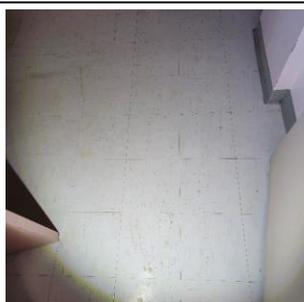
<p>VFT8 - 12"x12" Off-white with Blue Streaks was observed in the subject building. Based on the existing report the material is considered to be not asbestos-containing.</p> <p>Confirmatory bulk samples were collected during the assessment and results of analysis confirmed that this building material is not asbestos-containing. Refer to sample set 43 in Table 2.</p>

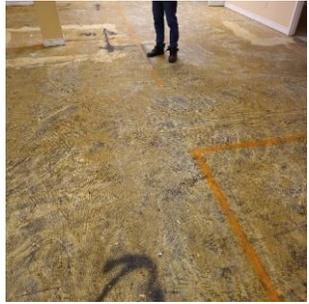
<p>Yellow Floor Mastic was observed in the subject building. Based on the existing report this building material contains 1% chrysotile asbestos. Refer to the location, condition, friability, and estimated quantity in Appendix A.</p>

Non-Friable: The caulking, vinyl floor tiles and mastic associated with vinyl floor tiles considered to be a non-friable ACM. As per O. Reg. 278/05, removal of non-friable ACM can be conducted following Type 1 operations; as long as the material can be removed without being broken, cut, drilled or otherwise similarly disturbed. If the material cannot be removed without it breaking or being similarly disturbed then the work should be conducted using non-powered hand tools and the material should be wetted to control the spread of dust. If the material cannot be wetted or if power tools attached to dust-collecting devices equipped with HEPA (high efficiency particulate aerosol) filters are used during removal or disturbance, then work should be performed following Type 2 operations. If non-friable materials are removed or disturbed using power tools that are not attached to dust-collecting devices that are equipped with HEPA filters then work should be conducted following Type 3 operations.

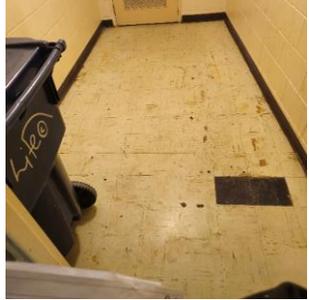
<p>Black Mastic on 9"x9" Vinyl Floor Tiles was observed in the subject building. Bulk samples were collected during the assessment and results of analysis confirmed that this building material contains 2% chrysotile asbestos. Refer to sample set 25 in Table 2 and the location, condition, friability, and estimated quantity in Appendix A.</p>

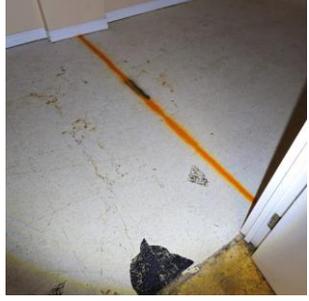
<p>Mastic</p>	<p>Black Mastic on Sample Set 26 was observed in the subject building. Bulk samples were collected during the assessment and results of analysis confirmed that this building material contains 1% chrysotile asbestos. Refer to sample set 27 in Table 2 and the location, condition, friability, and estimated quantity in Appendix A.</p>

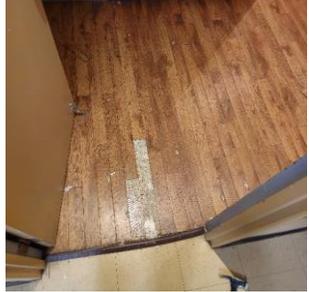
<p>Yellow Mastic on Sample Set 33 was observed in the subject building. Bulk samples were collected during the assessment and results of analysis confirmed that this building material is not asbestos-containing. Refer to sample set 34 in Table 2.</p>

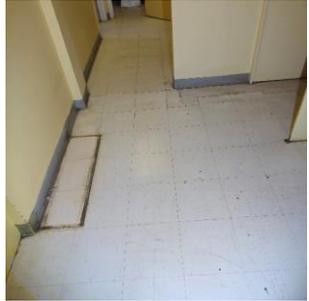
<p>Black Mastic on Sample Set 35 was observed in the subject building. Bulk samples were collected during the assessment and results of analysis confirmed that this building material is not asbestos-containing. Refer to sample set 36 in Table 2.</p>

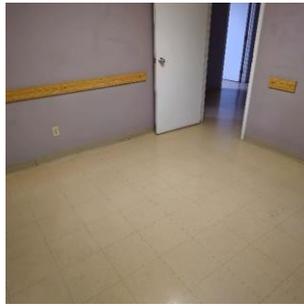
Mastic	<p>Black Mastic on Sample Set 37 was observed in the subject building. Bulk samples were collected during the assessment and results of analysis confirmed that this building material contains 3% chrysotile asbestos. Refer to sample set 38 in Table 2 and the location, condition, friability, and estimated quantity in Appendix A.</p>

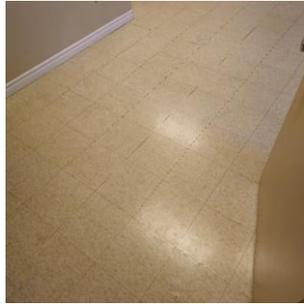
<p>Yellow Mastic on Sample Set 41 was observed in the subject building. Bulk samples were collected during the assessment and results of analysis confirmed that this building material is not asbestos-containing. Refer to sample set 42 in Table 2.</p>

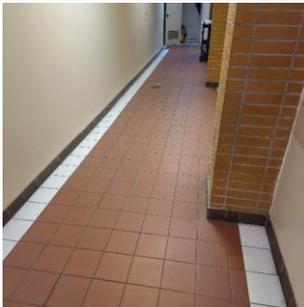
Asbestos Cement Products	Location/Description	
Piping	None identified in subject area.	
Roofing, Siding, Wallboard	None identified in subject building.	
Other Cement Products	<p>Mortarbed on Red Ceramic Floor Tiles was observed in the subject building. Bulk samples were collected during the assessment and results of analysis confirmed that this building material is not asbestos-containing. Refer to sample set 2 in Table 2.</p> <p>Black mastic under mortar associated with ceramic floor tiles was identified to 1% chrysotile asbestos.</p>

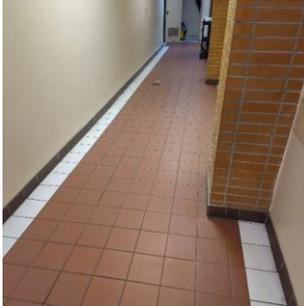
<p>Grout on Red Ceramic Floor Tiles was observed in the subject building. Bulk samples were collected during the assessment and results of analysis confirmed that this building material is not asbestos-containing. Refer to sample set 3 in Table 2.</p>

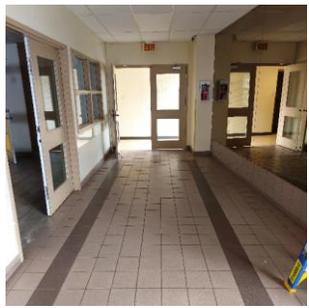
Other Cement Products	<p>Mortarbed on Ceramic Floor Tiles was observed in the subject building. Bulk samples were collected during the assessment and results of analysis confirmed that this building material is not asbestos-containing. Refer to sample set 4 in Table 2.</p>

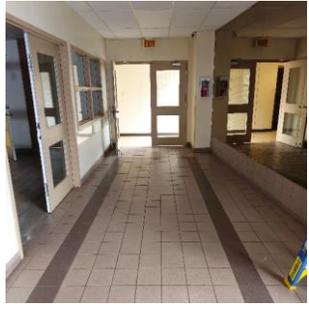
<p>Grout on Ceramic Floor Tiles was observed in the subject building. Bulk samples were collected during the assessment and results of analysis confirmed that this building material is not asbestos-containing. Refer to sample set 5 in Table 2.</p>

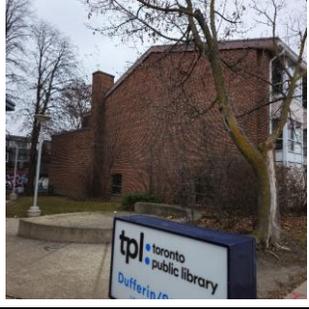
<p>Brick Mortar was observed in the subject building. Bulk samples were collected during the assessment and results of analysis confirmed that this building material is not asbestos-containing. Refer to sample set 6 in Table 2.</p>

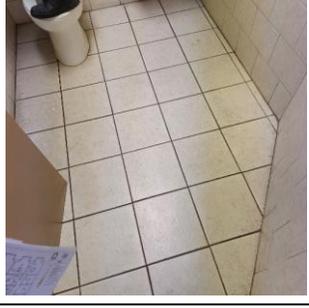
<p>Mortarbed on White Ceramic Floor Tiles was observed in the subject building. Bulk samples were collected during the assessment and results of analysis confirmed that this building material is not asbestos-containing. Refer to sample set 7 in Table 2.</p>

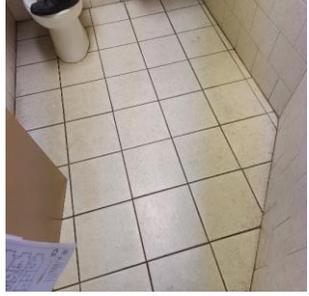
<p>Grout on White Ceramic Floor Tiles was observed in the subject building. Bulk samples were collected during the assessment and results of analysis confirmed that this building material is not asbestos-containing. Refer to sample set 8 in Table 2.</p>

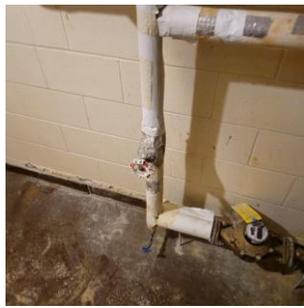
Other Cement Products	<p>Concrete Block Mortar was observed in the subject building. Bulk samples were collected during the assessment and results of analysis confirmed that this building material is not asbestos-containing. Refer to sample set 15 in Table 2.</p>

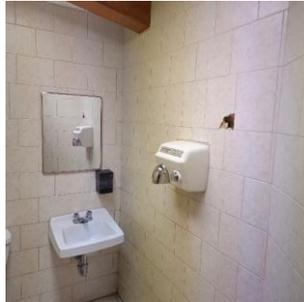
<p>Mastic on Ceramic Wall Tiles was observed in the subject building. Bulk samples were collected during the assessment and results of analysis confirmed that this building material is not asbestos-containing. Refer to sample set 31 in Table 2.</p>

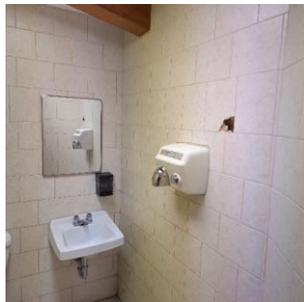
<p>Grout Ceramic Wall Tiles was observed in the subject building. Bulk samples were collected during the assessment and results of analysis confirmed that this building material is not asbestos-containing. Refer to sample set 32 in Table 2.</p>

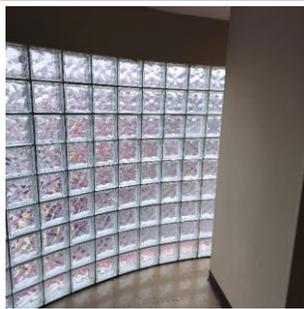
<p>Glass Block Mortar was observed in the subject building. Bulk samples were collected during the assessment and results of analysis confirmed that this building material is not asbestos-containing. Refer to sample set 40 in Table 2.</p>

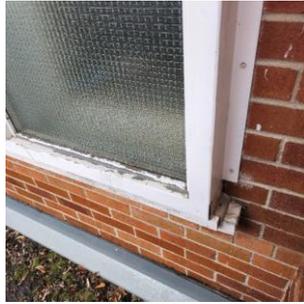
<p>Black Caulking was observed in the subject building. Bulk samples were collected during the assessment and results of analysis confirmed that this building material is not asbestos-containing. Refer to sample set 16 in Table 2.</p>

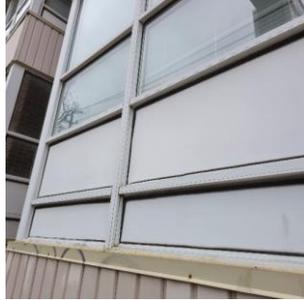
Caulking	<p>Grey/Black Caulking Window Glass was observed in the subject building. Bulk samples were collected during the assessment and results of analysis confirmed that this building material contains 3% chrysotile asbestos. Refer to sample set 17 in Table 2 and the location, condition, friability, and estimated quantity in Appendix A.</p>

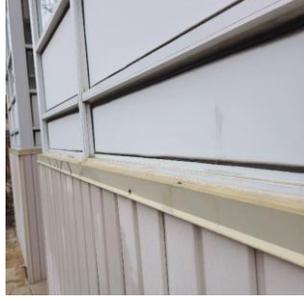
<p>White Window Caulking was observed in the subject building. Bulk samples were collected during the assessment and results of analysis confirmed that this building material is not asbestos-containing. Refer to sample set 18 in Table 2.</p>

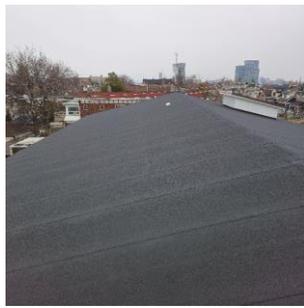
<p>Roof Membrane (Capsheet) were observed in the subject building. Bulk samples were collected during the assessment and results of analysis confirmed that this building material is not asbestos-containing. Refer to sample set 10 in Table 2.</p>

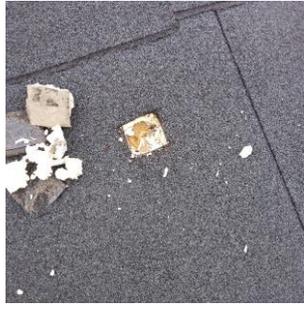
Roof Membrane	<p>Vapour Barrier/Craft Paper were observed in the subject building. Bulk samples were collected during the assessment and results of analysis confirmed that this building material is not asbestos-containing. Refer to sample set 11 in Table 2.</p>

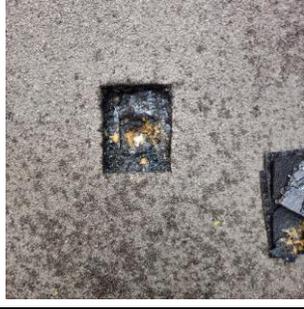
<p>Roof Membrane (Capsheet) – New were observed in the subject building. Bulk samples were collected during the assessment and results of analysis confirmed that this building material is not asbestos-containing. Refer to sample set 12 in Table 2.</p>

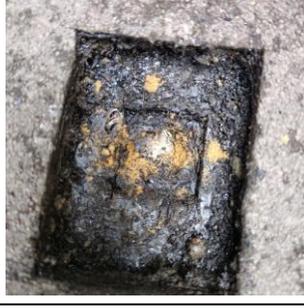
<p>Roof Felt – Old /Underlying were observed in the subject building. Bulk samples were collected during the assessment and results of analysis confirmed that this building material is not asbestos-containing. Refer to sample set 13 in Table 2.</p>

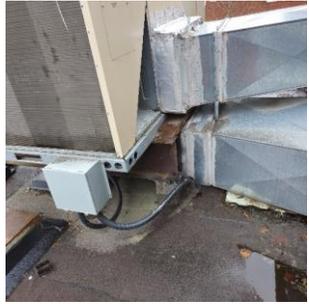
Mastic	Grey Mastic on Duct were observed in the subject building. Bulk samples were collected during the assessment and results of analysis confirmed that this building material is not asbestos-containing. Refer to sample set 20 in Table 2.

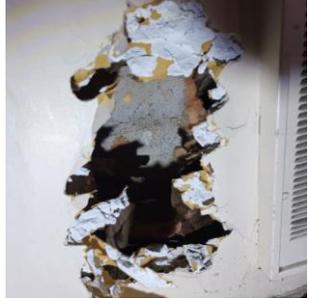
Misc. Materials	Location/Description	
Building Paper	Black Building Paper in Wall Cavity were observed in the subject building. Bulk samples were collected during the assessment and results of analysis confirmed that this building material is not asbestos-containing. Refer to sample set 21 in Table 2.

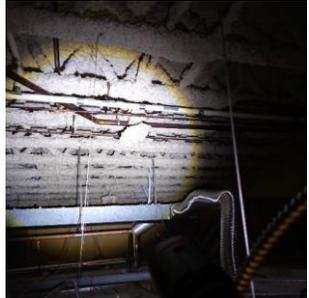
Heat Shield	Heat Shield on light fixture was observed in the subject building. Based on the existing report this building material contains 70% chrysotile asbestos. Refer to the location, condition, friability, and estimated quantity in Appendix A.

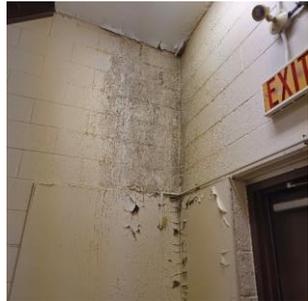
2-23 Stairwell	
<p>Findings:</p> <ul style="list-style-type: none"> Water damage and mould growth was observed to drywall ceiling and drywall wall and concrete block wall by the door.
