**TSSS DUFFERIN**

1615 DUFFERIN ST  
TORONTO, ON

**SPECIFICATIONS  
DEMOLITION SCOPE**

Designated Substances and Hazardous Building Materials Assessment Report, dated 13 January 2025, prepared by Safetech Environmental Ltd., Project No. 1-3240937 (90 pages)

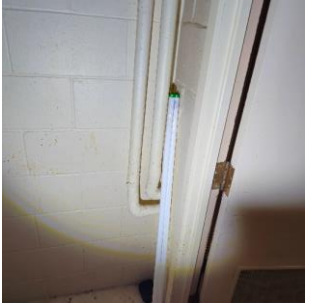
Mechanical Pipe Insulation – Fittings (elbows, valves, tees, hangars, etc.)	<b>Pipe fitting insulation</b> was observed in the subject building. Based on the existing report this building material contains <b>60% chrysotile</b> asbestos. Refer to the location, condition, friability, and estimated quantity in Appendix A.

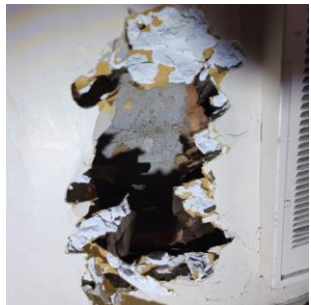
Drywall Joint Compound	<p>Drywall joint compound was observed on drywall walls and ceiling finishes in the subject building. Based on the existing report the material is considered to be not asbestos-containing.</p> <p>Confirmatory bulk samples were collected during the assessment and results of analysis confirmed that this building material is not asbestos-containing. Refer to sample set 23 in Table 2.</p>

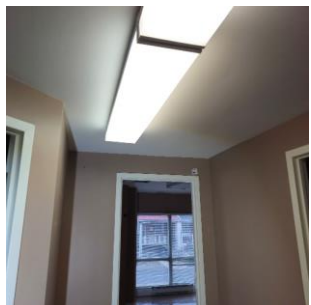
<b>Ceiling Tiles</b>	<b>Location/Description</b>	
Lay-in Acoustic Ceiling Tiles	<p>CT1 - 2'x4' Small Fissures and Pinholes was observed in the subject building. Based on the existing report the material is considered to be not asbestos-containing.</p> <p>Confirmatory bulk samples were collected during the assessment and results of analysis confirmed that this building material is not asbestos-containing. Refer to sample set 44 in Table 2.</p>

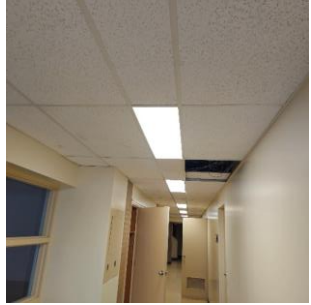
<p>Lay-in Acoustic Ceiling Tiles</p>	<p>2'x4' Small Fissures and Pinholes was observed in the subject building. Based on the date stamp (06/21/05) observed on the back of the ceiling tiles, the tiles are expected to be not asbestos-containing.</p>

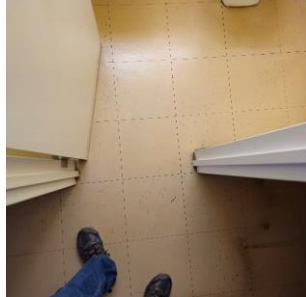
<p><b>Vinyl Floor Tile 6 - 9"x9" Grey with Green Streaks</b> was observed in the subject building. Based on the existing report this building material contains <b>5% chrysotile</b> asbestos. Refer to the location, condition, friability, and estimated quantity in Appendix A.</p>

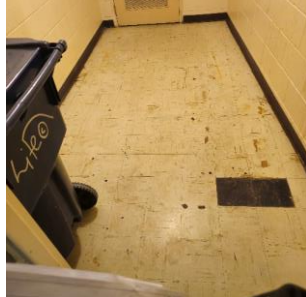
Vinyl Floor Tiles	<p>VFT10 - 12"x12" White with Grey Smudges was observed in the subject building. Based on the existing report the material is considered to be not asbestos-containing.</p> <p>Confirmatory bulk samples were collected during the assessment and results of analysis confirmed that this building material is not asbestos-containing. Refer to sample set 26 in Table 2.</p>	 
	<p>VFT3 - 12"x12" Pink with Light Pink and Dark Pink Smudges was observed in the subject building. Based on the existing report the material is considered to be not asbestos-containing.</p> <p>Confirmatory bulk samples were collected during the assessment and results of analysis confirmed that this building material is not asbestos-containing. Refer to sample set 28 in Table 2.</p>

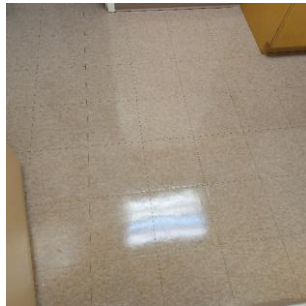
<p>Underlying Beige Vinyl Floor Tiles were observed in the subject building. Bulk samples were collected during the assessment and results of analysis confirmed that this building material is not asbestos-containing. Refer to sample set 29 in Table 2.</p>

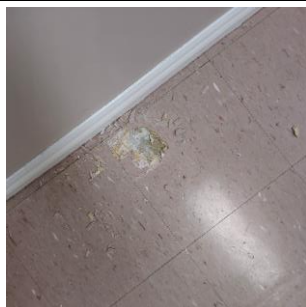
<p>VFT5 - 12"x12" Purple with White and Dark Purple Smudges was observed in the subject building. Based on the existing report the material is considered to be not asbestos-containing.</p> <p>Confirmatory bulk samples were collected during the assessment and results of analysis confirmed that this building material is not asbestos-containing. Refer to sample set 30 in Table 2.</p>

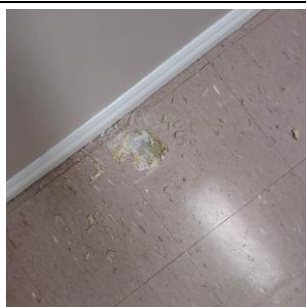
<p>Underlying White Vinyl Floor Tiles (Bottom Layer) were observed in the subject building. Bulk samples were collected during the assessment and results of analysis confirmed that this building material is not asbestos-containing. Refer to sample set 33 in Table 2.</p>

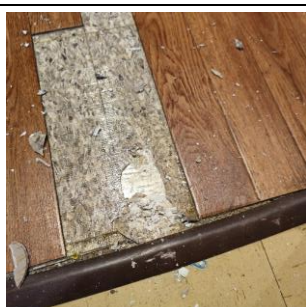
Vinyl Floor Tiles	<p>FT9 - 12"x12" White with Blue Streaks was observed in the subject building. Based on the existing report the material is considered to be not asbestos-containing.</p> <p>Confirmatory bulk samples were collected during the assessment and results of analysis confirmed that this building material is not asbestos-containing. Refer to sample set 35 in Table 2.</p>

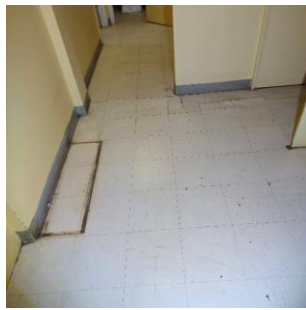
<p>VFT4 - 12"x12" Beige with White and Brown Smudges was observed in the subject building. Based on the existing report the material is considered to be not asbestos-containing.</p> <p>Confirmatory bulk samples were collected during the assessment and results of analysis confirmed that this building material is not asbestos-containing. Refer to sample set 37 in Table 2.</p>

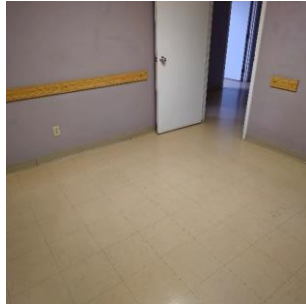
<p>VFT1 - 12"x12" Brown with White and Black Smudges (Under Wood Floor )was observed in the subject building. Based on the existing report the material is considered to be not asbestos-containing.</p> <p>Confirmatory bulk samples were collected during the assessment and results of analysis confirmed that this building material is not asbestos-containing. Refer to sample set 39 in Table 2.</p>

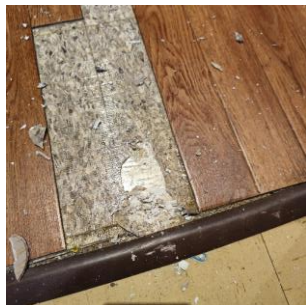
<p>VFT11 - 12"x12" White and Brown Smudges was observed in the subject building. Based on the existing report the material is considered to be not asbestos-containing.</p> <p>Confirmatory bulk samples were collected during the assessment and results of analysis confirmed that this building material is not asbestos-containing. Refer to sample set 41 in Table 2.</p>

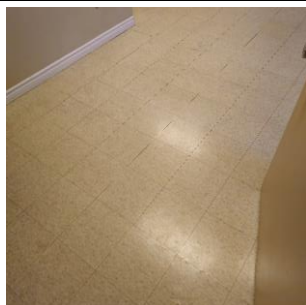
<p>VFT8 - 12"x12" Off-white with Blue Streaks was observed in the subject building. Based on the existing report the material is considered to be not asbestos-containing.</p> <p>Confirmatory bulk samples were collected during the assessment and results of analysis confirmed that this building material is not asbestos-containing. Refer to sample set 43 in Table 2.</p>

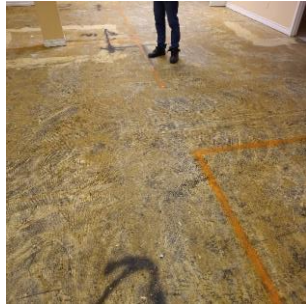
<p><b>Black Mastic on 9"x9" Vinyl Floor Tiles</b> was observed in the subject building. Bulk samples were collected during the assessment and results of analysis confirmed that this building material contains <b>2% chrysotile</b> asbestos. Refer to sample set 25 in Table 2 and the location, condition, friability, and estimated quantity in Appendix A.</p>

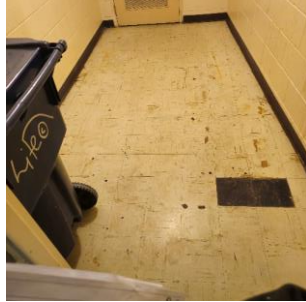
<p>Mastic</p>	<p><b>Black Mastic on Sample Set 26</b> was observed in the subject building. Bulk samples were collected during the assessment and results of analysis confirmed that this building material contains <b>1% chrysotile</b> asbestos. Refer to sample set 27 in Table 2 and the location, condition, friability, and estimated quantity in Appendix A.</p>

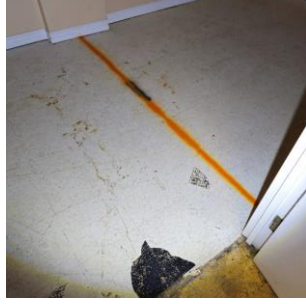
<p>Yellow Mastic on Sample Set 33 was observed in the subject building. Bulk samples were collected during the assessment and results of analysis confirmed that this building material is not asbestos-containing. Refer to sample set 34 in Table 2.</p>

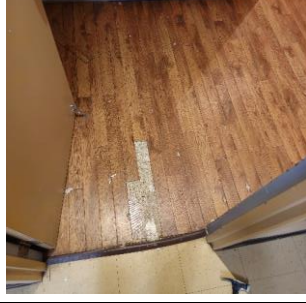
<p>Black Mastic on Sample Set 35 was observed in the subject building. Bulk samples were collected during the assessment and results of analysis confirmed that this building material is not asbestos-containing. Refer to sample set 36 in Table 2.</p>

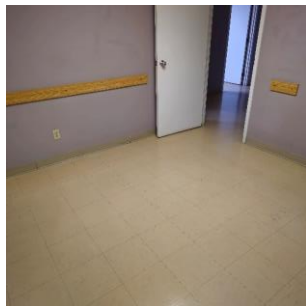
<p>Yellow Mastic on Sample Set 41 was observed in the subject building. Bulk samples were collected during the assessment and results of analysis confirmed that this building material is not asbestos-containing. Refer to sample set 42 in Table 2.</p>

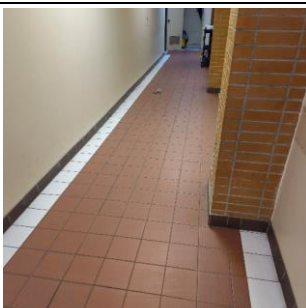
<p>Grout on Red Ceramic Floor Tiles was observed in the subject building. Bulk samples were collected during the assessment and results of analysis confirmed that this building material is not asbestos-containing. Refer to sample set 3 in Table 2.</p>

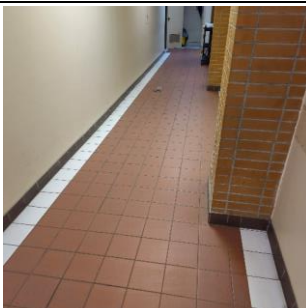
Other Cement Products	<p>Mortarbed on Ceramic Floor Tiles was observed in the subject building. Bulk samples were collected during the assessment and results of analysis confirmed that this building material is not asbestos-containing. Refer to sample set 4 in Table 2.</p>

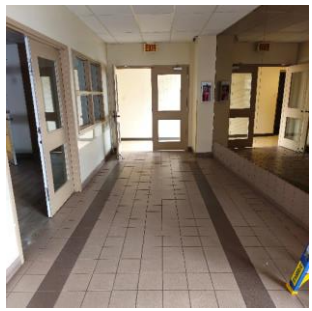
<p>Grout on Ceramic Floor Tiles was observed in the subject building. Bulk samples were collected during the assessment and results of analysis confirmed that this building material is not asbestos-containing. Refer to sample set 5 in Table 2.</p>

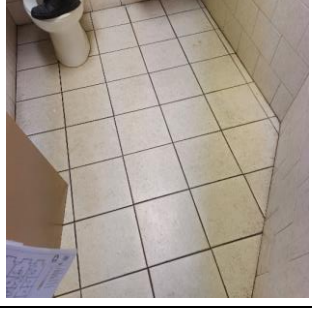
<p>Grout on White Ceramic Floor Tiles was observed in the subject building. Bulk samples were collected during the assessment and results of analysis confirmed that this building material is not asbestos-containing. Refer to sample set 8 in Table 2.</p>

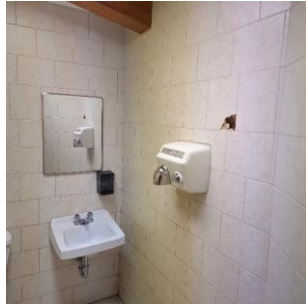
<p>Grout Ceramic Wall Tiles was observed in the subject building. Bulk samples were collected during the assessment and results of analysis confirmed that this building material is not asbestos-containing. Refer to sample set 32 in Table 2.</p>

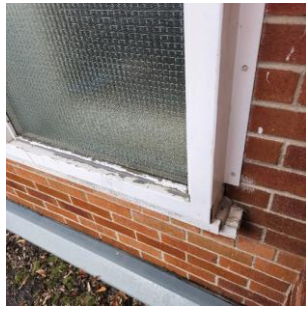
<p><b>Grey/Black Caulking Window Glass</b> was observed in the subject building. Bulk samples were collected during the assessment and results of analysis confirmed that this building material contains <b>3% chrysotile</b> asbestos. Refer to sample set 17 in Table 2 and the location, condition, friability, and estimated quantity in Appendix A.</p>

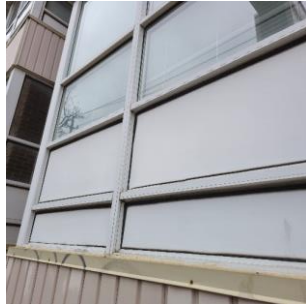
<p>White Window Caulking was observed in the subject building. Bulk samples were collected during the assessment and results of analysis confirmed that this building material is not asbestos-containing. Refer to sample set 18 in Table 2.</p>

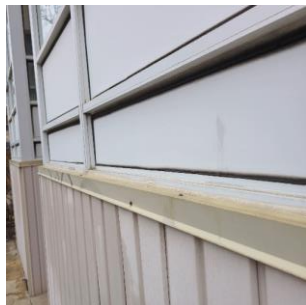
<p><b>Beige Caulking</b> was observed in the subject building. Bulk samples were collected during the assessment and results of analysis confirmed that this building material contains <b>0.5% chrysotile</b> asbestos. Refer to sample set 19 in Table 2 and the location, condition, friability, and estimated quantity in Appendix A.</p>

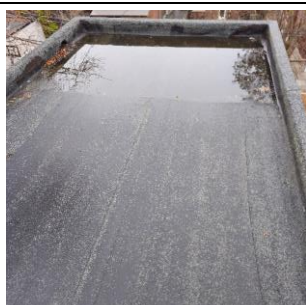
<p>Roof Membrane (Capsheet) were observed in the subject building. Bulk samples were collected during the assessment and results of analysis confirmed that this building material is not asbestos-containing. Refer to sample set 10 in Table 2.</p>

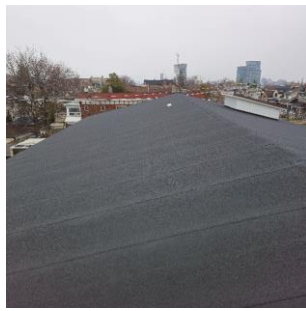
Roof Membrane	<p>Vapour Barrier/Craft Paper were observed in the subject building. Bulk samples were collected during the assessment and results of analysis confirmed that this building material is not asbestos-containing. Refer to sample set 11 in Table 2.</p>

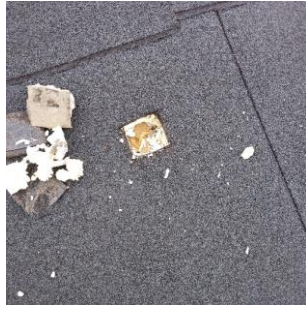
<p>Roof Membrane (Capsheet) – New were observed in the subject building. Bulk samples were collected during the assessment and results of analysis confirmed that this building material is not asbestos-containing. Refer to sample set 12 in Table 2.</p>

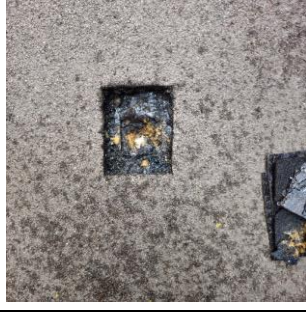
<p>Roof Felt – Old /Underlying were observed in the subject building. Bulk samples were collected during the assessment and results of analysis confirmed that this building material is not asbestos-containing. Refer to sample set 13 in Table 2.</p>

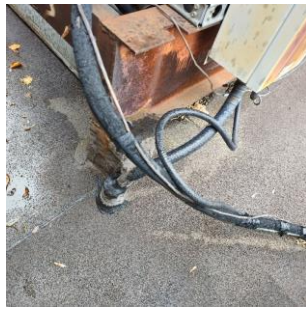
Mastic	<p>Black Mastic were observed in the subject building. Bulk samples were collected during the assessment and results of analysis confirmed that this building material is not asbestos-containing. Refer to sample set 14 in Table 2.</p>
