Hazardous Building Materials Assessment (Pre-construction)

Scotiabank Hall
1812 Sir Isaac Brock Way, St.
Catharines, Ontario

January 21, 2025

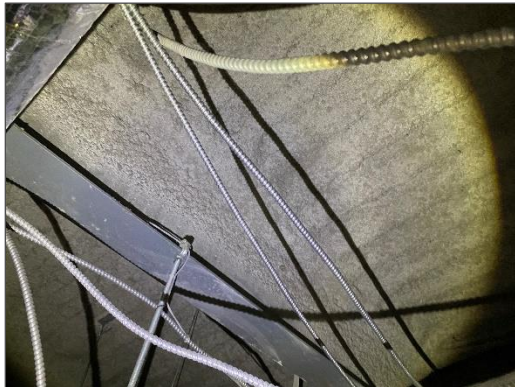
Photo 1

Spray-applied fireproofing and overspray present on the structure and roof decking above ceiling does not contain asbestos based on the date of construction (2002; Photo 1).

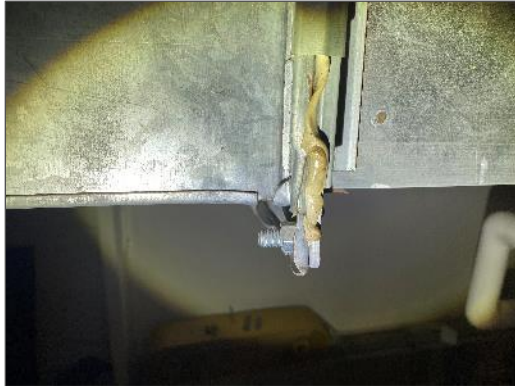
Photo 1

Grey duct mastic present at seams / joints on the exterior of ducts in the Mechanical Room (Location 15) does not contain asbestos (samples S0002A-C; Photo 1).

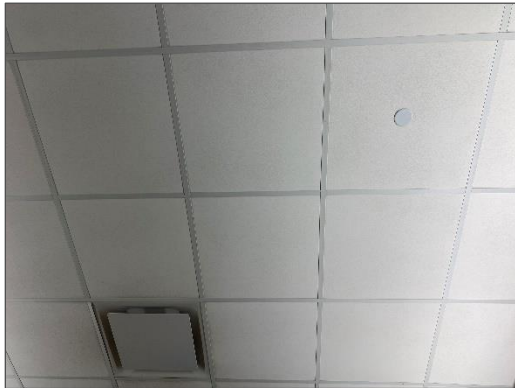
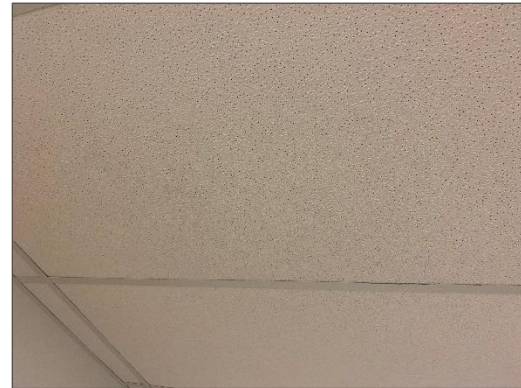
Ceiling tiles are presumed to be non-asbestos based on the age of the materials determined from the age of the building construction (2002; Photos 1 – 2). The tiles were manufactured after asbestos stopped being used in acoustic ceiling tiles.

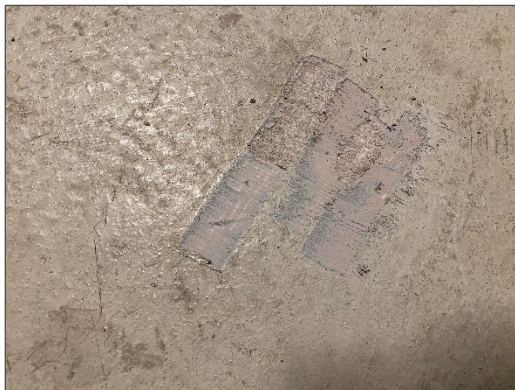
Photo 1

Levelling compound present in the Mechanical Room (Location 15), does not contain asbestos (samples S0003A-C; Photo 1).

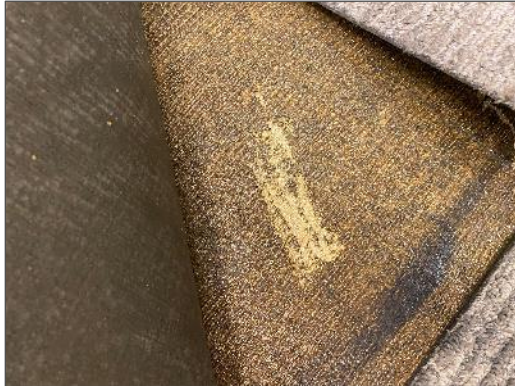
Photo 1

Yellow/grey carpet mastic found below carpet tile throughout the assessed area does not contain asbestos (samples S0001A-C; Photo 1).

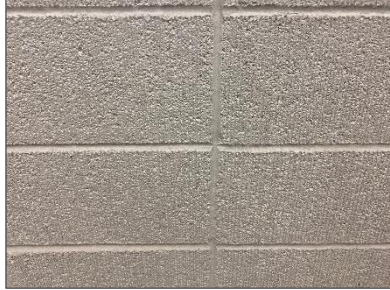
Sample Number	Colour, Substrate Description	Sample Location	Lead (%)	Photo
L0001	Light blue/grey paint on concrete block wall	Classroom and Offices (Location 8)	0.00077

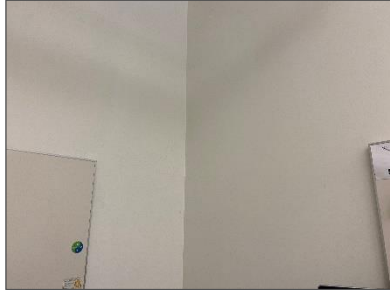
L0002	White paint on drywall	Classroom and Offices (Location 8)	0.00030

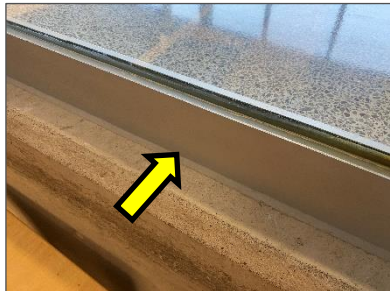
L0003	Dark grey paint on door and window frames	Computer Lab (Location 6)	0.070

Results less than or equal to 0.1% (1,000 mg/kg), but equal to or greater than 0.009% (90 mg/kg), are considered low-level lead paints or surface coatings in accordance with the EACC guideline.

For paints identified as having low levels of lead (i.e., equal to or above 0.009% (90 mg/kg) but less than or equal to the EACC guideline of 0.1% (1,000 mg/kg) for lead-containing paints) special precautions are not recommended unless aggressive disturbance (grinding, blasting, torching) is planned. Exposure from construction disturbance of paints containing lead less than 0.009% (90 mg/kg) is assumed to be insignificant.

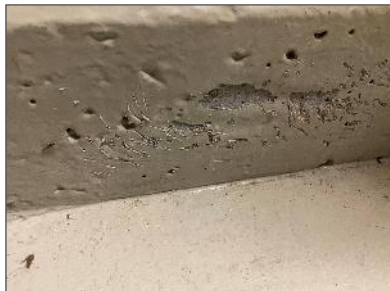
L0004	Grey paint on poured concrete floor	Mechanical Rooms and Vestibule (Location 15)	<0.00027

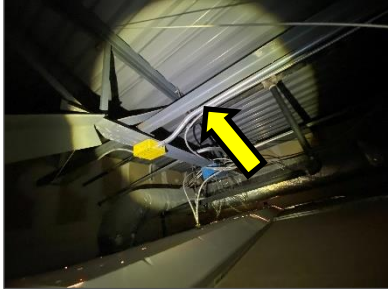
Sample Number	Colour, Substrate Description	Sample Location	Lead (%)	Photo
V9500	Grey paint/primer on steel structure	Office Area (Location 14)	Presumed

Items painted with paints containing elevated levels of lead may be a hazardous waste. Test lead-painted materials for leachable lead and other metals prior to disposal. Metallic components coated with lead paint do not require leachate testing and can be disposed of as non-hazardous construction and demolition (C&D) waste.
