Limited Designated Substance Survey Report

Ajax High School

105 Bayly Street East, Ajax, Ontario

November 29, 2024
Parasol Project No: 13260

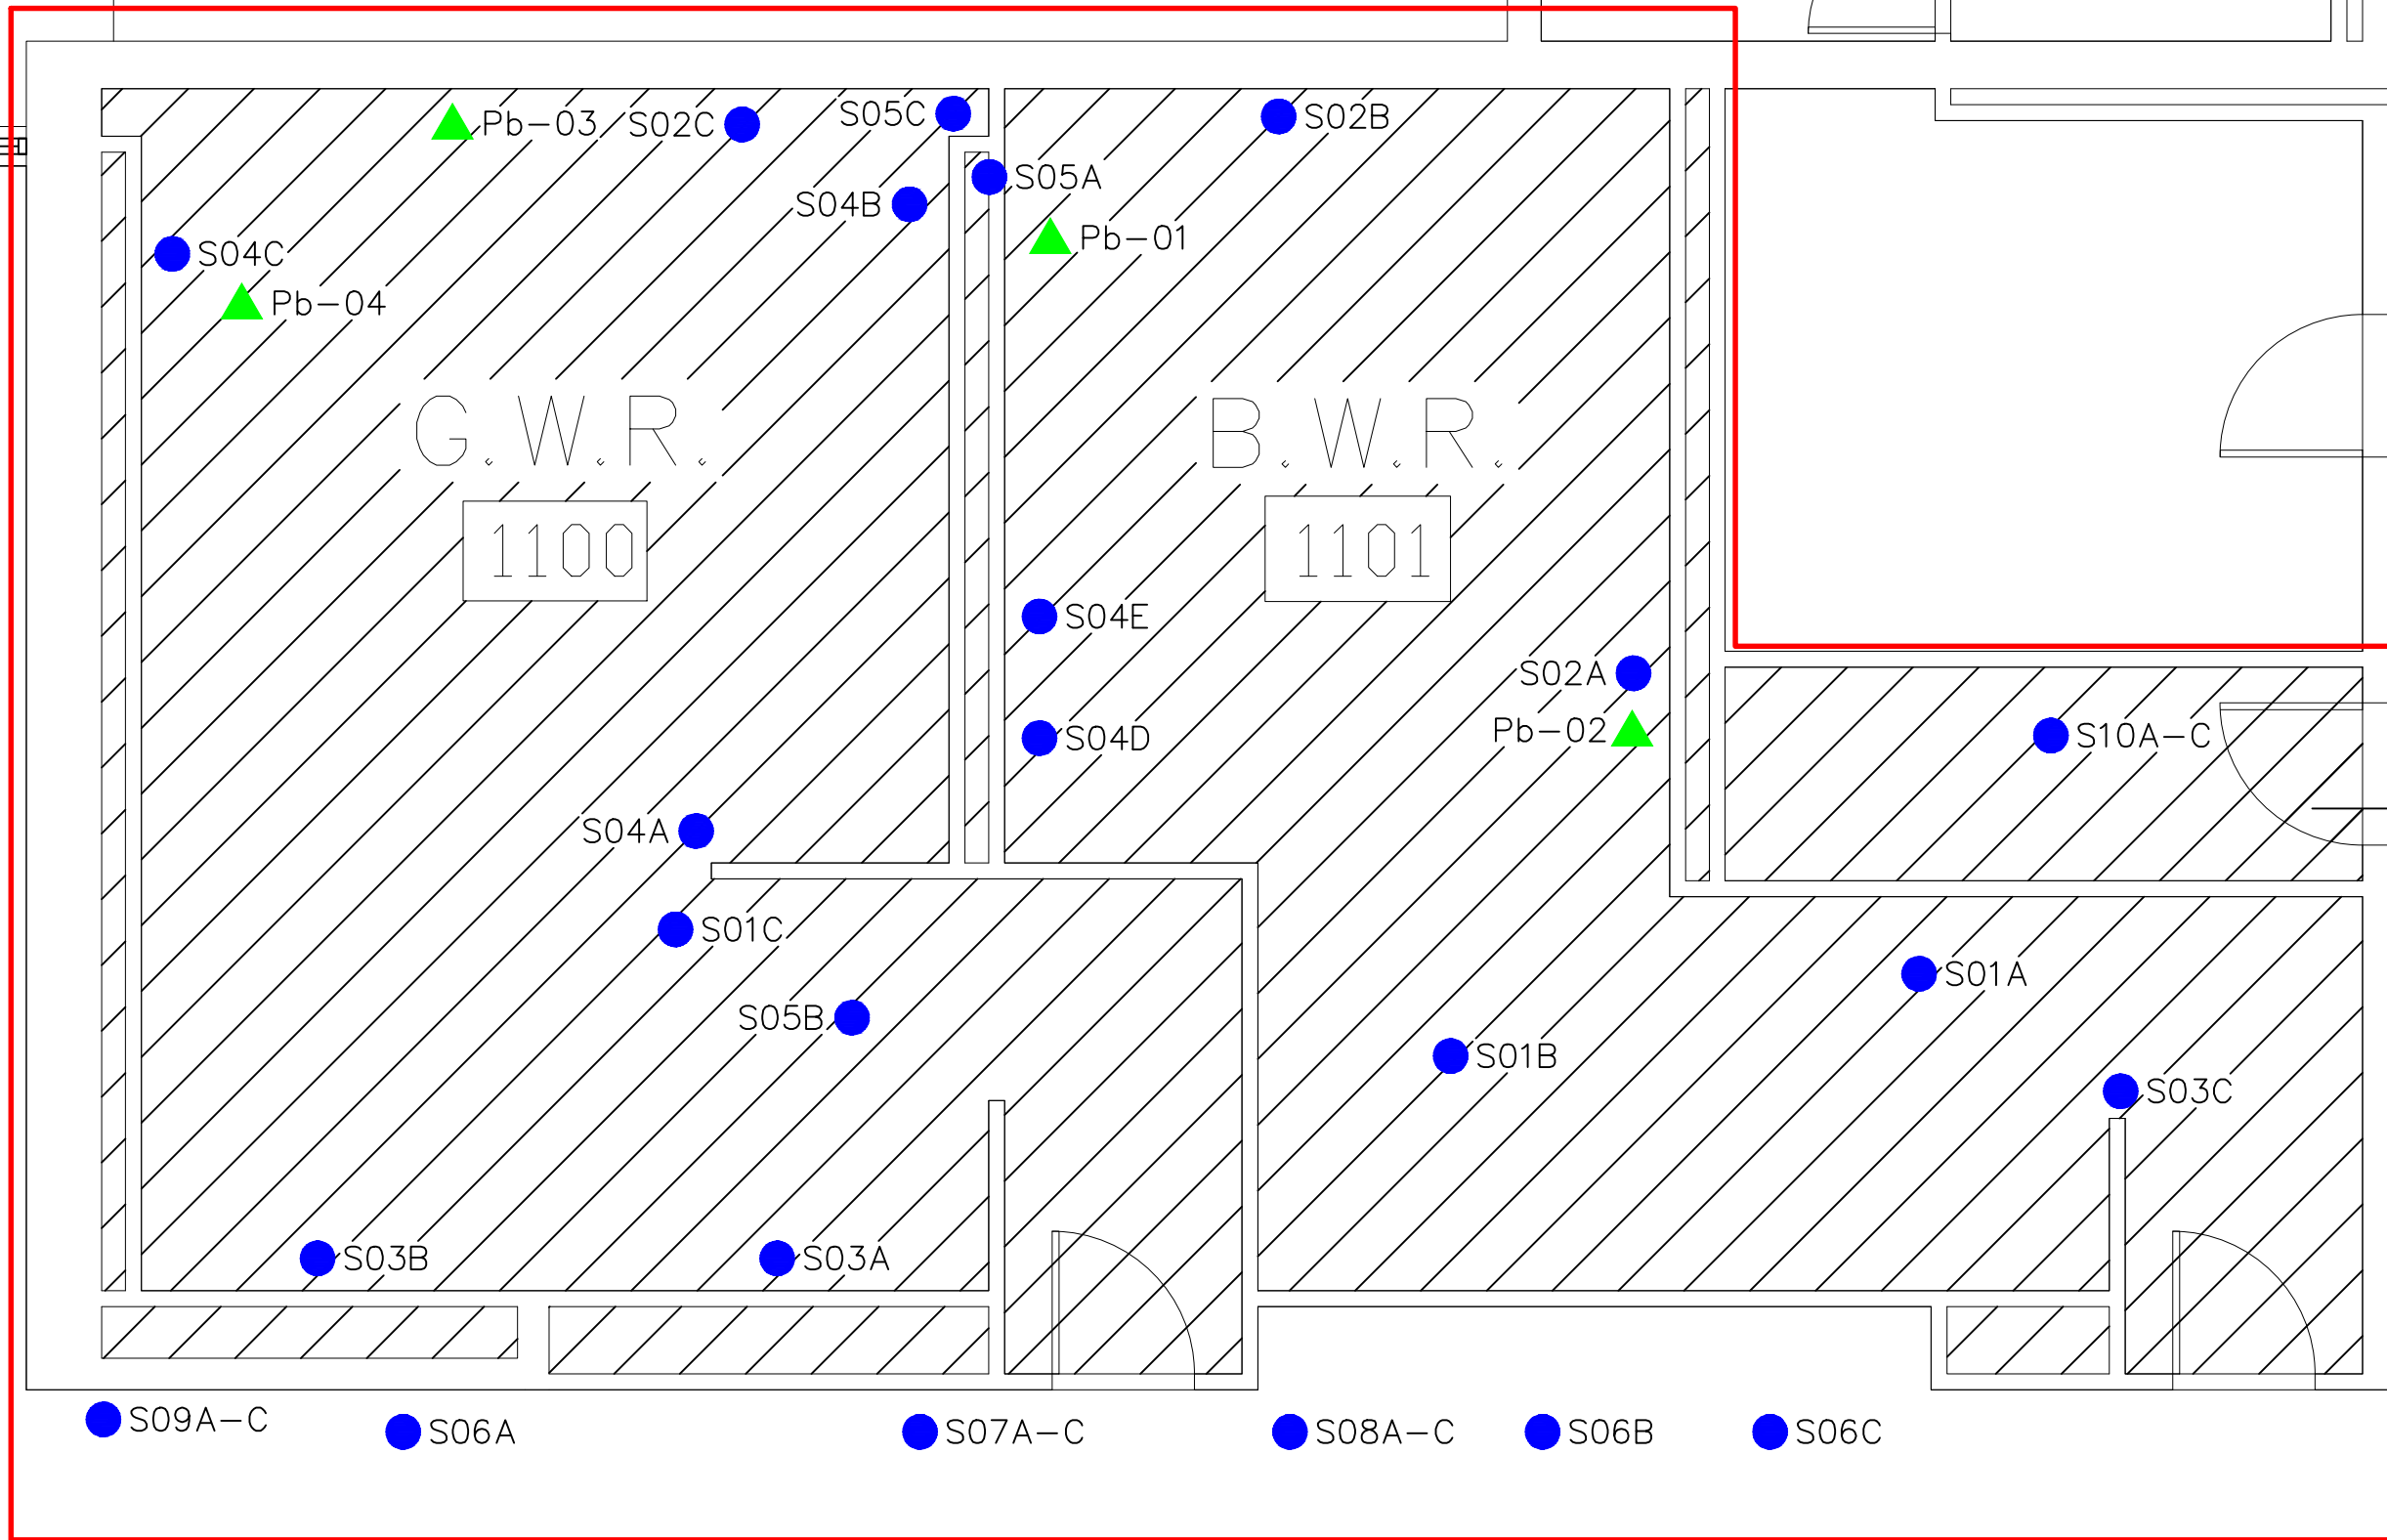
The survey was limited to Location #1100-Girl's Washroom, #1101-Boy's Washroom, #1119-Custodian and the immediate Corridor as illustrated on the attached drawing (DSR-01). The scope of the assessment was carried out in all accessible areas on a non-intrusive basis. Areas that were inaccessible at the time of the survey are listed in Section 3.11.

Asbestos-containing parging cement insulation was observed to be applied to pipe fittings throughout the surveyed area. Analysis of Sample Set S05A-C determined that sample S05A was found to contain **60% Chrysotile asbestos**. The remaining samples were not analyzed due to the stop positive confirmation. Ontario Regulation 278/05, requires a material to be considered as asbestos-containing if one or more samples within the set is determined to contain asbestos. Therefore, all parging cement is considered to be asbestos-containing. Parging cement fittings were observed in FAIR to GOOD condition at the time of the assessment.

Layered paper pipe insulation was observed to be applied to pipe straights within Location #1119-Custodian. Analysis of Sample Set S10A-C determined that sample S10A was found to contain **60% Chrysotile asbestos**. The remaining samples were not analyzed due to the stop positive confirmation. Ontario Regulation 278/05, requires a material to be considered as asbestos-containing if one or more samples within the set is determined to contain asbestos. Layered paper pipe insulation was observed in GOOD condition at the time of the assessment.

Location	Description and Quantity	Remedial Recommendations
1100-Girl’s Washroom	10 Parging Cement Fittings in FAIR Condition located in plaster bulkhead	Repair insulation using Type 2 Asbestos Abatement Procedures (Limited access)
1100-Girl’s Washroom	1 Parging Cement Fitting in FAIR Condition located at floor level in washroom stall	Repair insulation using Type 2 Asbestos Abatement Procedures
1101-Boy’s Washroom	2 Parging Cement Fittings in FAIR Condition located in plaster bulkhead	Repair insulation using Type 2 Asbestos Abatement Procedures (Limited access)
1101-Boy’s Washroom	2 Parging Cement Fittings in FAIR Condition located behind glazed masonry block wall	Repair insulation using Type 2 Asbestos Abatement Procedures (Limited access)
