Limited Designated Substance Survey Report

Ajax High School

105 Bayly Street East, Ajax, Ontario

February 3, 2025
Parasol Project No: 13275

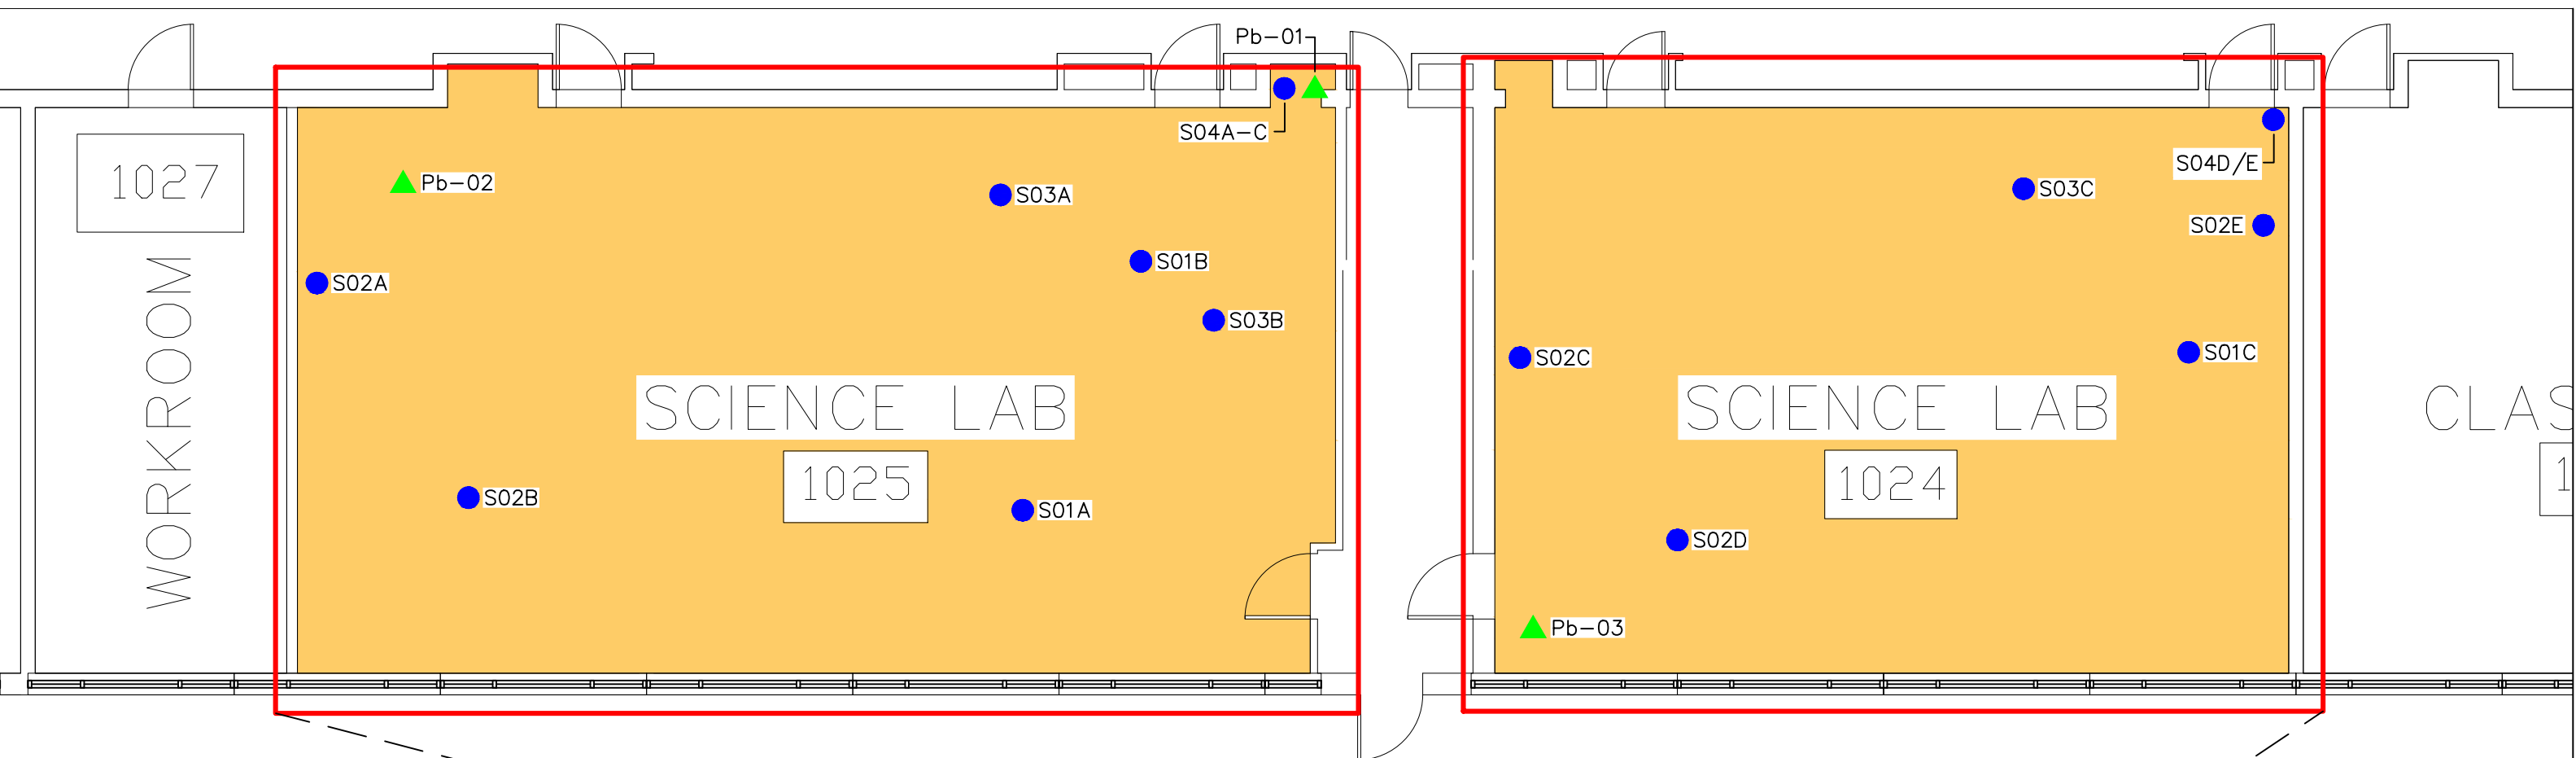
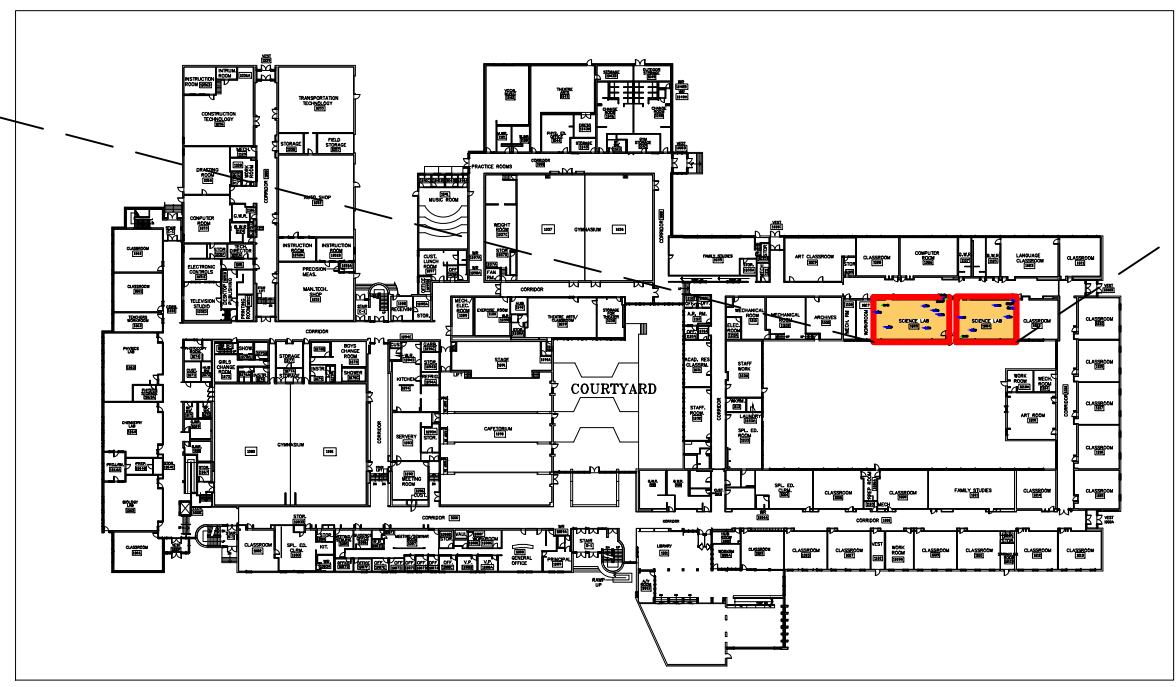
- 1) Drywall finishes where present within the surveyed area are confirmed to contain Chrysotile asbestos. Sampling is required in specific areas to prove non-ACM.
 - 2) Transite cement panels located within the fume hoods are suspected to contain asbestos. Sampling of the material is required to prove them non-ACM.
 - 3) Black desk tops where present throughout the surveyed are confirmed to contain Chrysotile asbestos.
- Refer to Main Report.
