## DESIGNATED SUBSTANCES and HAZARDOUS MATERIALS SURVEY

### LONG TERM CARE HOMES & SERVICES Castlevue - Wychwood Tower 351 Christie Street Toronto, Ontario

Project Number: FE 24-13855

August 30, 2024

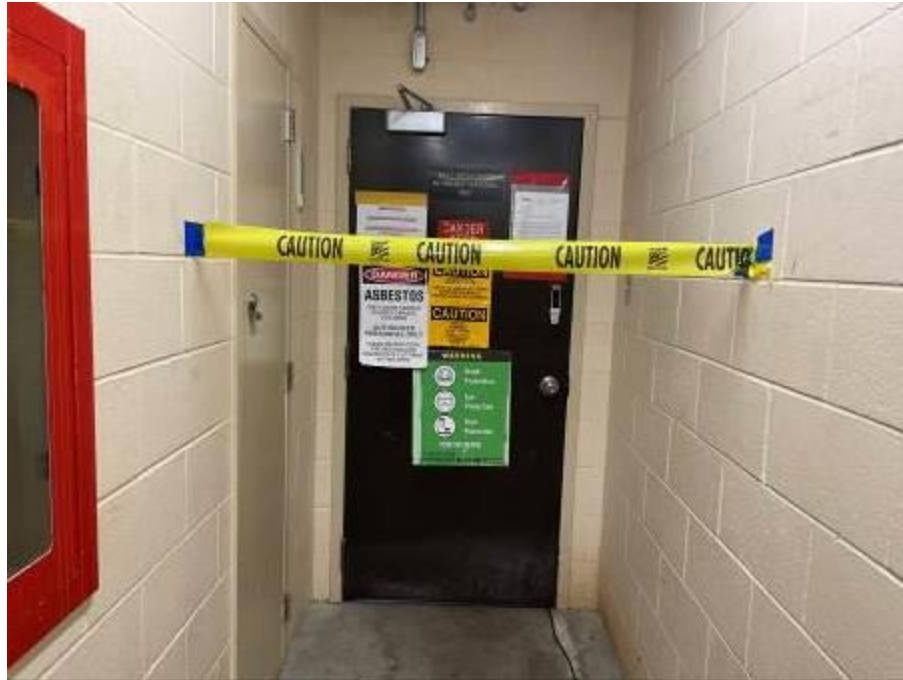
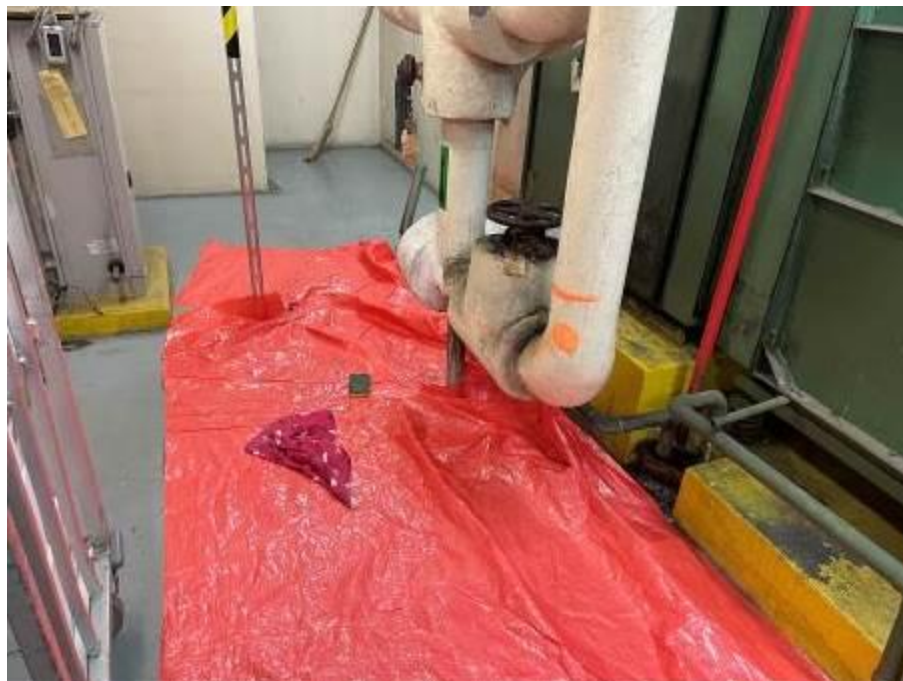
**Photos 1 and 2** – View of the Level 1 Work Area preparation in the East Mechanical Room (B-053).

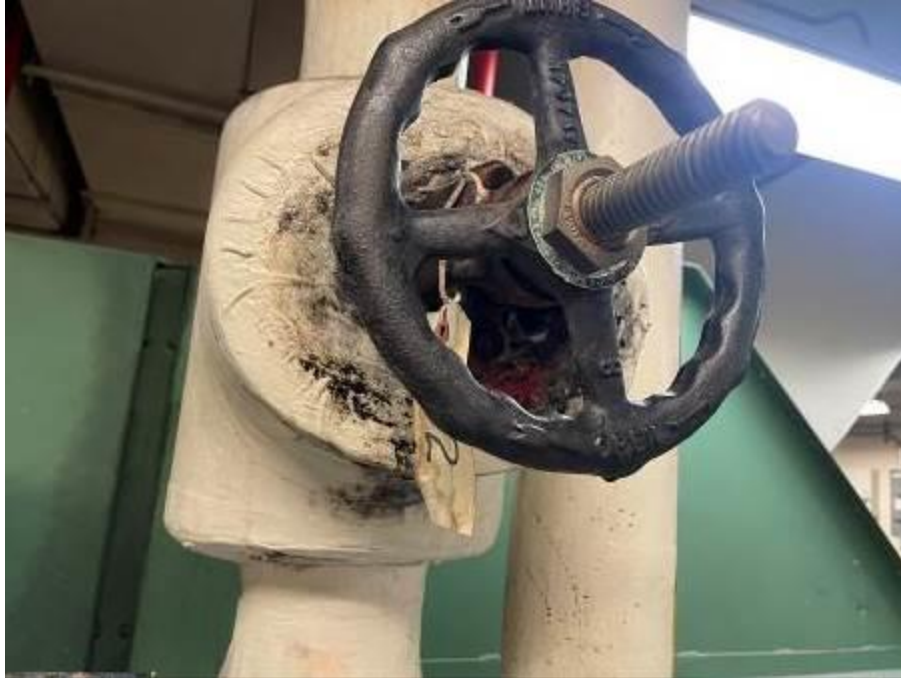
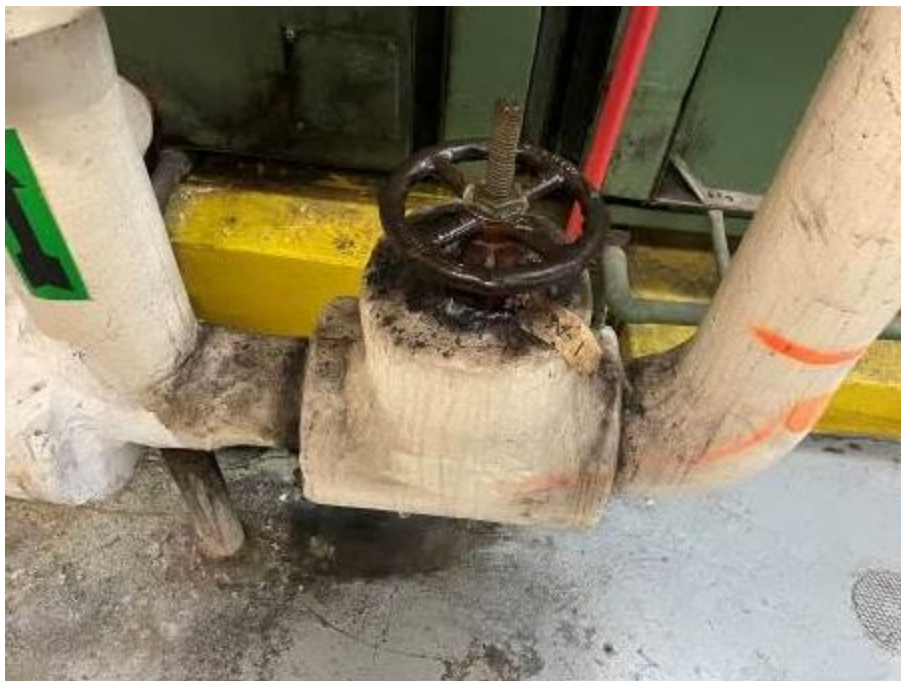
Visible mould growth was observed on asbestos-containing parging cement fittings in East Mechanical Room, B-053. Efflorescence was observed on the concrete floor in West Mechanical Room, B-013.

**Photos 3 and 4:** View of the mould-impacted fittings before the abatement work.

Fisher Engineering Limited communicated the reported deficiencies and recommendations for corrective actions to the City of Toronto. Suggested abatement activities in East Mechanical Room, B-053 and Laundry Room, B-007, have been completed and an Addendum was made to this report to confirm completion of the corrective actions. Details of the abatement work can be found in the Corrective Actions Inspection Report (Project No. FE 24-14158), which is provided in Appendix V.

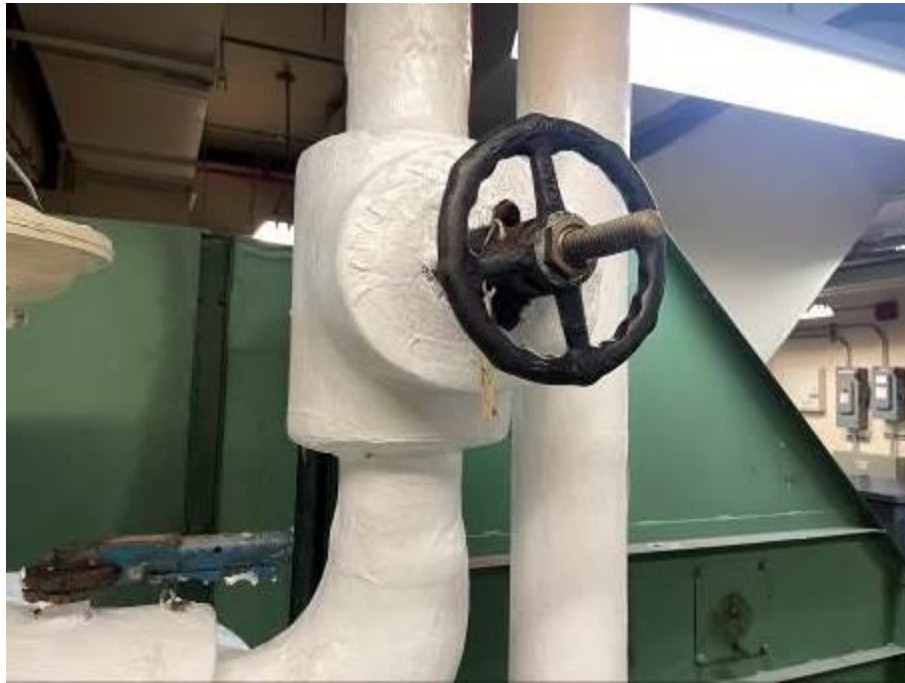
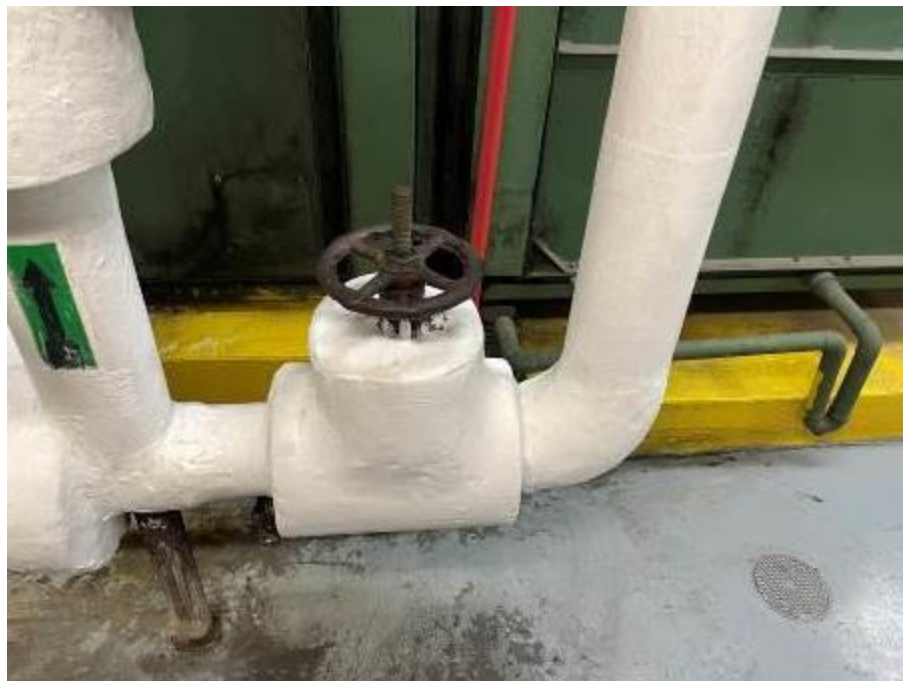
**Photos 5 and 6:** Post abatement view of the pipe fittings in the East Mechanical Room (B-053).

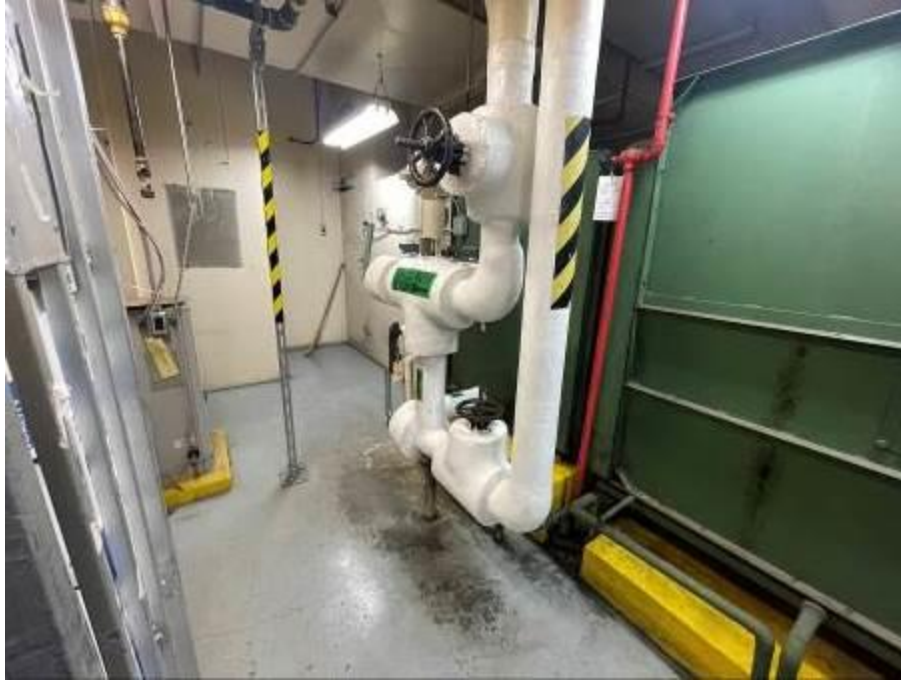
**Photo 7:** View of the Work Area after completion of the abatement work.

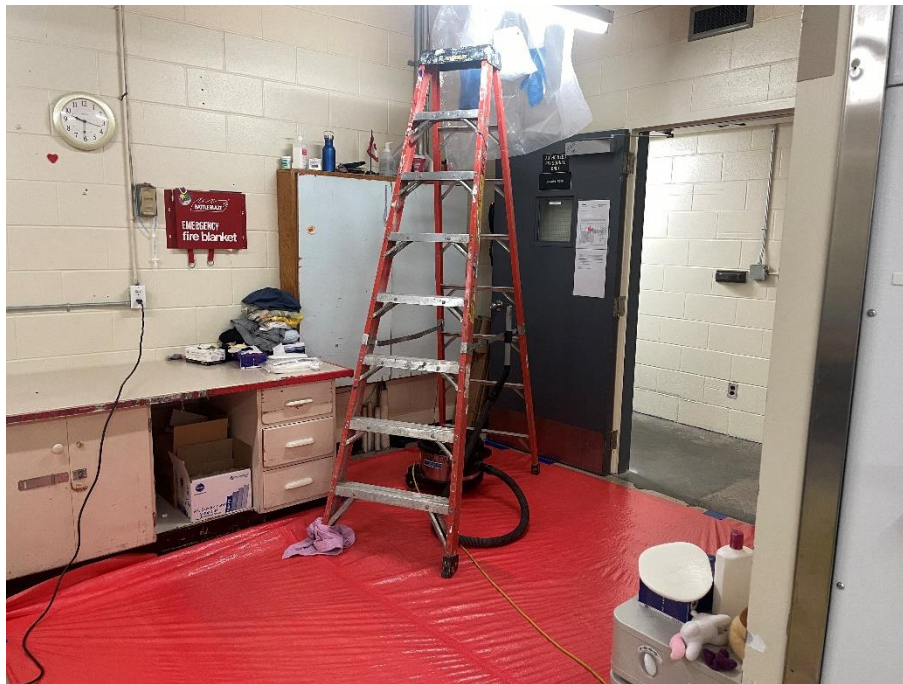
**Photo 8:** View of the Type 2 Glove Bag Work Area Preparation in the Laundry Room (B-007).

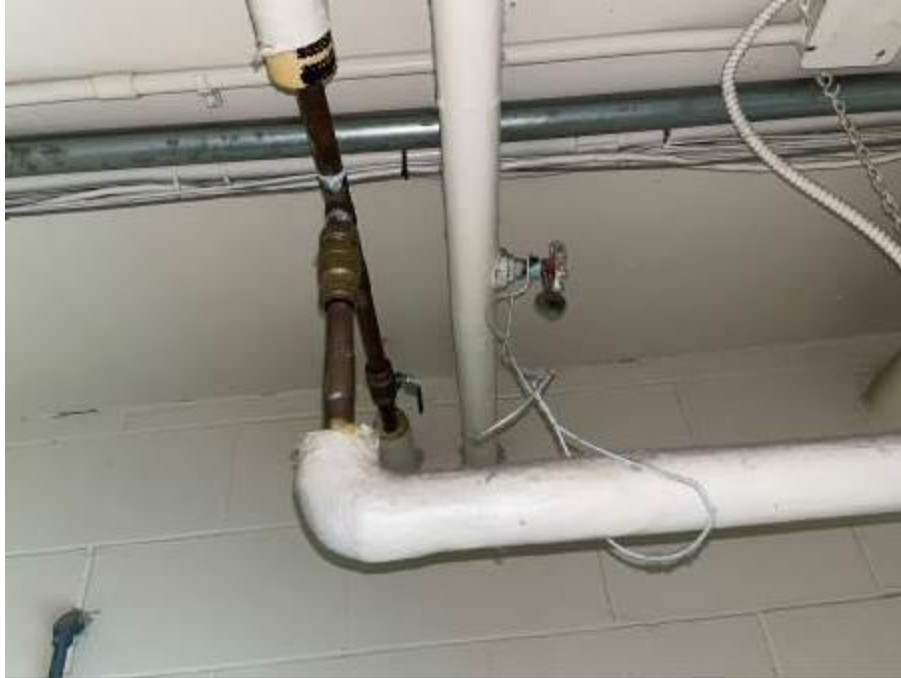
All assumed and confirmed ACM were observed to be in GOOD condition, with the exception of one (1) damaged pipe fitting with asbestos-containing paring cement in the Laundry Room, B-007. The damaged asbestos-containing paring cement should be repaired or removed following Type 2 (Glove Bag) Asbestos Abatement procedures.

**Photo 9:** View of the damaged fitting prior to the abatement.

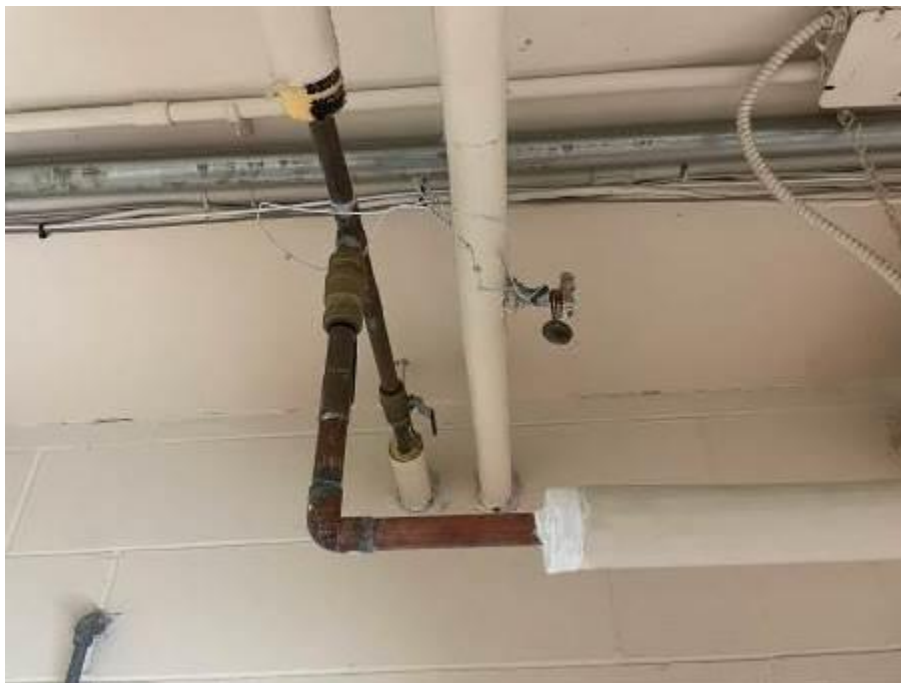
**Photo 10:** Post-abatement view of the fitting in the Laundry Room (B-007).
