Re: Asbestos-Containing Smooth Plaster Condition Assessment Report

E.A. Lovell School (Durham Continuing Education)
120 Centre Street South, Oshawa, Ontario
Parasol Project Number 13160

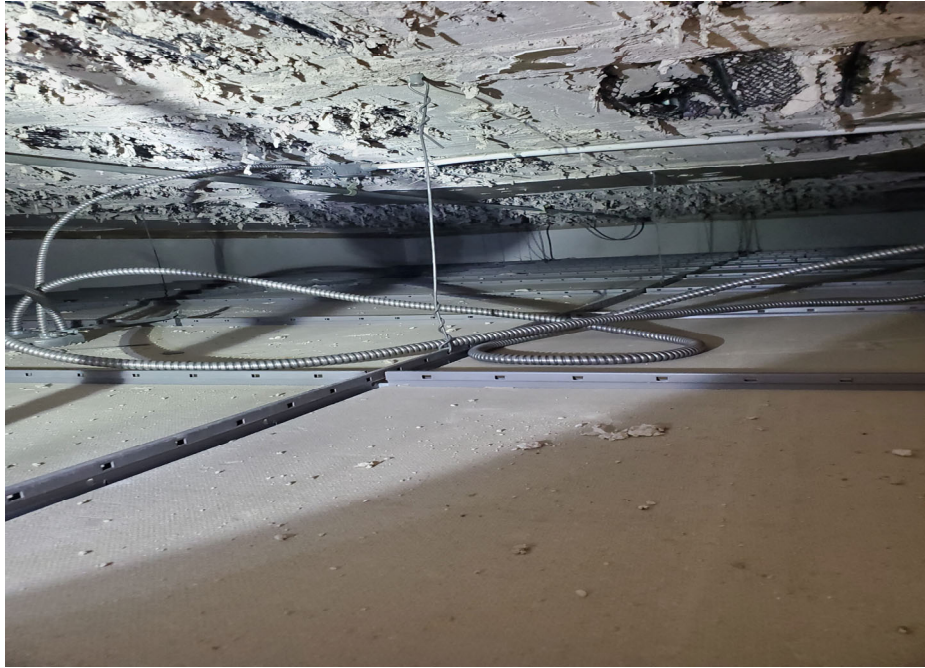
Location #350 (Stair) – Smooth plaster delaminated from lath, debris on lay-in ceiling

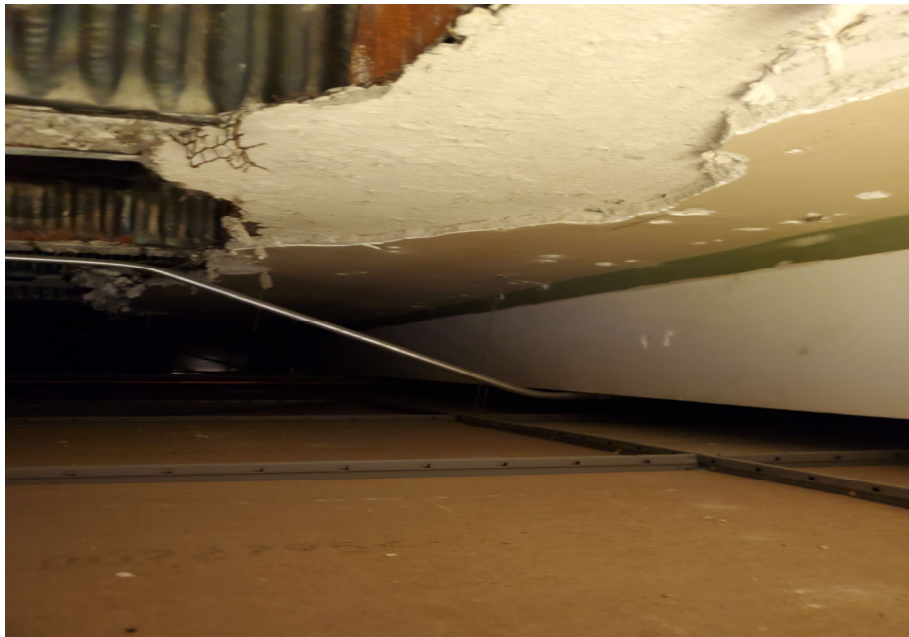
Location #112B (Classroom) – Smooth plaster remains around the perimeter of the room

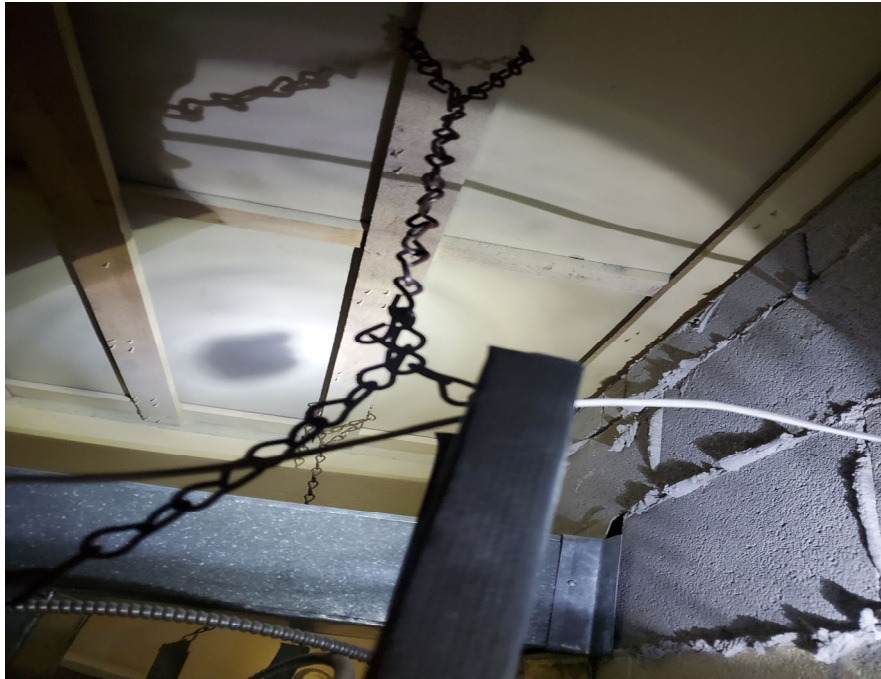
Location #348 (Men's Washroom) – Smooth plaster in GOOD condition. Reinforced with wood strapping
