Designated Substance Survey Report

Toronto Fire Services Station 243
4560 Sheppard Avenue East,
Toronto, Ontario

City of Toronto

December 21, 2020

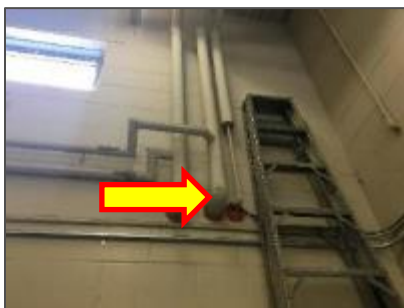
Previously sampled paring cement is present on pipe fittings and does not contain asbestos (samples 11850-B-71-07a-c, 14-8368-05 to 07).

Photo 1: Non-asbestos paring cement – Fire Apparatus Bay (Location 1-01).

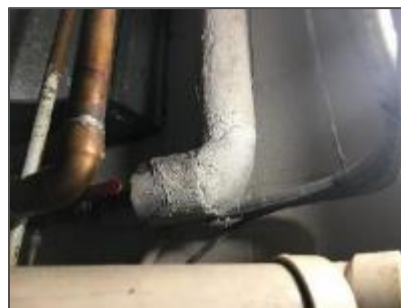
Photo 2: Non-asbestos paring cement – Mechanical Room (Location 1-04).

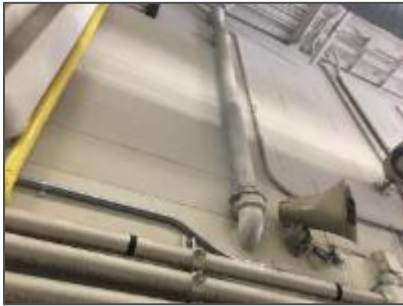
Photo 3: Uninsulated pipe – Fire Apparatus Bay (Location 1-01).

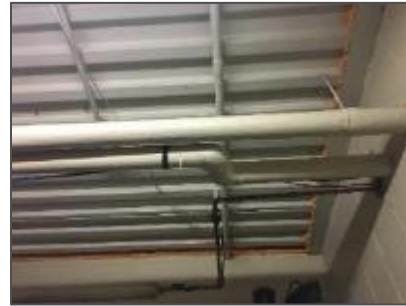
Photo 4: Pipe insulated with fiberglass – Equipment Storage (Location 1-05).

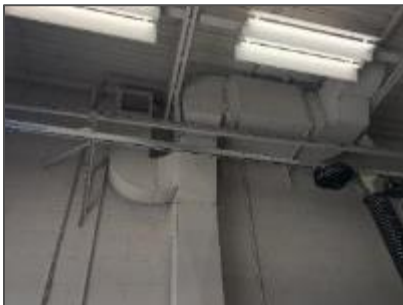
Photo 5: Uninsulated duct – Fire Apparatus Bay (Location 1-01).

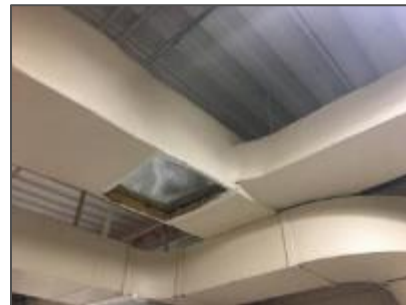
Photo 6: Duct insulated with fiberglass – Supply Room (Location 1-03).

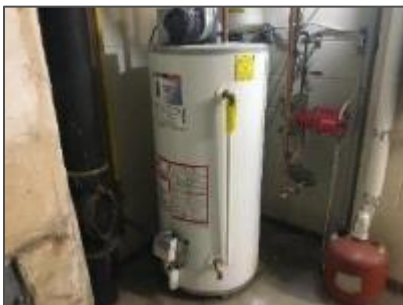
Mechanical equipment observed were uninsulated.

Photo 7: Hot water tank – Mechanical Room (Location 1-04).

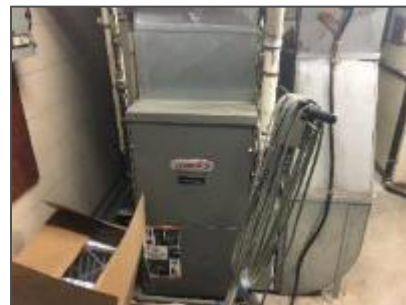
Photo 8: Furnace – Mechanical Room (Location 1-04).

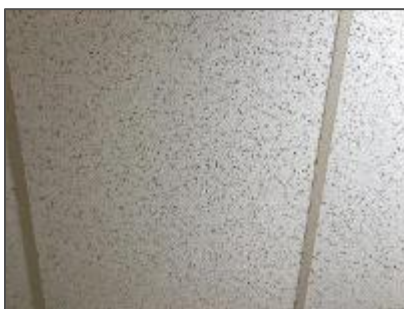
Photo 9: Non-asbestos ACT01.

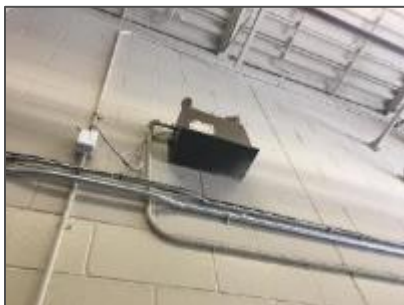
Lead-containing batteries may be present in emergency lighting.

Photo 11: Emergency lighting – Fire Apparatus Bay (Location 1-01).

Lead-containing items should be recycled when taken out of service.

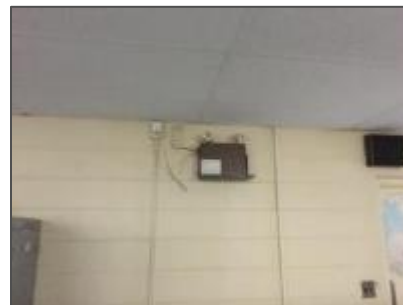
Photo 12: Emergency lighting – Dormitory (Location 1-09).
