**REVISED**  
**Hazardous Building**  
**Materials Assessment**  
**(Pre-construction)**

Toronto Fire Services Station 243  
4560 Sheppard Avenue East,  
Toronto, Ontario

March 24, 2025

Pinchin File: 355561.000

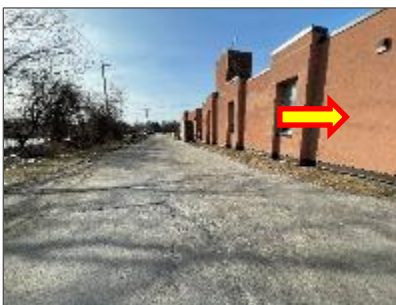
Texture finish on exterior walls in the assessed area does not contain asbestos (samples S0006A-C).

Non-asbestos texture coat on exterior walls (S0006A-C), Exterior (Loc.1-27).

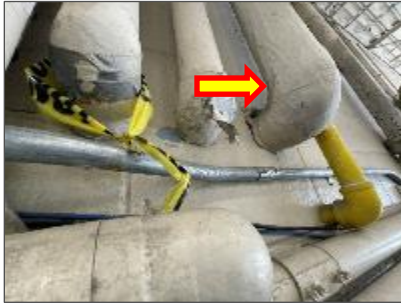
Previously sampled paring cement present on pipe fittings in Fire Apparatus Bay 1-01 does not contain asbestos (Pinchin Report 274992.003, samples 11850-B-71-07a-c, 14-8368-05 to 07).

Non-asbestos paring cement, Fire Apparatus Bay 1-01.

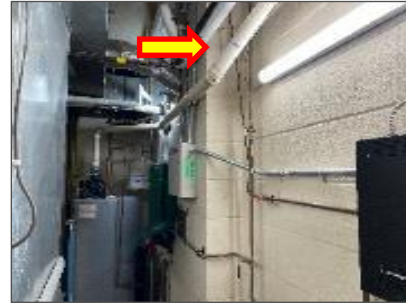
Uninsulated pipe, Mechanical Room 1-04.

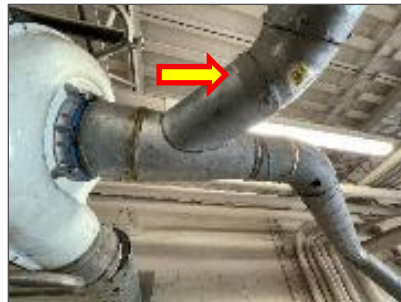
Grey duct mastic present at seams / joints on the exterior of ducts connected to exhaust fan in the Fire Apparatus Bay (Loc. 1-01) does not contain asbestos (samples S0003A-C).

None-asbestos grey mastic on uninsulated duct pipe, Apparatus Bay (Loc. 1-01).

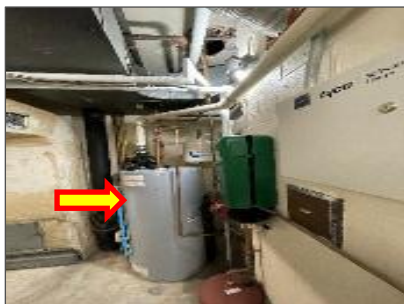
Hot water tank, Mechanical Room (Loc.1-04).

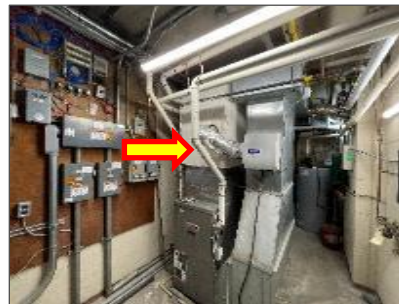
Uninsulated Furnace, Mechanical Room (Loc.1-04).

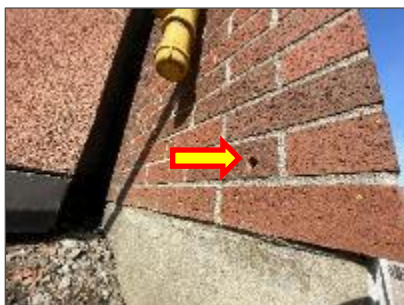
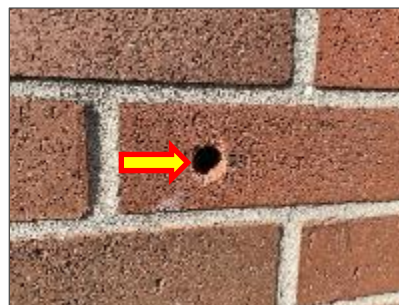
Loose fill vermiculite was not observed within the cavities.

Vermiculite drill on exterior brick wall, Exterior (Loc. 1-27).

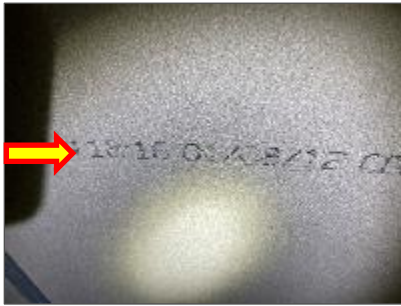
Non-asbestos ACT, Bedroom (Loc. 1-12).

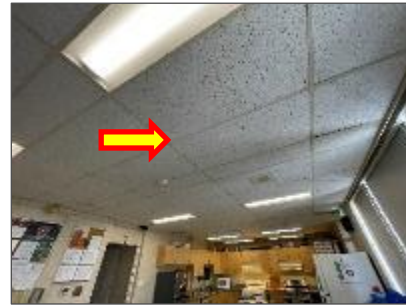
Non-asbestos ACT, Kitchen/Lounge (Loc. 1-08).

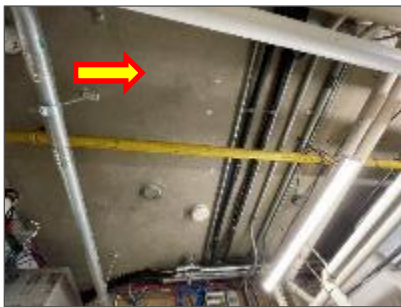
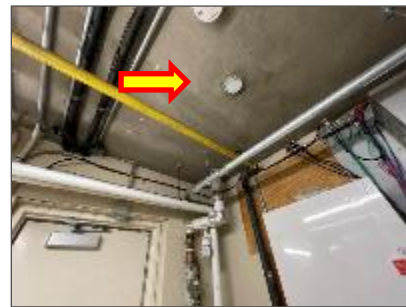
Plaster present on ceilings in the Mechanical Room (Location 1-04) does not contain asbestos (Lab report b333878 samples S0002A-C and Pinchin Report 274992.003, 14-8368-02 to 04).

Non-asbestos ceiling plaster, Mechanical Room (Loc.1-04).

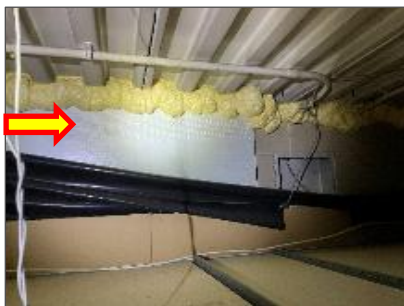
Cement (Transite) panel, **presumed to contain asbestos** based on visual observation, is present as a perforated panel above non-asbestos ceiling tiles in the Dormitory (Loc. 1-09) and Kitchen/Lounge (Loc.1-08). Approximately 20 squares in each location. Cement (Transite) panel is a non-friable material and observed in good condition.

Presumed asbestos Transite panel at Dormitory Room and Kitchen/lounge walls above ceiling (Loc.1-09, 1-08).

4. Remove and properly dispose of asbestos-containing materials prior to demolition or renovation activities.
5. Recycle mercury-containing lamp tubes when removed from service.

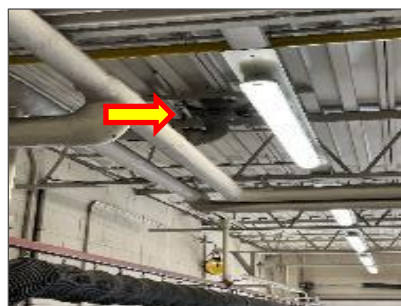
Cement (Transite) pipe, **presumed to contain asbestos** based on visual observation, is present as rainwater leaders in the Fire Apparatus Bay (Loc.1-01) area. Cement (Transite) pipe is a non-friable material and observed in good condition.

Presumed asbestos Transite rainwater leader pipe in the Fire Apparatus Bay area (Loc. 1-01).

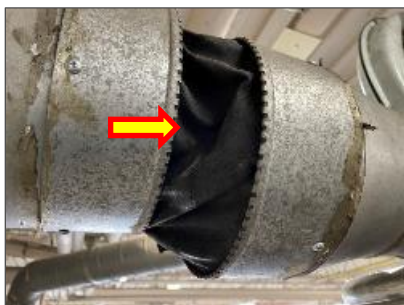
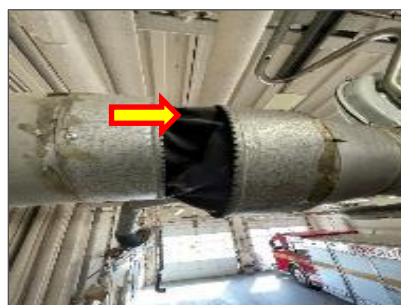
Textile vibration dampers, **presumed to contain asbestos**, are present as duct connectors in the Fire Apparatus Bay area (Loc.1-01). Vibration damper was observed connected to an operative duct system; therefore, the damper was not sampled to avoid damaging the integrity of the material. If the damper is planned to be disturbed during the planned work, destructive sampling will be required to confirm presence of asbestos.

Presumed textile vibration damper present in the Fire Apparatus Bay area (Loc.1-01).

3. Conduct further investigation of the following items, areas, or locations, which were not completed during this assessment:
  - a. Vibration damper was observed connected to an operative duct system; therefore, the damper was not sampled to avoid damaging the integrity of the material. If the damper is planned to be disturbed during the planned work, conduct destructive sampling once the duct system has been taken out of service to confirm presence of asbestos.
  - b. Any items listed as exclusions in this report, prior to disturbance.
4. Provide this report to the contractor prior to bidding or commencing work.
5. Retain a qualified consultant to specify, observe and document the successful removal of hazardous materials.
6. Update the asbestos inventory upon completion of the abatement and removal of asbestos-containing materials and any other relevant findings.

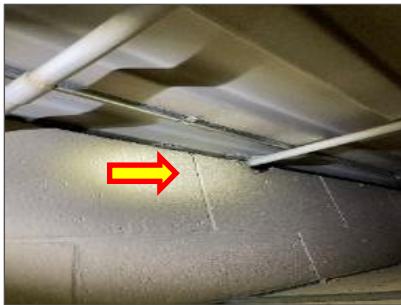
Non-asbestos mortar on masonry wall present in the Fire Apparatus Bay area (Loc. 1-01).

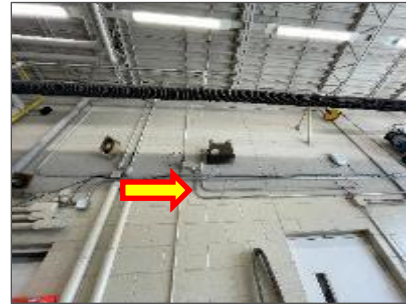
Cementitious coating (beige paint), **containing chrysotile asbestos**, is present applied on masonry walls within Fire Apparatus Bay, Bedroom, Dormitory (Loc. 1-01, 1-12 and 1-09, respectively) (samples S0004A-C). Coating is a non-friable material and observed in good condition.

Asbestos-containing coating (beige paint) on masonry wall present in the Fire Apparatus Bay area (Loc. 1-01).

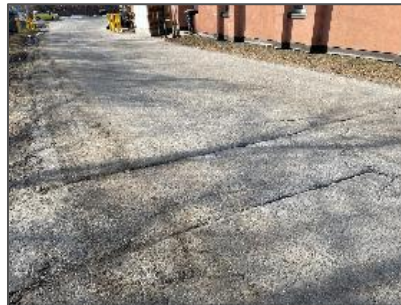
Asphalt driveway area (Loc. 1-27) does not contain asbestos (samples S0028A-C).

Non-asbestos asphalt present on driveway exterior (Loc. 1-27).

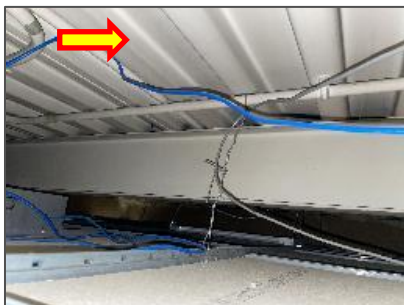
Paint sampled are below the City of Torontos detection limit (0.1%).

Beige paint on corrugated steel deck, South Vestibule (Loc.1-10).

For paint sampled with results below the City of Toronto's detection limit (0.1%), special precautions are not recommended unless aggressive disturbance (grinding, blasting, torching) is planned.

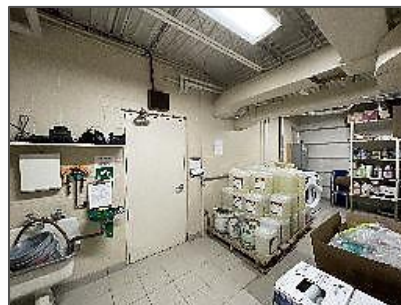
Off-white paint on concrete block wall, Supply Room (Loc. 1-03).

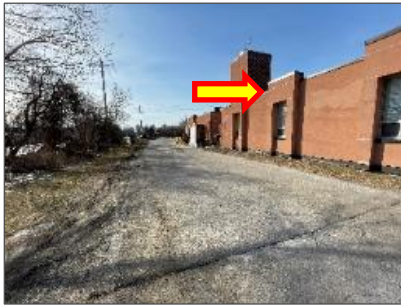
Light brown paint on exterior texture coat, Loc. 1-27.

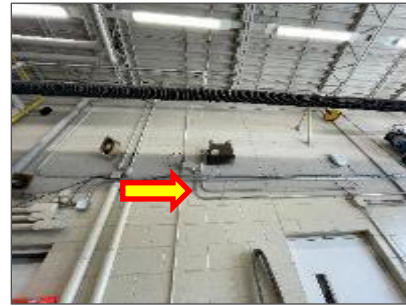
Beige paint on masonry wall, Apparatus Bay (Loc. 1-01).

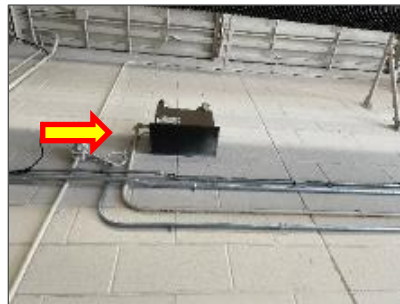
Lead-containing batteries are presumed to be present in emergency lighting.

Emergency lighting, Fire Apparatus Bay (Loc. 1-01).
