February 11, 2025

Kawartha Pine Ridge District School Board 1994 Fisher Drive Peterborough, Ontario, K9J 7A1

#### Re: Hazardous Building Materials Assessment (Pre-Construction) Enniskillen Public School, 8145 Old Scugog Road, Enniskillen, Ontario Pinchin File: 349417.020

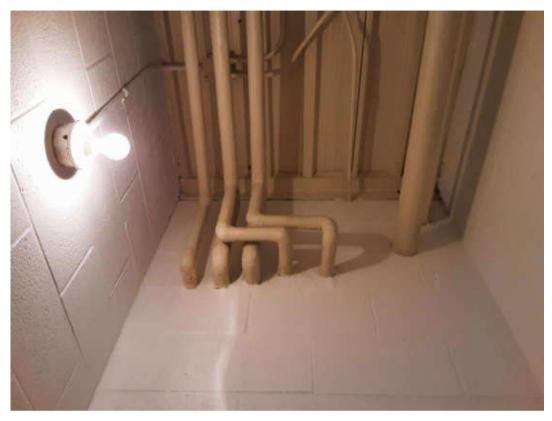
V0003 (Confirmed Asbestos), Parging Cement on Pipe Fittings, CUSTODIAN CLOSET (Location #: 54)

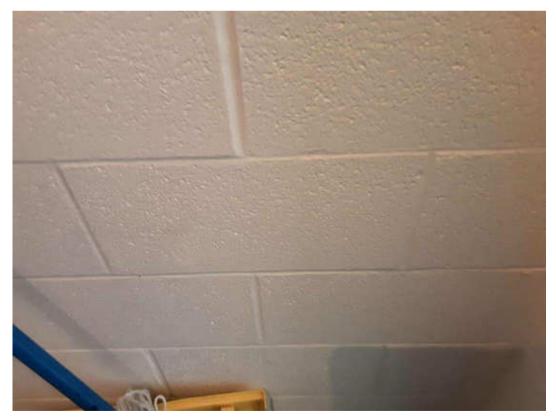
S0043A (Confirmed Asbestos), Wall, Paint, CUSTODIAN CLOSET (Location #: 54)

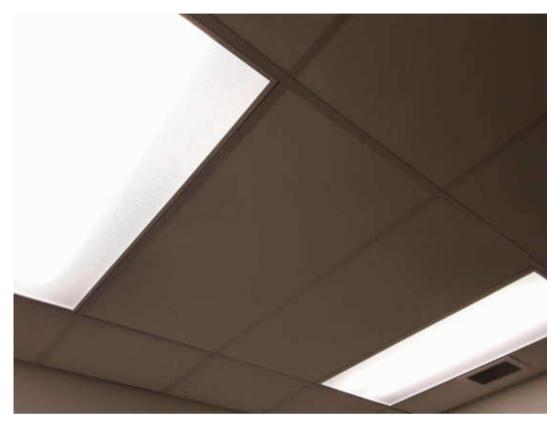
V0000 (None), Ceiling, Ceiling Tiles (lay-in), GIRLS WASHROOM (Location #: 53) Date code present

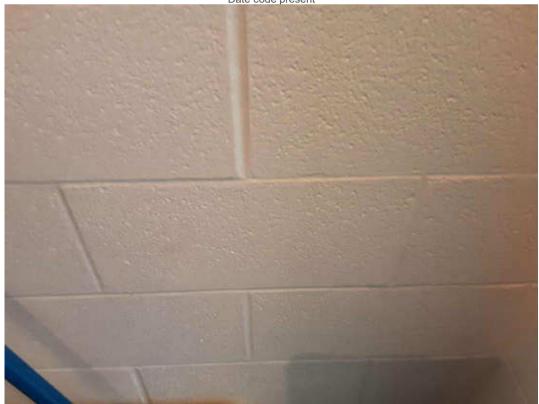
L0009(Lead, Low), White paint, Wall, CUSTODIAN CLOSET (Location #: 54)

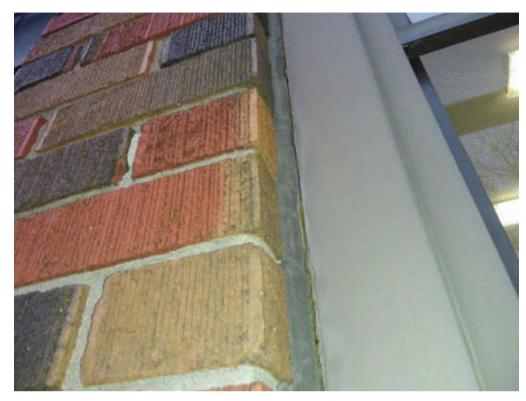
S0020A (None), Soft brown vertical and upper window caulking, Other, Window, Caulking, EXTERIOR (Location #: 71)

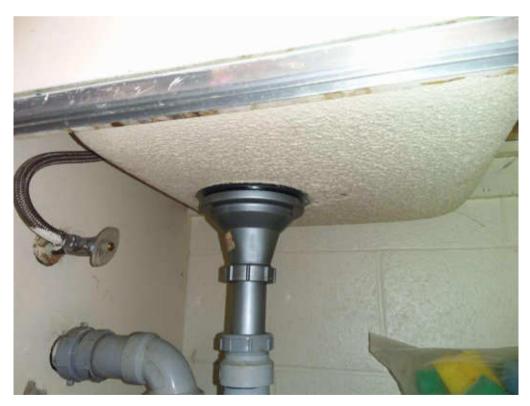
S0022A (None), Grey sink mastic, Other, Sink, Mastic, Grey, CLASSROOM (Location #: 13)

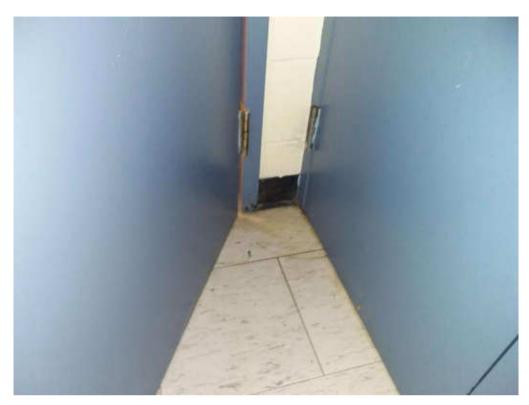
S0023B (None), Black vinyl trim adhesive, Wall, Adhesive/mastic, CUSTODIAN ROOM (Location #: 14)

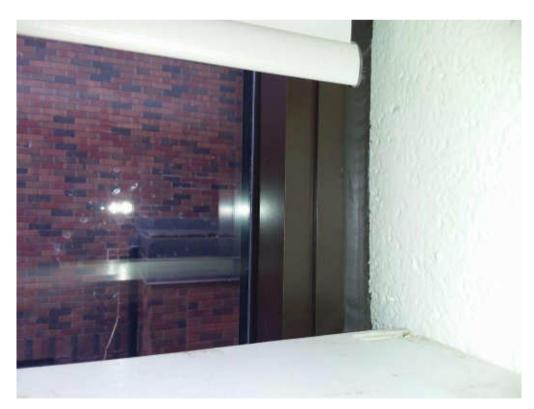
S0025A (None), Brown window frame caulking 2002 date stamp, Other, Window, Caulking, CUSTODIAN ROOM (Location #: 14)

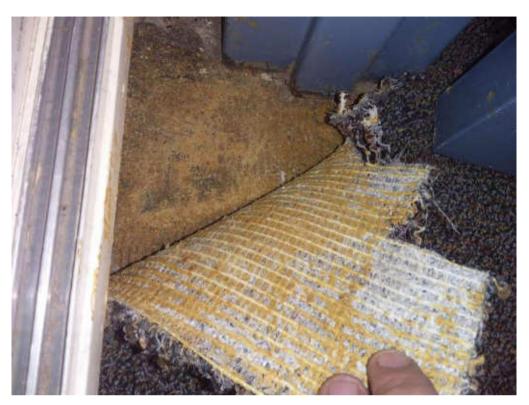
S0027A (None), Carpet adhesive Burgundy brown streak carpet adhesive, Floor, Adhesive/mastic, CLASSROOM (Location #: 27)

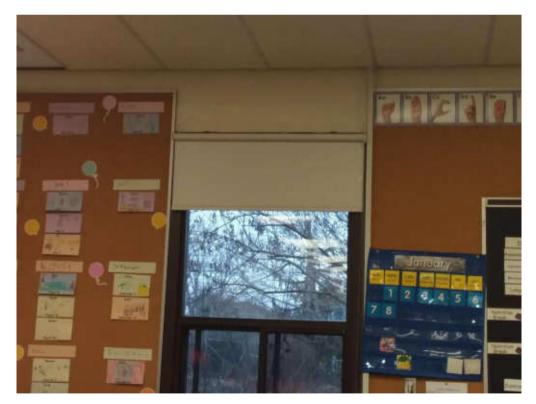
S0029A (Confirmed Asbestos), Exterior masonry brick paint on masonry, Wall, Paint, CLASSROOM (Location #: 30)

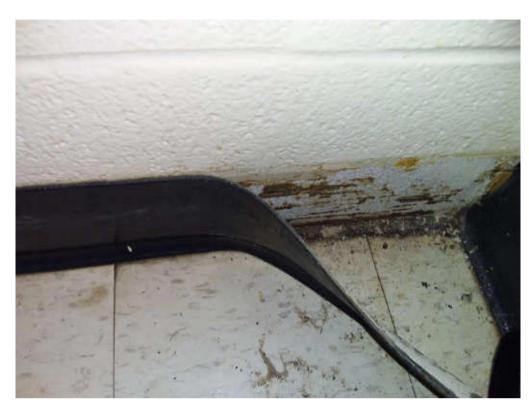
S0032A (Confirmed Asbestos on wall paint phase C ), Brown adhesive black vinyl trim on asbestos-containing promer paint, Wall, Adhesive/mastic, GIRLS WASHROOM (Location #: 53)
