PRE-RENOVATION DESIGNATED SUBSTANCES AND HAZARDOUS MATERIALS ASSESSMENT

**ABSORPTION CHILLER DECOMMISSIONING
(230467-274385)
OPP GENERAL HEADQUARTERS
777 MEMORIAL AVENUE
ORILLIA, ONTARIO**

MAY 9, 2025
ECOH Project No. 29240

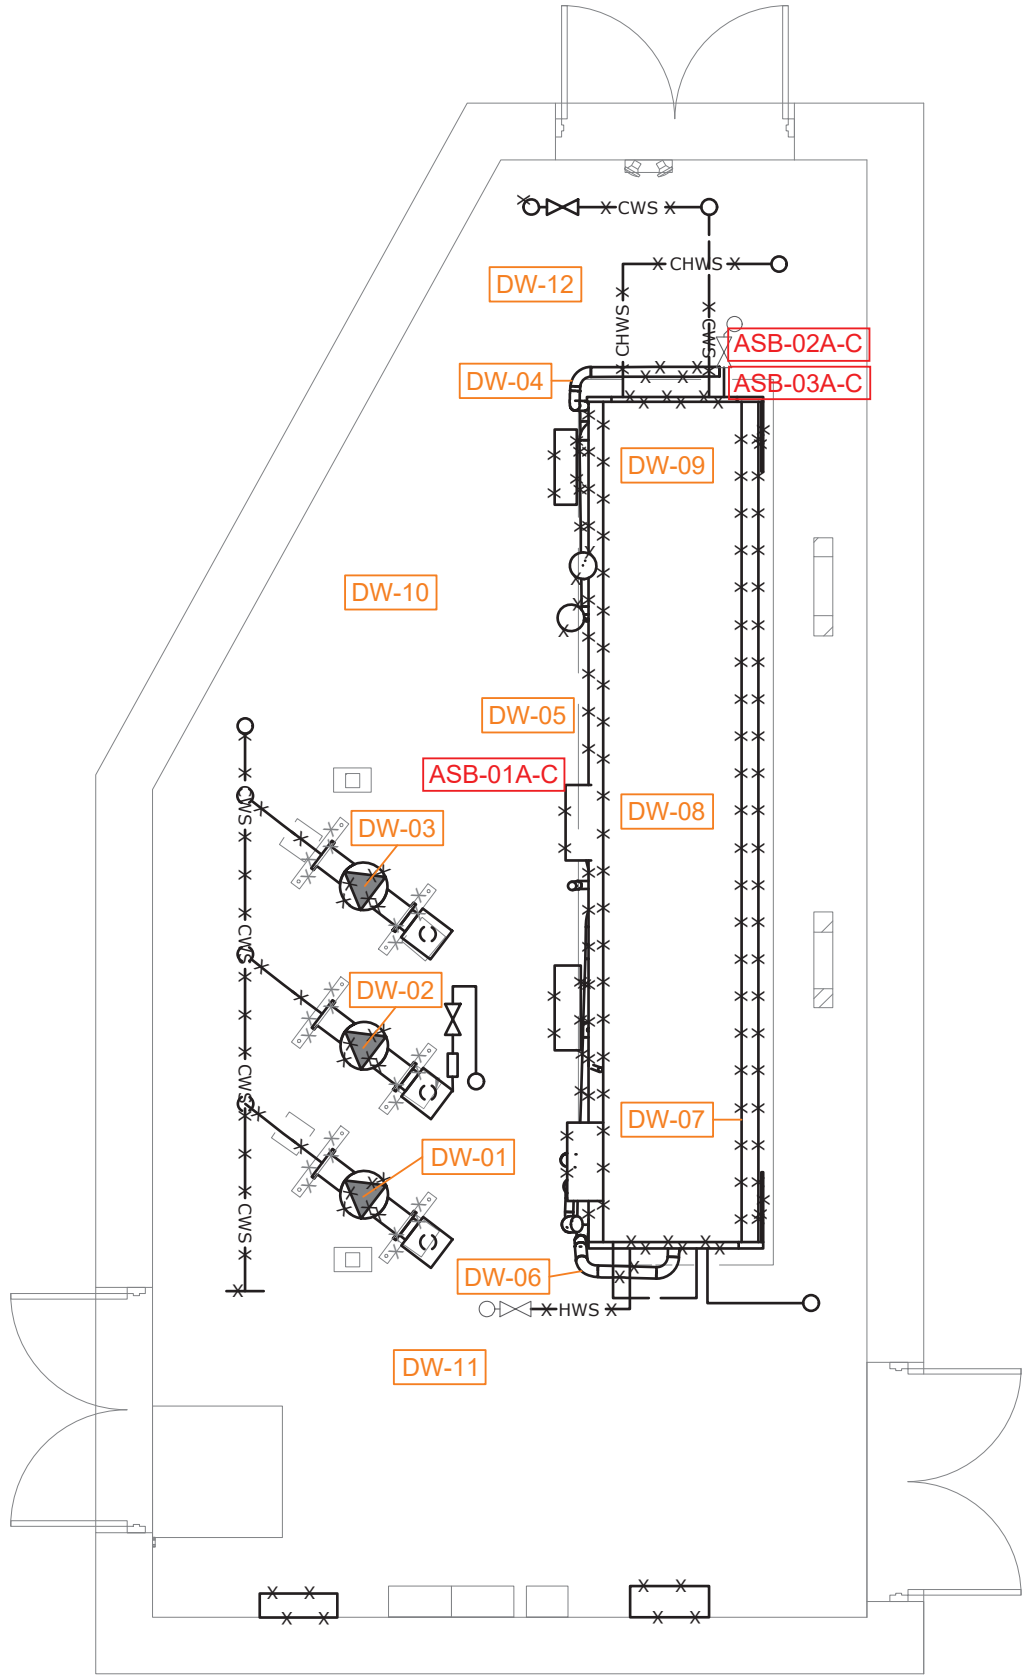
Figure 1

Ground Floor Mechanical Room (M1)

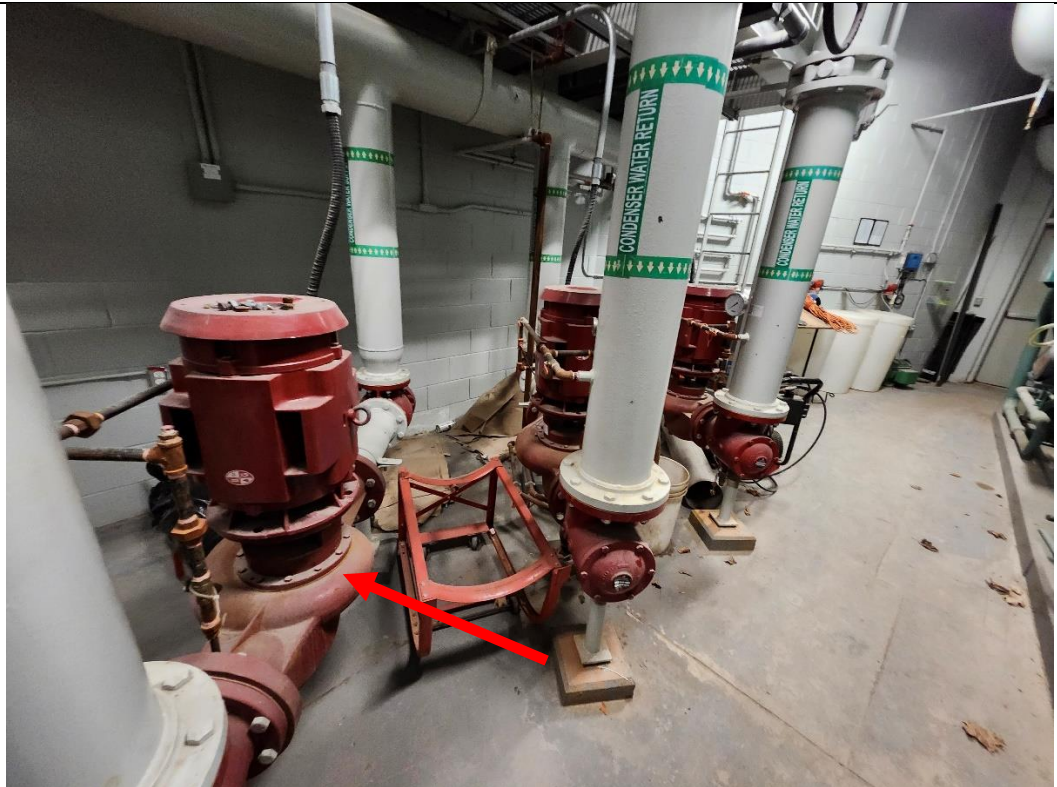
Representative
photo of pumps.

*Lead wipe samples
were collected from
this surface (29240-
DW-01-03) and
determined by
laboratory analysis
to **exceed the
Guideline Limit of
200 ug/ft2***

Work requiring disturbance of the settled dust on piping, access above suspended ceilings, and/or proactive cleaning of settled dust in the Project Area(s), where lead-in-dust is above 200 µg/ft², should be conducted following Class 2 lead safety precautions detailed in the Ministry of Labour document *Guideline - Lead on Construction Projects*, dated November 2022 and the Environmental Abatement Council of Canada (EACC) document; “*Lead Guideline for Construction, Renovation, Maintenance or Repair*”, dated January 2025.

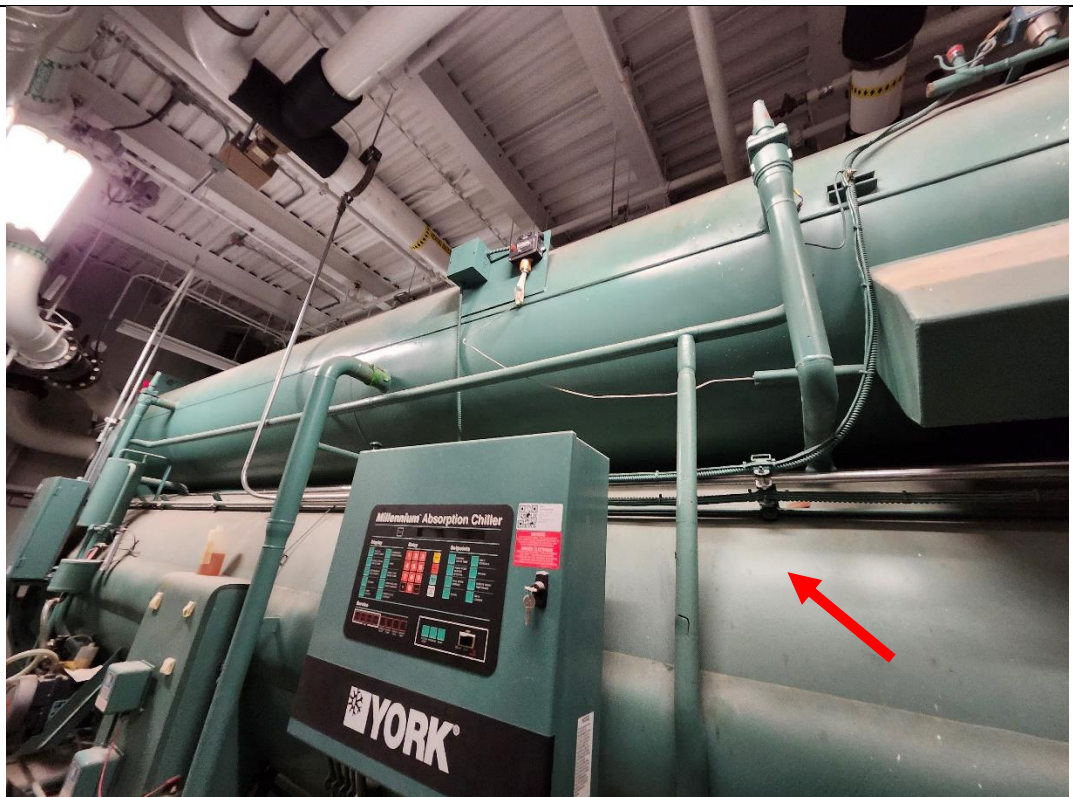
Photo No. 2.

Representative
photo of chiller unit.

*Lead wipe samples
were collected from
this surface (29240-
DW-07-09) and
determined by
laboratory analysis
to **exceed the
Guideline Limit of
200 ug/ft2***

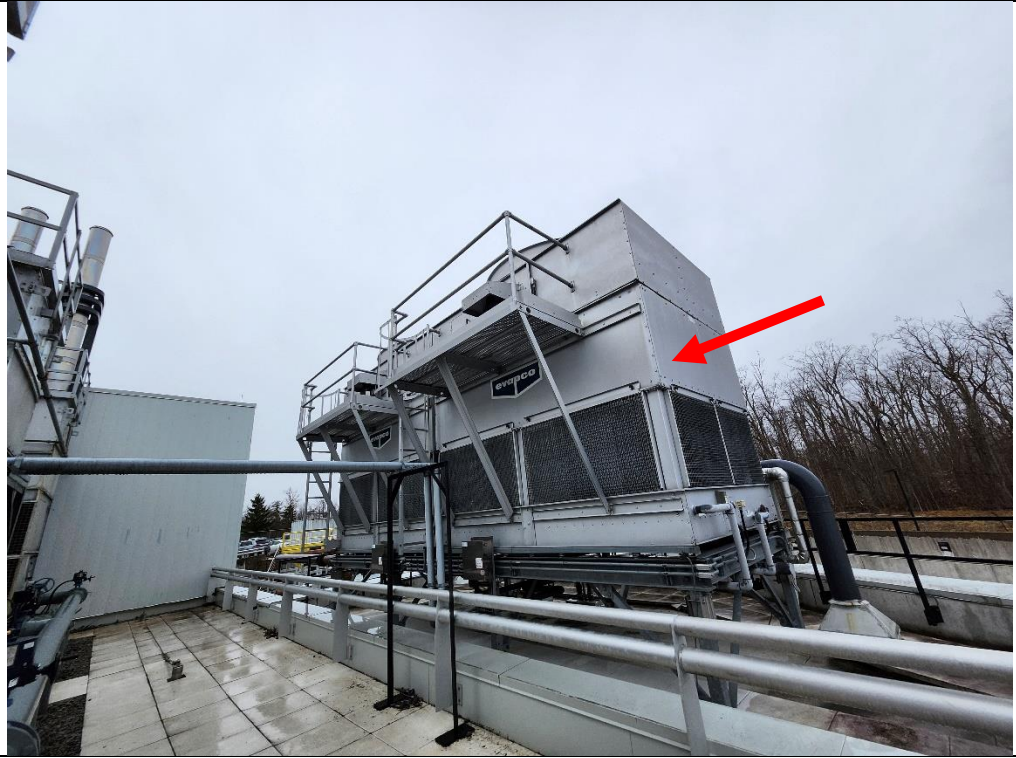
Representative
photo of grey paint
on rooftop unit

*This material was
sampled (29240-Pb-
01) and determined
by laboratory
analysis to be low-
level lead
containing.*

5. Renovation, demolition or general construction work involving the removal of paints with trace concentrations of lead (i.e. paints that are considered low-level lead paint or surface coatings) can be completed without lead specific safety precautions provided that;

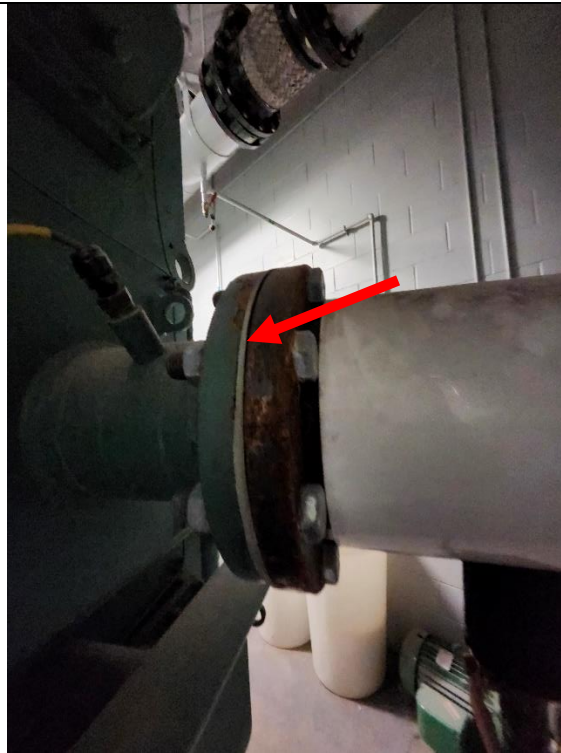
Photo No. 4.

- f. Grey mechanical gasket observed on the Chiller. Three (3) samples of this material were collected (29240-ASB-02A-C) and determined by laboratory analysis to be **asbestos-containing (55% Chrysotile)**.
- g. Red mechanical gasket observed on the Chiller. Three (3) samples of this material were collected (29240-ASB-03A-C) and determined by laboratory analysis to be non-asbestos.
- h. Grey caulking observed on exterior cooling towers. Three (3) samples of this material were collected (29240-ASB-04A-C) and determined by laboratory analysis to be non-asbestos.
- i. Black caulking observed on exterior cooling towers. Three (3) samples of this material were collected (29240-ASB-05A-C) and determined by laboratory analysis to be non-asbestos.
- j. Structural concrete and steel building components are not insulated.

**Asbestos-
containing** grey
mechanical gasket.

- Type 1 Asbestos Safety Precautions should be utilized for the disturbance or removal, of grey mechanical gaskets provided that materials are wetted to control the spread of dust or fibres and work is done only by means of non-powered hand-held tools.
2. All work should employ worker hygiene practices in compliance with Environmental Abatement Council of Canada (EACC) document; “*Construction Worker Hygiene Practices Guideline*”, dated 2014.
 3. For the purposes of this project, based on current and prior sampling results, it shall be presumed that all mechanical piping and associated equipment within the Project Area is contaminated with lead-dust.
