# Pre-Renovation Hazardous Materials Assessment Report

*Science Wing SW247, SW428E, SW526, SW526A, SW545, SW545V & SW546,  
University of Toronto Scarborough, 1265 Military Trail, Toronto, Ontario*

CA0049511.7487.0103 Rev1

28 April 2025

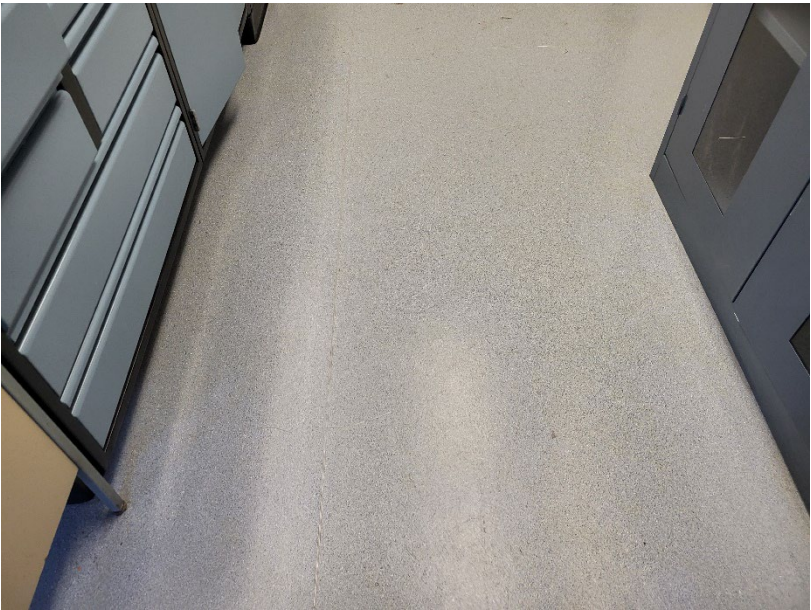
PHOTO NO.	DESCRIPTION & LOCATION	PHOTO
1	Representative view of asbestos-containing vinyl sheet flooring and associated mastic within SW546.

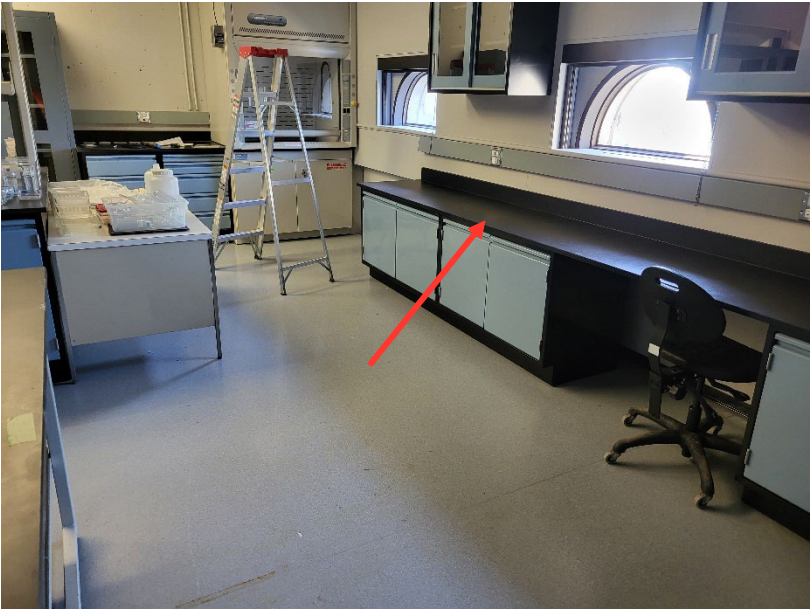
The discrepancy in laboratory analytical results between the initial sample submission and the extensive follow up bulk sample submission on the countertops is due to an initial false positive result that is attributable to cross contamination either during material sampling or laboratory sample preparation. However, based on the results of extensive supplementary sampling and analyses, the countertops should be considered non-asbestos containing.

2	Representative view of the non-asbestos containing countertops observed in SW546.

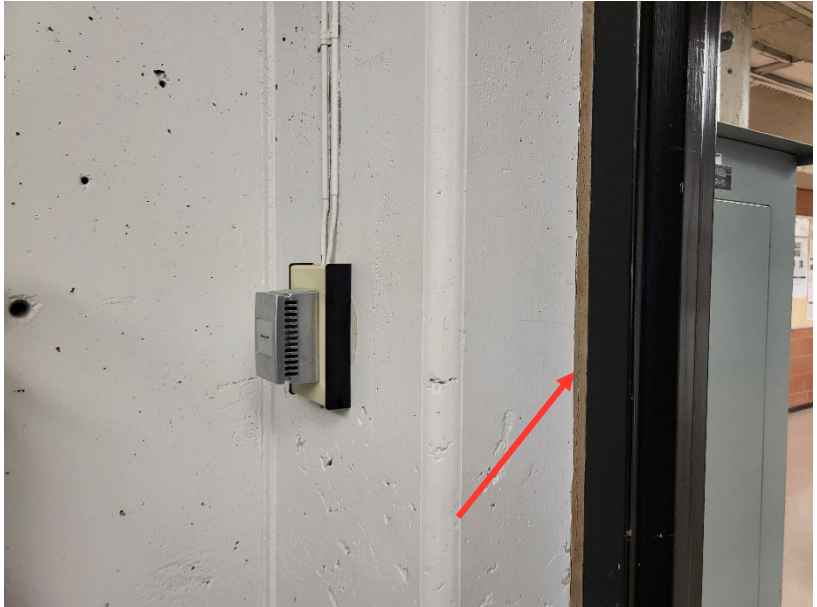
PHOTO NO.	DESCRIPTION & LOCATION	PHOTO
3	View of asbestos containing grey caulking observed around interior and exterior side of doors of SW546.

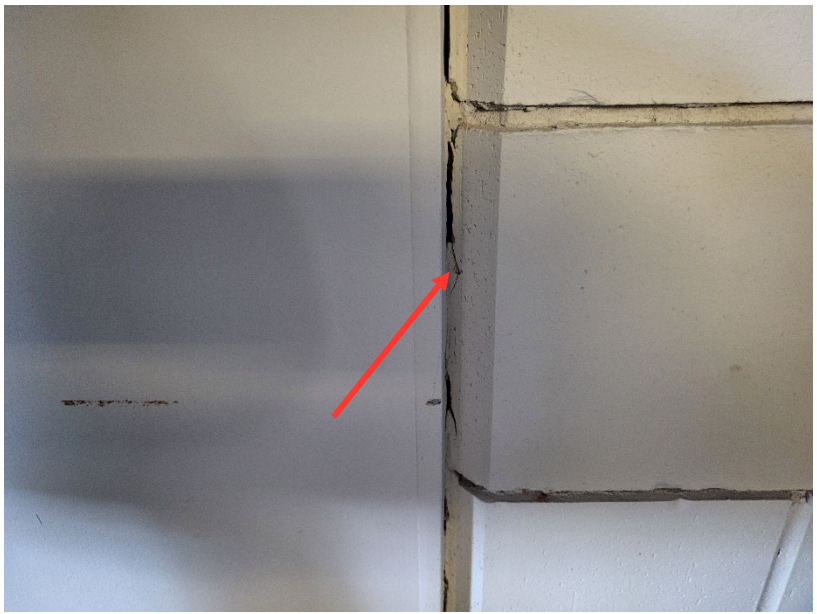
4	View of asbestos containing white caulking observed between cinderblock wall and metal door within SW546.

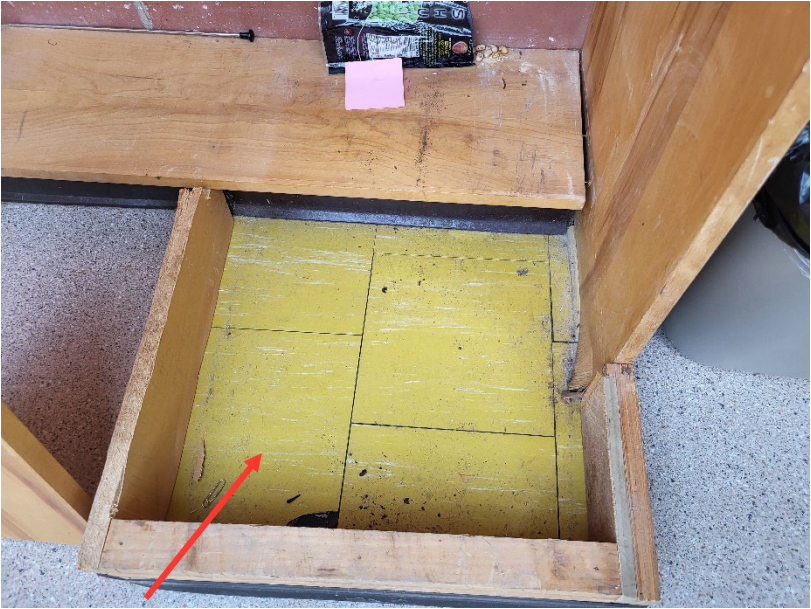
PHOTO NO.	DESCRIPTION & LOCATION	PHOTO
5	View of asbestos containing vinyl floor tile (9" x 9" yellow) and associated mastic observed as flooring (between cabinets) within SW526 and SW526A.

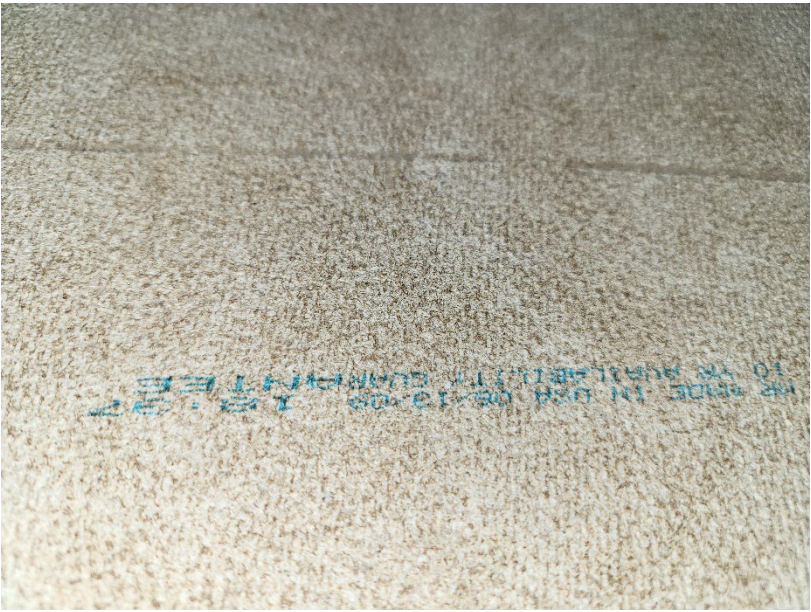
6	Representative view of date stamp on ceiling tiles within SW546.

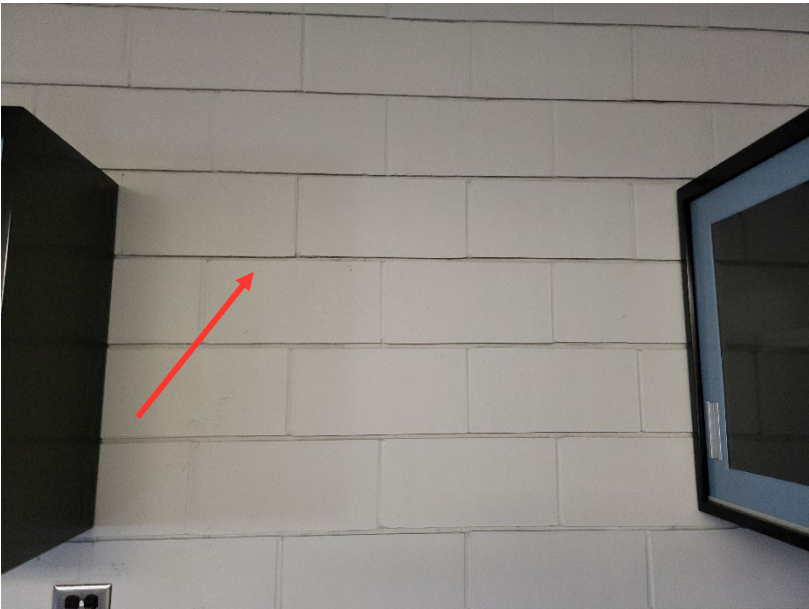
SAMPLE ID	PAINT COLOUR / SUBSTRATE	LOCATION	RESULTS <sup>1</sup>
Pb-01	White paint on concrete and drywall finishes	Interior walls and bulkhead ceiling within SW546	0.0071% lead by weight

PHOTO NO.	DESCRIPTION & LOCATION	PHOTO
7	View of lead-containing white paint observed on interior walls and bulkhead ceiling within SW546.

Material Description	Location	Sample Number	Sample Result	Qty	Unit	Condition	Recommendation	Photo #	Containing?
White paint on concrete, concrete block and drywall	Interior walls and bulkhead ceiling - SW546	Pb-01	0.0071% wt	-	-	Good	Disturbance should be performed in accordance with Ministry of Labour, Immigration, Training and Skills Development (MOL) "Guideline - Lead on Construction Projects".	7	Yes

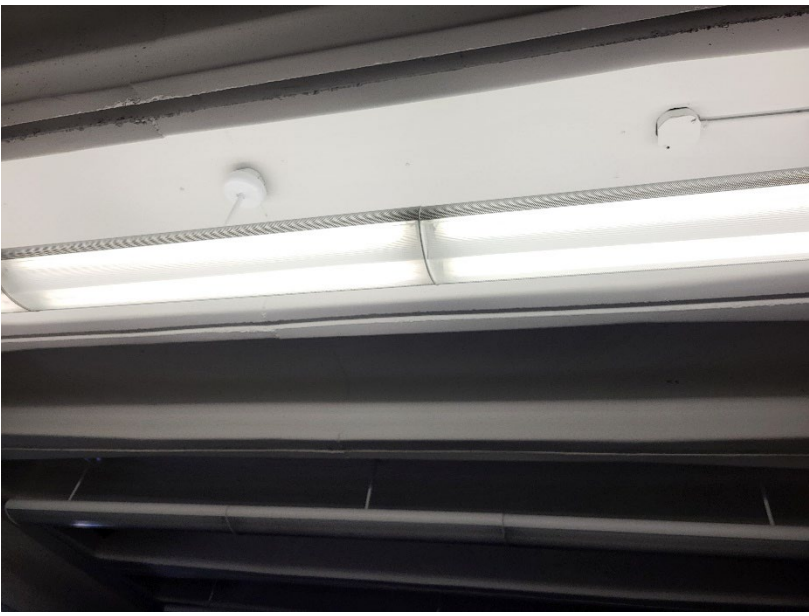
Florescent light tubes observed in the Study Area contain mercury vapour.

8	View of suspected mercury-containing fluorescent light tubes observed throughout the Study Area.

Mercury-containing devices are to be recycled wherever possible. Mercury is a hazardous waste, and recovery and disposal should be completed in accordance with provincial and federal requirements.

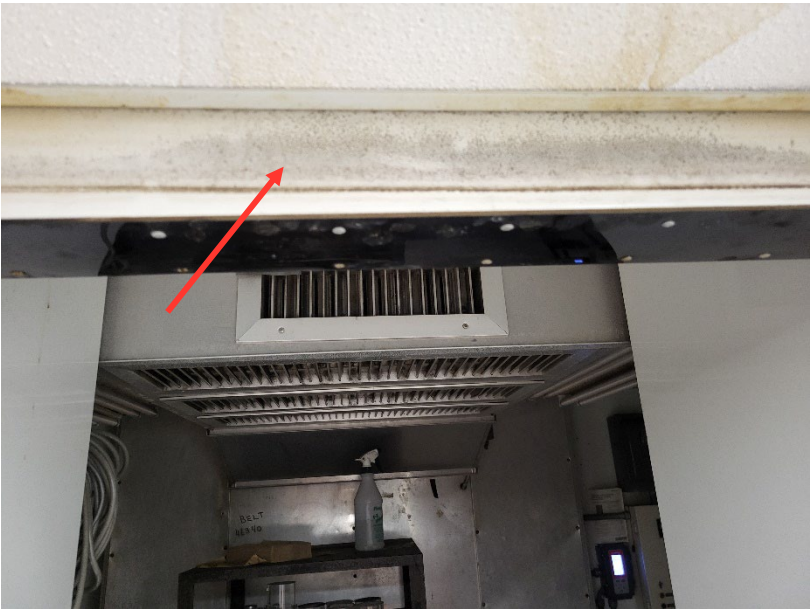
PHOTO NO.	DESCRIPTION & LOCATION	PHOTO
9	View of black staining observed on top of exterior side of door of SW545.

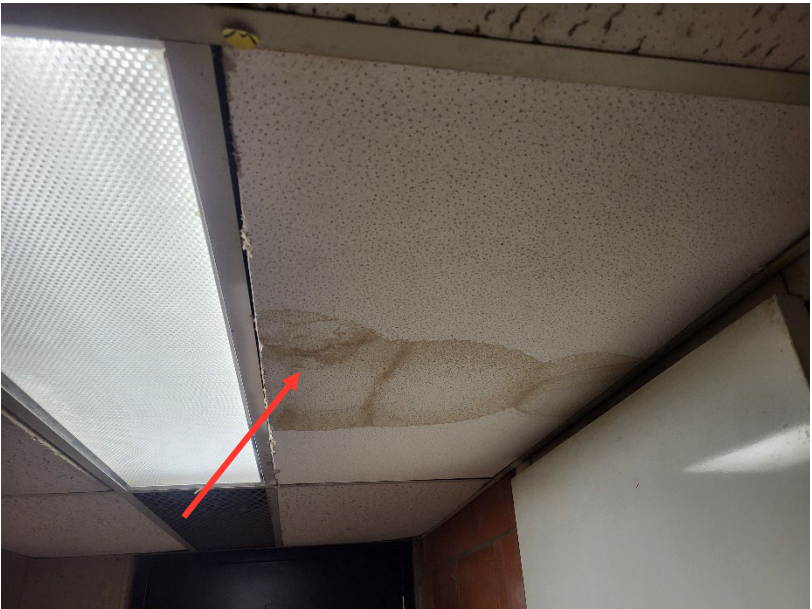
Visible water-stained building materials (drywall finishes and ceiling tiles) were noted in select areas of the Study Areas.

10	Representative view of water staining observed on ceiling tiles in SW545V.

Select building materials were noted to have water-staining. Water-impacted materials can be removed/remediated in accordance with Environmental Abatement Council of Canada (EACC) Level 1 mould remediation procedures.
