## **SURVEY FOR DESIGNATED SUBSTANCES AND HAZARDOUS MATERIALS**

**SCARBOROUGH CIVIC CENTRE AND TORONTO PUBLIC HEALTH  
140, 150, 160 BOROUGH DRIVE  
SCARBOROUGH, ONTARIO**

**ECOH Project No.: 28437-02**  
**October 17, 2024**

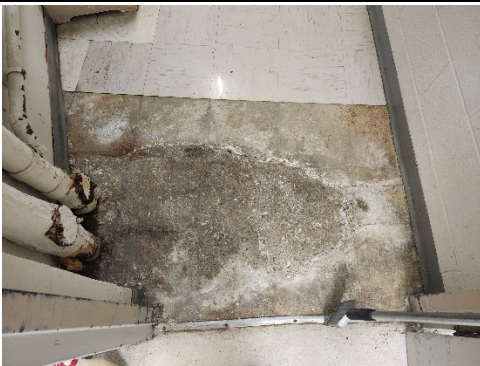
- One (1) mould affected / water-damaged non-asbestos ceiling tile within the Caretakers Office (Loc. B028).
- One (1) mould affected carpet within the Caretakers Office (Loc. B028).
- Approximately fifteen (15) square feet (SF) of mould affected / water-damaged asbestos containing vinyl floor tile (VFT) within the Caretakers Office (Loc. B028).
- Approximately forty (40) SF of damaged VFT and mastic within the Janitors Room (Loc. B042b).
- Two (2) loose VFT's within the Storage Room (Loc. A017).
- One (1) mould affected / water-damaged non-asbestos ceiling tile and four (4) other ceiling tiles with minor water stains within the Training Room (Loc. A008).
- One (1) SF of delaminated drywall with asbestos containing joint compound and surrounding debris within the Security Office (Loc. A119).

**Photo 1:** Site conditions after abatement work. (Loc. B028)

TABLE 5: Recommendations for Corrective Action - Mould			
Location Number	Location Name	Quantity and Type of Material	Recommended Action
B028	Basement Caretakers Office	3 SF Mould Growth on Non-Asbestos Ceiling Tile	REMOVE (Level I)
		1 Mould Effected Carpet	REMOVE (Level I)
		2 LF Mould Growth on Non-Asbestos Fiberglass Pipe Insulation	REMOVE (Level I)
		15 SF Mould Growth on Asbestos Containing Vinyl Floor Tiles	REMOVE/REPAIR (Level I)
A008	Training Room	4 SF Mould Growth on Non-Asbestos Ceiling Tile	REMOVE (Level I)

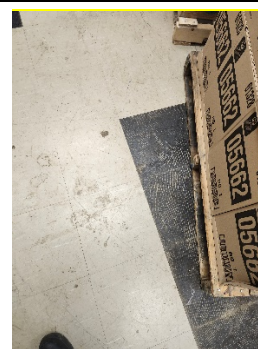
**Photo 2:** Site conditions after abatement work. (Loc. A017)

TABLE 2: Recommendations for Corrective Action - Asbestos			
Location Number	Location Name	Quantity and Type of Material	Recommended Action
B042b	Janitors Room	40 SF Loose Vinyl Floor Tiles	REMOVE (Type 1)
A017	Storage	2 SF Loose Vinyl Floor Tiles	REMOVE (Type 1)
A119	Security Office	1 SF Delaminating Drywall Joint Compound and Debris – Poor Condition	REMOVE (Type 1)

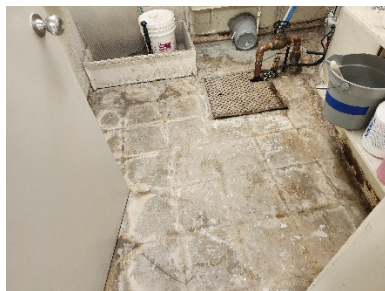
**Photo 3:** Site conditions after abatement work. (Loc. B042b)

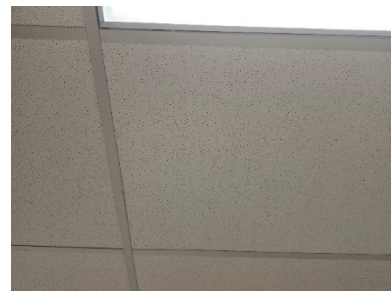
**Photo 3:** Site conditions after abatement work. (Loc. A008)

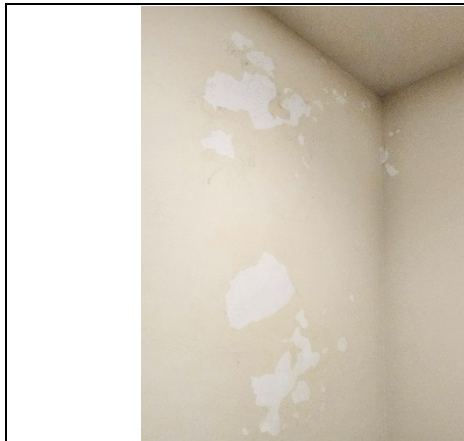
- Ten (10) SF of delaminated lead-containing yellow paint within the Room 213 Office (Loc. A223).
- Fifteen (15) SF of delaminated lead-containing white paint on two different planters in the 4<sup>th</sup> Floor Elevator Lobby (Loc. A402).
- Fifteen (15) SF of delaminated lead-containing white paint on two different planters in the 5<sup>th</sup> Floor Elevator Lobby (Loc. A502).
- Repaired one (1) SF of delaminated drywall with asbestos containing joint compound and surrounding debris within the Security Office (Loc. A119).

**Photo 1:** Site conditions after abatement work. (Loc. A223)

TABLE 3: Recommendations for Corrective Action - Lead			
Location Number	Location Name	Quantity and Type of Material	Recommended Action
A223	Office	10 SF Yellow Paint on Wall – Poor Condition	REMOVE (Class 2a)
A402	Elevator Lobby	15 SF White Paint on Wall – Poor Condition	REMOVE (Class 2a)
A502	Elevator Lobby	15 SF White Paint on Wall – Poor Condition	REMOVE (Class 2a)

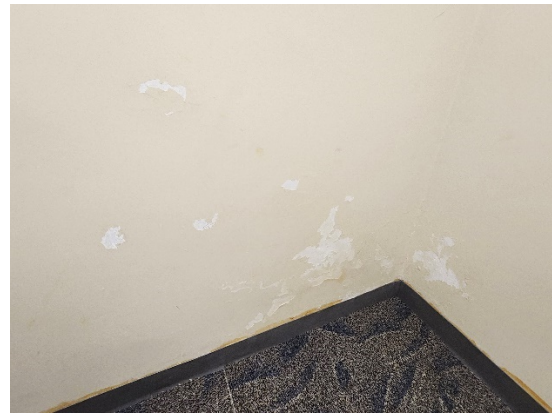
**Photo 2:** Site conditions after abatement work. (Loc. A223)

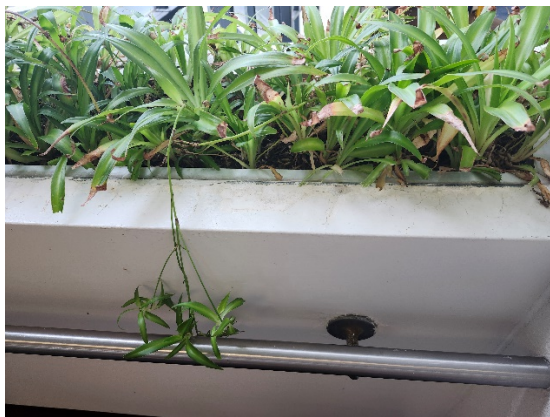
**Photo 3:** Site conditions after abatement work. (Loc. A402)

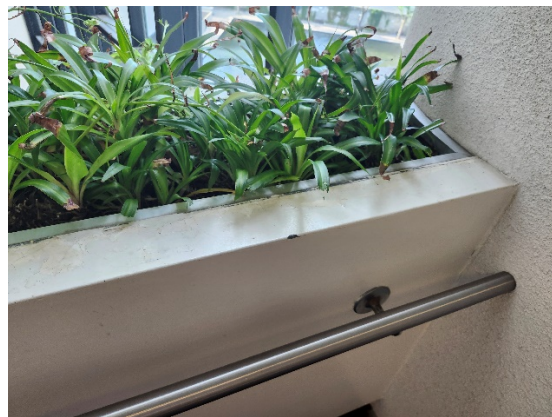
**Photo 3:** Site conditions after abatement work. (Loc. A402)
