## **PRE-RENOVATION DESIGNATED SUBSTANCES AND HAZARDOUS MATERIALS ASSESSMENT**

**SUITE 301 OFFICE OPTIMIZATION PROJECT  
465 DAVIS DRIVE  
NEWMARKET, ON**

**BGIS Project No.: IONP2716**

**May 14, 2025**

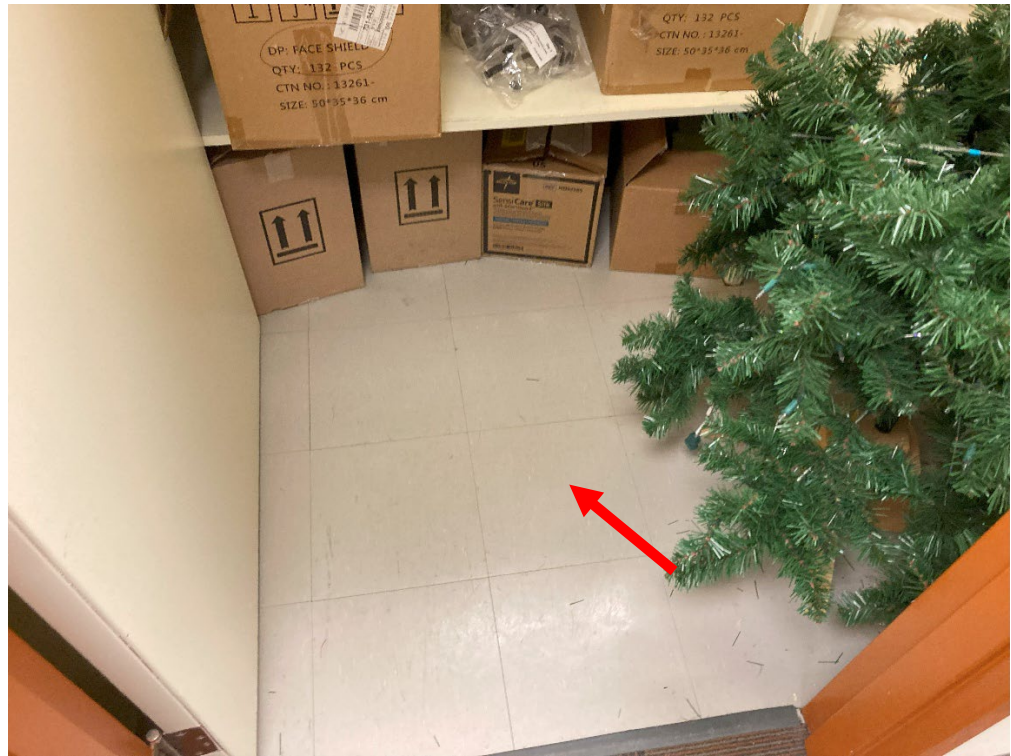
**Photo No. 1.**

- Vinyl Floor Tile 1 – 12" x 12" Grey. Three (3) representative samples of this material were collected (29231-ASB-02A-C) and were determined by laboratory analysis to be non-asbestos containing. The associated mastic was also determined to be non-asbestos containing.

Representative photo of non-asbestos containing Vinyl Floor Tile 1: 12" x 12" Grey.

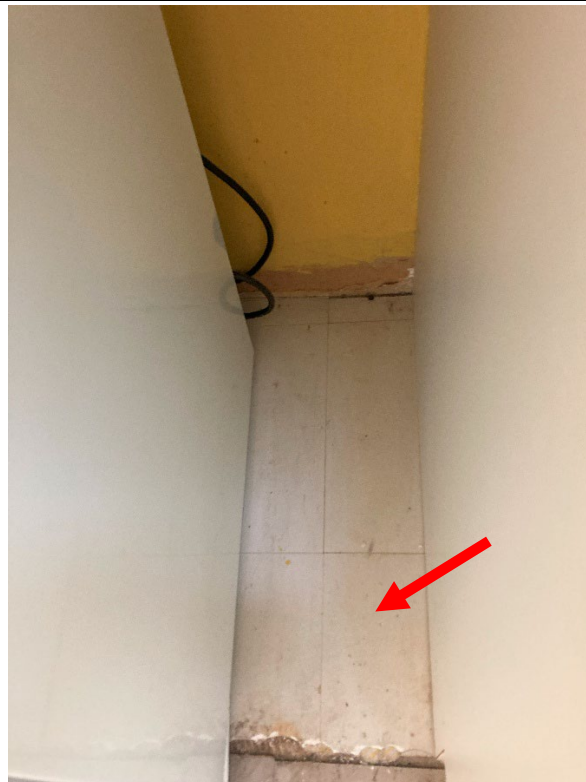
**Photo No. 2.**

- Vinyl Floor Tile 2 – 12"x12" White. Three (3) representative samples of this material were collected (29231-ASB-03A-C) and was determined by laboratory analysis to be non-asbestos containing. The associated mastic was also determined to be non-asbestos containing.

Representative photo of non-asbestos containing Vinyl Floor Tile 2: 12" x 12" White.

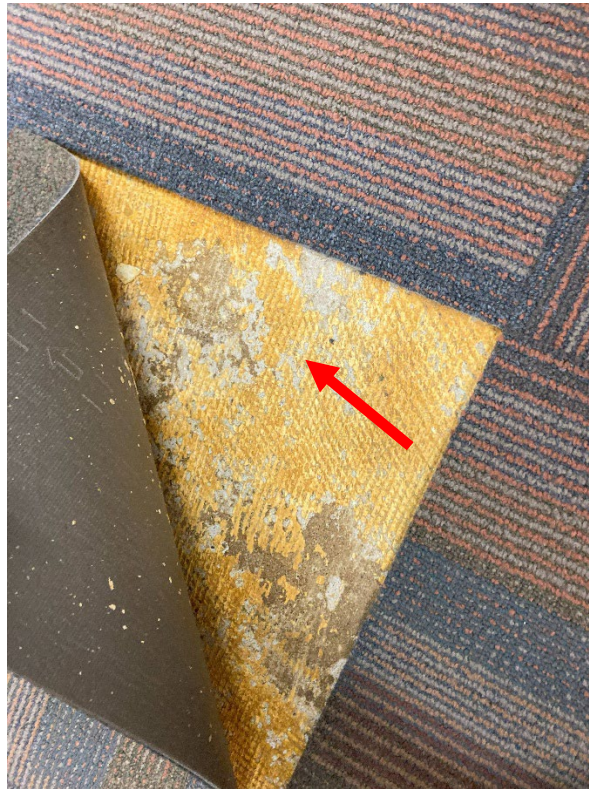
**Photo No. 3.**

- Carpet with Yellow Carpet Mastic. Three (3) representative samples of the yellow carpet mastic were collected (29231-ASB-01A-C) and were determined by laboratory analysis to be non-asbestos containing.

Representative  
photo of non-  
asbestos containing  
yellow carpet mastic  
on floor

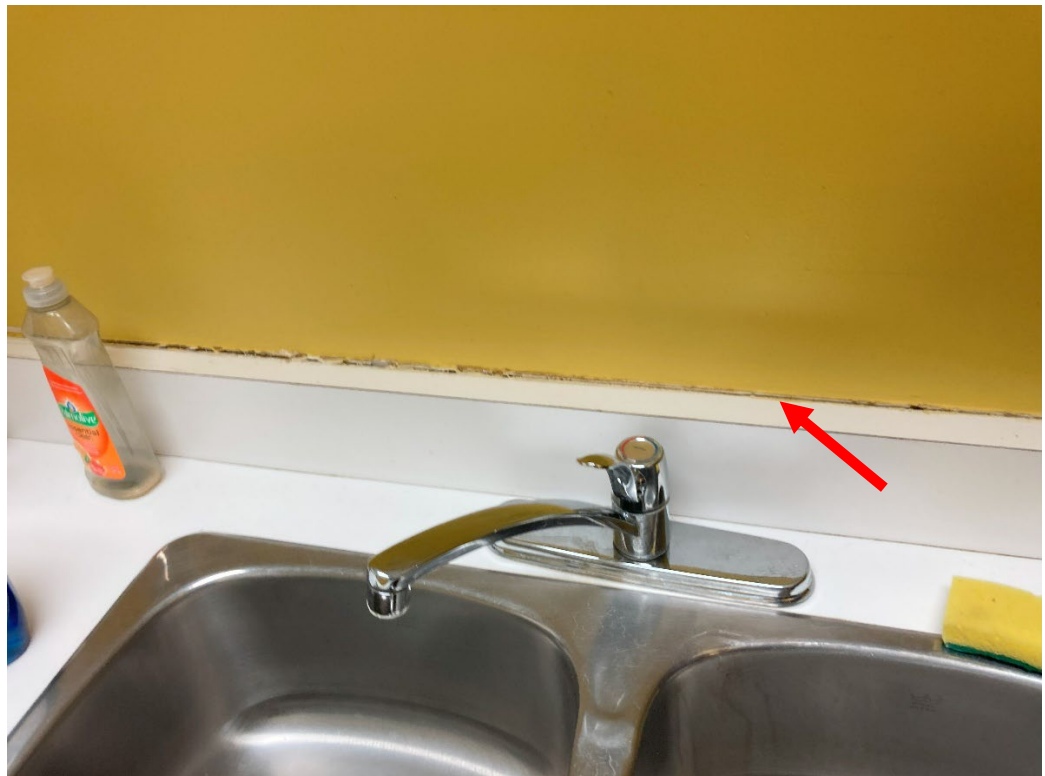
**Photo No. 4.**

- f) White Caulking on server cabinets was observed within the Project Area. Three (3) representative samples of this material were collected (29231-ASB-07A-C) and determined by laboratory analysis to be non-asbestos containing.

Representative  
photo of non-  
asbestos containing  
white caulking on  
cabinets.

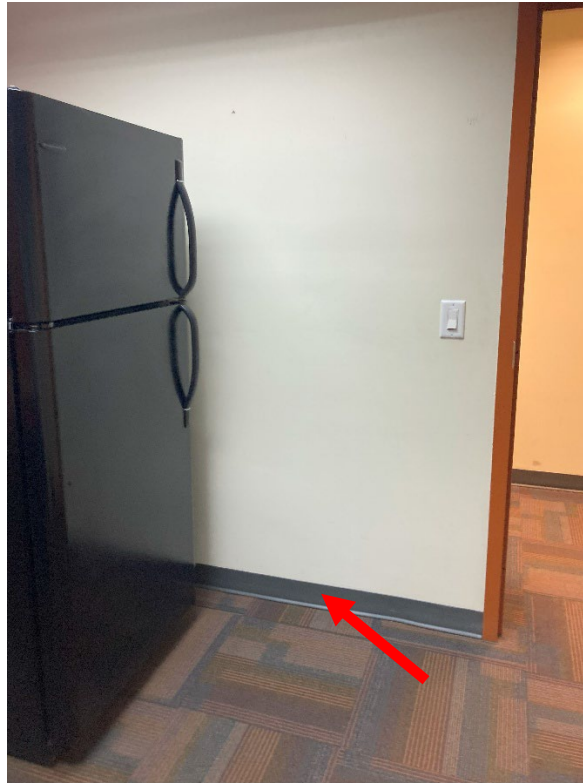
**Photo No. 5.**

- Ceiling Tile 3 – 2' x 2' with small and large pinholes. This material was not suspected to contain asbestos based on a date stamp (05/21/2018).
- d) Vinyl baseboards with yellow mastic were observed throughout the Project Area. Three (3) representative samples of the mastic were collected (29231-ASB-08A-C) and determined by laboratory analysis to be non-asbestos containing.

Representative  
photo of vinyl  
baseboard with non-  
asbestos containing  
yellow vinyl  
baseboard mastic.

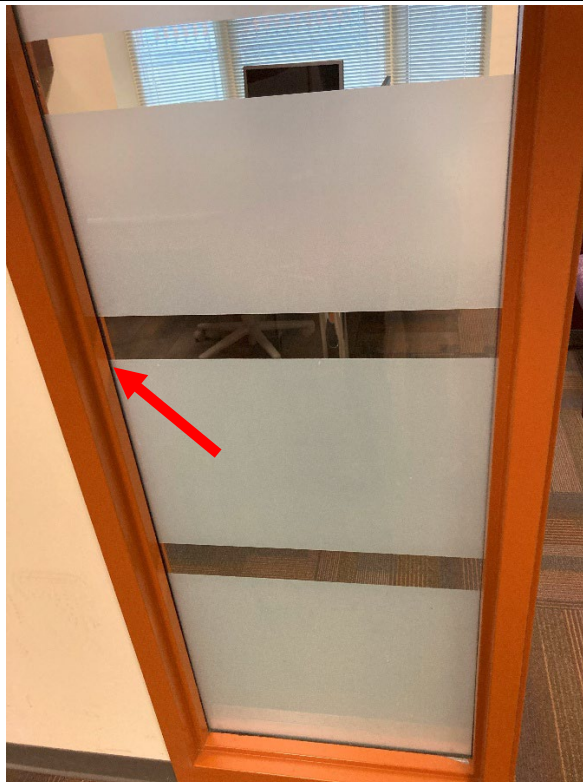
**Photo No. 6.**

- e) Black window glazing was observed on doors within the Project Area. Three (3) representative samples of this material were collected (29231-ASB-06A-C) and determined by laboratory analysis to be non-asbestos containing.

Representative  
photo non-asbestos  
containing black  
window glazing on  
office doors

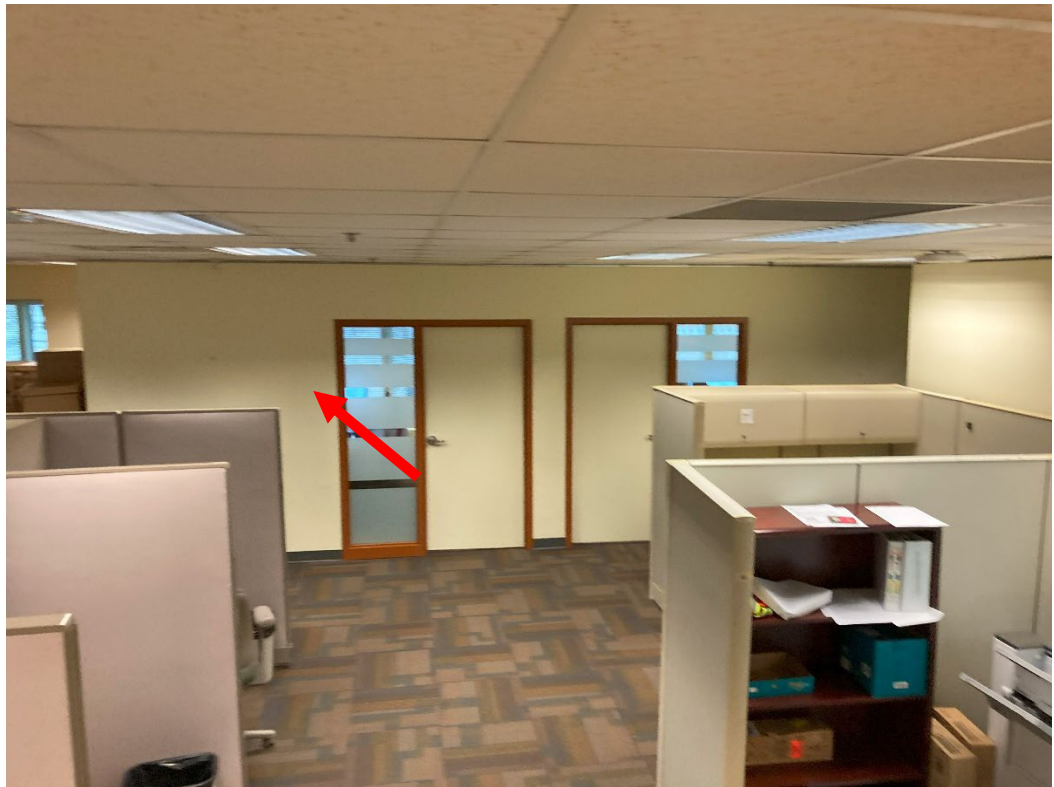
**Photo No. 7.**

- Drywall Joint Compound is a component of partition walls. Three representative samples of this material were collected (29231-ASB-04A-C) and determined by laboratory analysis to be non-asbestos containing.

- Drywall Joint Compound is a component of demising walls. Three representative samples of this material were collected (29231-ASB-05A-C) and determined by laboratory analysis to be non-asbestos containing.

Representative  
photo of drywall with  
non-asbestos  
containing drywall  
joint compound.
