**PRE-RENOVATION DESIGNATED SUBSTANCES AND
HAZARDOUS MATERIALS ASSESSMENT**

**CHILD CARE PROGRAM
MCNICOLL AVENUE
155 MCNICOLL AVENUE
TORONTO, ON**

ECOH Project No.: 29547

December 2, 2025

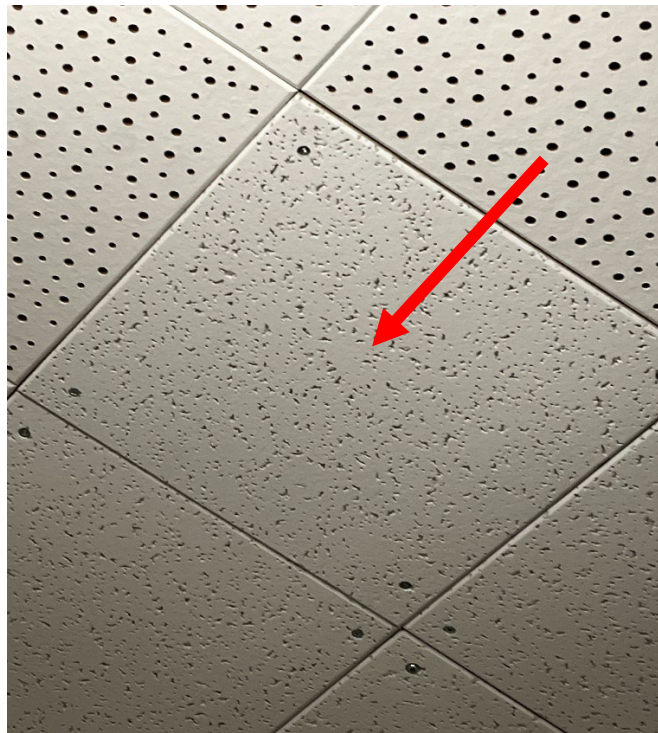
Description:
Representative photo of 1'x1' glue-on ceiling tile – medium fissures and pinholes.

This material was sampled and determined by laboratory analysis to be non-asbestos containing.

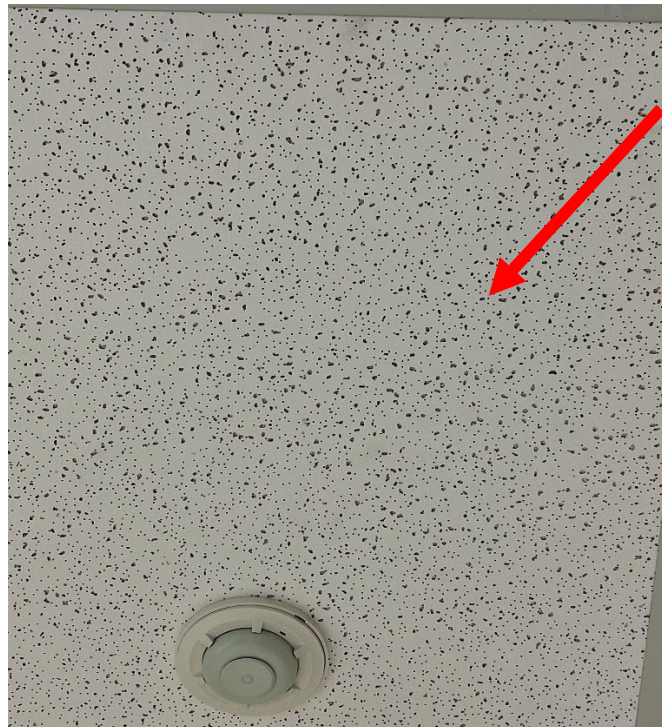
Photo No. 2.

Description:
Representative photo of 2'x4' lay-in ceiling tile – round fissures and pinholes.

This material was sampled and determined by laboratory analysis to be non-asbestos containing.

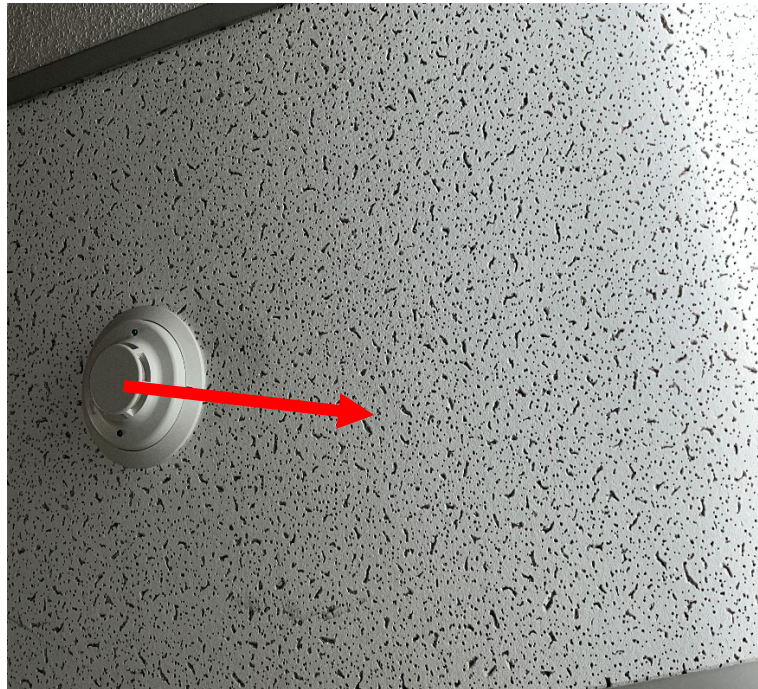
Representative photo of 2'x4' lay-in ceiling tile – long fissures and pinholes

This material was sampled and determined by laboratory analysis to be non-asbestos containing.

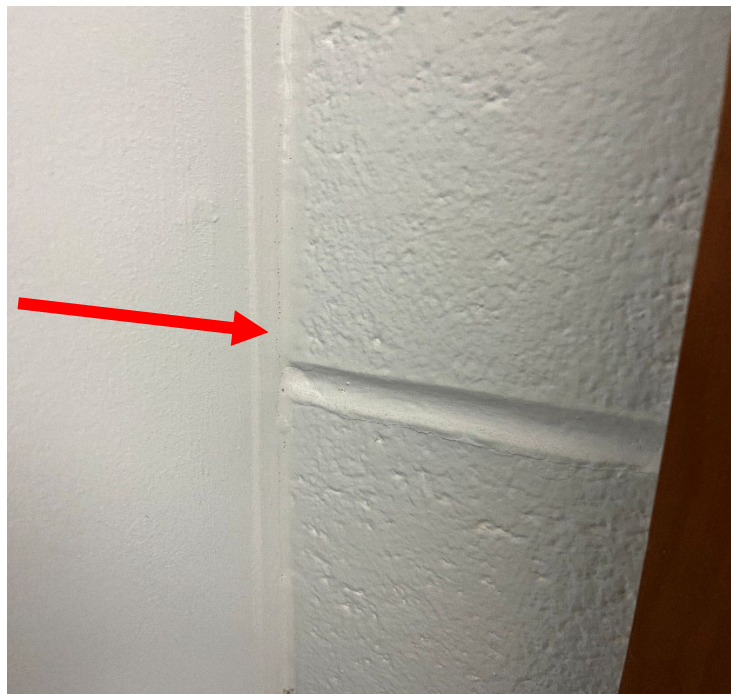
Photo No. 4.

Representative photo of grey caulking on wall.

This material was sampled and determined by laboratory analysis to be non-asbestos containing.

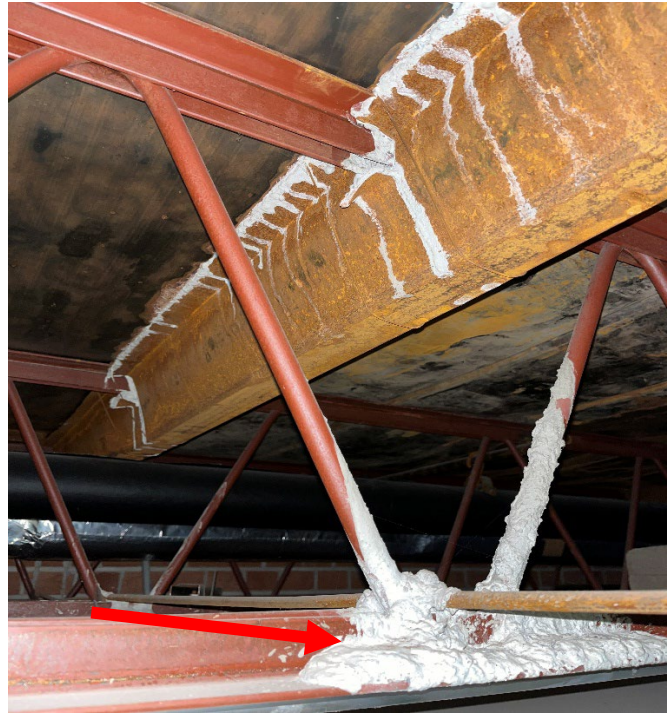
- d) Structural components (deck, beams, joists, etc.) in the Project Area are composed of metal.
- White Cementitious Material on Steel Joists. Three (3) representative samples were collected (Sample ID: 29547-ASB-05A-C) from the Project Area and determined by laboratory analysis to be **asbestos-containing material (0.5% Chrysotile)**.

Description:
Representative
photo of white
cementitious
material on steel
joist above 2'x4' lay-
in ceiling tile.

This material was
sampled and
determined by
laboratory analysis
to be **asbestos-
containing (0.5%
Chrysotile)**.

- Friable asbestos-containing white cementitious material observed on structural joists in the Facility/Project Area:
 - Type 2 Asbestos Safety Precautions must be utilized for the disturbance or removal of one square meter (~10 sq.ft.) or less of friable ACMs.

- Type 2 Glove Bag Asbestos Safety Precautions can be utilized where practical.
- Type 3 Asbestos Safety Precautions must be utilized for the disturbance or removal of more than one square meter of friable ACMs.

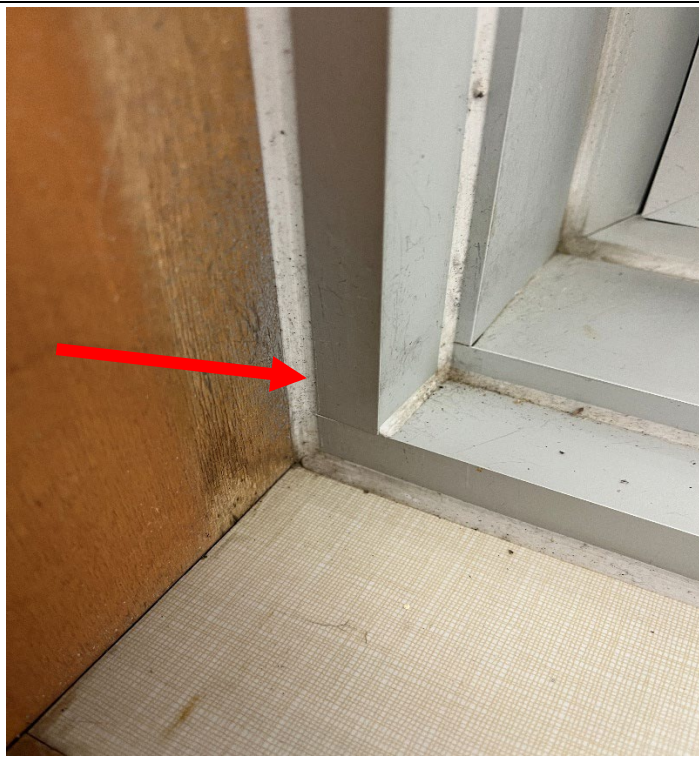
Photo No. 6.

Description:
Representative
photo of window
sealer.

This material was
sampled and
determined by
laboratory analysis
to be non-asbestos
containing.

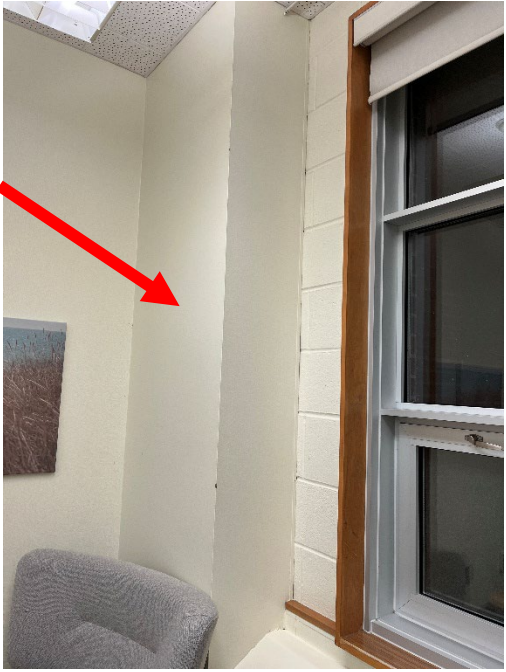
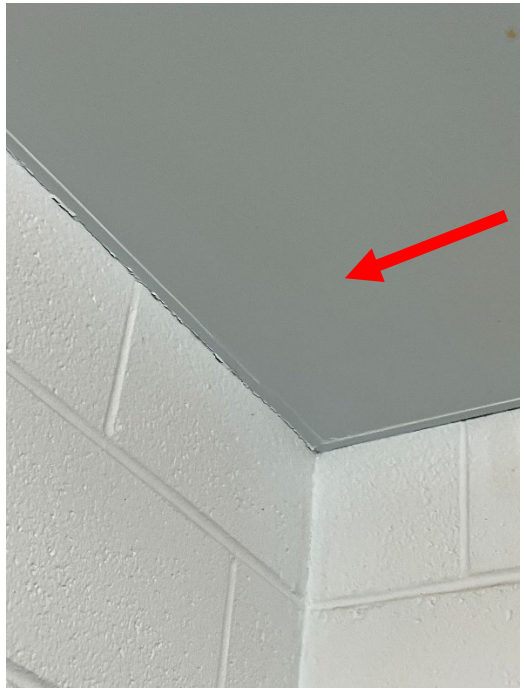
Photo No. 8.

Date: November 12, 2025		
Location: Various location.		
Description: Representative photo of drywall and joint compound on wall and ceiling.. This material was previously sampled and determined by laboratory analysis to be asbestos-containing .

- Potentially friable drywall joint compound observed throughout the Facility/Project Area:
 - Type 1 Asbestos Safety Precautions should be utilized for the disturbance or removal of less than one square metre of asbestos-containing drywall.

- Type 2 Asbestos Safety Precautions should be utilized for the disturbance or removal of one square metre or more of asbestos-containing drywall.
- 3. During work, if additional materials are revealed beyond what are described in this report, and historical reports referenced herein (i.e., materials not identified or materials that are not homogenous to those identified or materials that become revealed during the work), additional testing for asbestos-content should be completed immediately and prior to disturbance of the material.

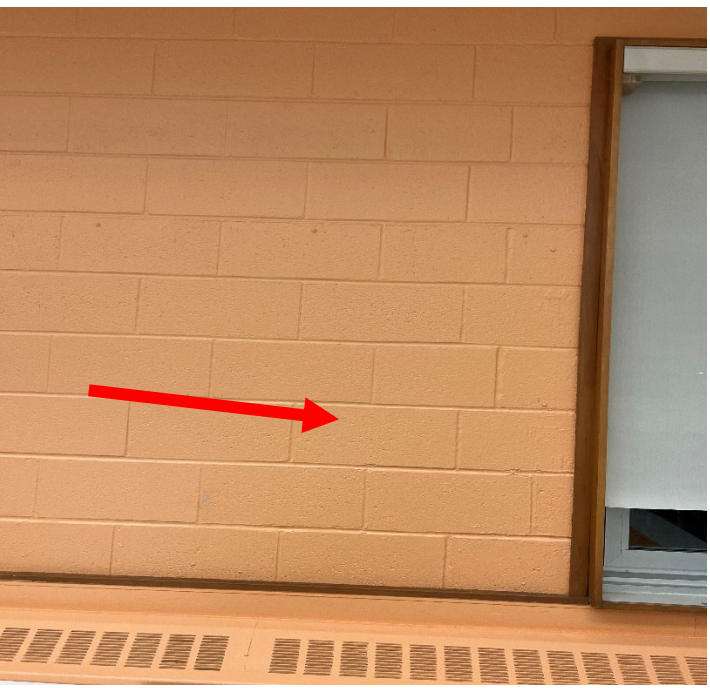
Photo No. 10.

Date: November 12, 2025	
Location: 2 nd Floor, Classroom (Loc. 216)	
Description: Representative photo of orange paint on wall. This material was sampled and determined by laboratory analysis to be low-level lead (44 ppm).

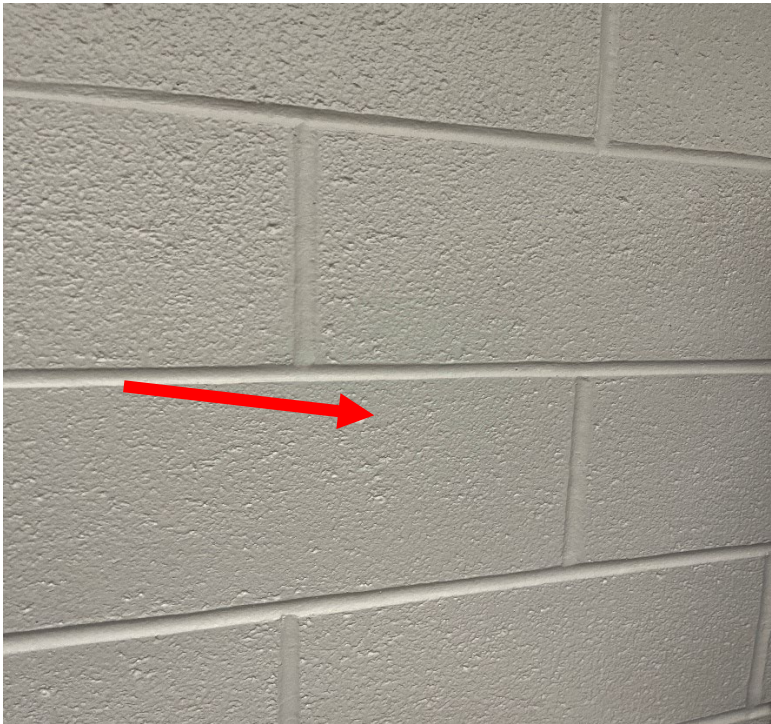
Photo No. 12.

Date: November 12, 2025	
Location: 1 st Floor, Office (Loc. 108)	
Description: Representative photo of Beige Paint on Wall. This material was sampled and determined by laboratory analysis to be low-level lead (92 ppm).

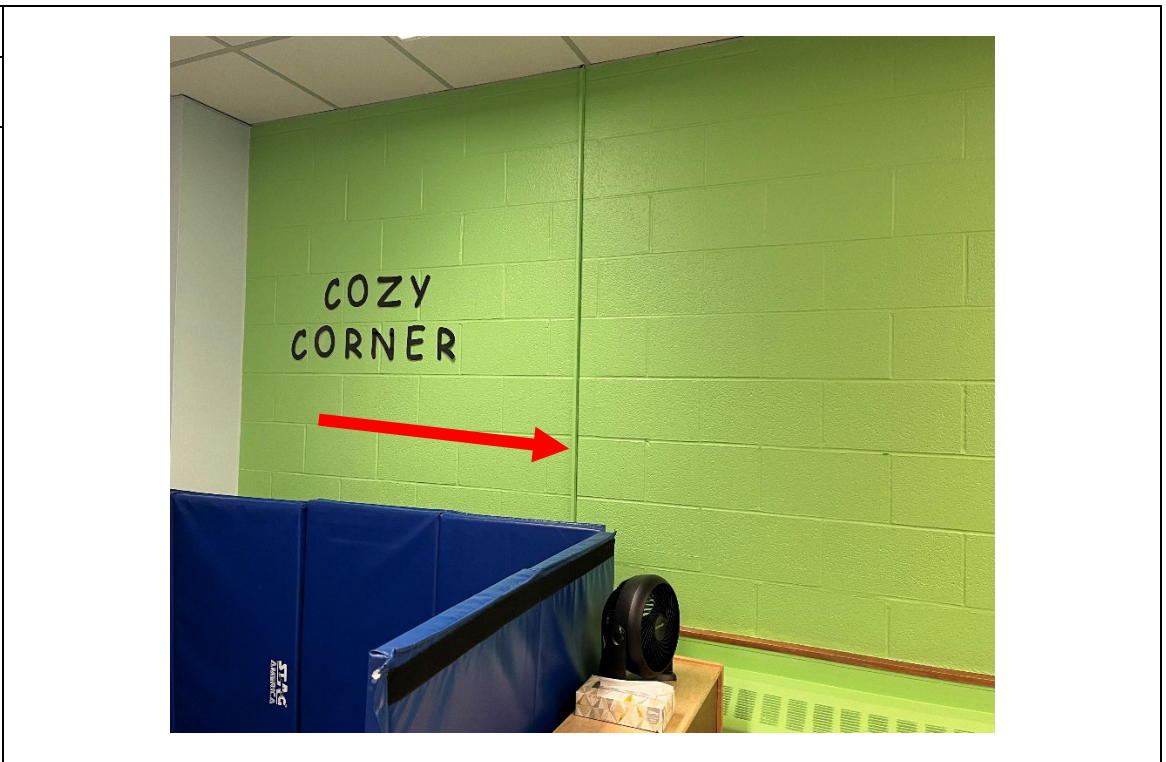
Description:
Representative photo of green paint on wall.

This material was sampled and determined by laboratory analysis to be low-level lead (<5 ppm).

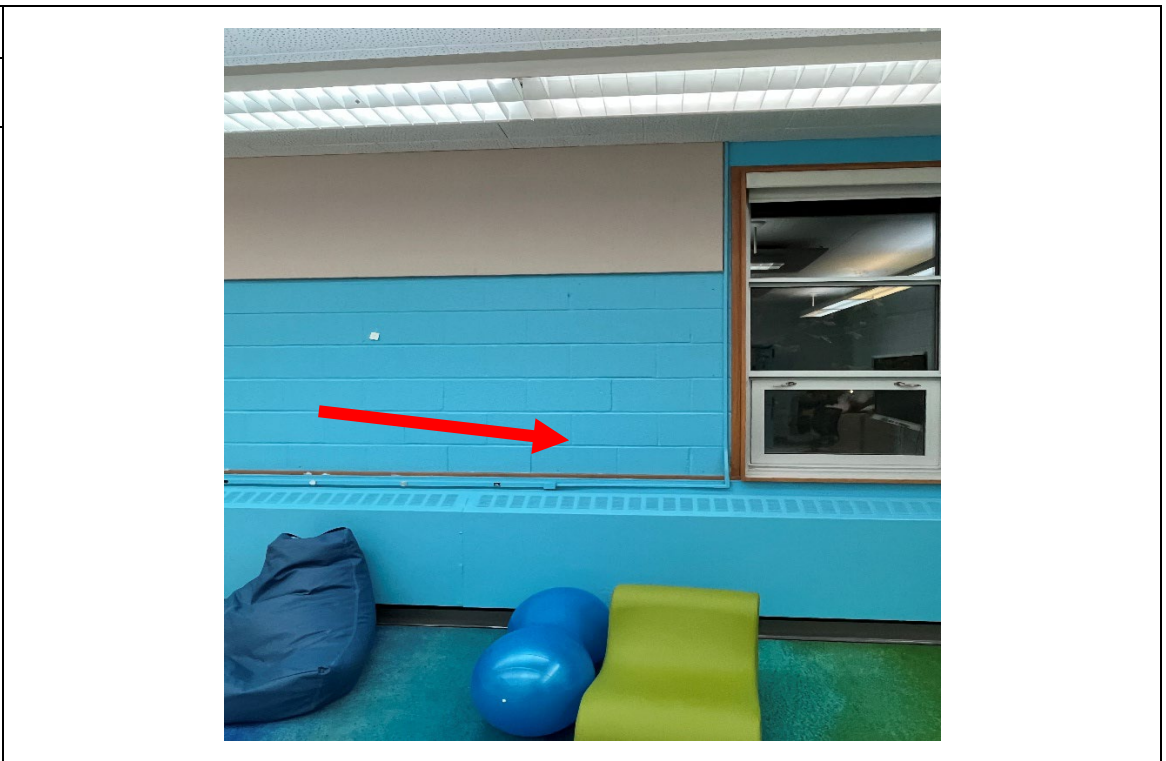
Photo No. 14.

Description:
Representative photo of sky-blue paint on wall.

This material was sampled and determined by laboratory analysis to be low-level lead (34 ppm).

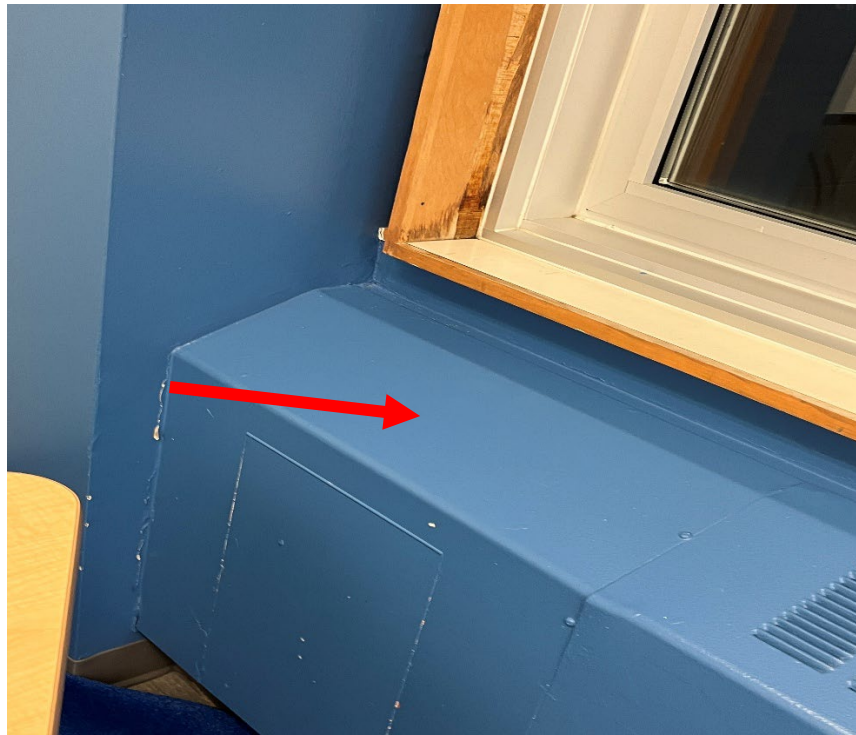
Representative photo of blue paint on wall.

This material was sampled and determined by laboratory analysis to be low-level lead (<5 ppm).

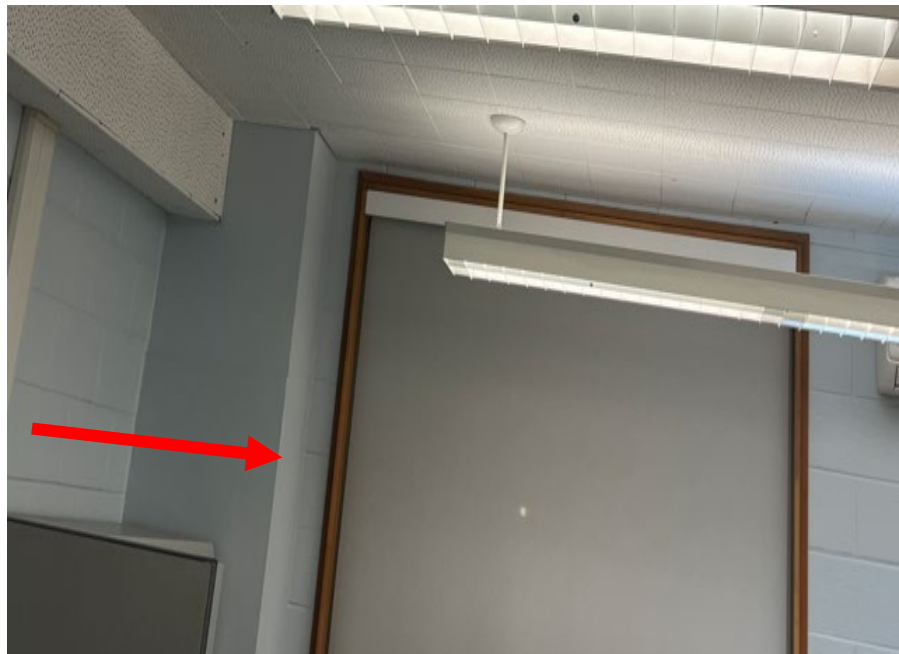
Photo No. 16.

Representative photo of Light Blue.

This material was sampled and determined by laboratory analysis to be low-level lead (57 ppm).

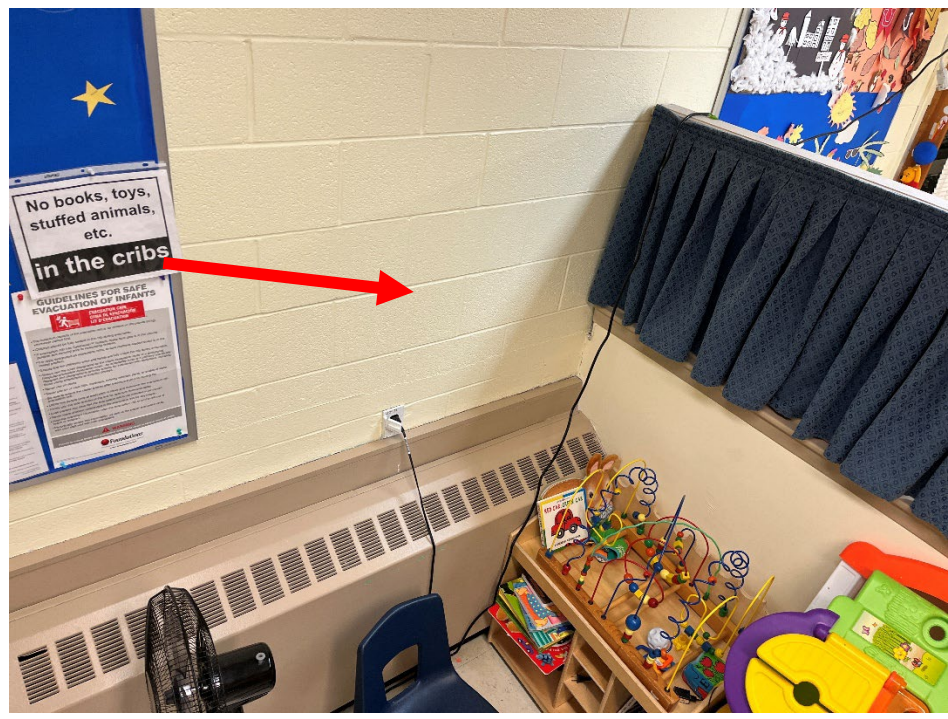
Description:
Representative
photo of light-yellow
paint on wall.

This material was
sampled and
determined by
laboratory analysis
to be **lead-
containing (1,160
ppm).**

- 4. Any work involving the disturbance of “lead-containing” paints should be conducted following recommendations detailed within the Ministry of Labour document Guideline - Lead on Construction Projects, dated November 2022, and the Environmental Abatement Council of Canada (EACC) Lead Guideline, dated January 2025.
