August 29, 2025

**Re: Asbestos Reassessment**

St. James Catholic School, 10 Clover Ridge Drive West, Ajax, Ontario  
Pinchin File: 358839.000

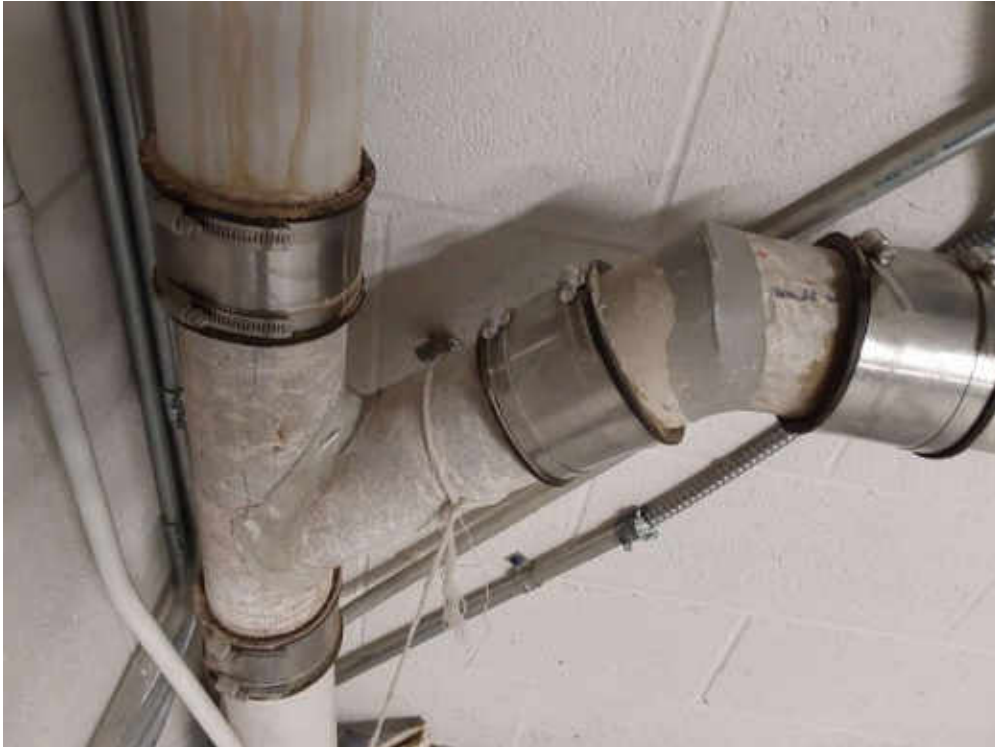
| Sample Number | Material Description | Type of Asbestos | Confirmed Hazard | Total Quantity Present | Material Specific Notes |
|---|---|---|---|---|---|
| S0002 ABC | Grey cementitious adhesive on Transite pipe | Chrysotile | Yes | 6 SF | |

S0002A (Confirmed Asbestos), Cementitious adhesive, Other, Adhesive/mastic, Boiler Room (Location #: 44)  
 On Transite rainwater leaders

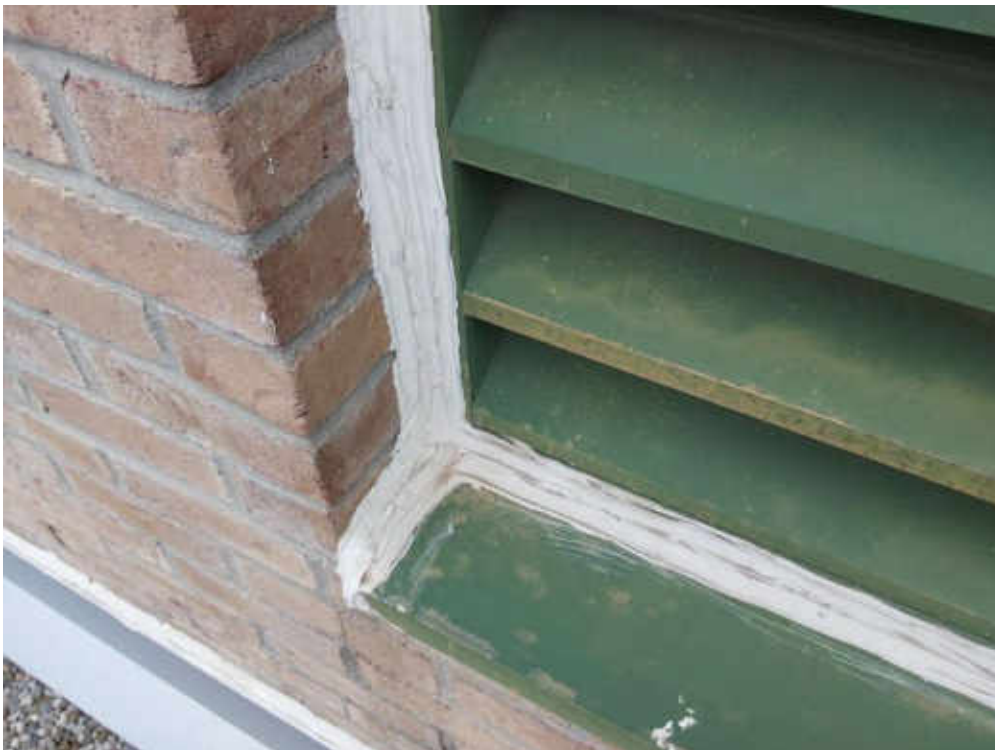
| Sample Number | Material Description | Type of Asbestos | Confirmed Hazard | Total Quantity Present | Material Specific Notes |
|---|---|---|---|---|---|
| S0006 ABC | Black caulking on roof louvres | Chrysotile | Yes | 500 LF | |

S0006A (Confirmed Asbestos), Black caulking on roof louvers, Other, Caulking, Roof 1 (Location #: 54)  
 Beneath new white caulking on roof louvers, b126740 - 2016 - 0002

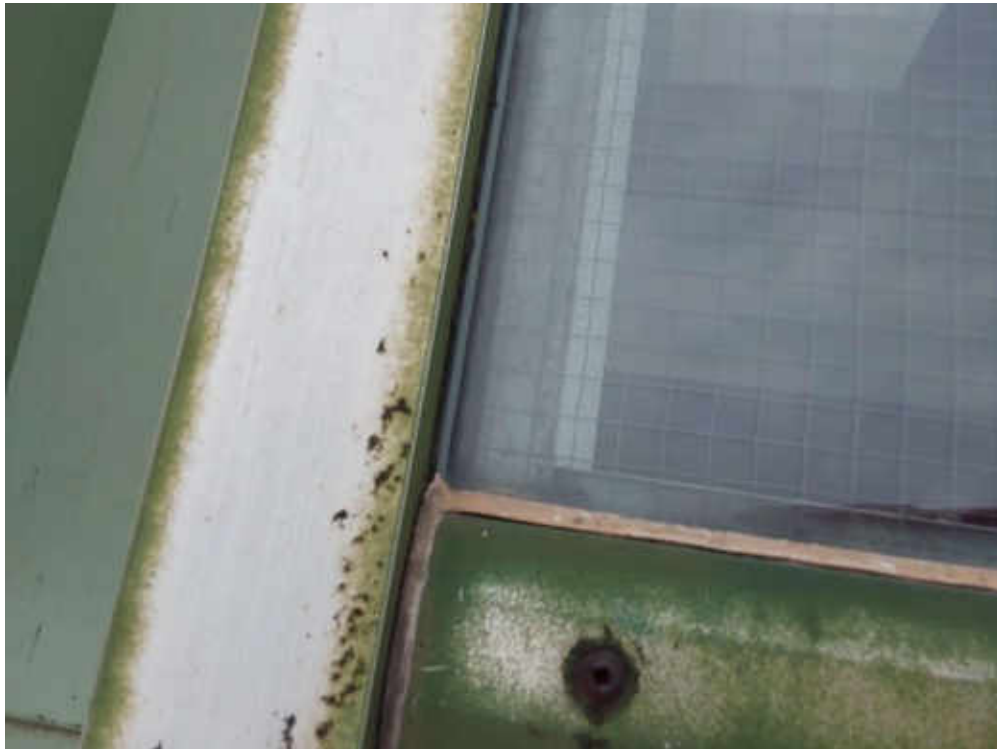
| Sample Number | Material Description | Type of Asbestos | Confirmed Hazard | Total Quantity Present | Material Specific Notes |
|---|---|---|---|---|---|
| S0017 ABC | Butyl sealant on atrium and chapel windows | Chrysotile | Yes | 500 LF | |

S0017A (Confirmed Asbestos), Butyl Sealant, Other, Window Liner, Caulking, Roof 1 (Location #: 54)  
On Atrium and Chapel windowpanes and frames.

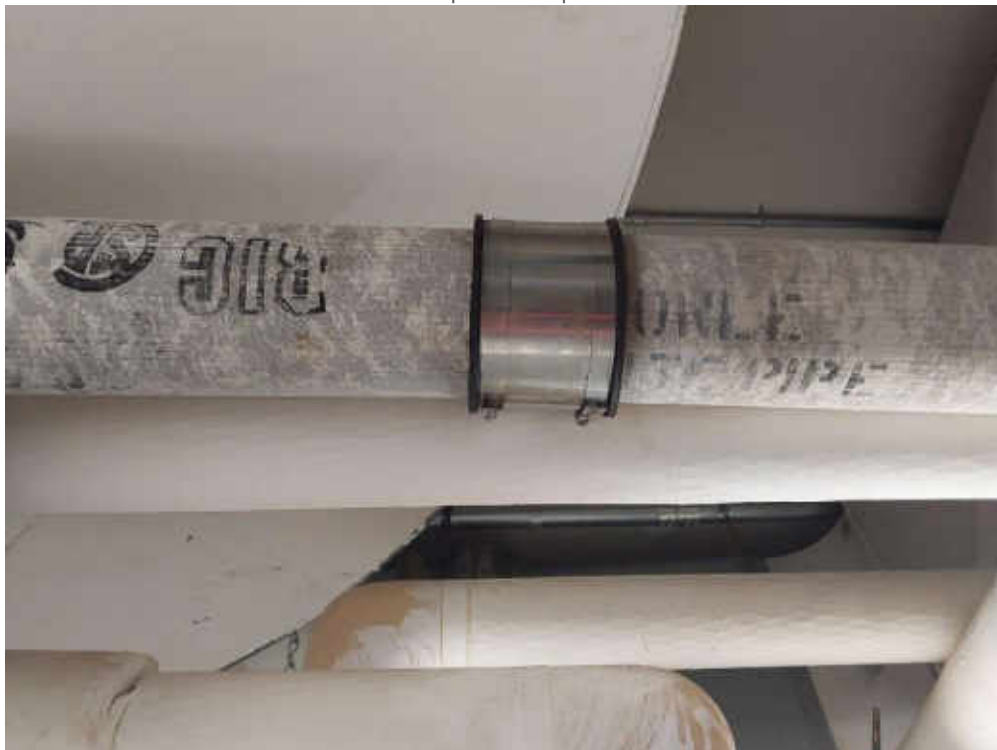
| Sample Number | Material Description | Type of Asbestos | Confirmed Hazard | Total Quantity Present | Material Specific Notes |
|---|---|---|---|---|---|
| V9000 | Transite pipe as rainwater leaders | Confirmed Asbestos | Yes | 150 LF | |

V9000 (Confirmed Asbestos), Piping, Rainwater Leader, Cement Product, Boiler Room (Location #: 44)  
Transite pipe

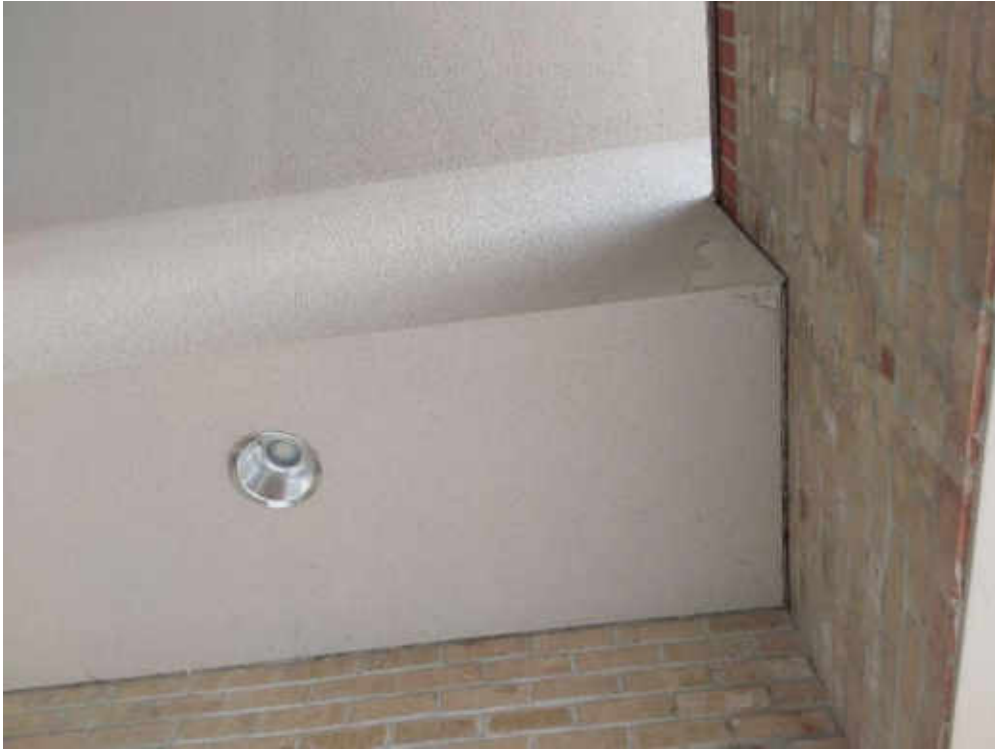
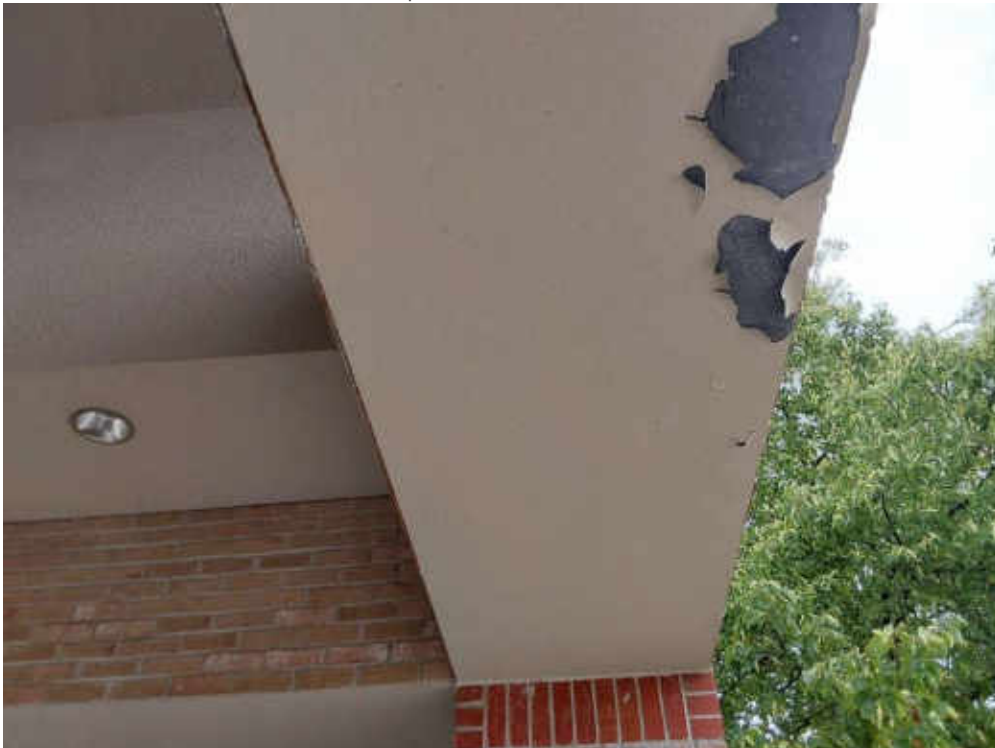
| Sample Number | Material Description | Type of Asbestos | Confirmed Hazard | Total Quantity Present | Material Specific Notes |
|---|---|---|---|---|---|
| V9500 | Transite panels on exterior soffits | Presumed Asbestos | Yes | 400 SF | |

V9500 (Presumed Asbestos), Other, Cement Product, Exterior (Location #: 1)  
Transite panels above main entrance

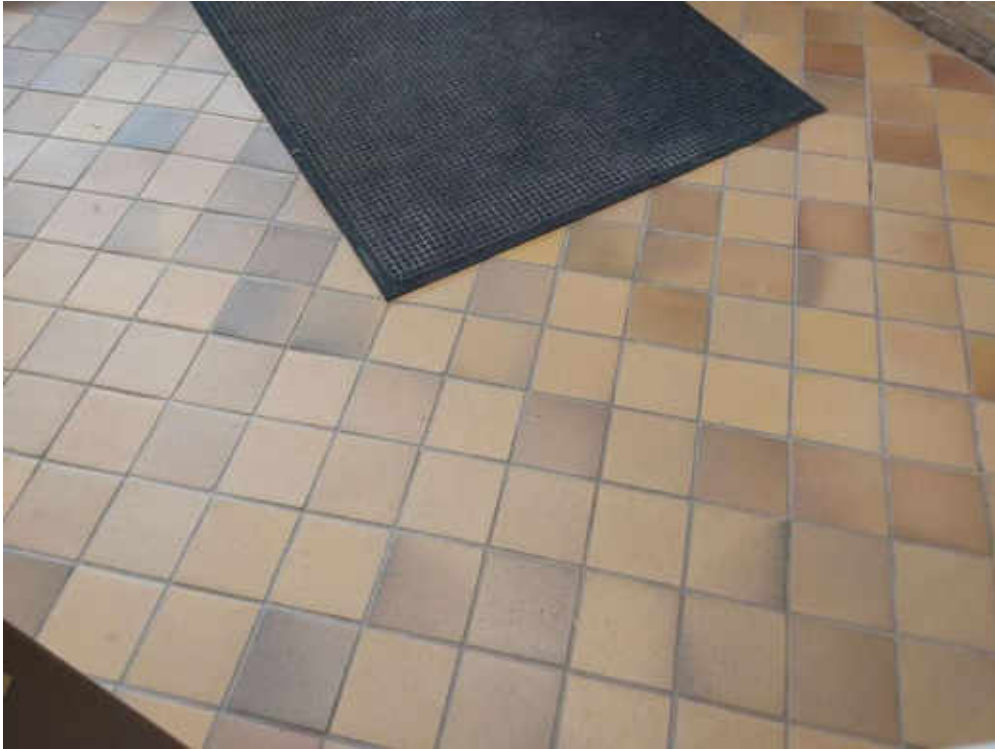
| Sample Number | Material Description | Type of Asbestos | Confirmed Hazard | Total Quantity Present | Material Specific Notes |
|---|---|---|---|---|---|
| V9500 | Thin set beneath ceramic tiles | Presumed Asbestos | Yes | 2,950 SF | |

V9500 (Presumed Asbestos), Floor, All, Mortar, Vestibule (Location #: 2)
