September 2, 2025

**Re: Asbestos Reassessment**

St. John the Evangelist Catholic Element, 1103 Giffard Street, Whitby, Ontario  
Pinchin File: 358839.000

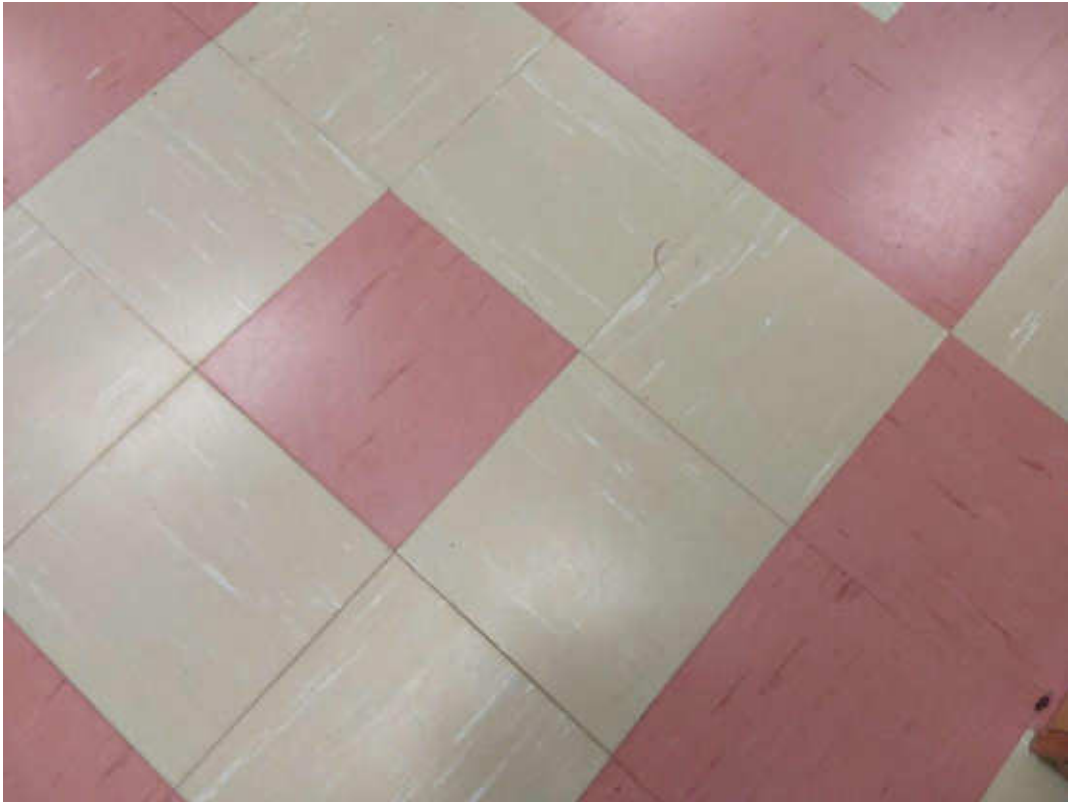
V0002 (Confirmed Asbestos), 9 x 9 beige with white streaks, Floor, Vinyl Floor Tile and Mastic, Room 3 (Location #: 5)  
Mastic is presumed to contain asbestos

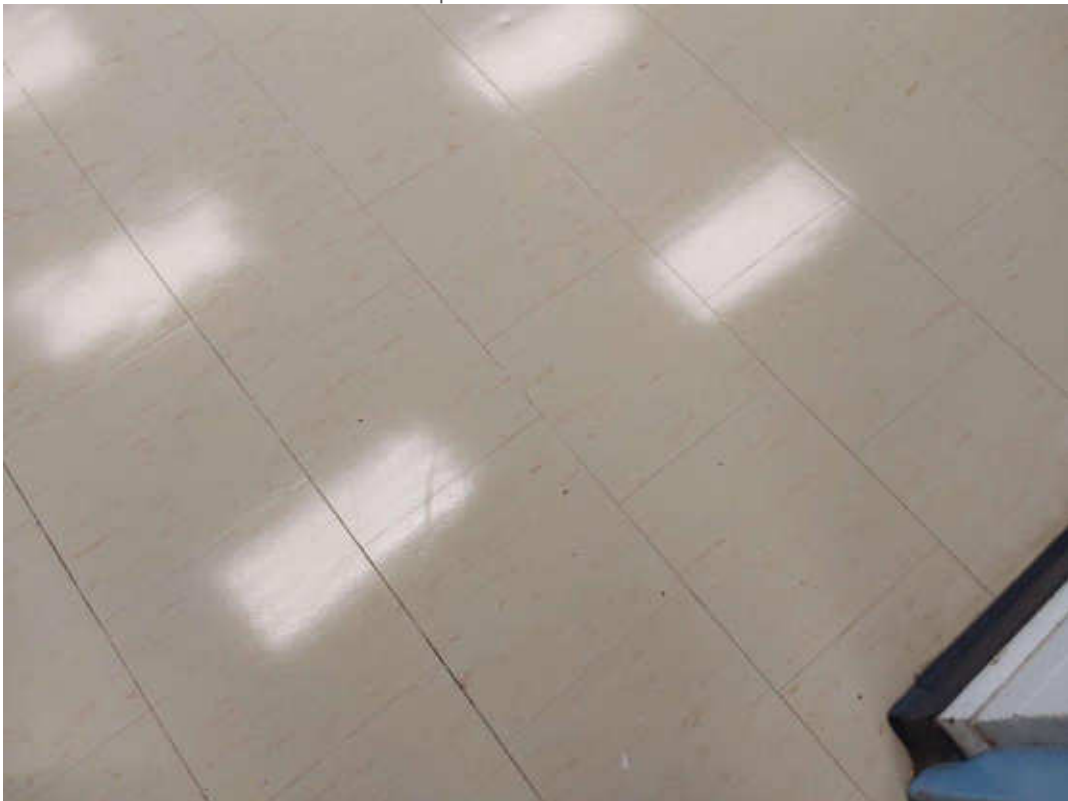
V0003 (Confirmed Asbestos), 12 x 12 tan with white and brown flecks, Floor, Vinyl Floor Tile and Mastic, Classroom 109  
(Location #: 29) Mastic is presumed to contain asbestos

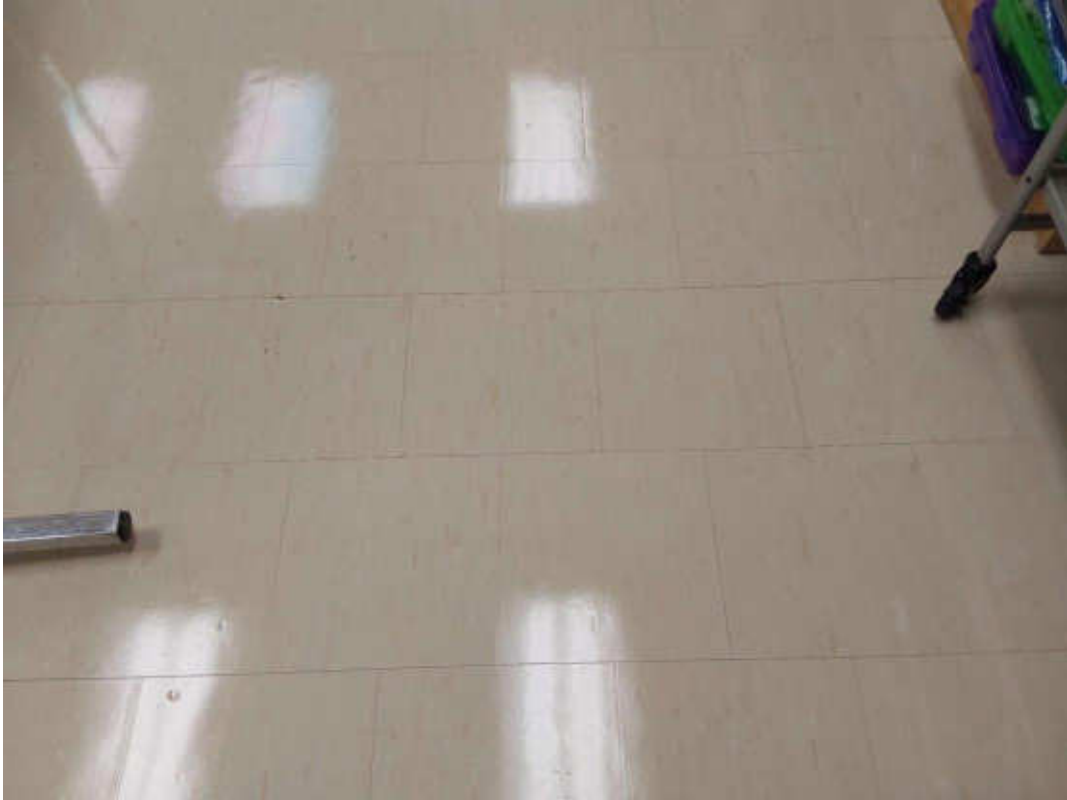
S0010 (Confirmed Asbestos), 12 x 12 tan with white and brown flecks, Floor, Vinyl Floor Tile and Mastic, Classroom 103  
(Location #: 26) Mastic is presumed to contain asbestos

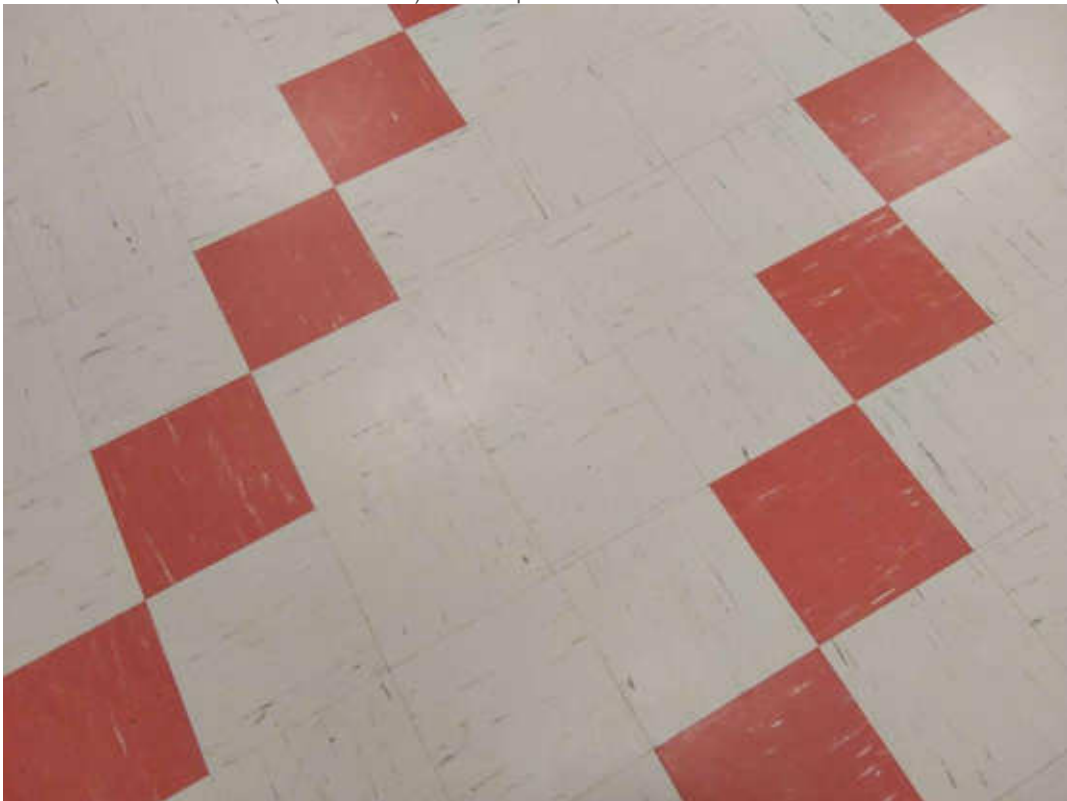
S0017 (Confirmed Asbestos), 9 x 9 grey with black streaks, Floor, Vinyl Floor Tile and Mastic, Room 1 (Location #: 4)  
Mastic is presumed to contain asbestos

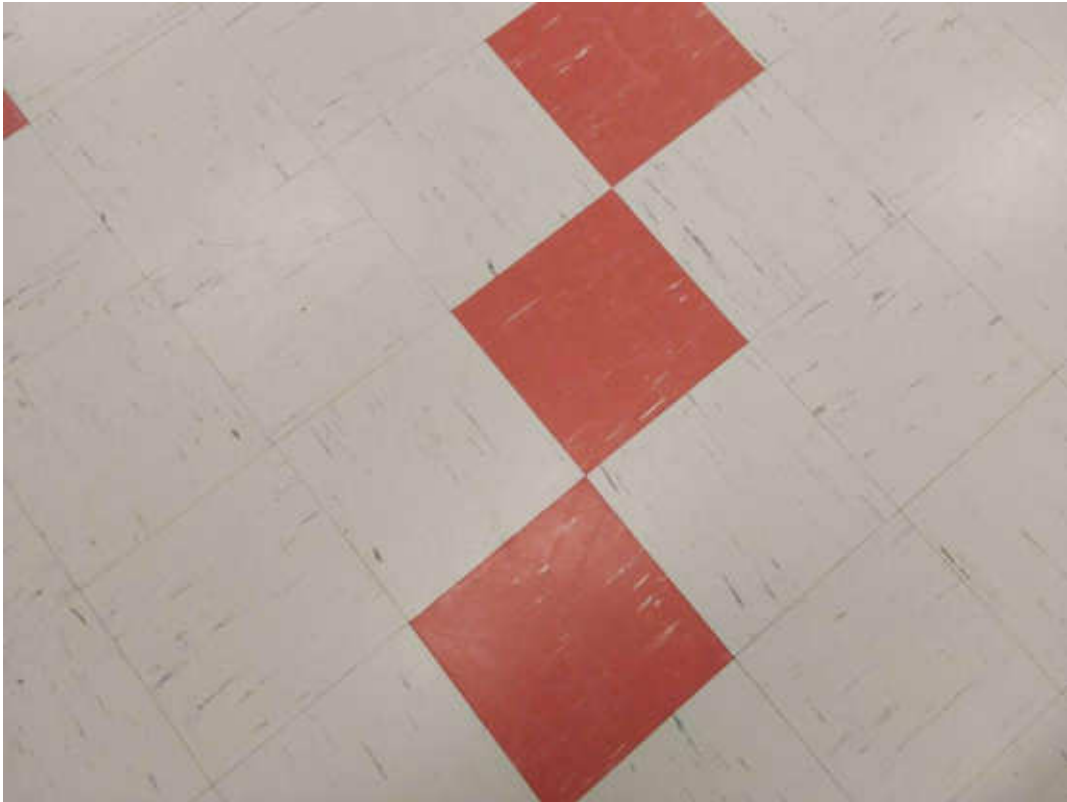
S0018 (Confirmed Asbestos), 9 x 9 red with white streaks, Floor, Vinyl Floor Tile and Mastic, Room 1 (Location #: 4)  
Mastic is presumed to contain asbestos

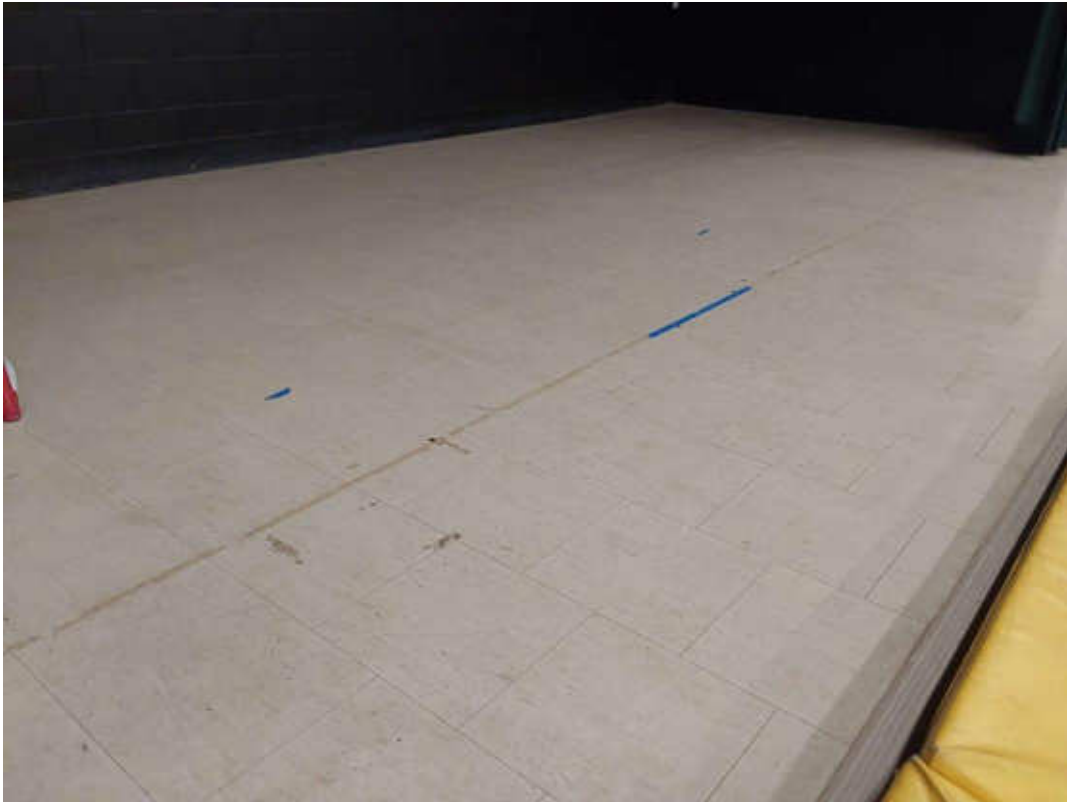
V0020 (Confirmed Asbestos), 12 x 12 off-white with brown streaks, Floor, Vinyl Floor Tile and Mastic, Gym (Location #: 1)  
Stage floor, Mastic is presumed to contain asbestos

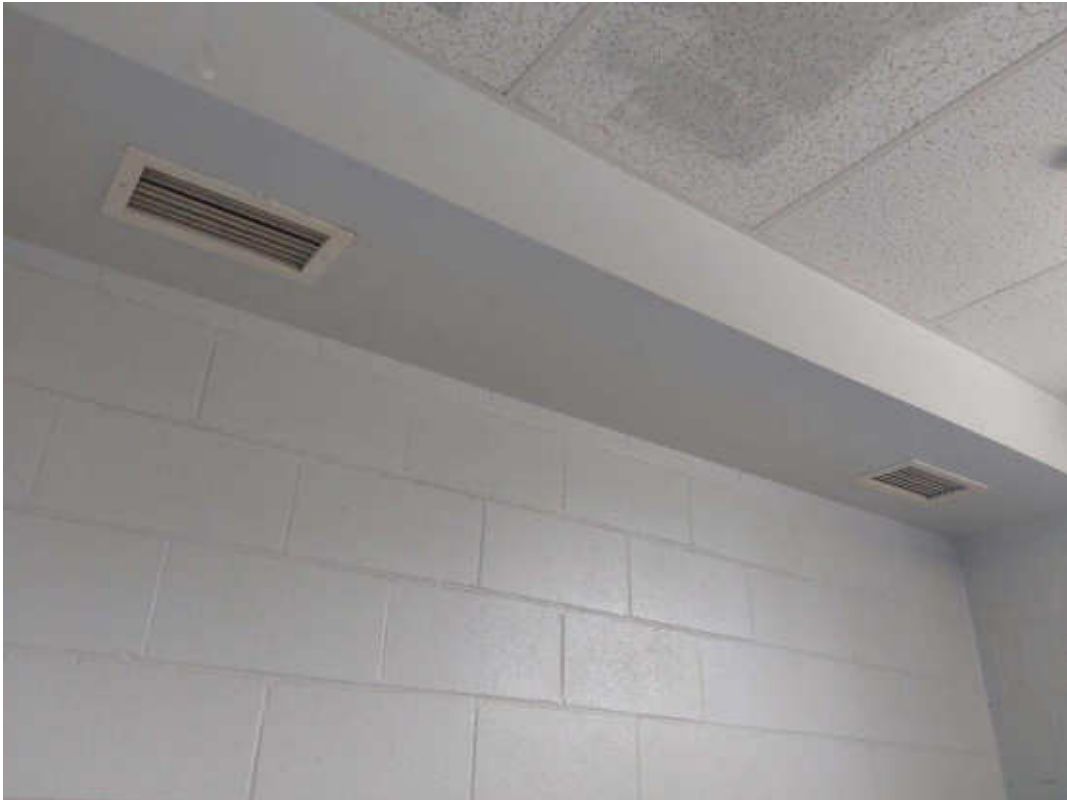
V0028 (Confirmed Asbestos), Ceiling, Drywall and joint compound, Men's Washroom (Boys) (Location #: 12)

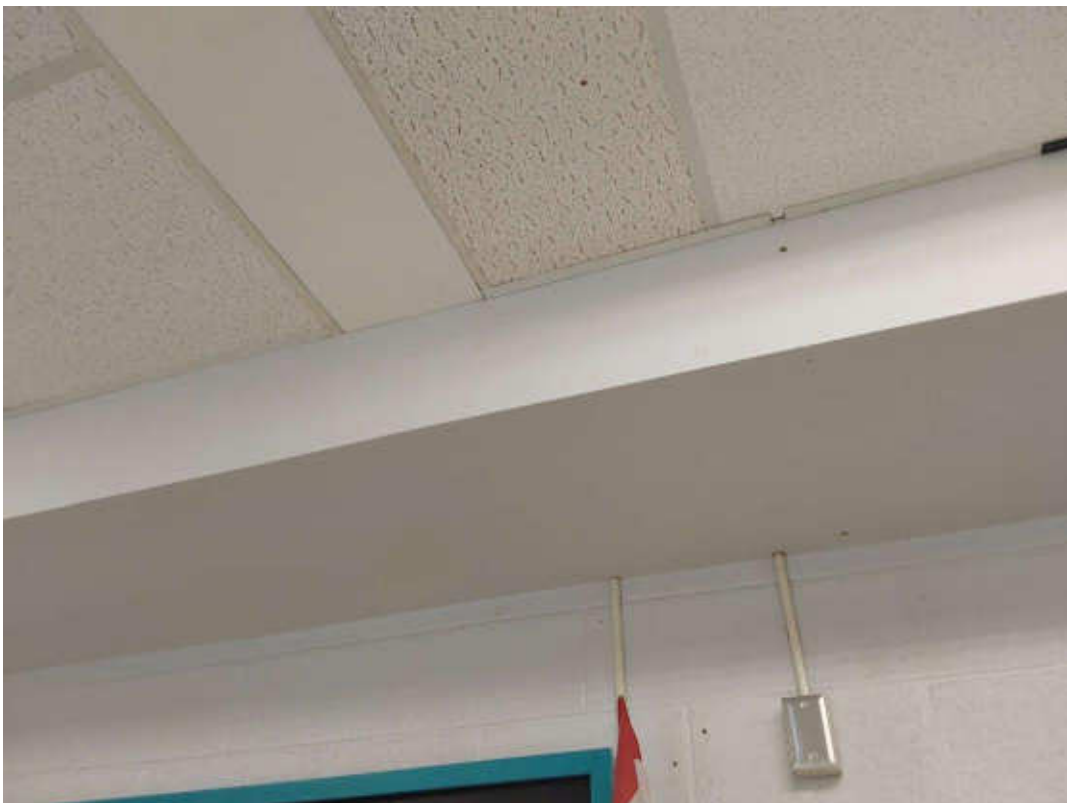
V0028 (Confirmed Asbestos), Ceiling, Drywall and joint compound, Classroom 109 (Location #: 29)

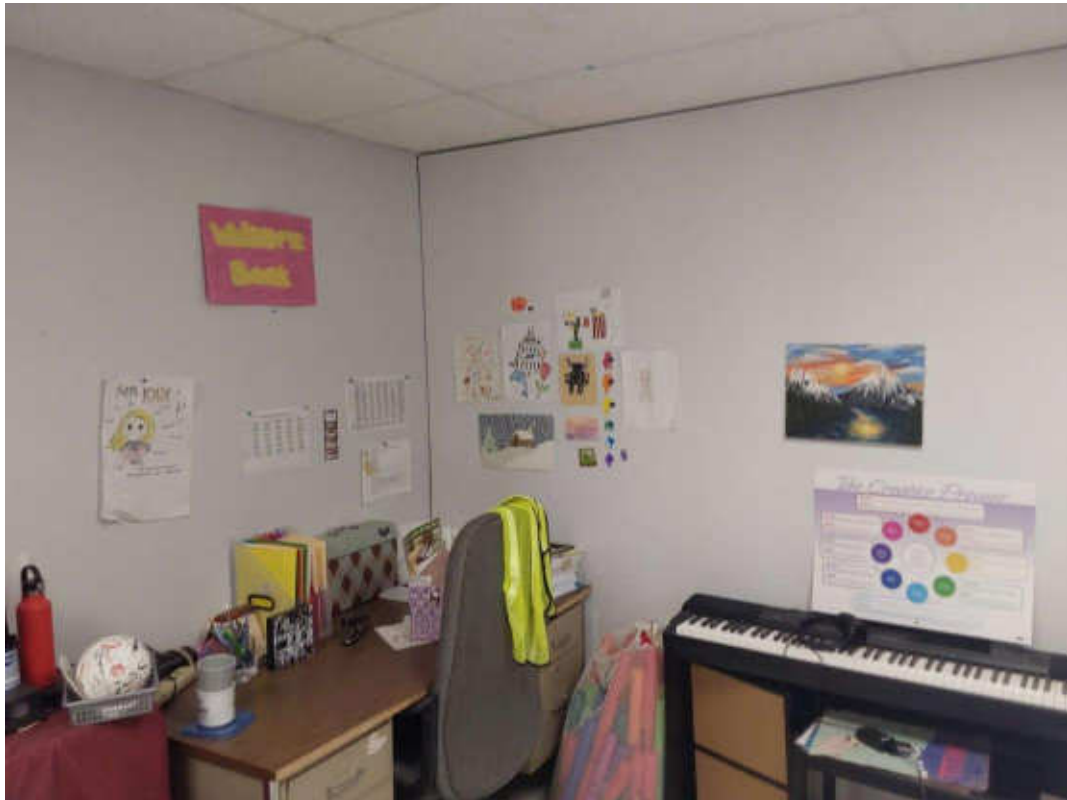
V0028 (Confirmed Asbestos), Wall, Drywall and joint compound, Physiotherapy Room (Location #: 31)

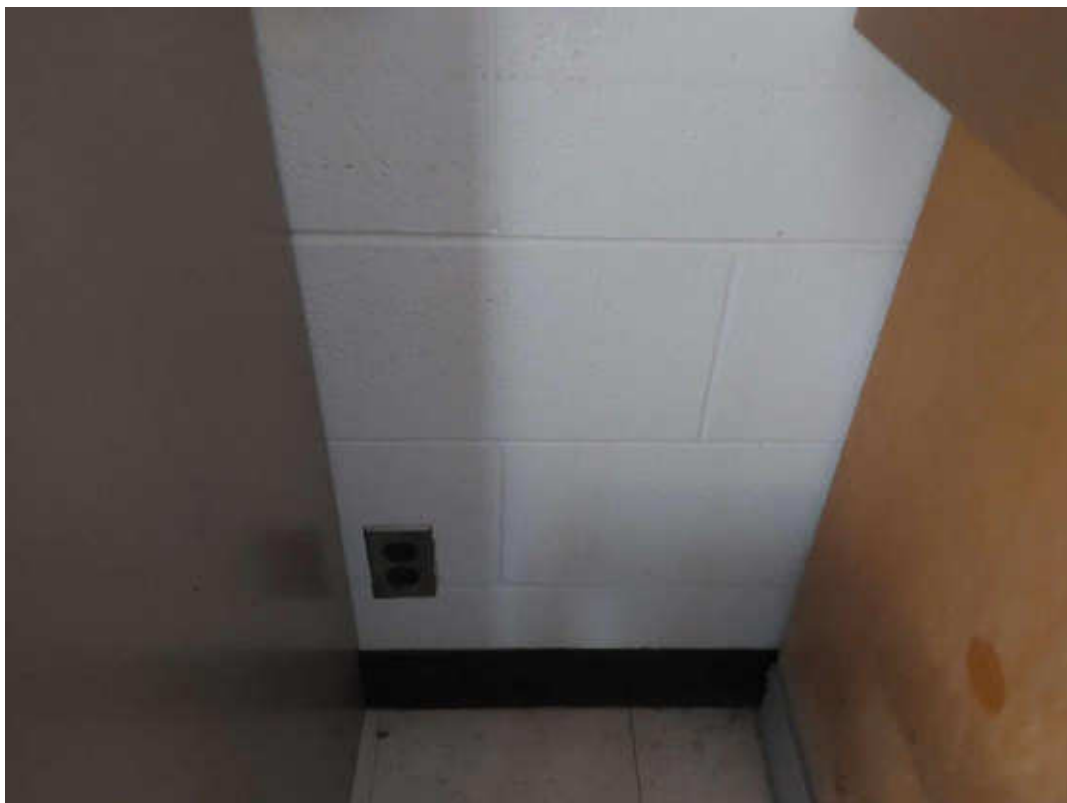
| Sample Number | Material Description | Type of Asbestos | Confirmed Hazard | Approximate Quantity Present | Material Specific Notes |
|---|---|---|---|---|---|
| V9000 | Vermiculite/concrete block walls | Confirmed Asbestos | Yes | 400 SF | Vermiculite found in the Offices (Loc. 30) by client and confirmed to contain asbestos |

V9000 (Confirmed Asbestos), Wall, Vermiculite Investigation, Offices (Location #: 30)  
Vermiculite found

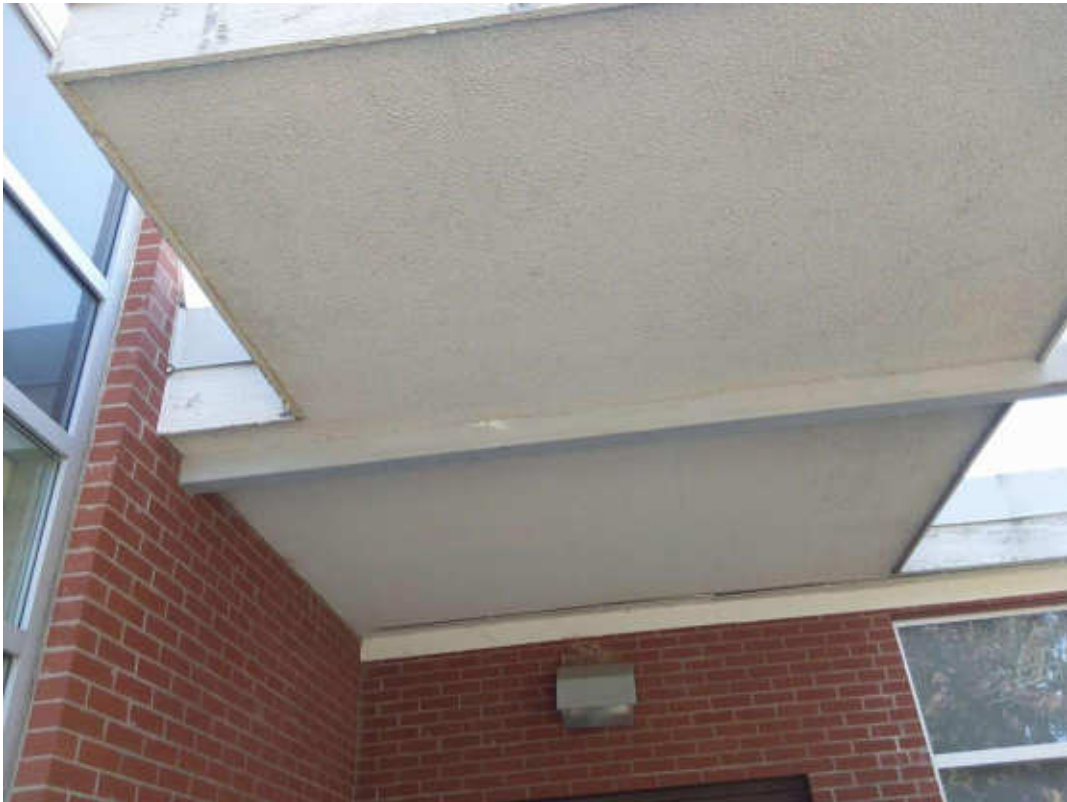
V9000 (Confirmed Asbestos), Wall, Fascia, Cement Product, Exterior (Location #: 47)  
Above the front entrance and on the exterior of the gym

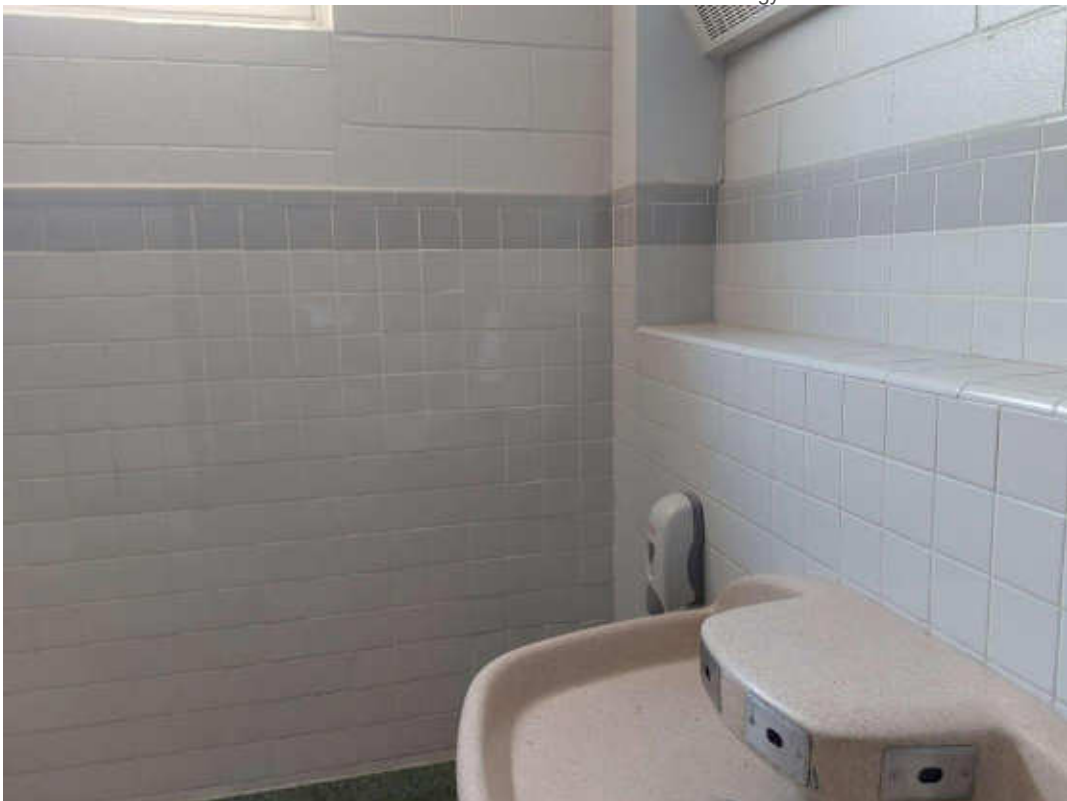
V9500 (Presumed Asbestos), Wall, Mortar, Men's Washroom (Boys) (Location #: 12)

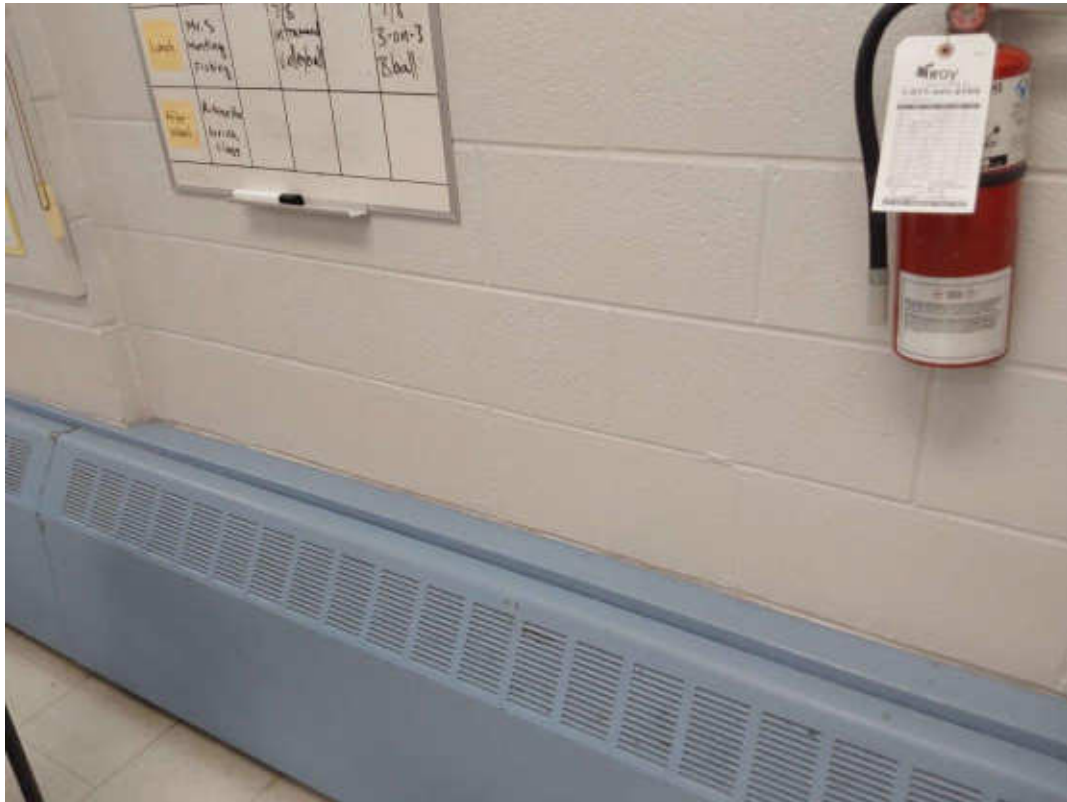
V9500 (Presumed Asbestos), Wall, Vermiculite/concrete block walls, Staff Room (Location #: 16)

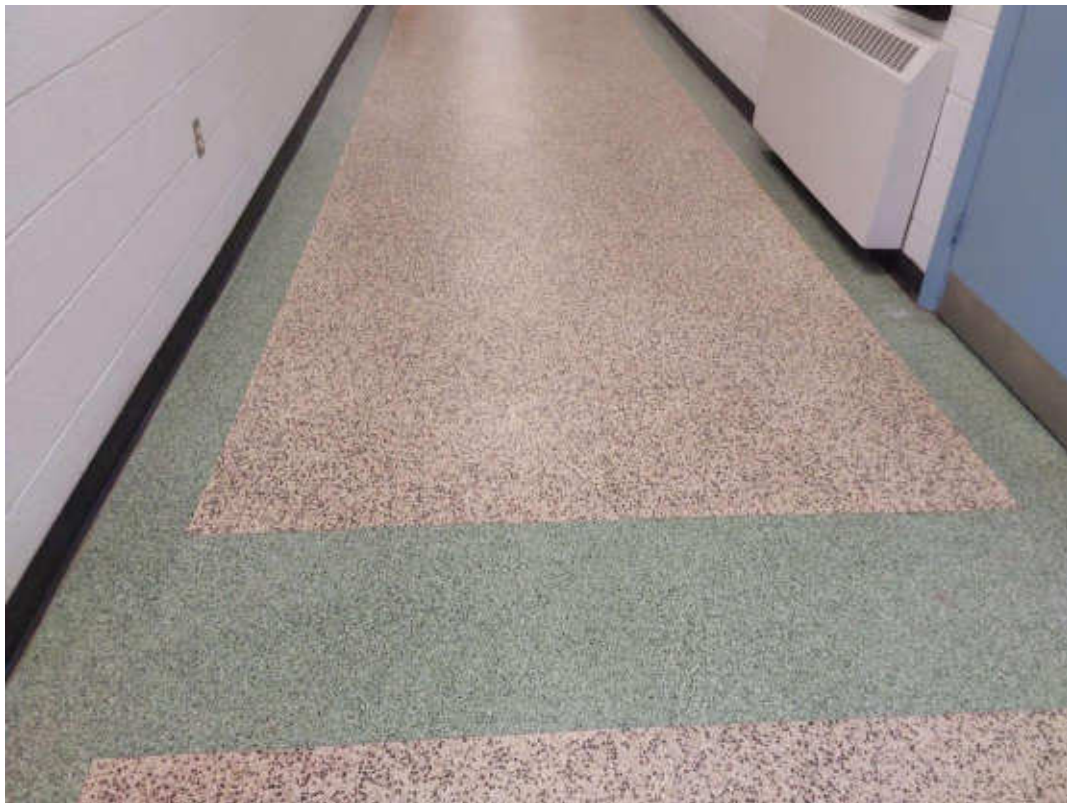
V9500 (Presumed Asbestos), Floor, Terrazzo, Corridor (Location #: 25)

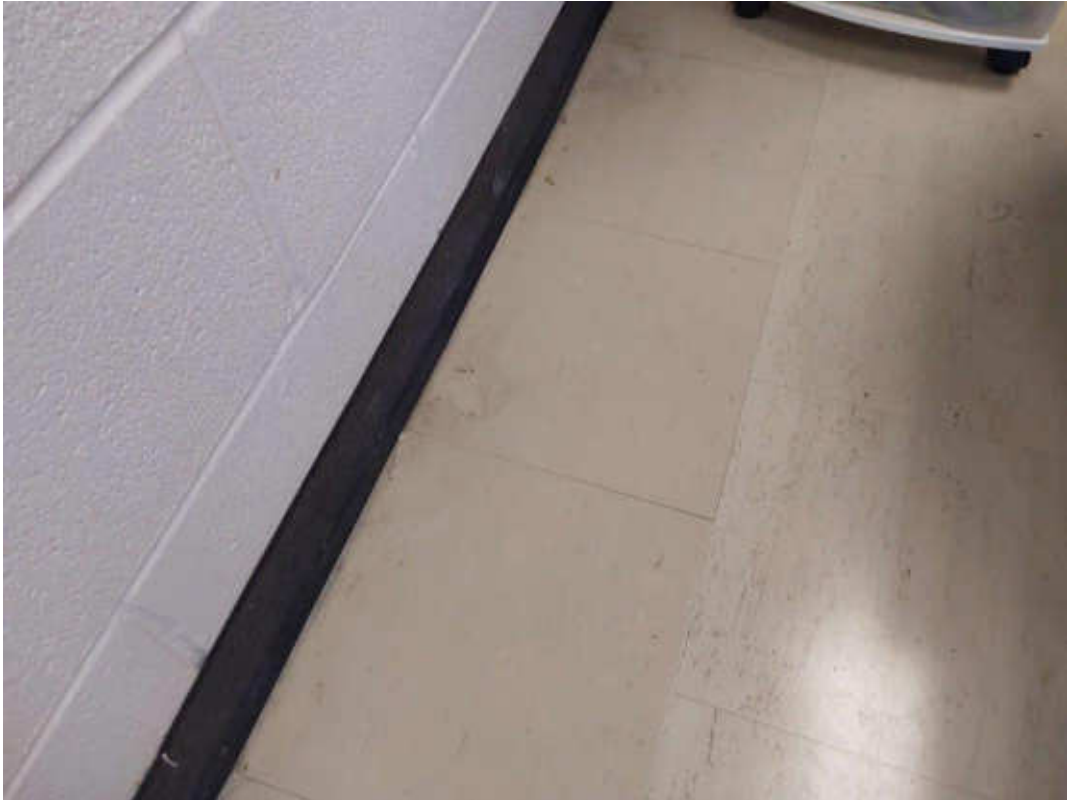
V9500 (Presumed Asbestos), 12 x 12 beige with brown flecks, Floor, Vinyl Floor Tile and Mastic, Classroom 115 (Location #: 43)  
Mastic is confirmed to contain asbestos

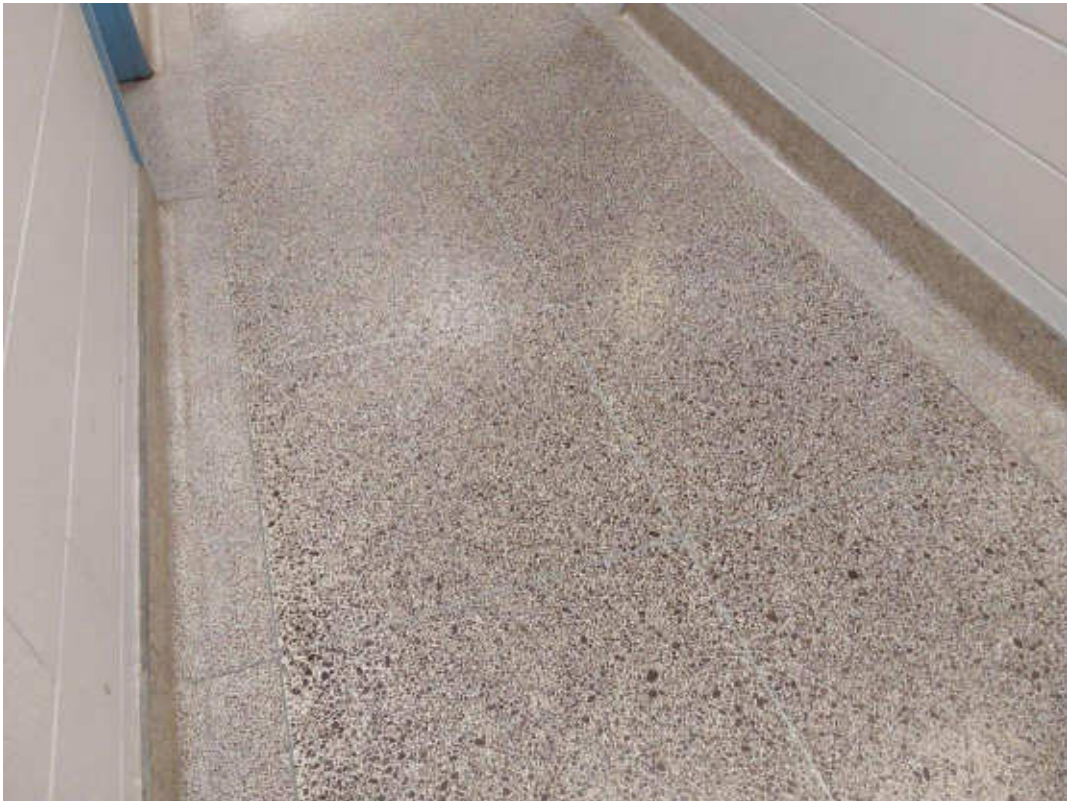
V9500 (Presumed Asbestos), Floor, Terrazzo, Corridor (Location #: 46)

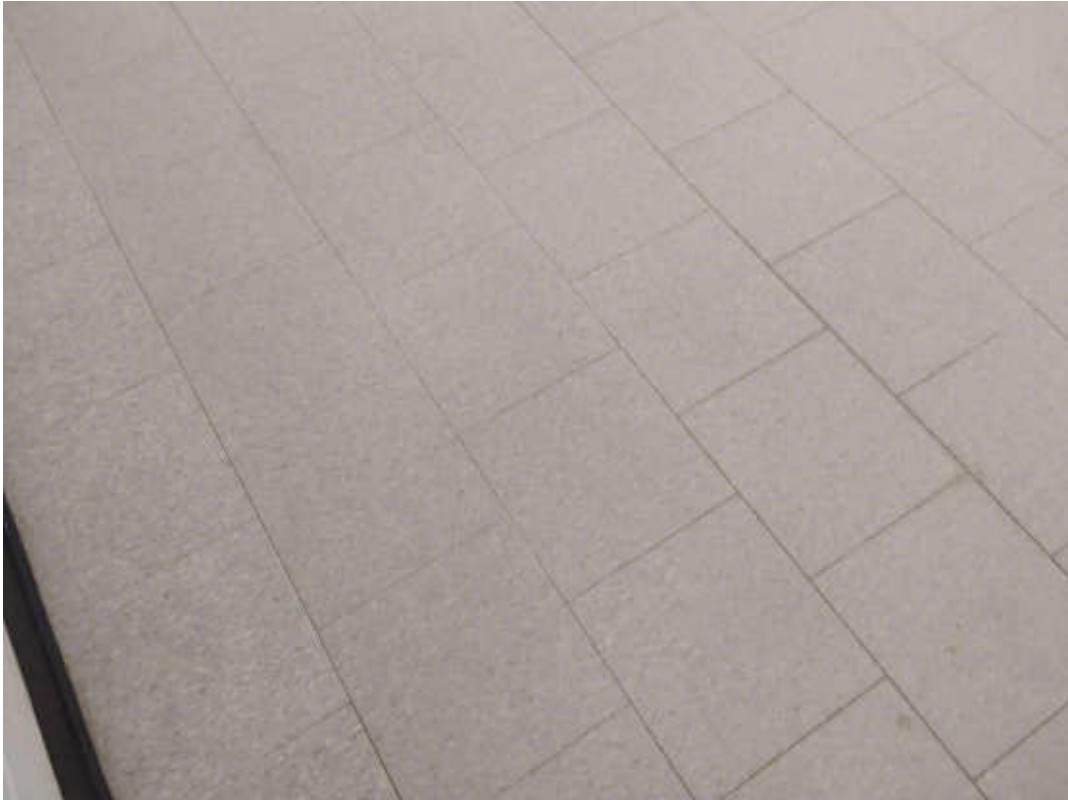
V0000 (None), 12 x 12 grey mottled, Floor, Vinyl Floor Tile and Mastic, Classroom 132 (Location #: 35)  
Post 2005 new
