# **ASBESTOS-CONTAINING MATERIALS REASSESSMENT SURVEY**

**HUMBER RIVER HOSPITAL  
REACTIVATION CARE CENTRE  
2111 FINCH AVENUE WEST  
NORTH YORK, ONTARIO**

**ECO Project Number: 28849-02**

**December 18, 2024**

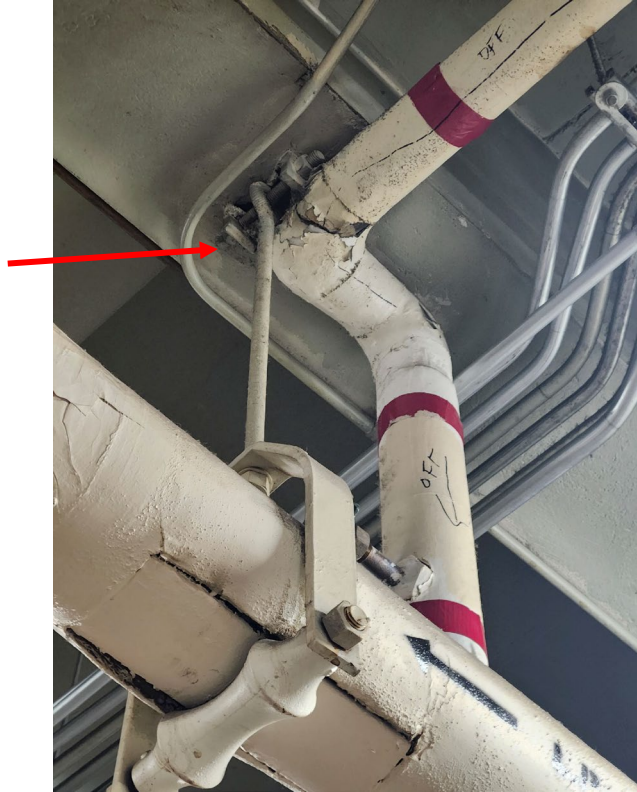
**Location:**  
Stairs/2<sup>nd</sup> Level – Boiler House (Loc. 7)

- One (1) fitting in the Stairs/Second Level (Location 7).

**Description:**  
One (1) asbestos-containing parging cement fittings observed to be in POOR condition, located in the back corner of room.

- FAIR and POOR condition asbestos-containing mechanical insulations (i.e. parging cement) should be repaired or removed as follows:
  - Utilizing Type 2, or Type 2 Glovebag asbestos safety procedures for the removal, enclosure (repair) or disturbance of one square metre (approx. 10 square feet) or less of friable asbestos-containing thermal mechanical insulation, or

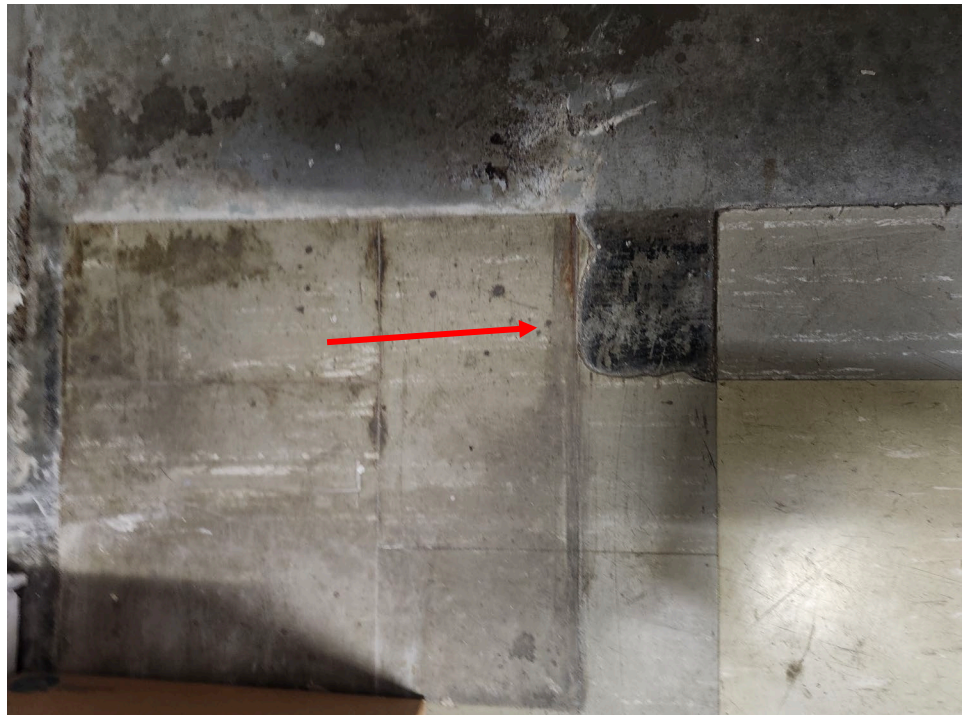
**Photo No. 2.**

**Location:**  
Stock Room (Loc. 14)

**Description:**  
One (1) asbestos-containing vinyl floor tile observed to be in POOR condition, located in front of Stock Room Office (Loc. 15).
