March 27, 2026

Re: Hazardous Building Materials Assessment (Preconstruction)
Dust Collector Replacement Project
Waterdown District Highschool, 215 Parkside Drive, Waterdown, ON
Pinchin File: 368258.006

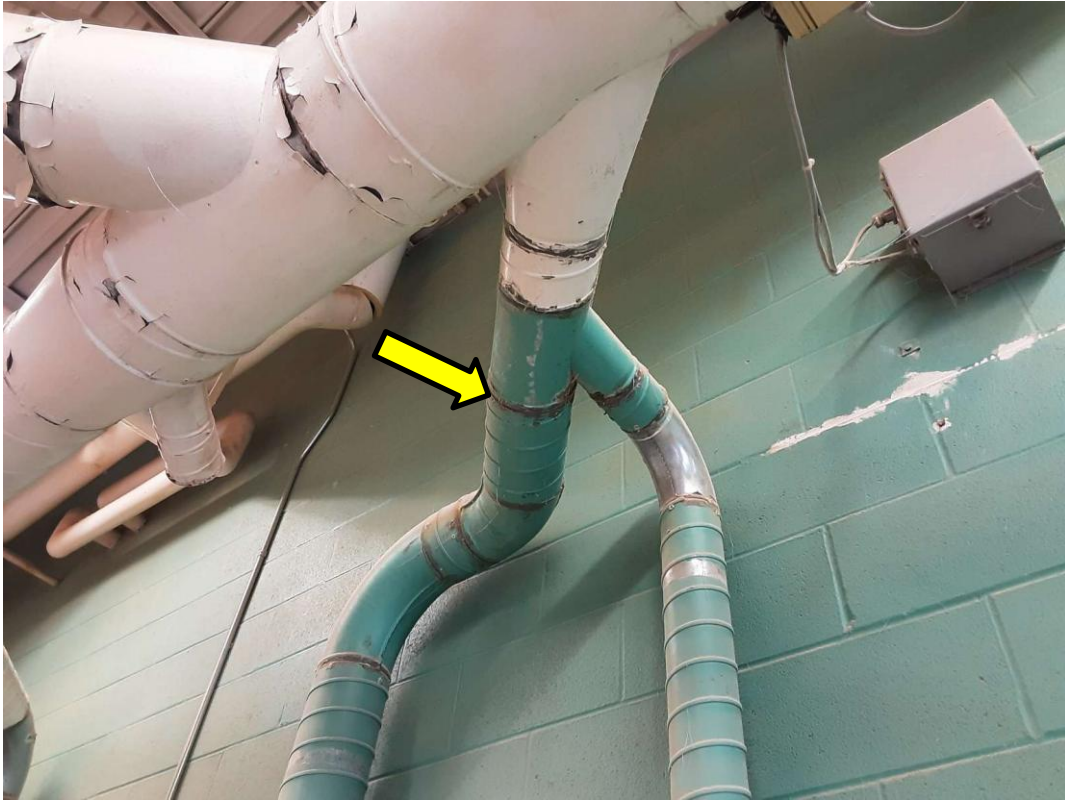
S0013A (None), Grey, Duct, Mastic, Construction Shop (Location #: 22)

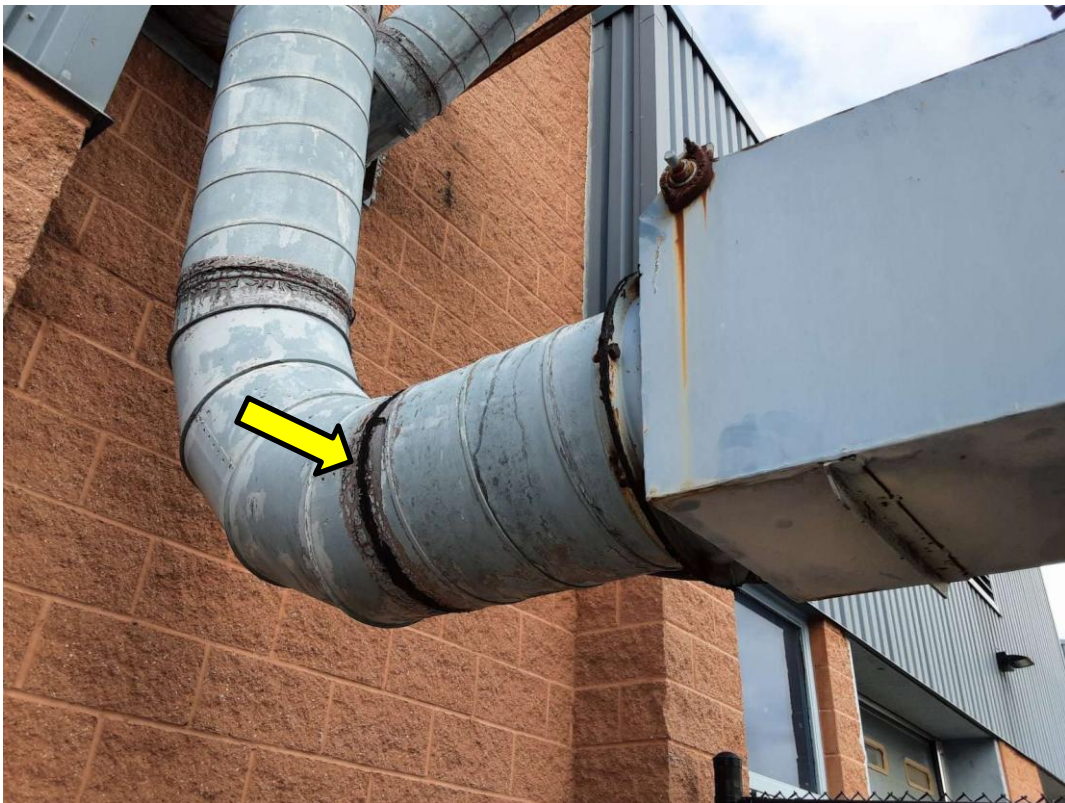
S0014A (None), Black on sawdust collector, Duct, Mastic, Exterior 1991 (Location #: 19)

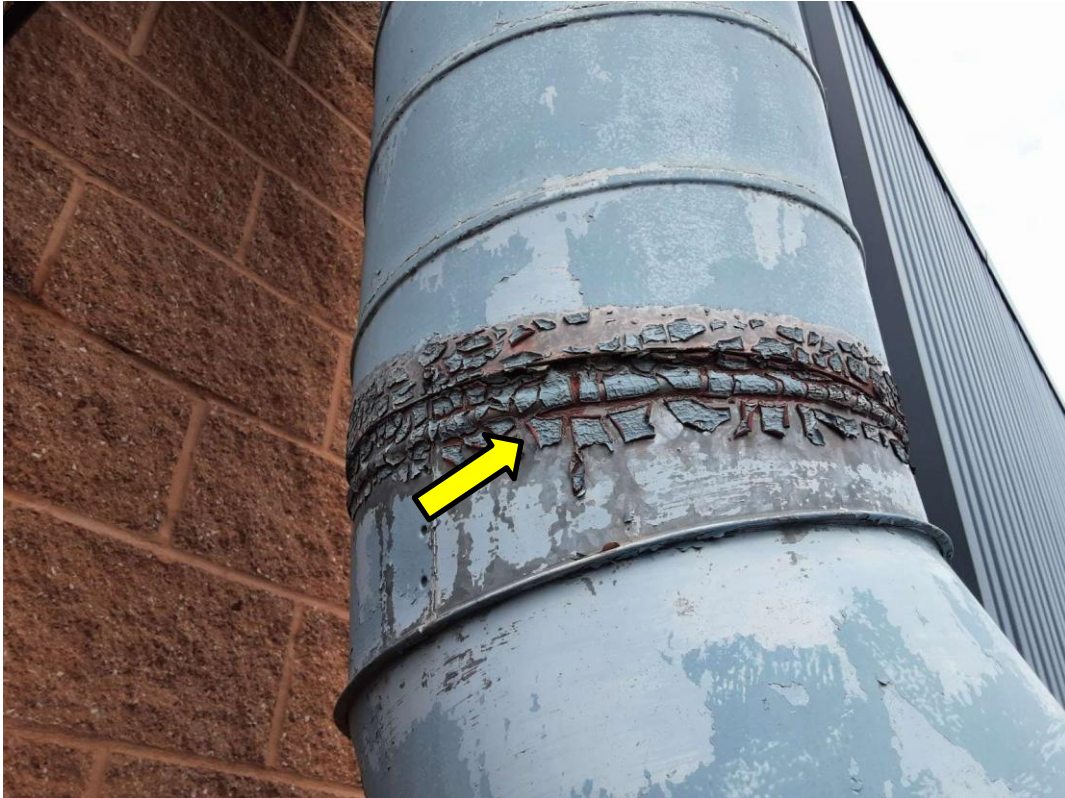
S0015A (None), Red on sawdust collector, Duct, Mastic, Exterior 1991 (Location #: 19)

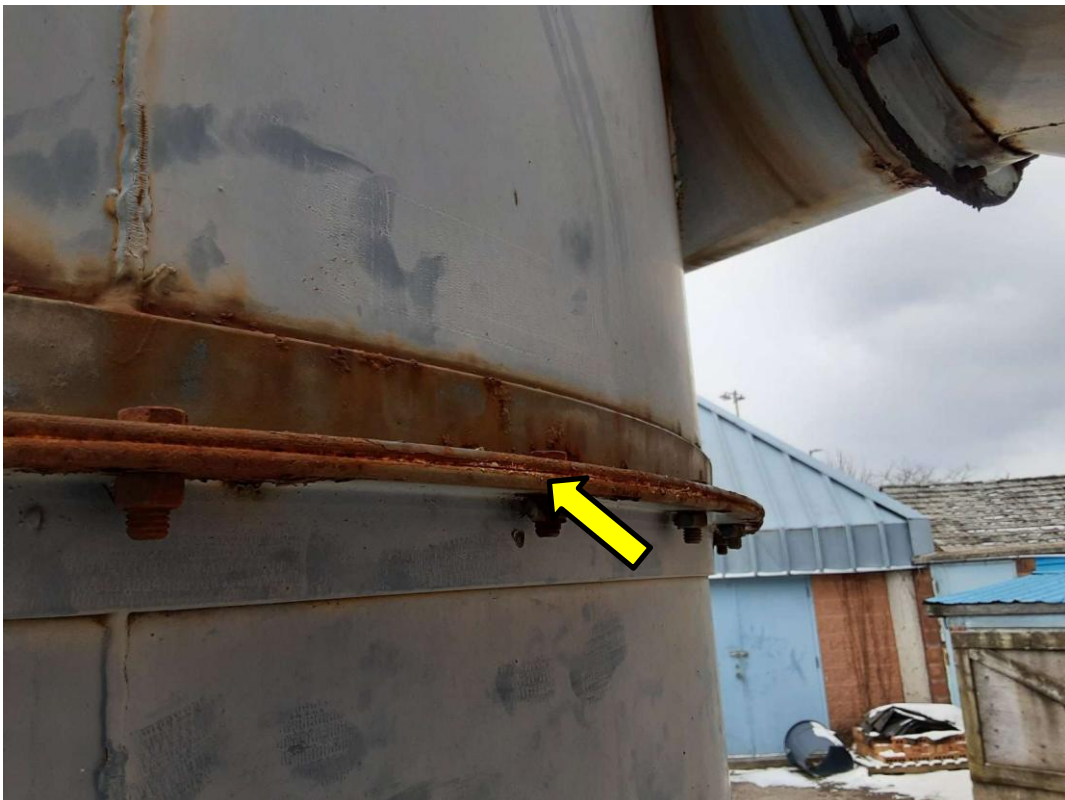
S0016A (None), White, Duct, Caulking, Exterior 1991 (Location #: 19)

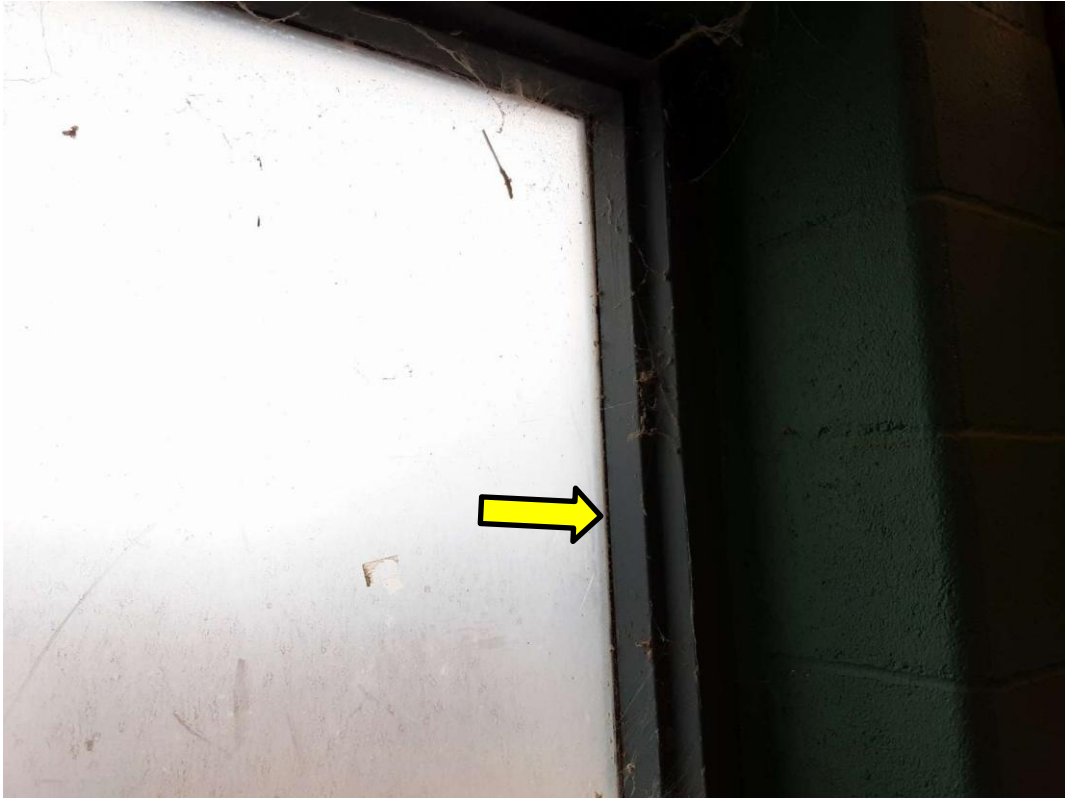
S0017A (None), Butyl sealant, Other, Window, Putty, Construction Shop (Location #: 22)

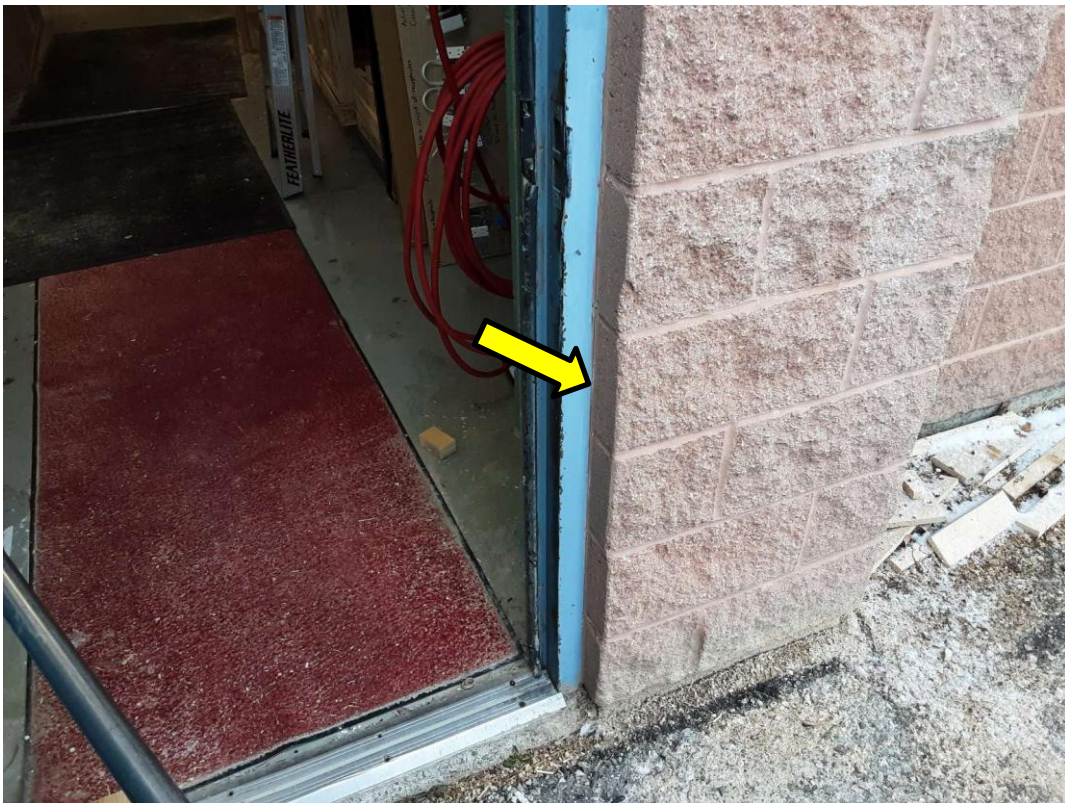
S0018A (None), Light brown, Other, Door, Caulking, Exterior 1991 (Location #: 19)

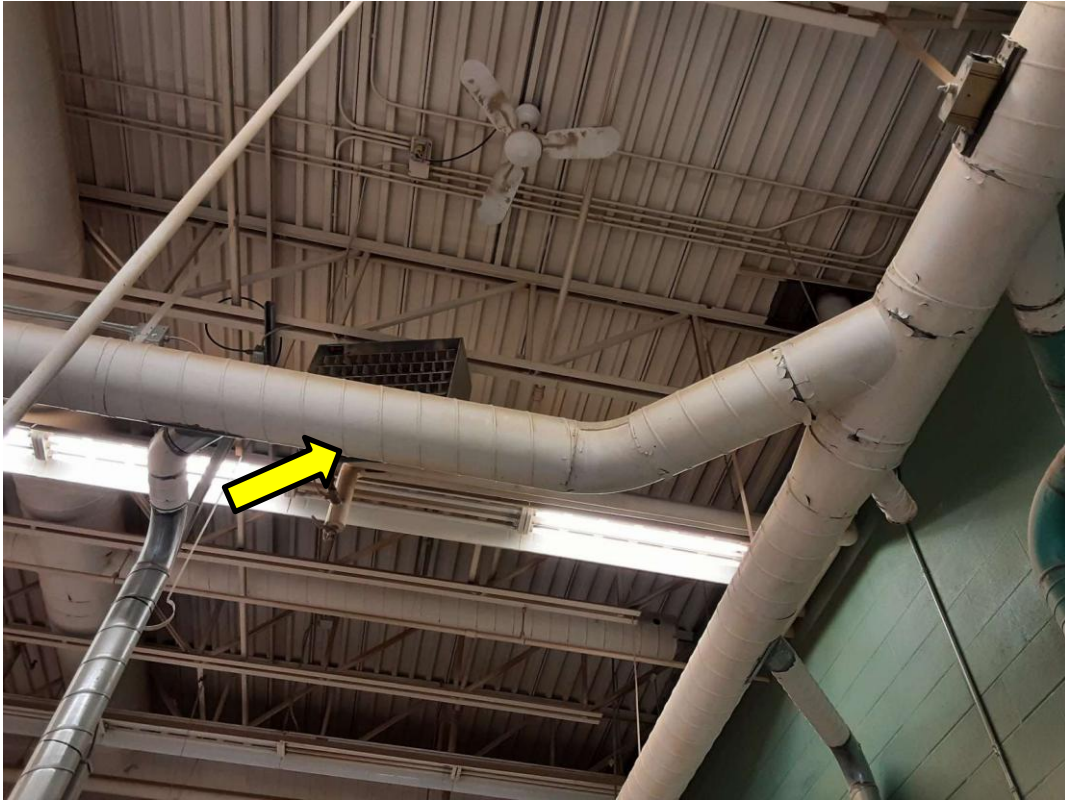
L0010(Lead, None), Cream on dust collector, Duct, Construction Shop (Location #: 22)

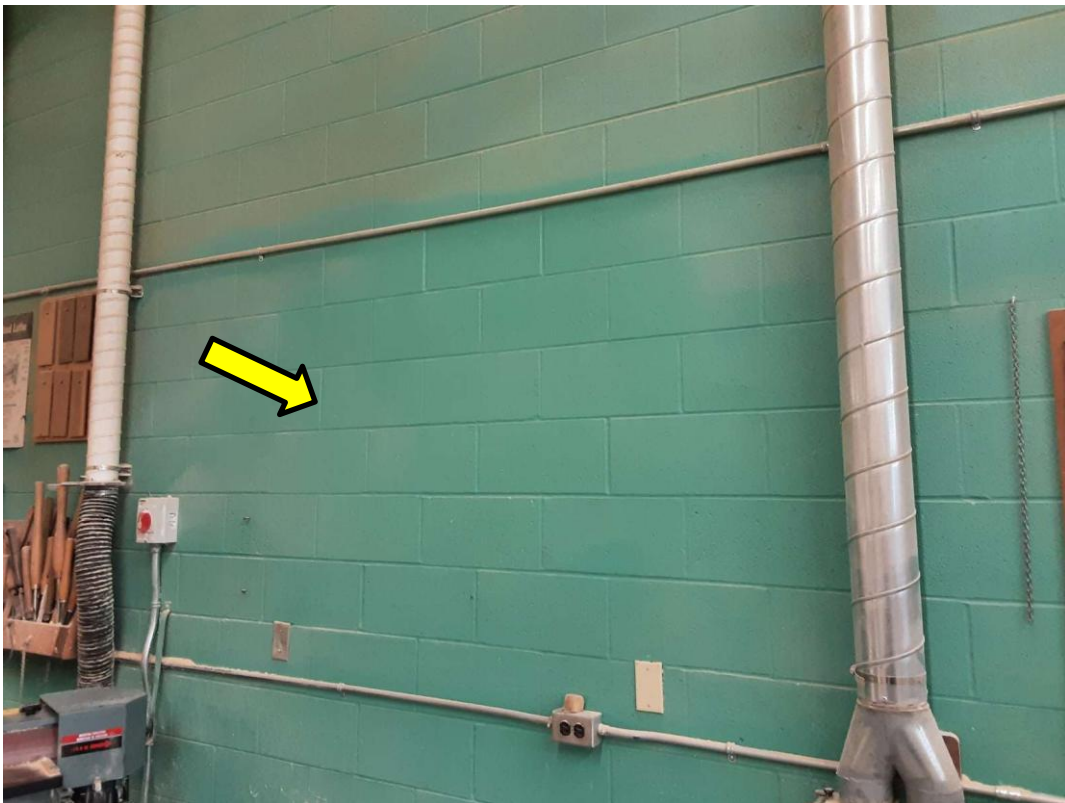
L0011(Lead, None), Green, Wall, Construction Shop (Location #: 22)

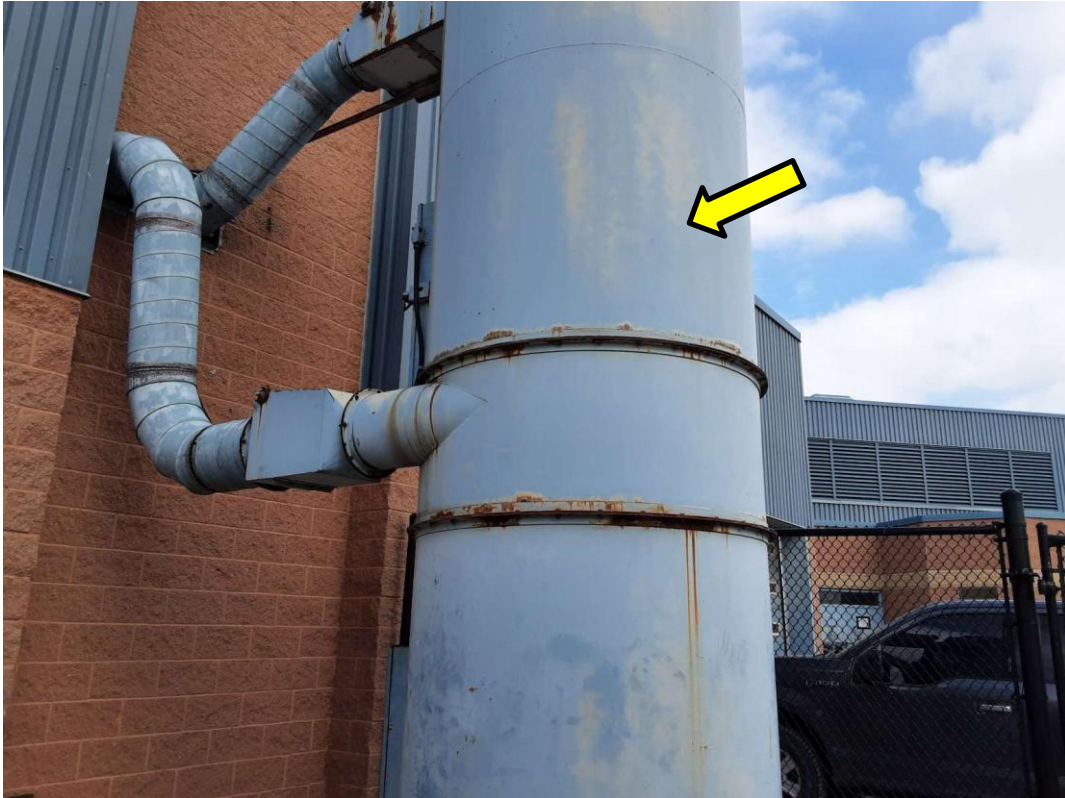
L0012(Lead, None) , Blue on sawdust collector, Mechanical Equipment, Exterior 1991 (Location #: 19)

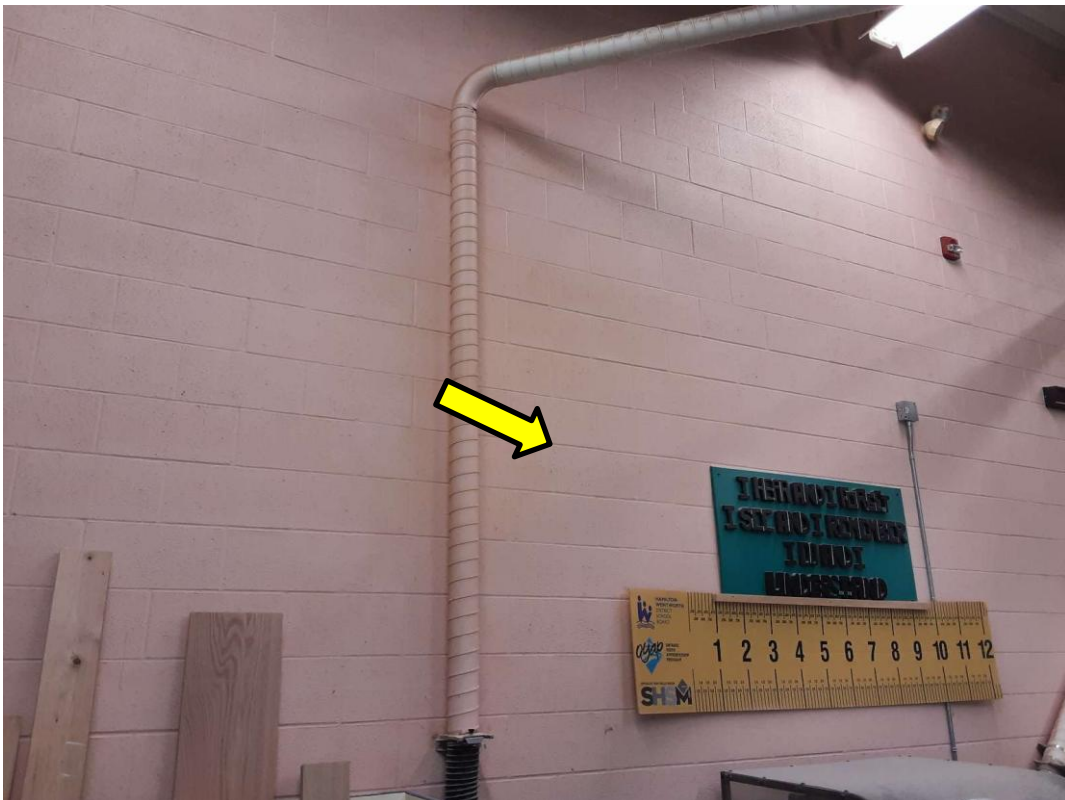
L0013(Lead, None), Salmon, Wall, Construction Shop (Location #: 22)

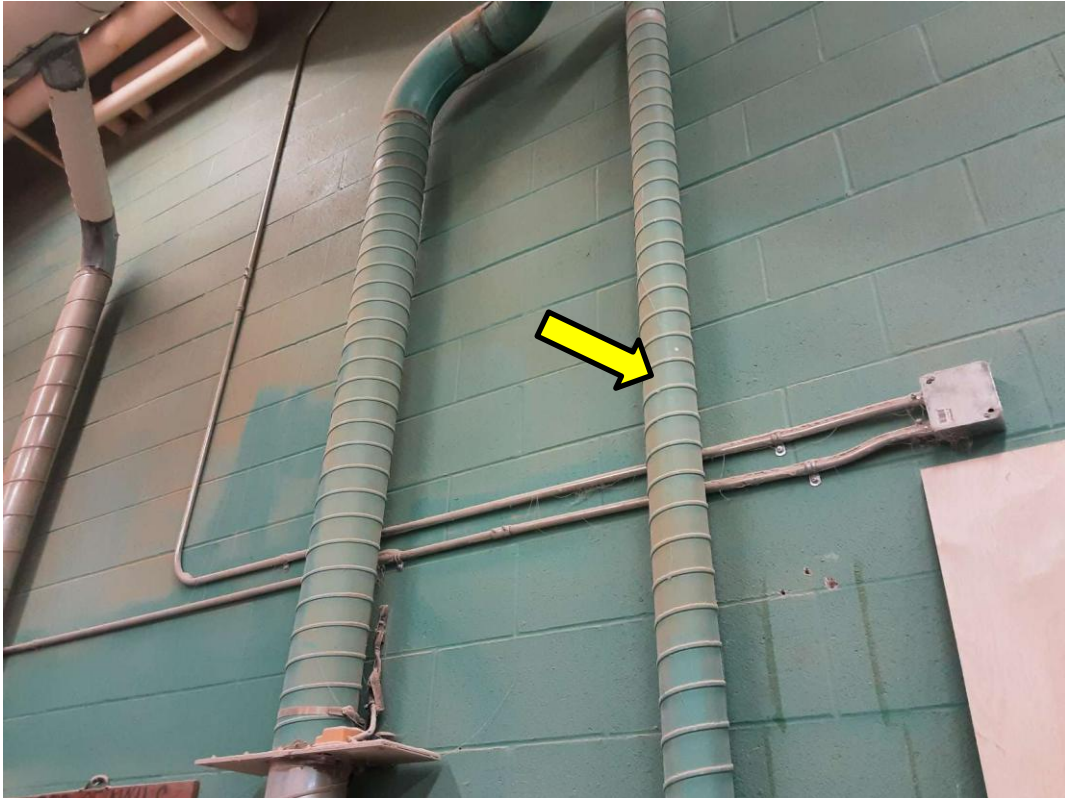
L0014(Lead, None), Green, Duct, Construction Shop (Location #: 22)

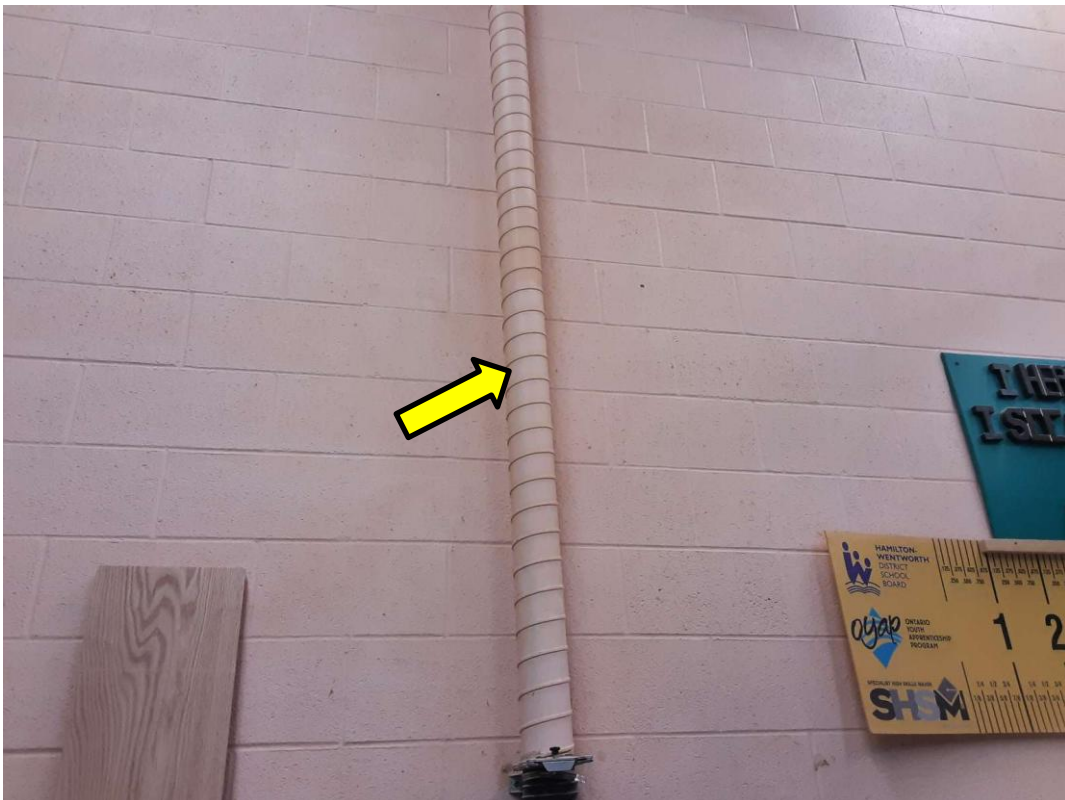
L0015(Lead, None), Salmon, Duct, Construction Shop (Location #: 22)

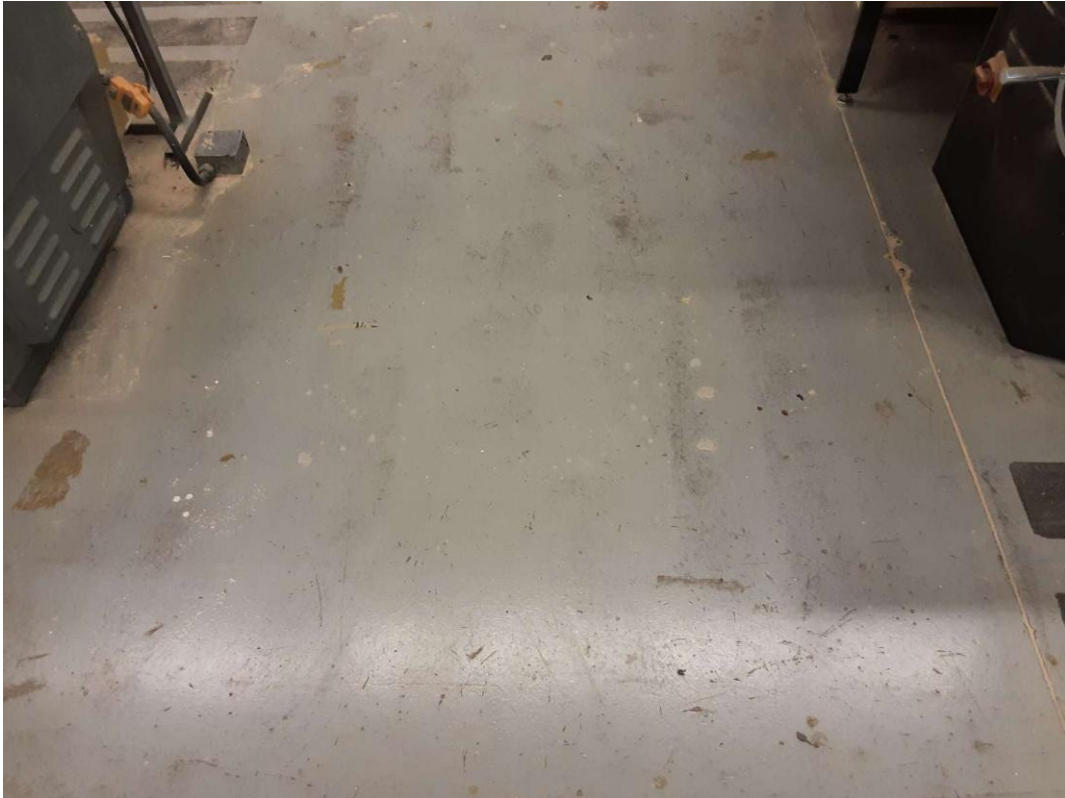
L0016(Lead, None), Grey, Floor, Construction Shop (Location #: 22)

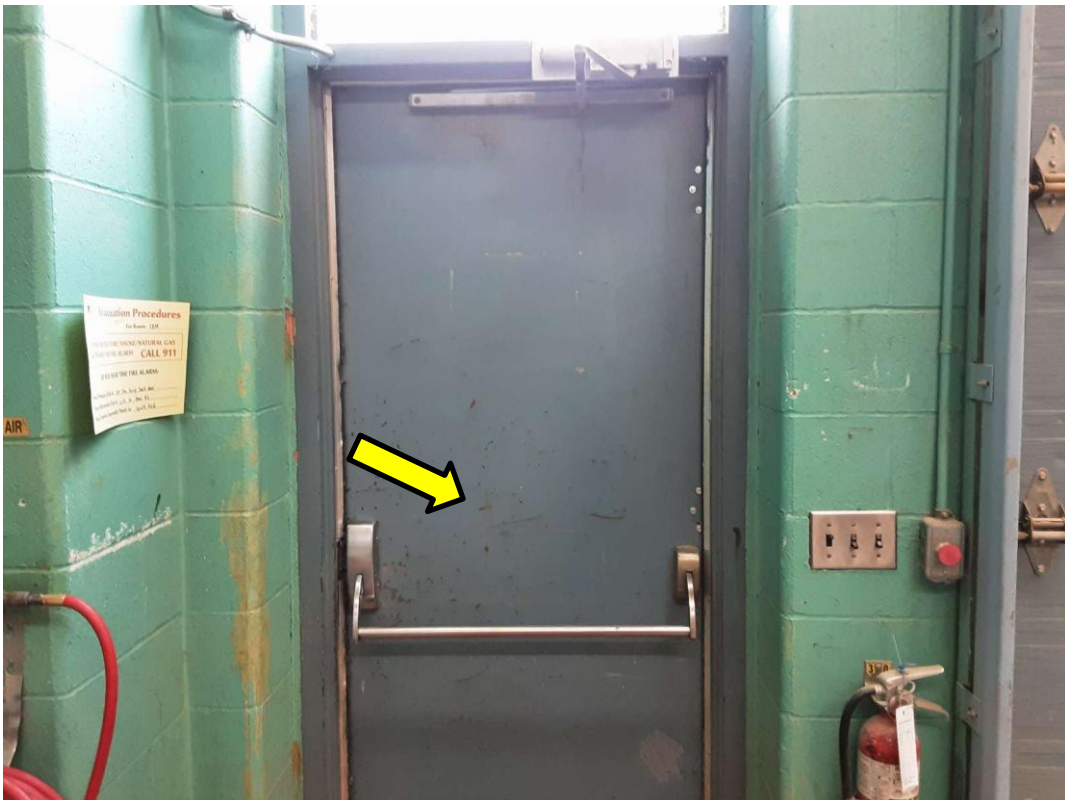
L0017(Lead, None), Blue on door, Other, Construction Shop (Location #: 22)

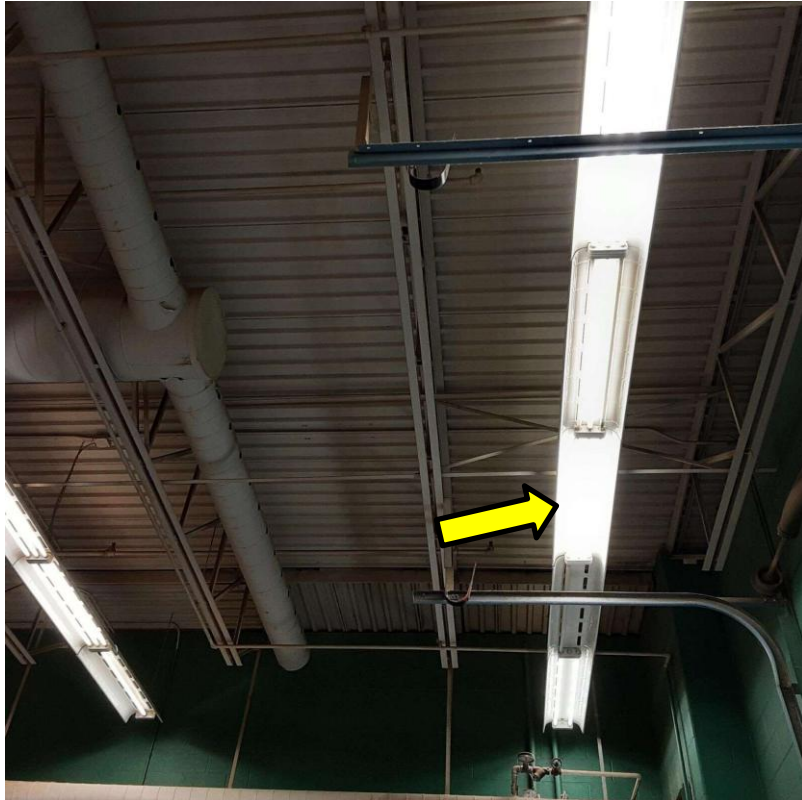
Sample Number	Material Description	Confirmed Hazard	Total Quantity Present	Material Specific Notes
V9500	Mercury Vapour Lamp	Yes	138 EA

Items identified as Sample Number V9500 were observed to be present but could not be definitively determined to contain mercury (e.g., inaccessible lamps and thermostats).

Mercury, V9500(Presumed), Mercury Vapour Lamp, Construction Shop (Location #: 22)

Do not break lamps. Recycle and reclaim mercury from fluorescent lamps when taken out of service. Mercury is classified as a hazardous waste and must be disposed of in accordance with applicable regulations.
