Re: Hazardous Building Materials Assessment (Preconstruction)

Renovations to Sir Allan MacNab Secondary School
145 Magnolia Drive, Hamilton, ON
Pinchin File: 352293.014

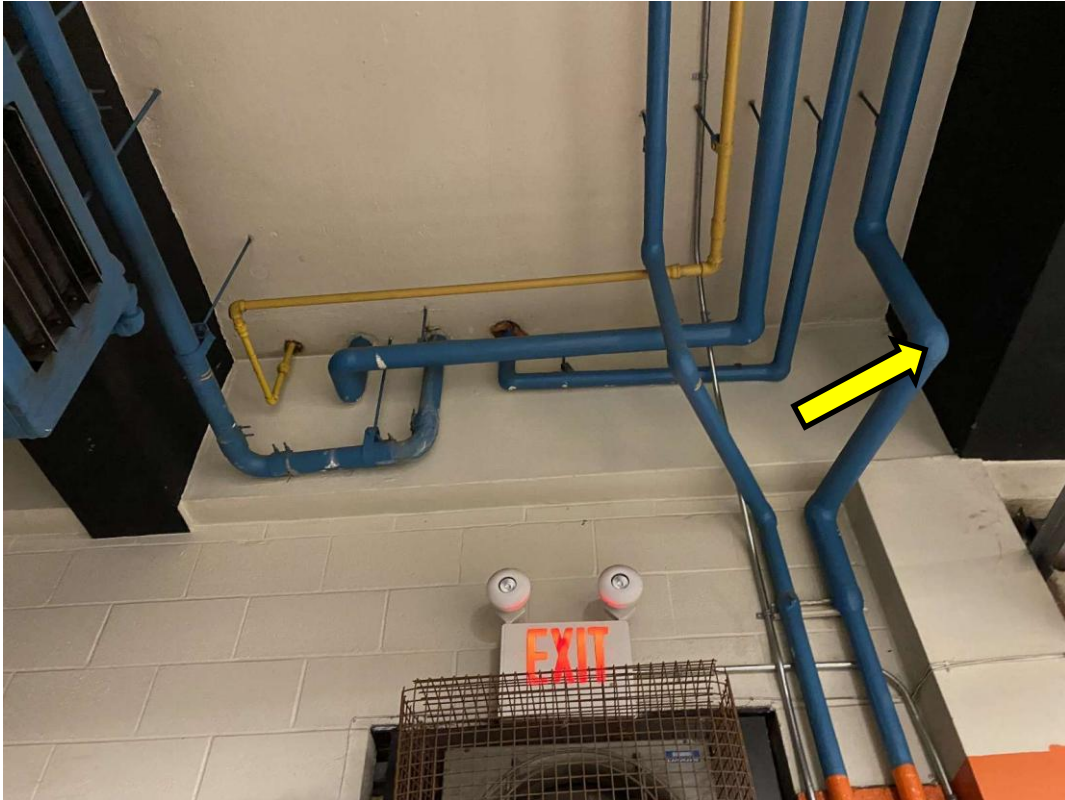
V0021 (Confirmed Asbestos), Piping, Parging Cement, Classroom (Location #: 7558)

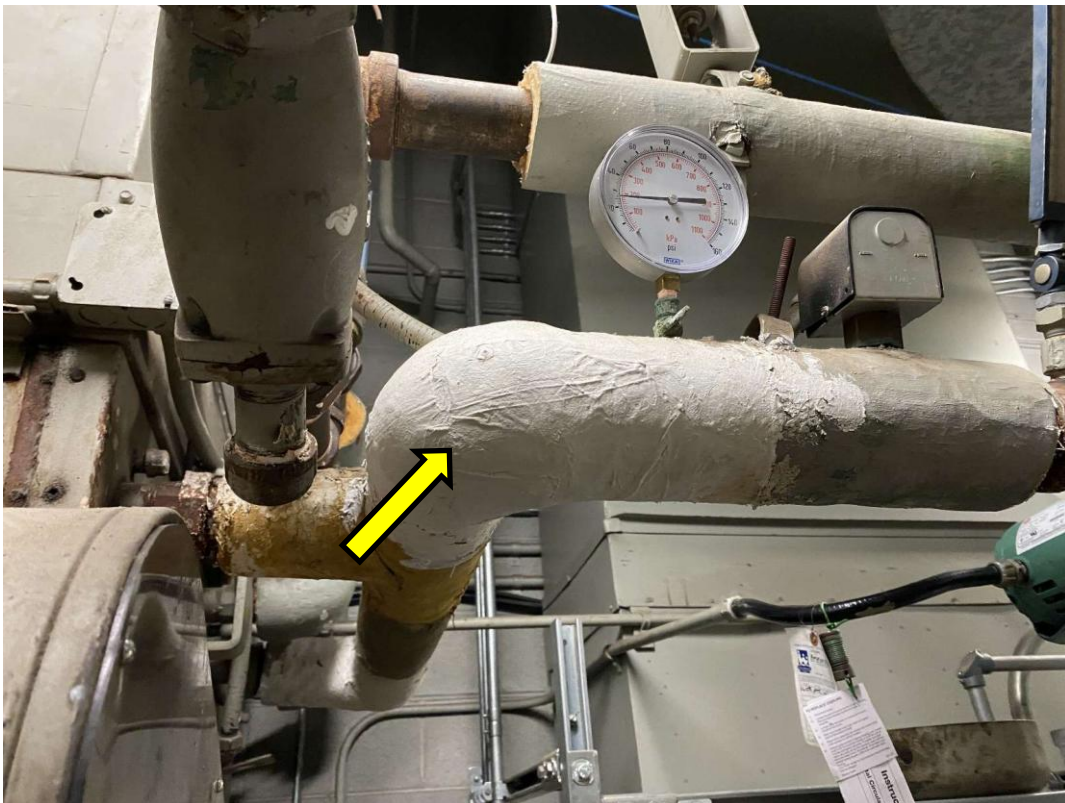
V0021 (Confirmed Asbestos), Piping, Parging Cement, Mechanical Room (Location #: 7692)

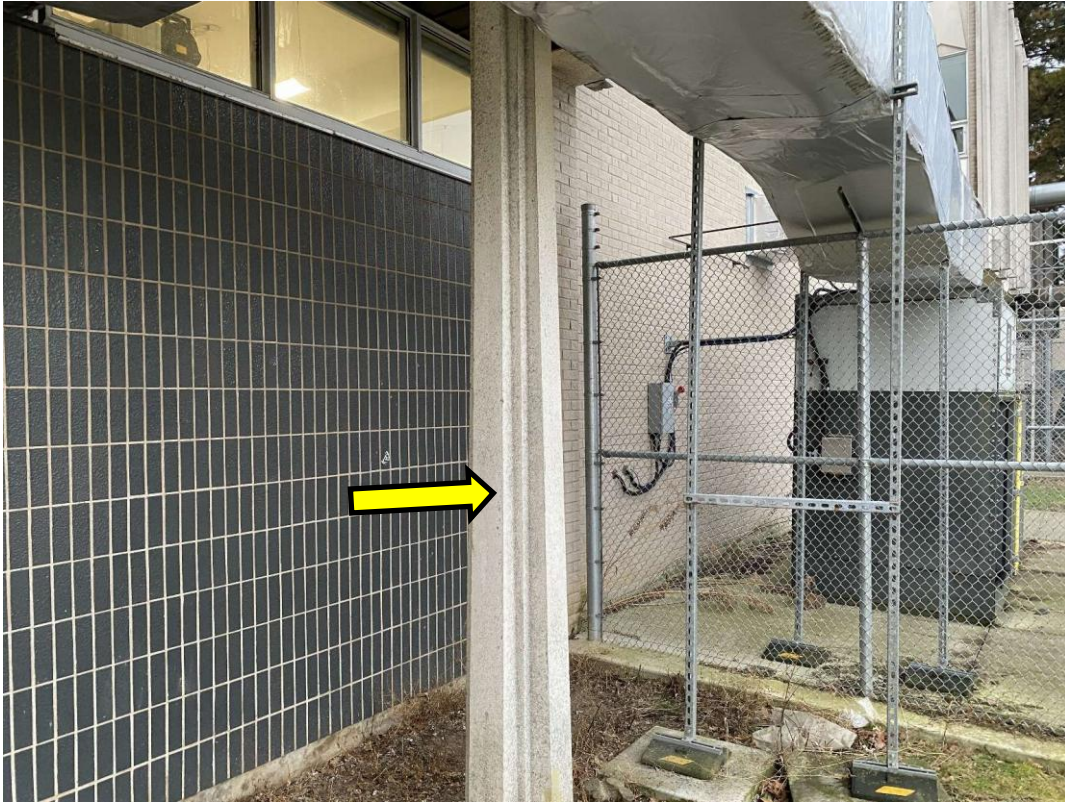
S0040 (Confirmed Asbestos), Wall, Column, Texture Finish - Non Friable, Exterior at 7562 and 7690 (Location #: 75620)

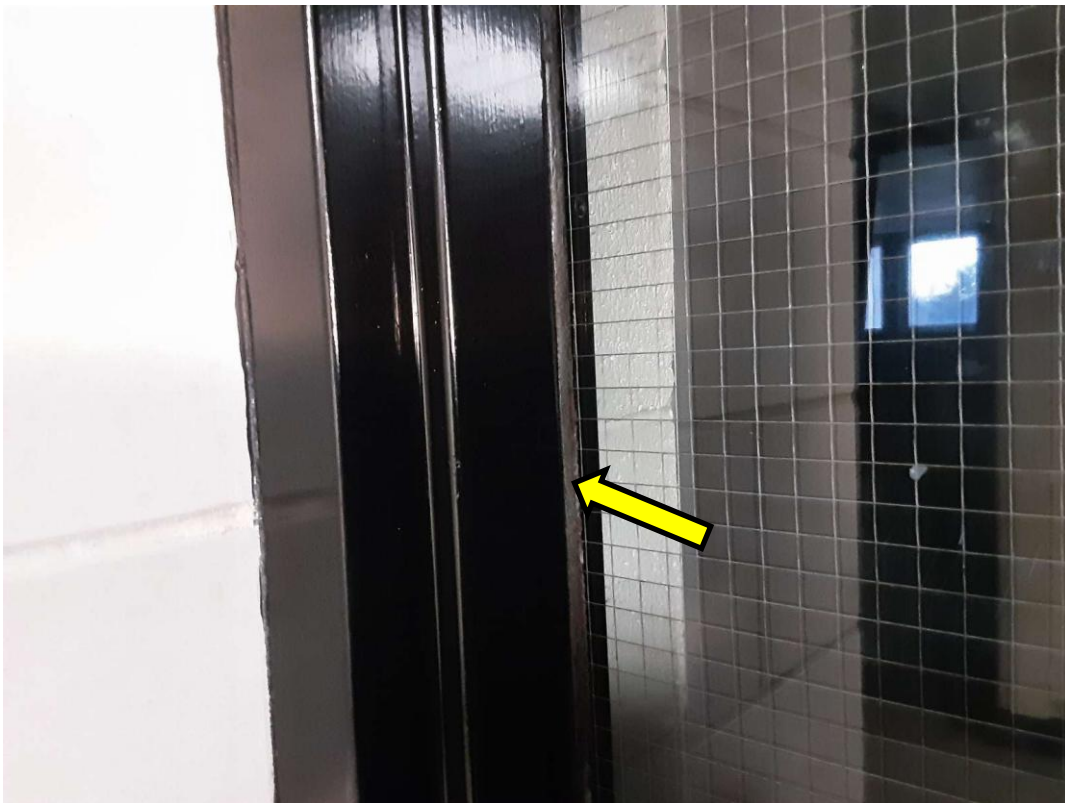
S0051A (Confirmed Asbestos), Black butyl sealants, Wall, Window Liner, Caulking, Corridor (Location #: 7752)

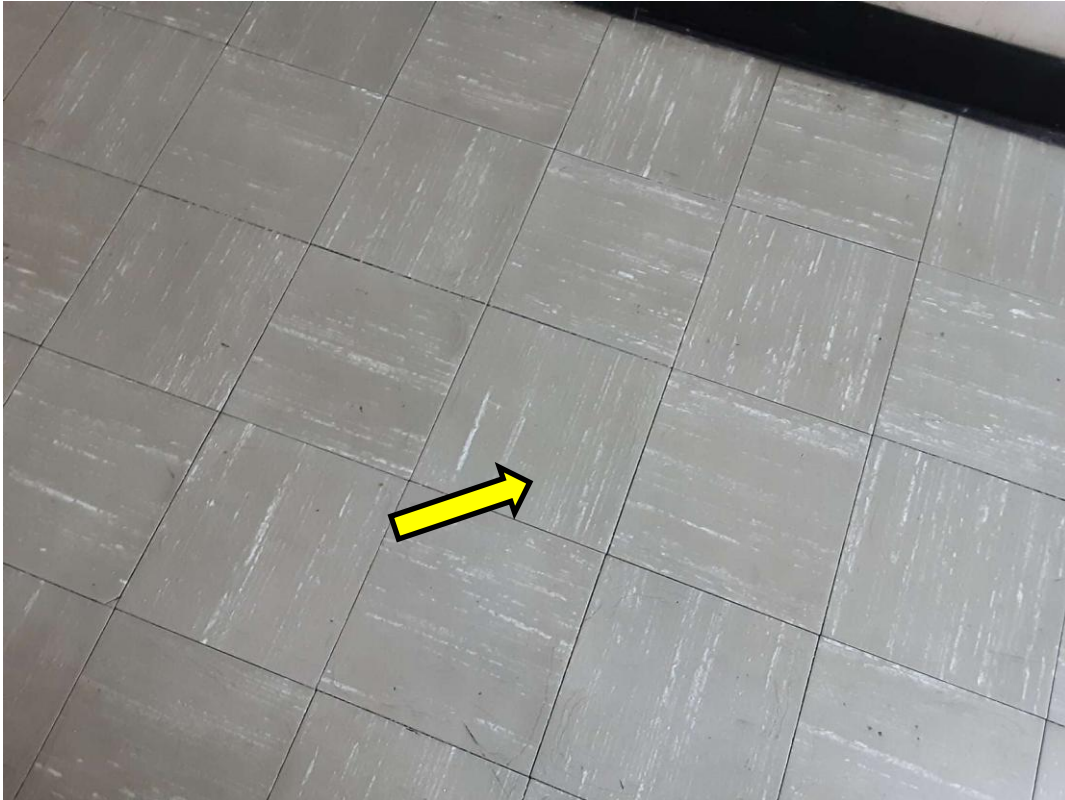
V0052 (Confirmed Asbestos), 12" x 12" Olive with white streaks; S0052B; phase c, Floor, Floor Levelling Compound, Corridor (Location #: 7696)

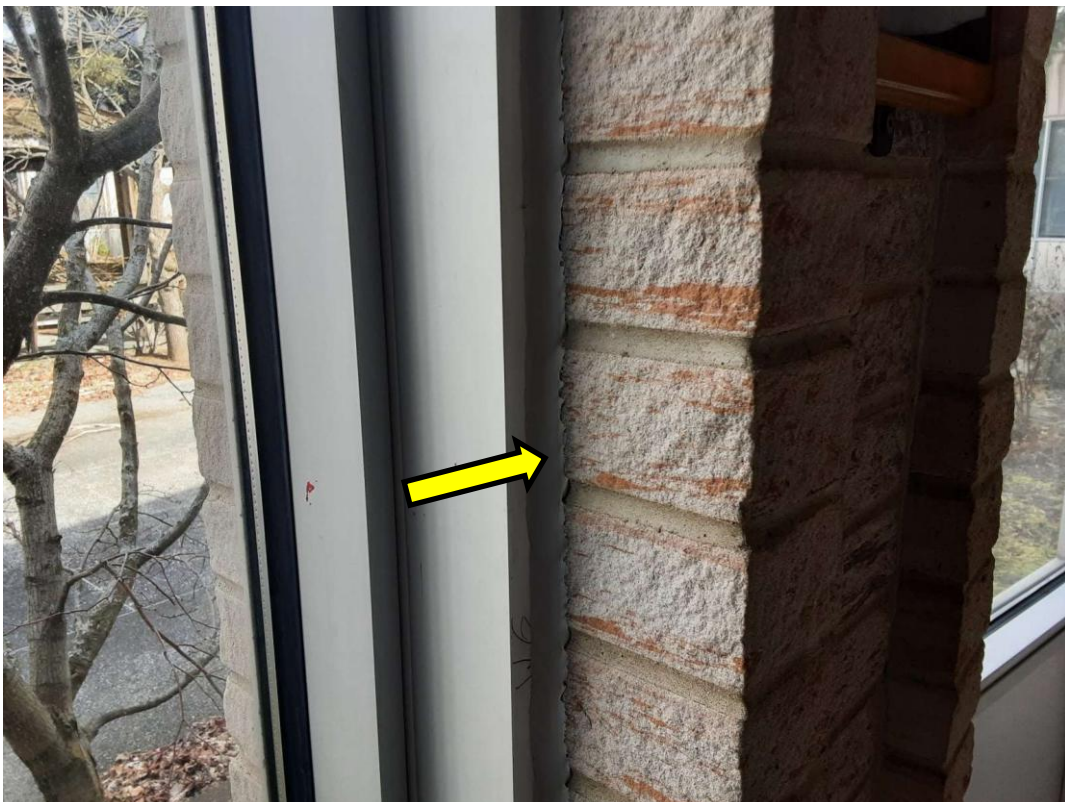
V0053 (None), Grey on window frame, Wall, Window, Caulking, Corridor (Location #: 7596)

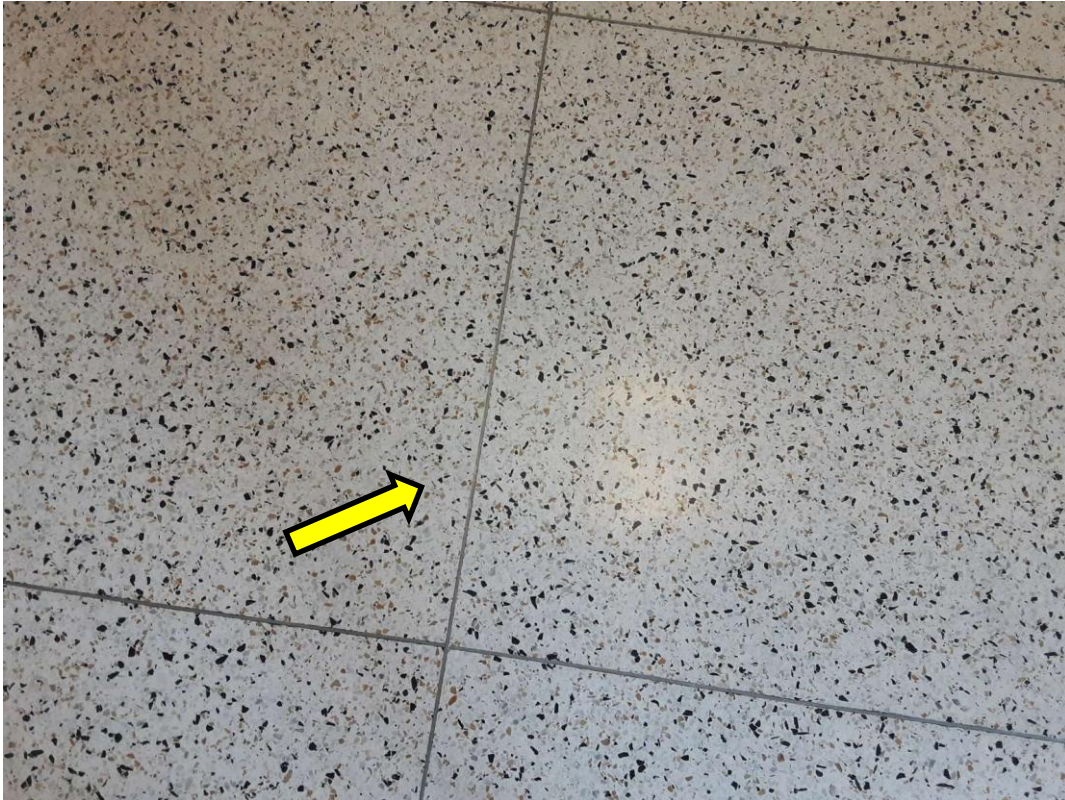
V0054 (None), Beige, Floor, All, Terrazzo, Corridor (Location #: 7596)

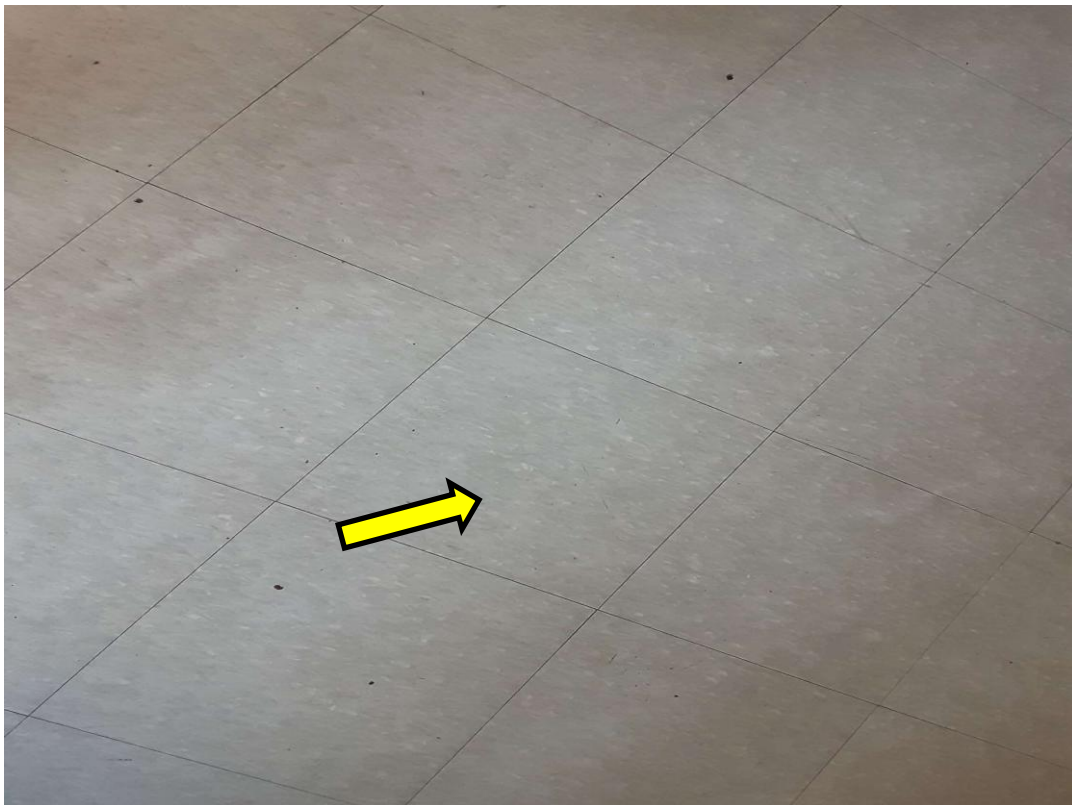
S0056A (None), 12" x 12" Beige with flecks, Floor, All, Vinyl Floor Tile and Mastic, Corridor (Location #: 7744)

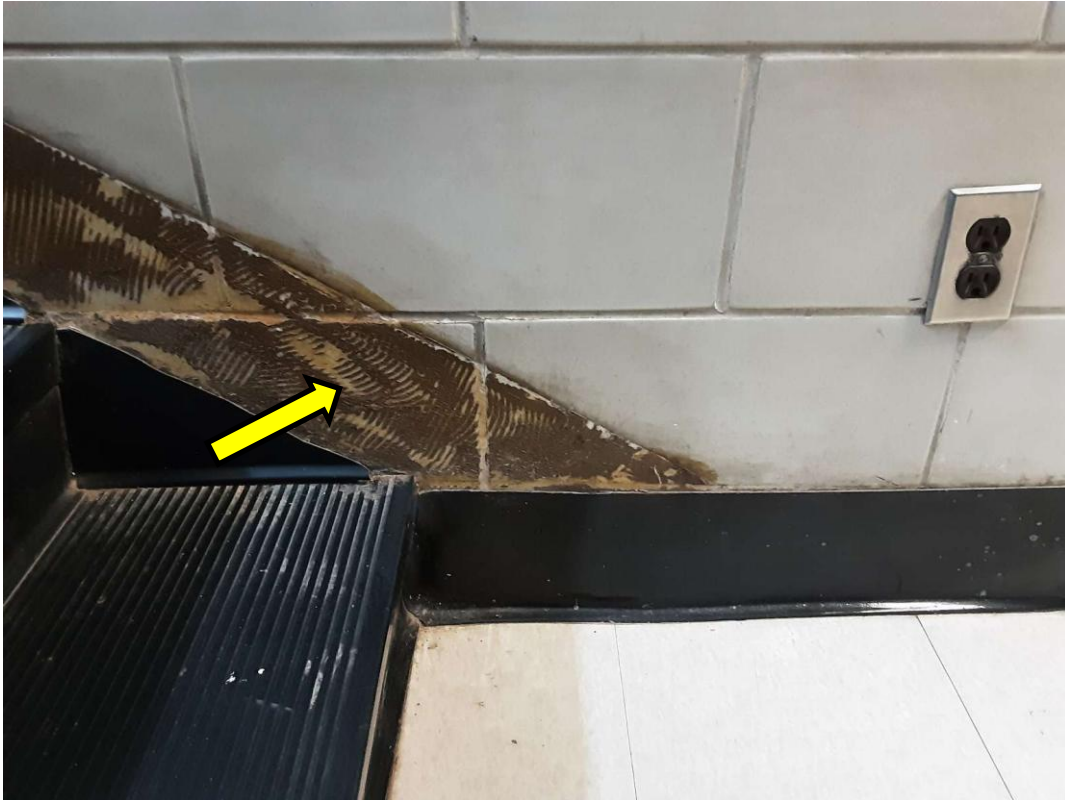
S0058B (None), Brown on black baseboard, Wall, Base, Adhesive/mastic, Corridor (Location #: 7744)

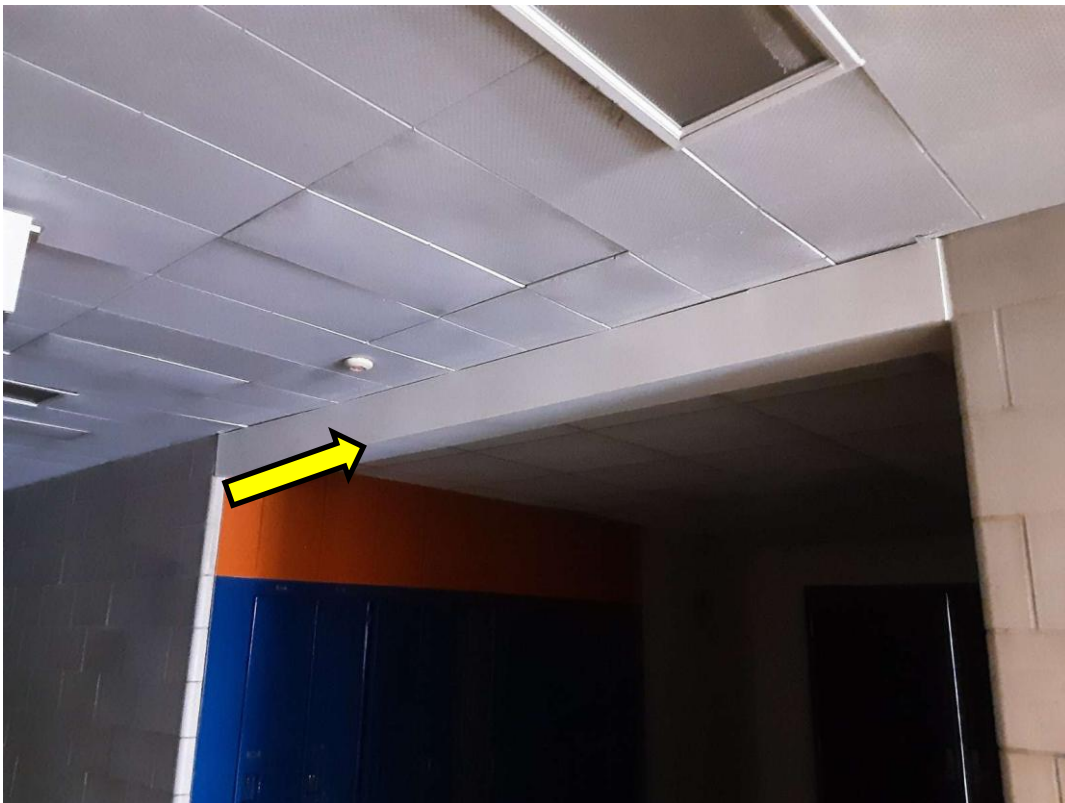
S0059B (None), Ceiling, Bulkhead, Drywall and joint compound, Corridor (Location #: 7696)

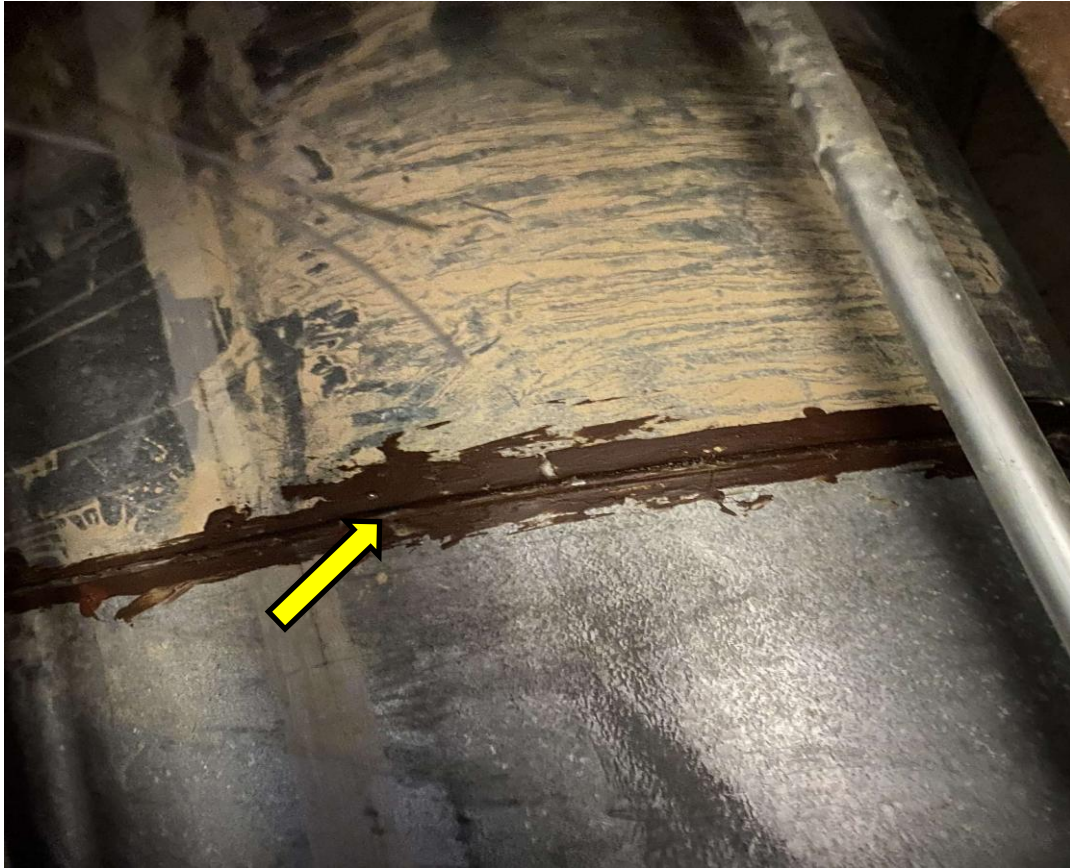
S0062B (Confirmed Asbestos), Dark Brown, Duct, Mastic, Corridor (Location #: 7554)

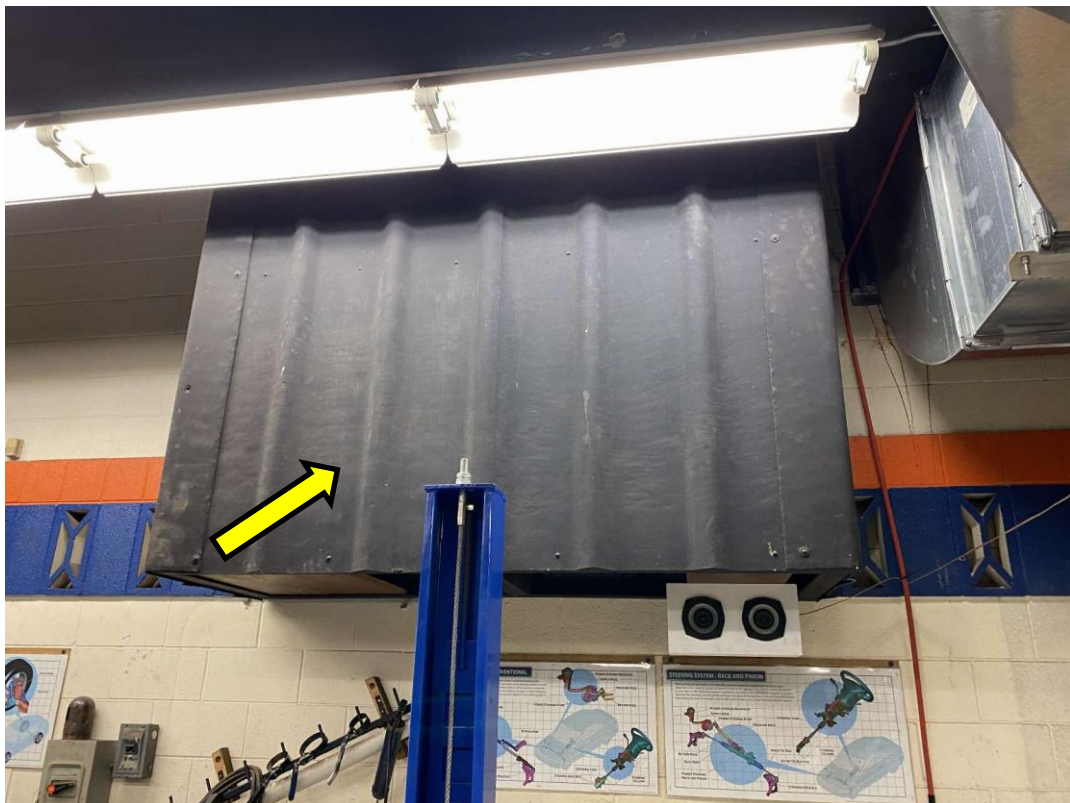
V0064 (Confirmed Asbestos), Transite, Other, Cement Product, Classroom (Location #: 7558)

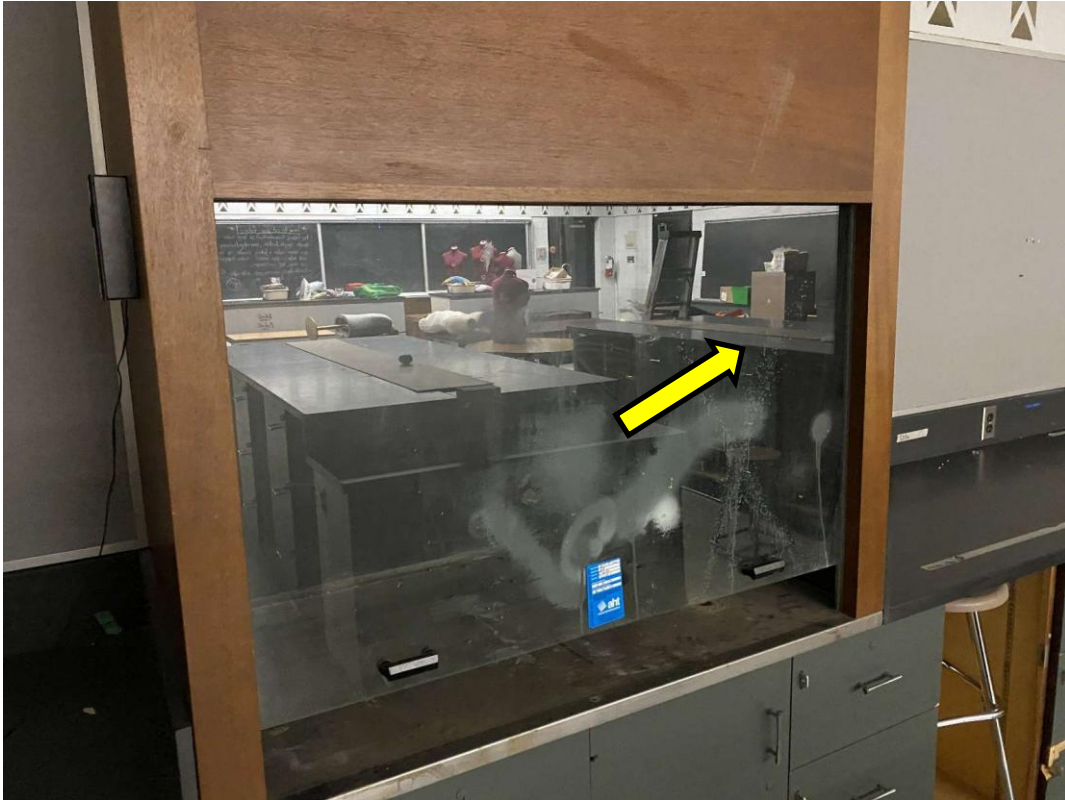
V0064 (Confirmed Asbestos) , Transite, Other, Fumehood, Cement Product, Classroom (Location #: 7689)

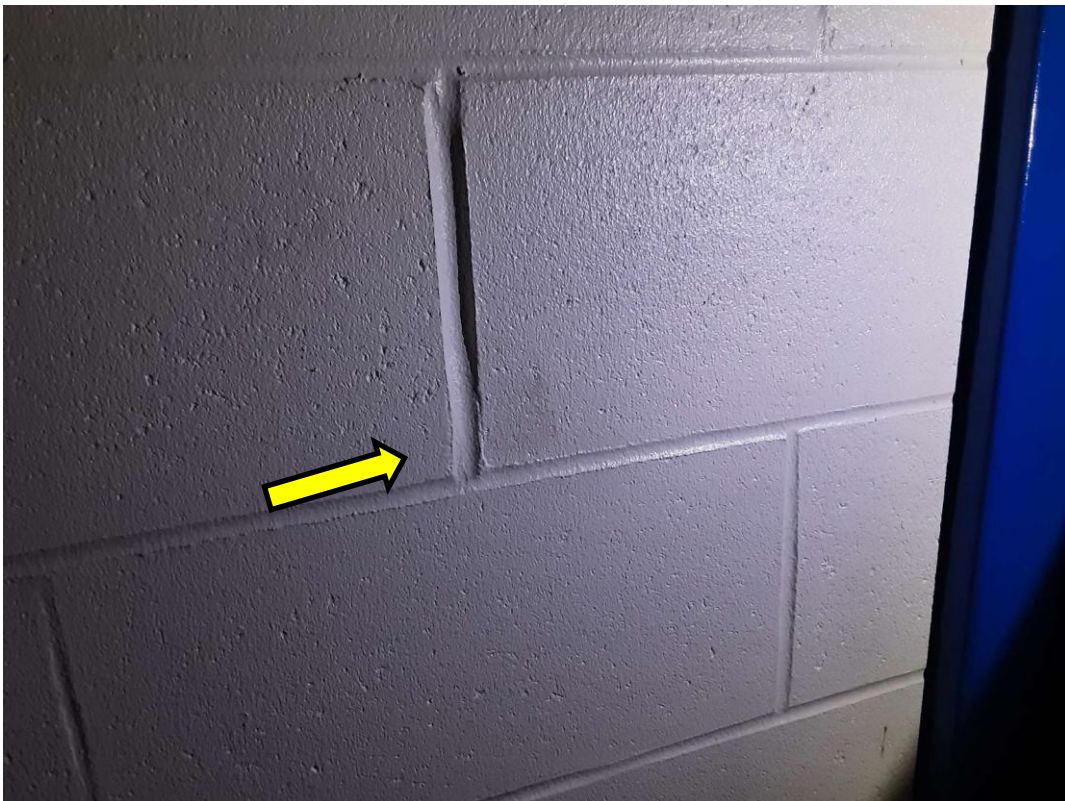
S0065F (None), Concrete block, Wall, Paint, Corridor (Location #: 7708)

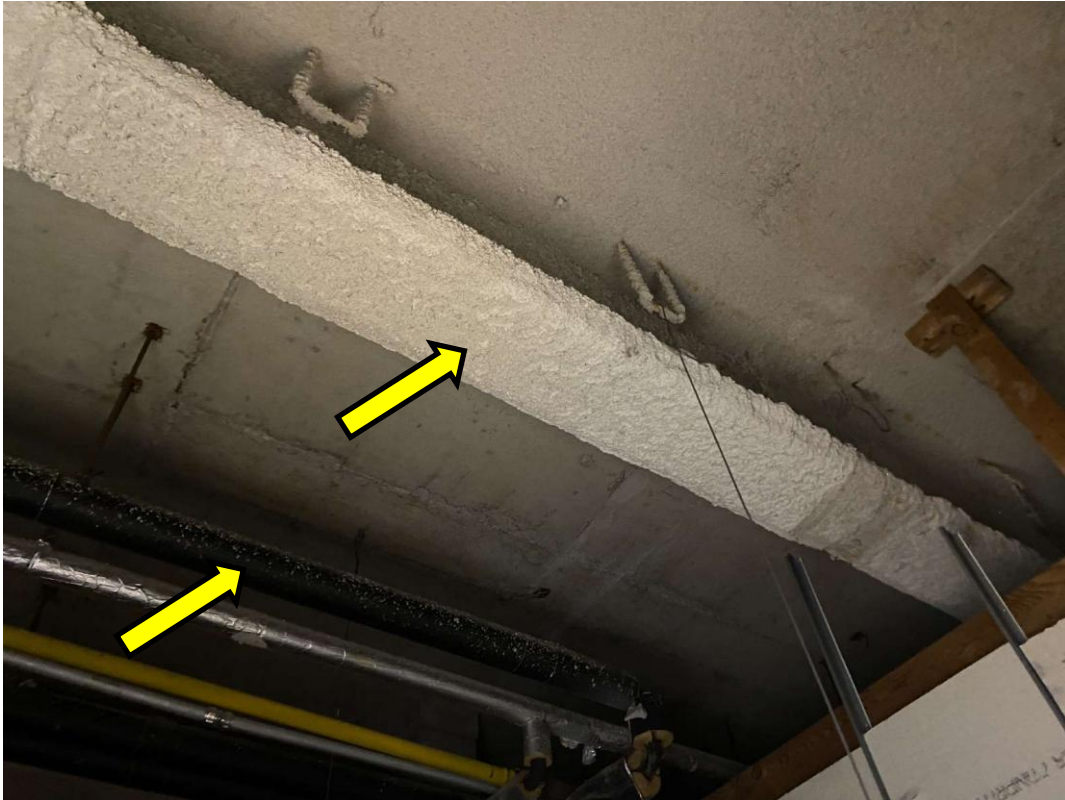
S0067A (Confirmed Asbestos), Structure, Fireproofing (Cementitious) and overspray, Classroom (Location #: 7561)

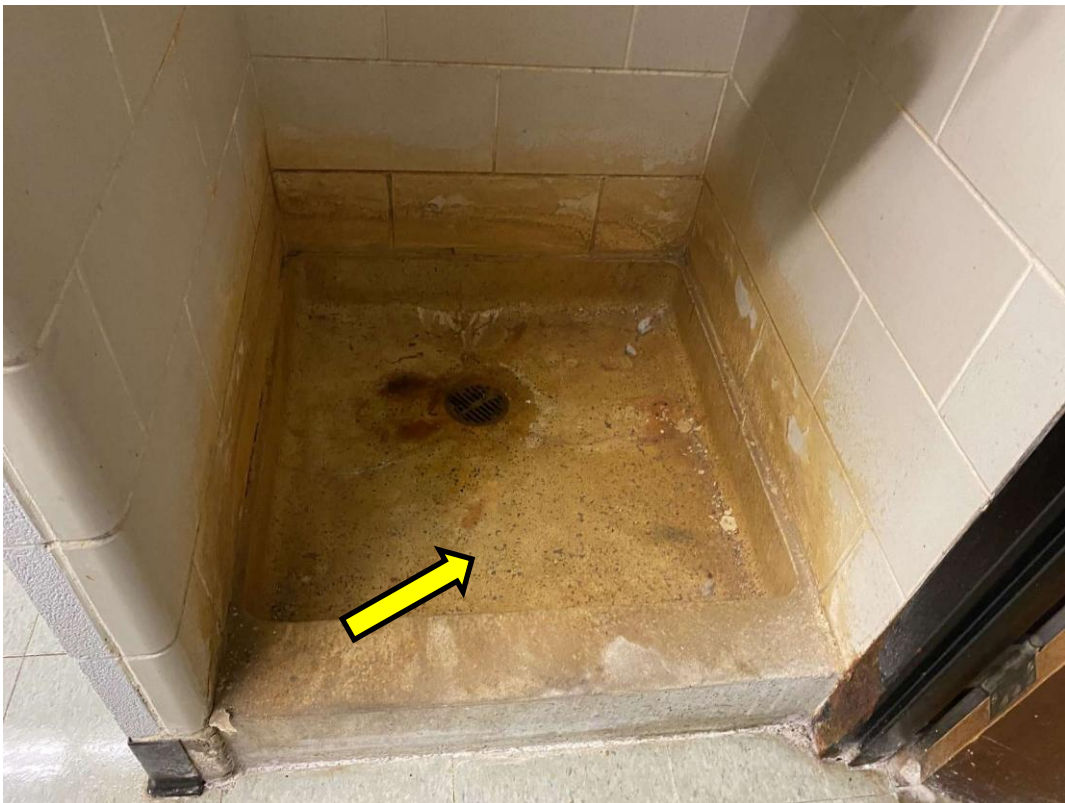
S0068A (None), Floor, Terrazzo, Classroom (Location #: 7689)

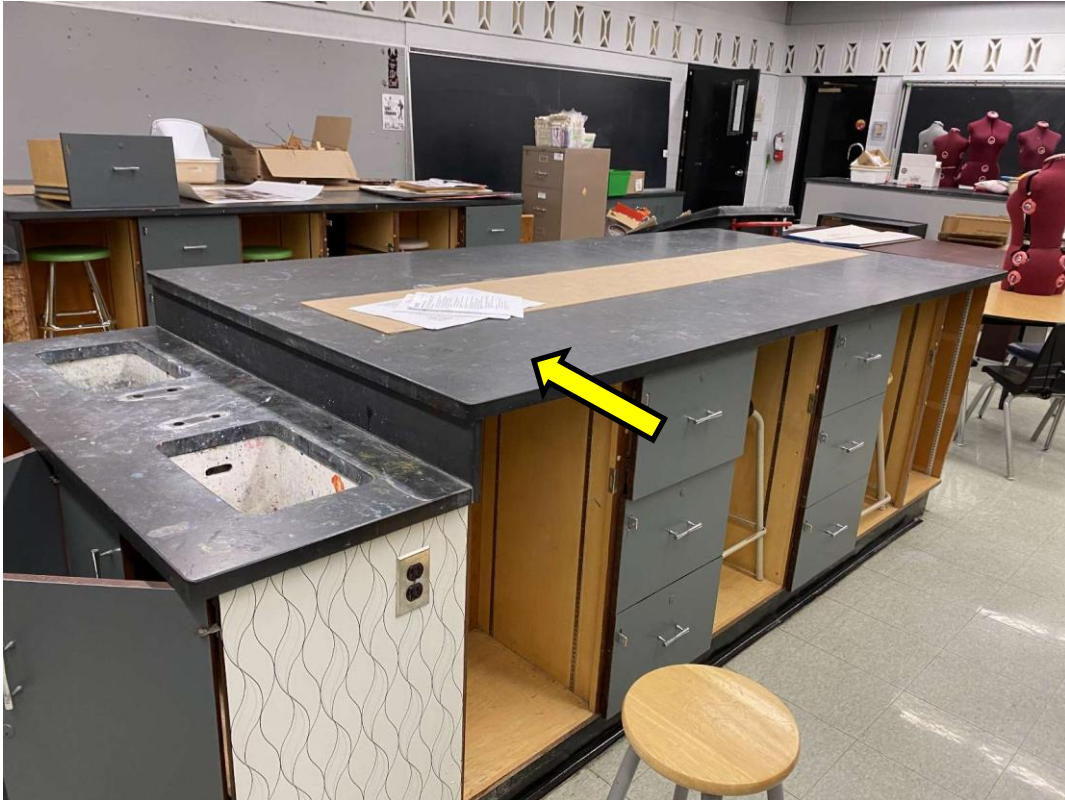
S0069A (Confirmed Asbestos), Other, Bakelite, Classroom (Location #: 7689)

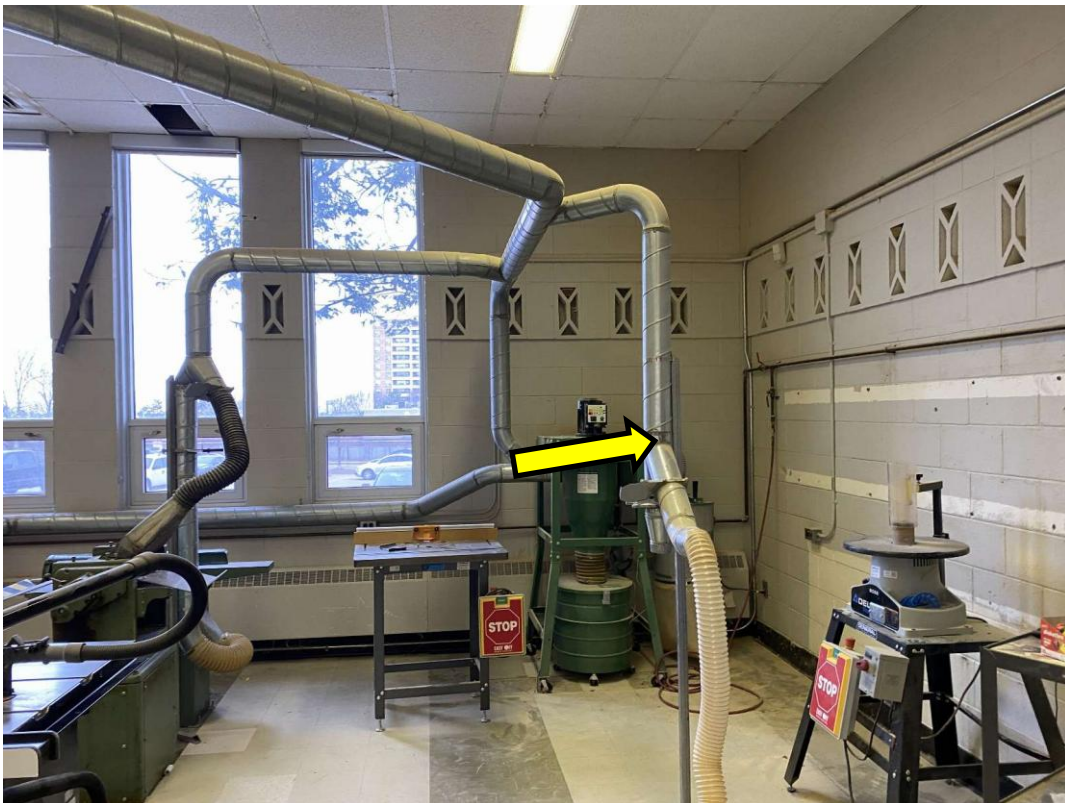
S0071A (None), Duct, Mastic, Grey, Classroom (Location #: 7561)

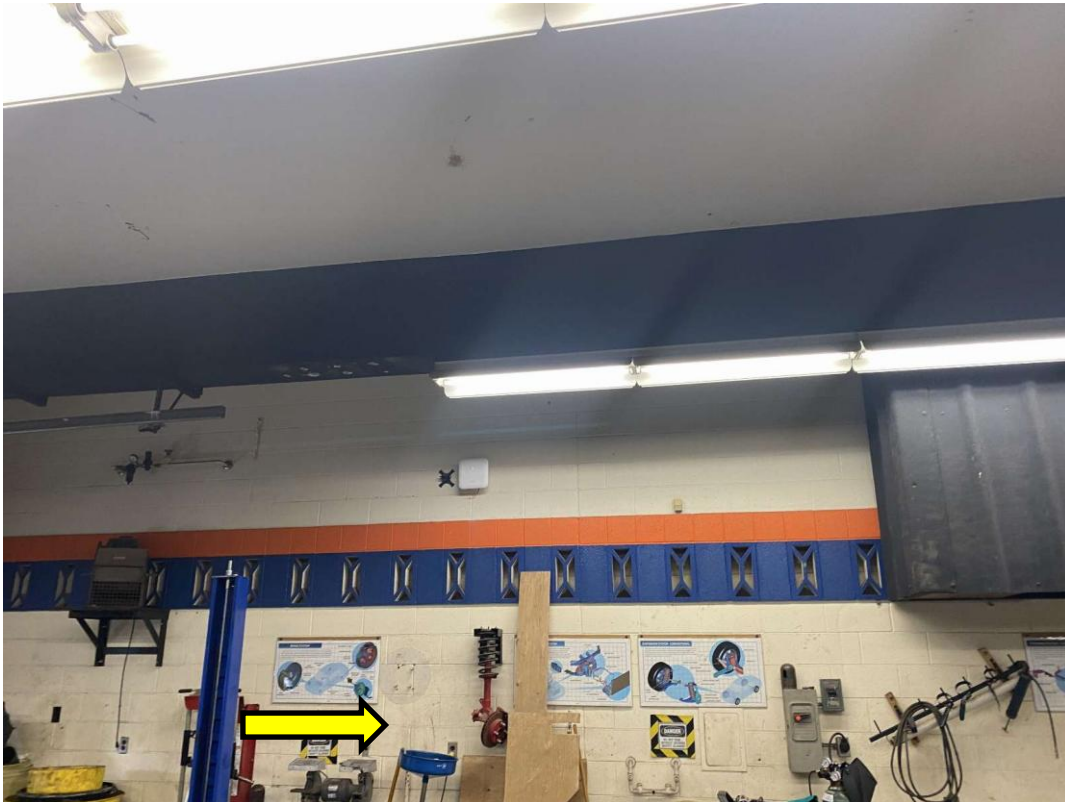
S0072A (None), Concrete block, Wall, Paint, Classroom (Location #: 7558)

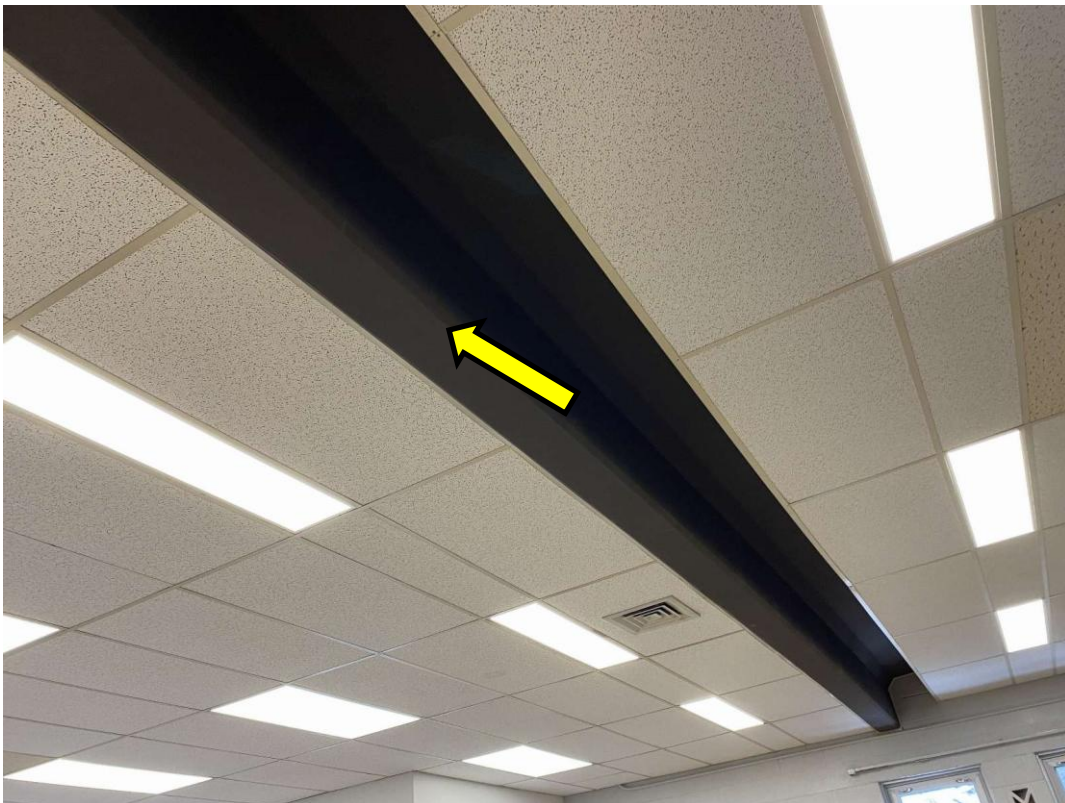
S0073A (Confirmed Asbestos), Structure, Paint, Classroom (Location #: 7689)

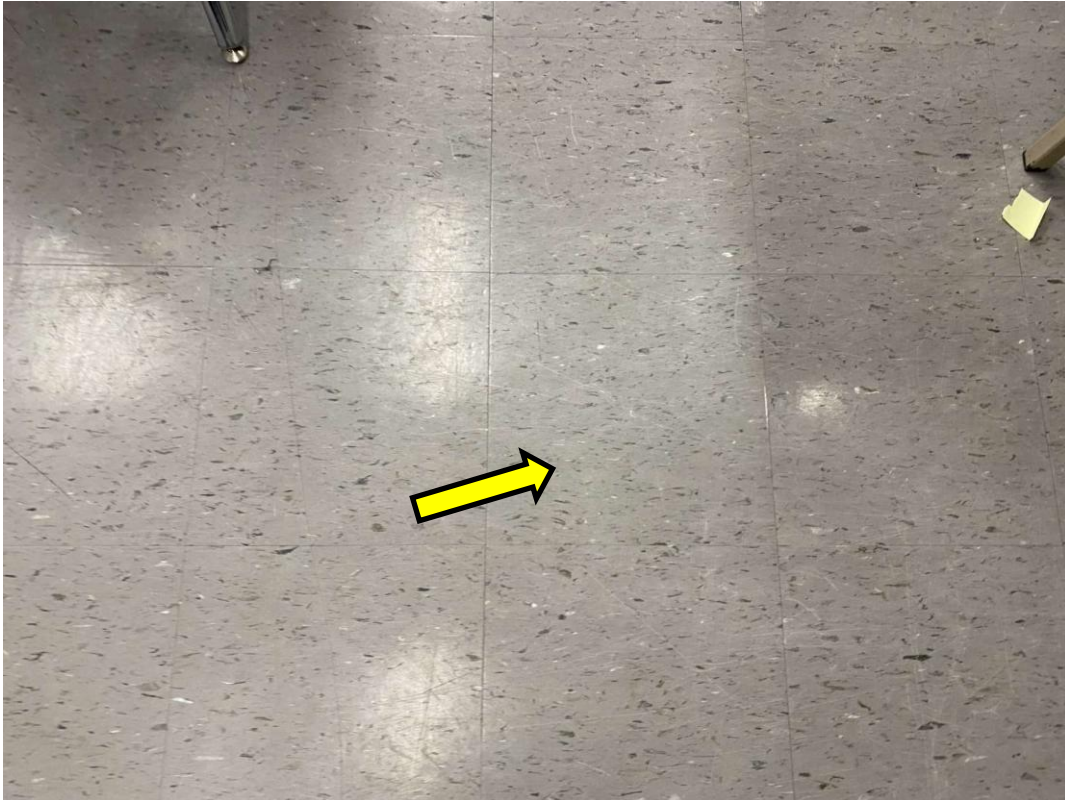
S0074A (None), 12x12 grey with fleck, Floor, Vinyl Floor Tile and Mastic, Classroom (Location #: 7697)

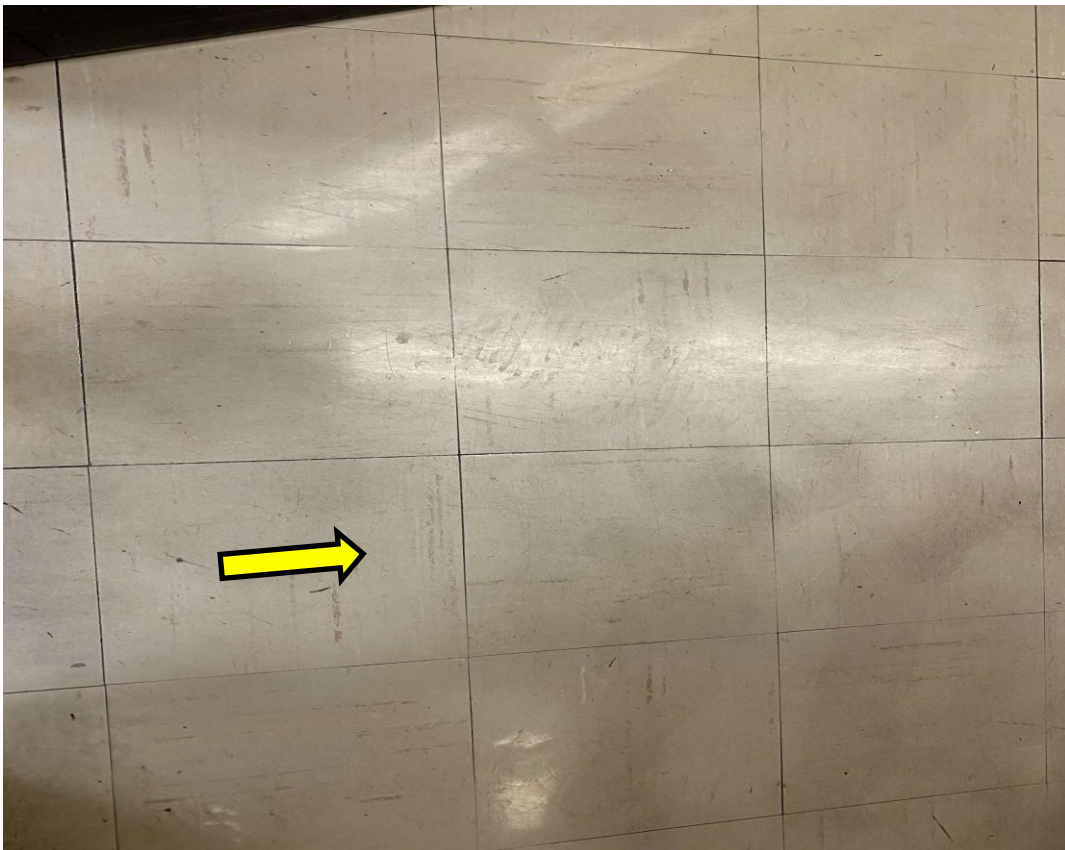
S0075A (None), 12x12 beige with brown streaks, Floor, Vinyl Floor Tile and Mastic, Office (Location #: 7698)

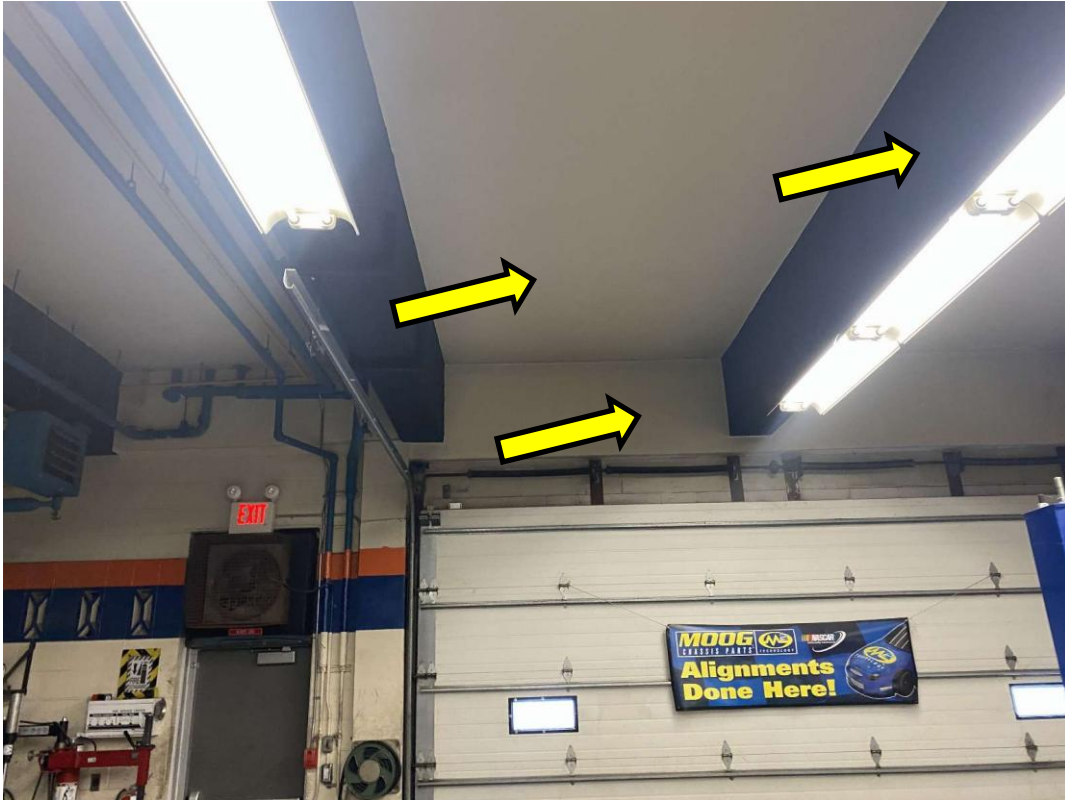
S0076A (Confirmed Asbestos), Structure, Paint, Classroom (Location #: 7558)

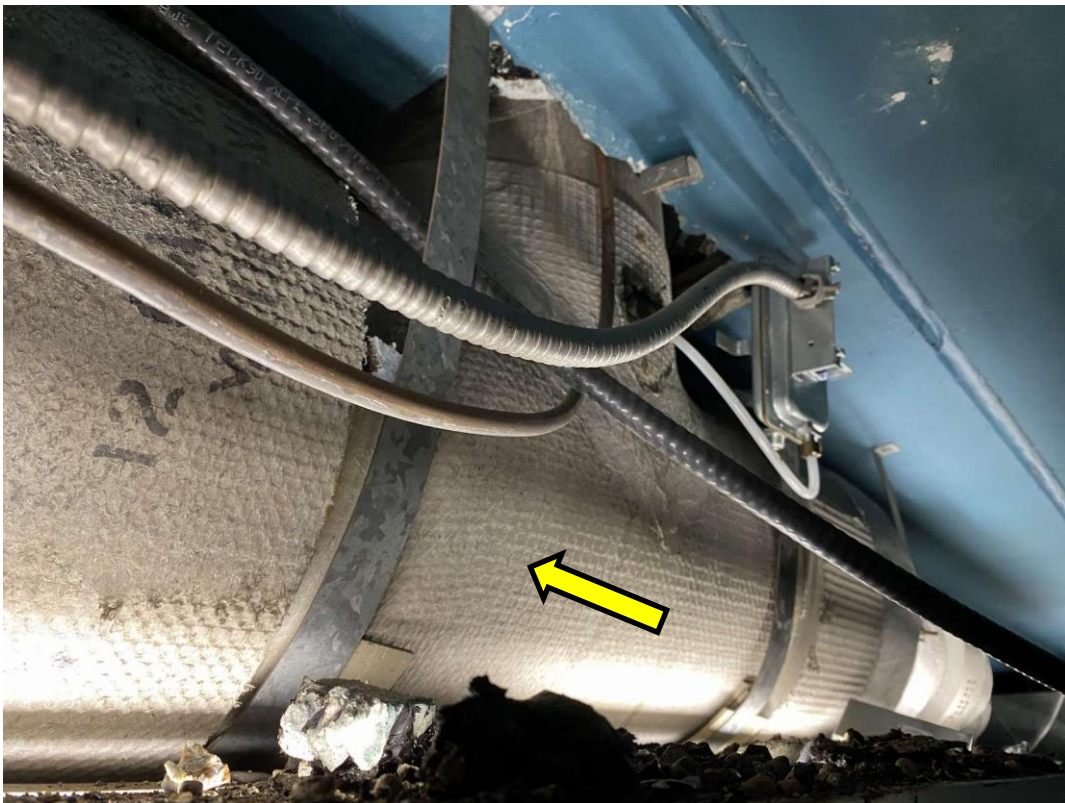
V9500 (Presumed Asbestos), Transite, Piping, Cement Product, Classroom (Location #: 7689)

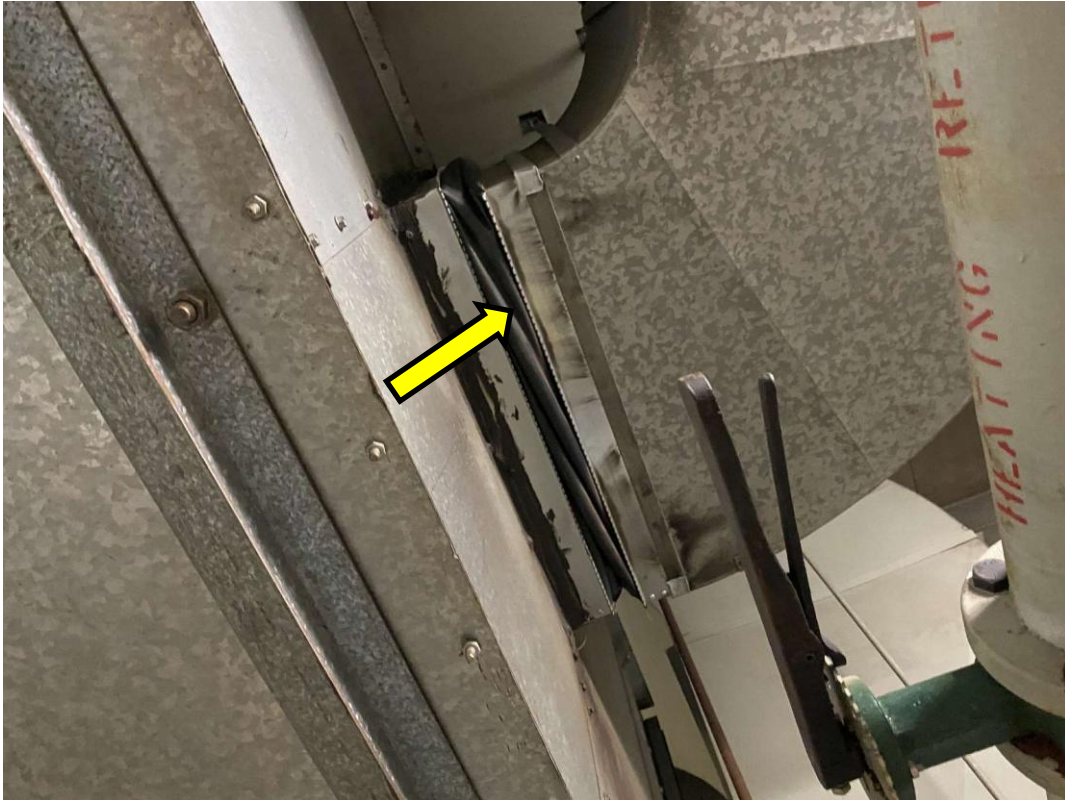
V9500 (Presumed Asbestos), Textile vibration damper, Duct, Exhaust, Textile, Mechanical Room (Location #: 7692)

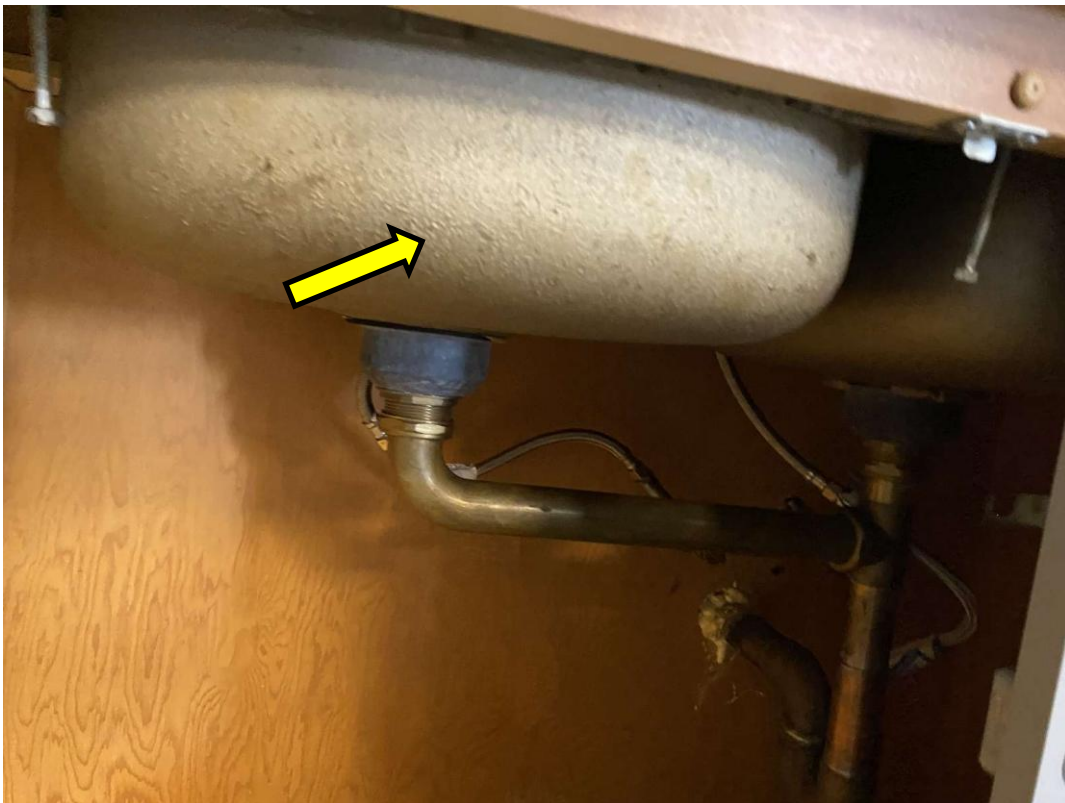
V9500 (Presumed Asbestos), Other, Sink, Mastic, Gold, Classroom (Location #: 7697)
